**Cherry Orchard  
Development  
Preliminary and Detailed  
Site Investigation**

**Rippon Holdings Limited  
and Rippon Investments  
Limited**

*March 2026*

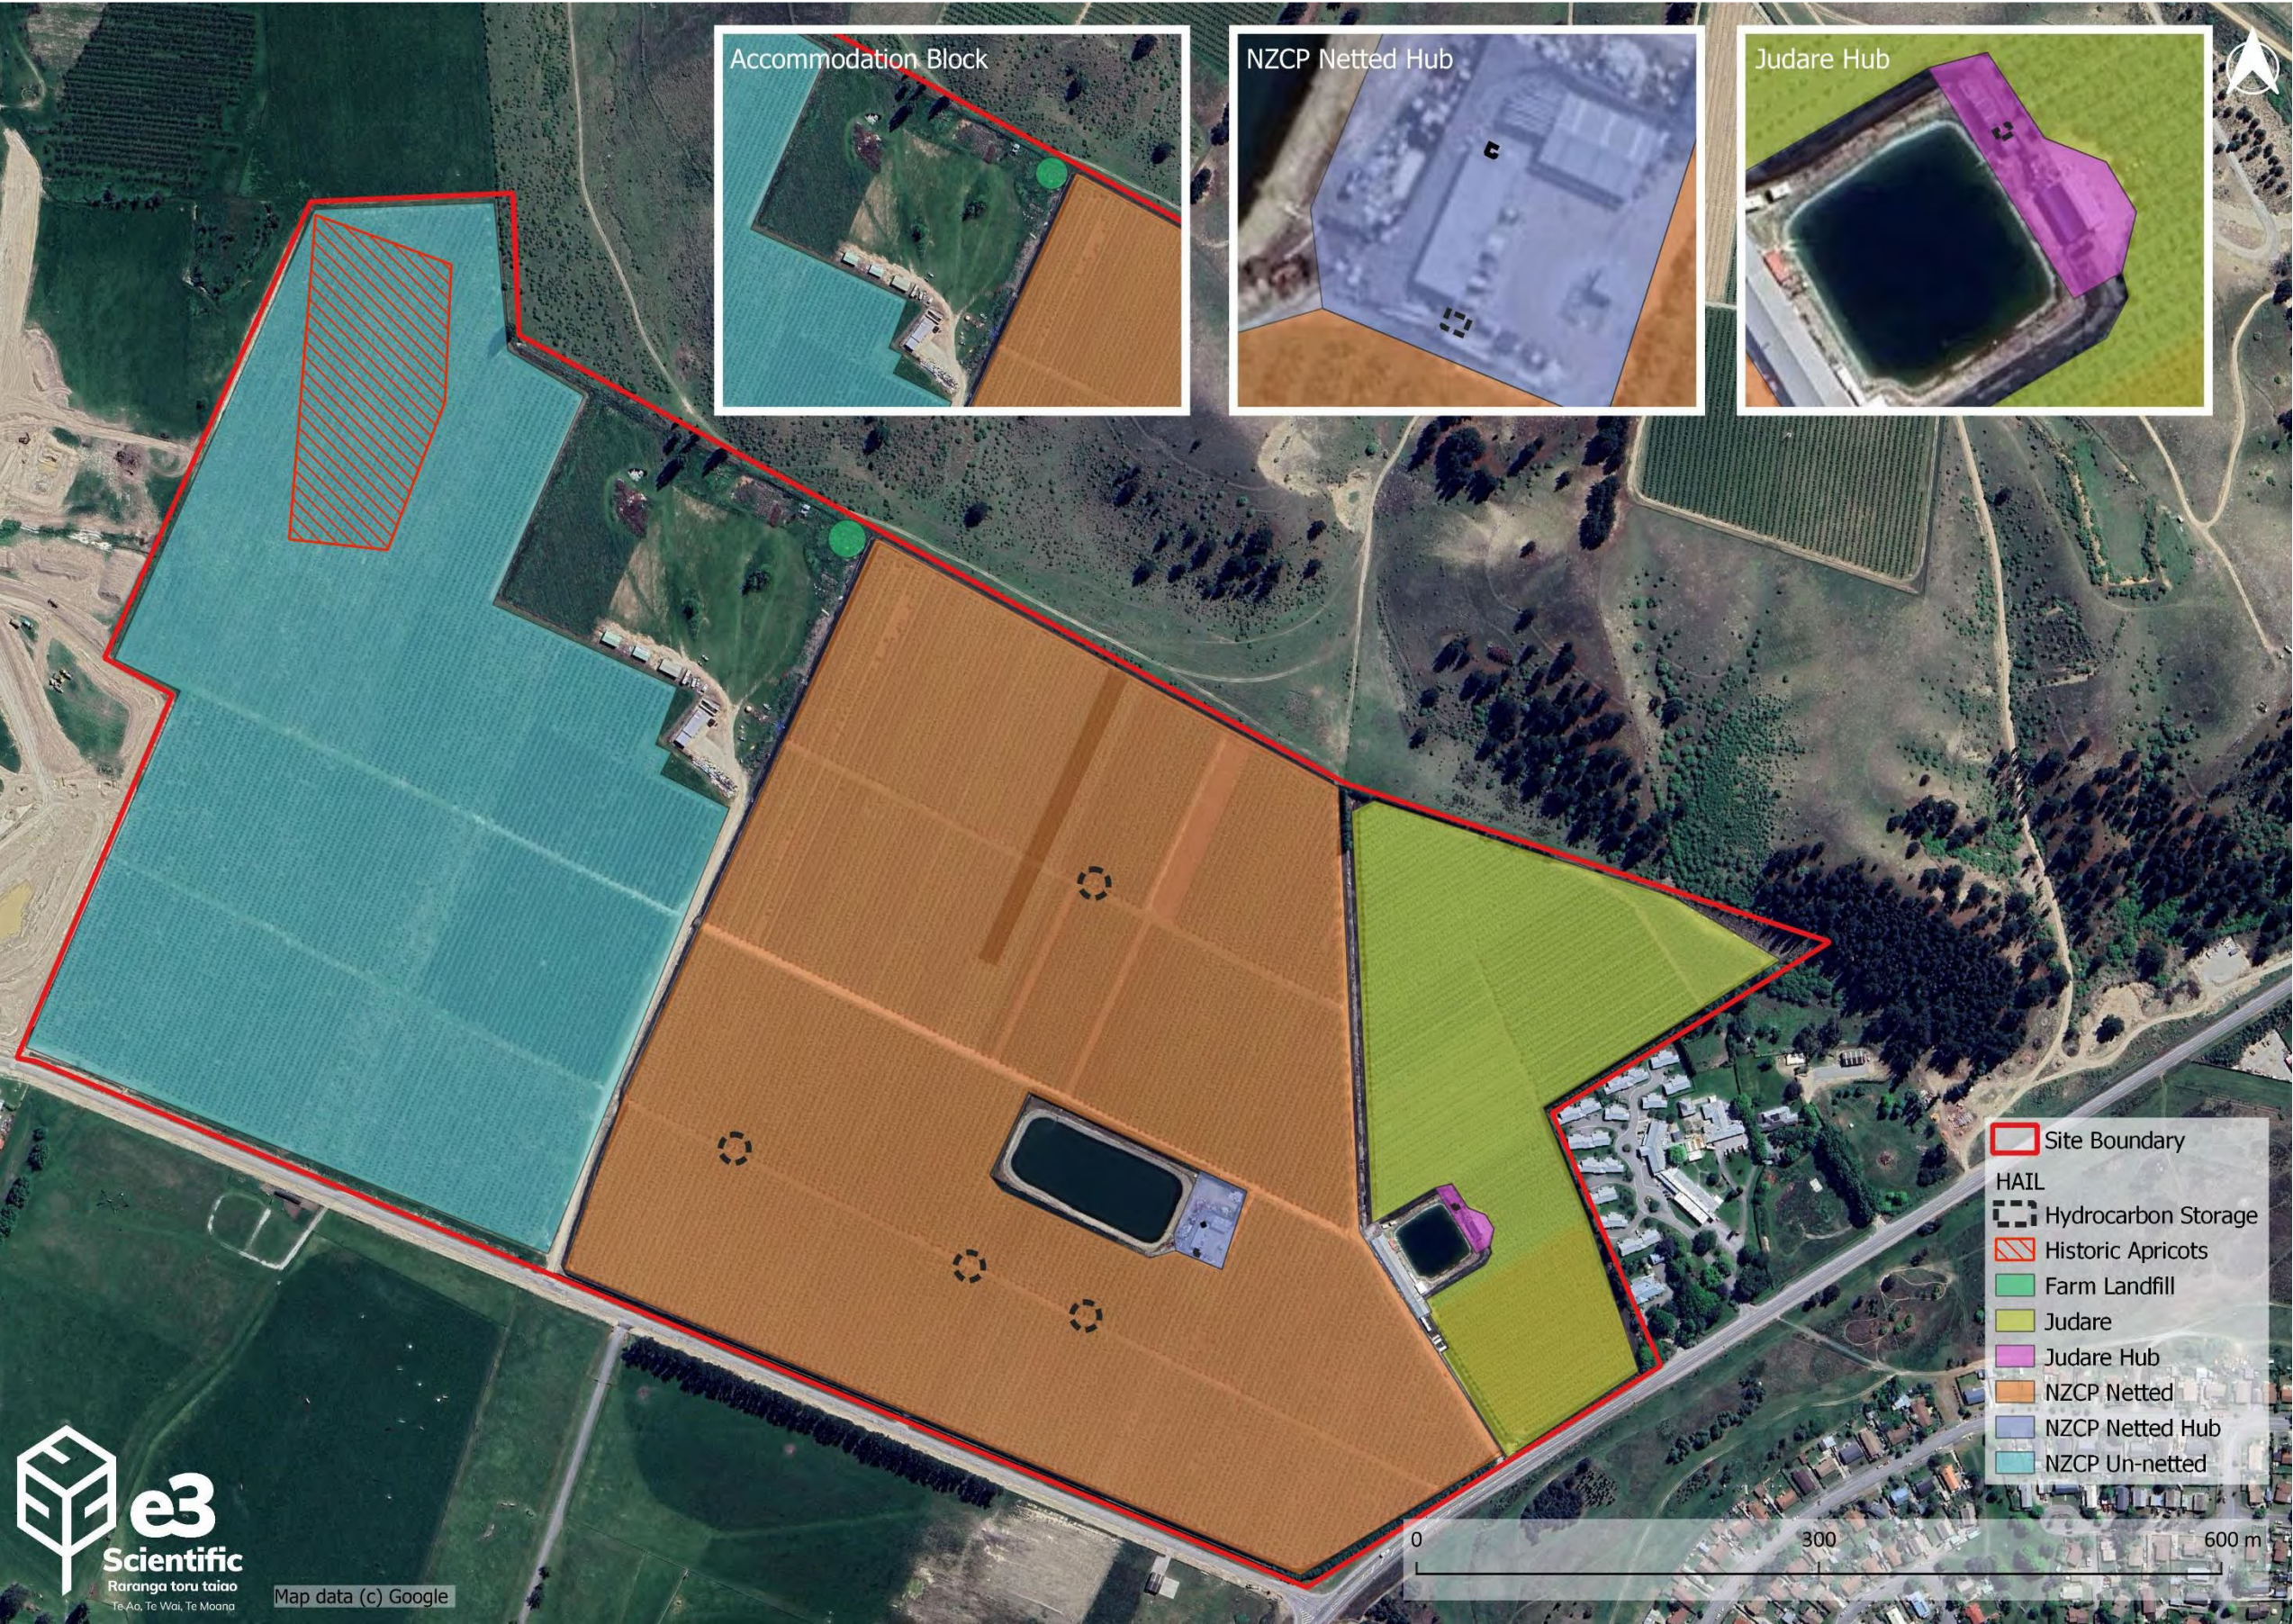
Figure 8: Identified HAIL area

Overall, the established site history spans a period of approximately 120 years and shows a transition from rural pasture to intensive orchard operations, accompanied by typical horticultural HAIL activities such as pesticide application, fuel storage for vehicles and frost fans, and minor on-site disposal of inert waste. Historical records, historic aerial images from 1950 to 2023 (with a maximum gap of 16 years between 1985 and 2001), interviews, and a site inspection collectively demonstrate a well-understood, largely agricultural land-use history with localised contamination sources consistent with orchard operations.

Minor areas of uncertainty include the spray regime at the historic apricot orchard, and the exact contents of the area of fill within the accommodation block.

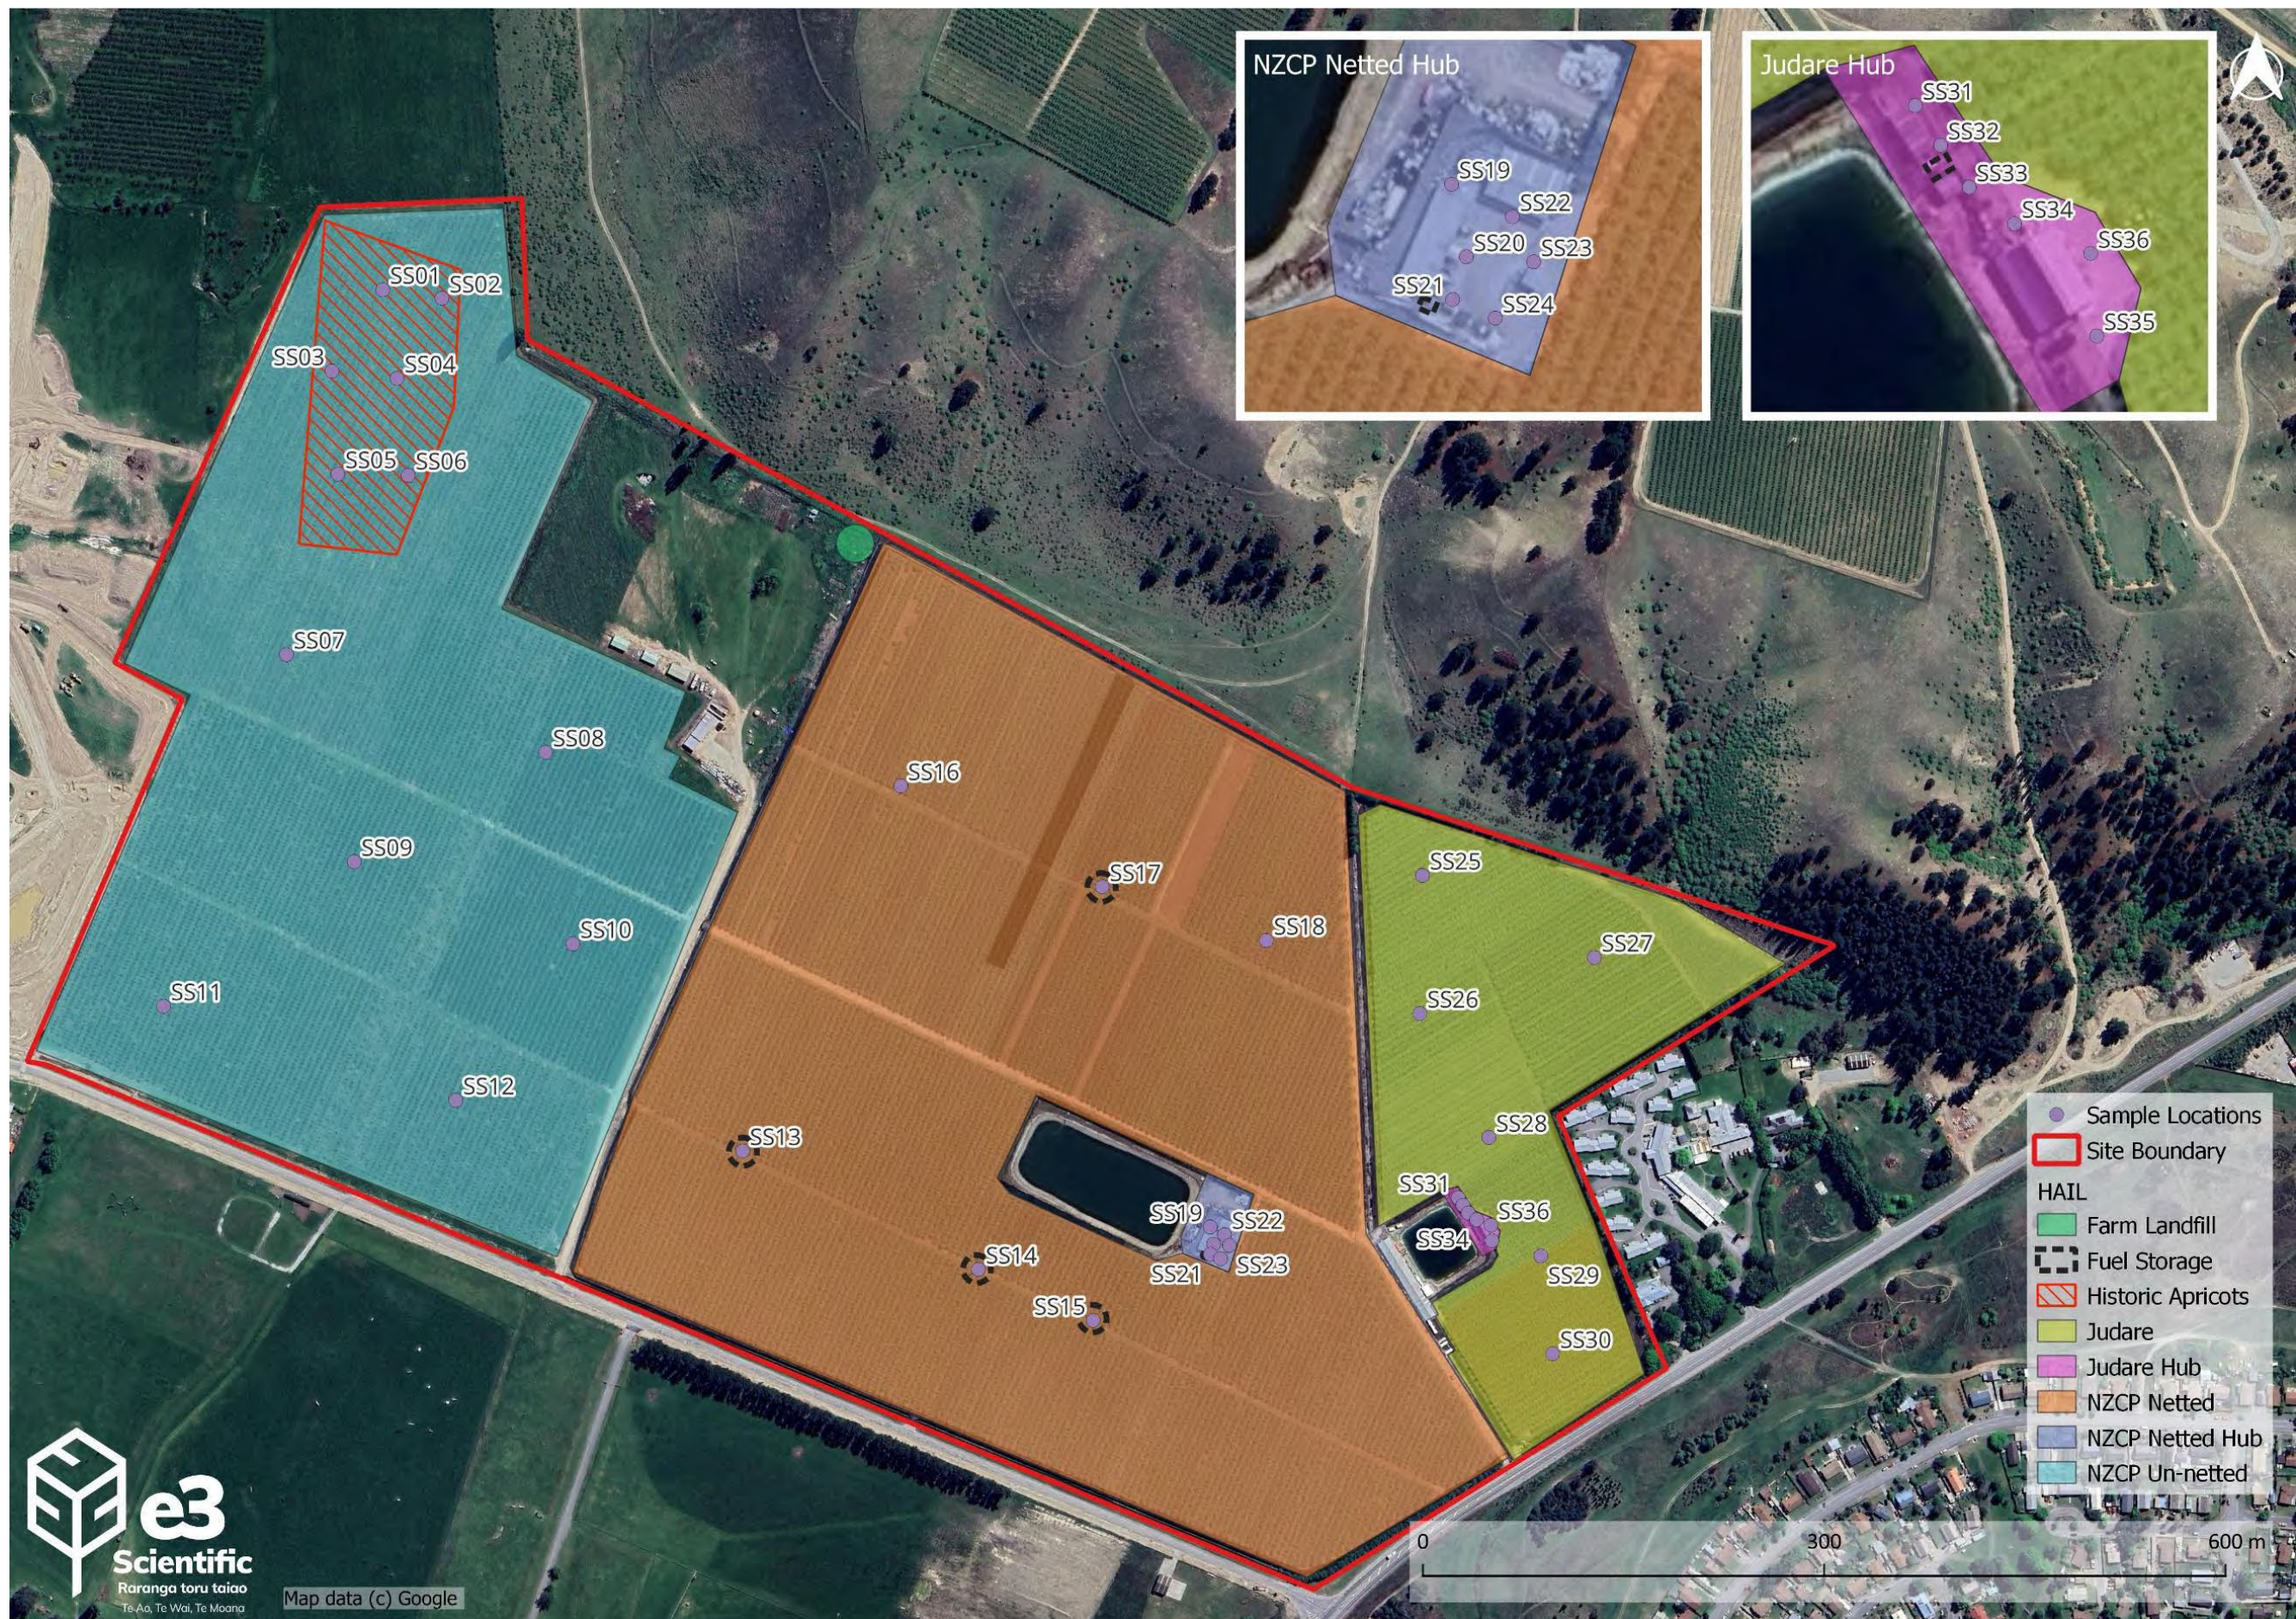
Figure 9: Sample Plan

To characterise contaminants in soil, a stratified sampling approach was adopted. Six samples were collected systematically across each of the orchard areas (the historic apricot orchard, the NZCP netted and unnetted blocks, and the Judare block). Targeted samples were collected from the frost fans, chemical sheds, and workshops.

| Location | Sample ID | Analysis | Rationale |
|---|---|---|---|
| NZCP Netted | SS13-SS18 | Heavy metals<br>TPH (for sample locations adjacent to frost fans) | Characterise contamination associated with current use of pesticides and fuel storage at frost fans |
| Judare Hub | SS31-SS36 | Heavy metals<br>TPH | Characterise contamination associated with storage, use and mixing of pesticides and minor workshop activities |

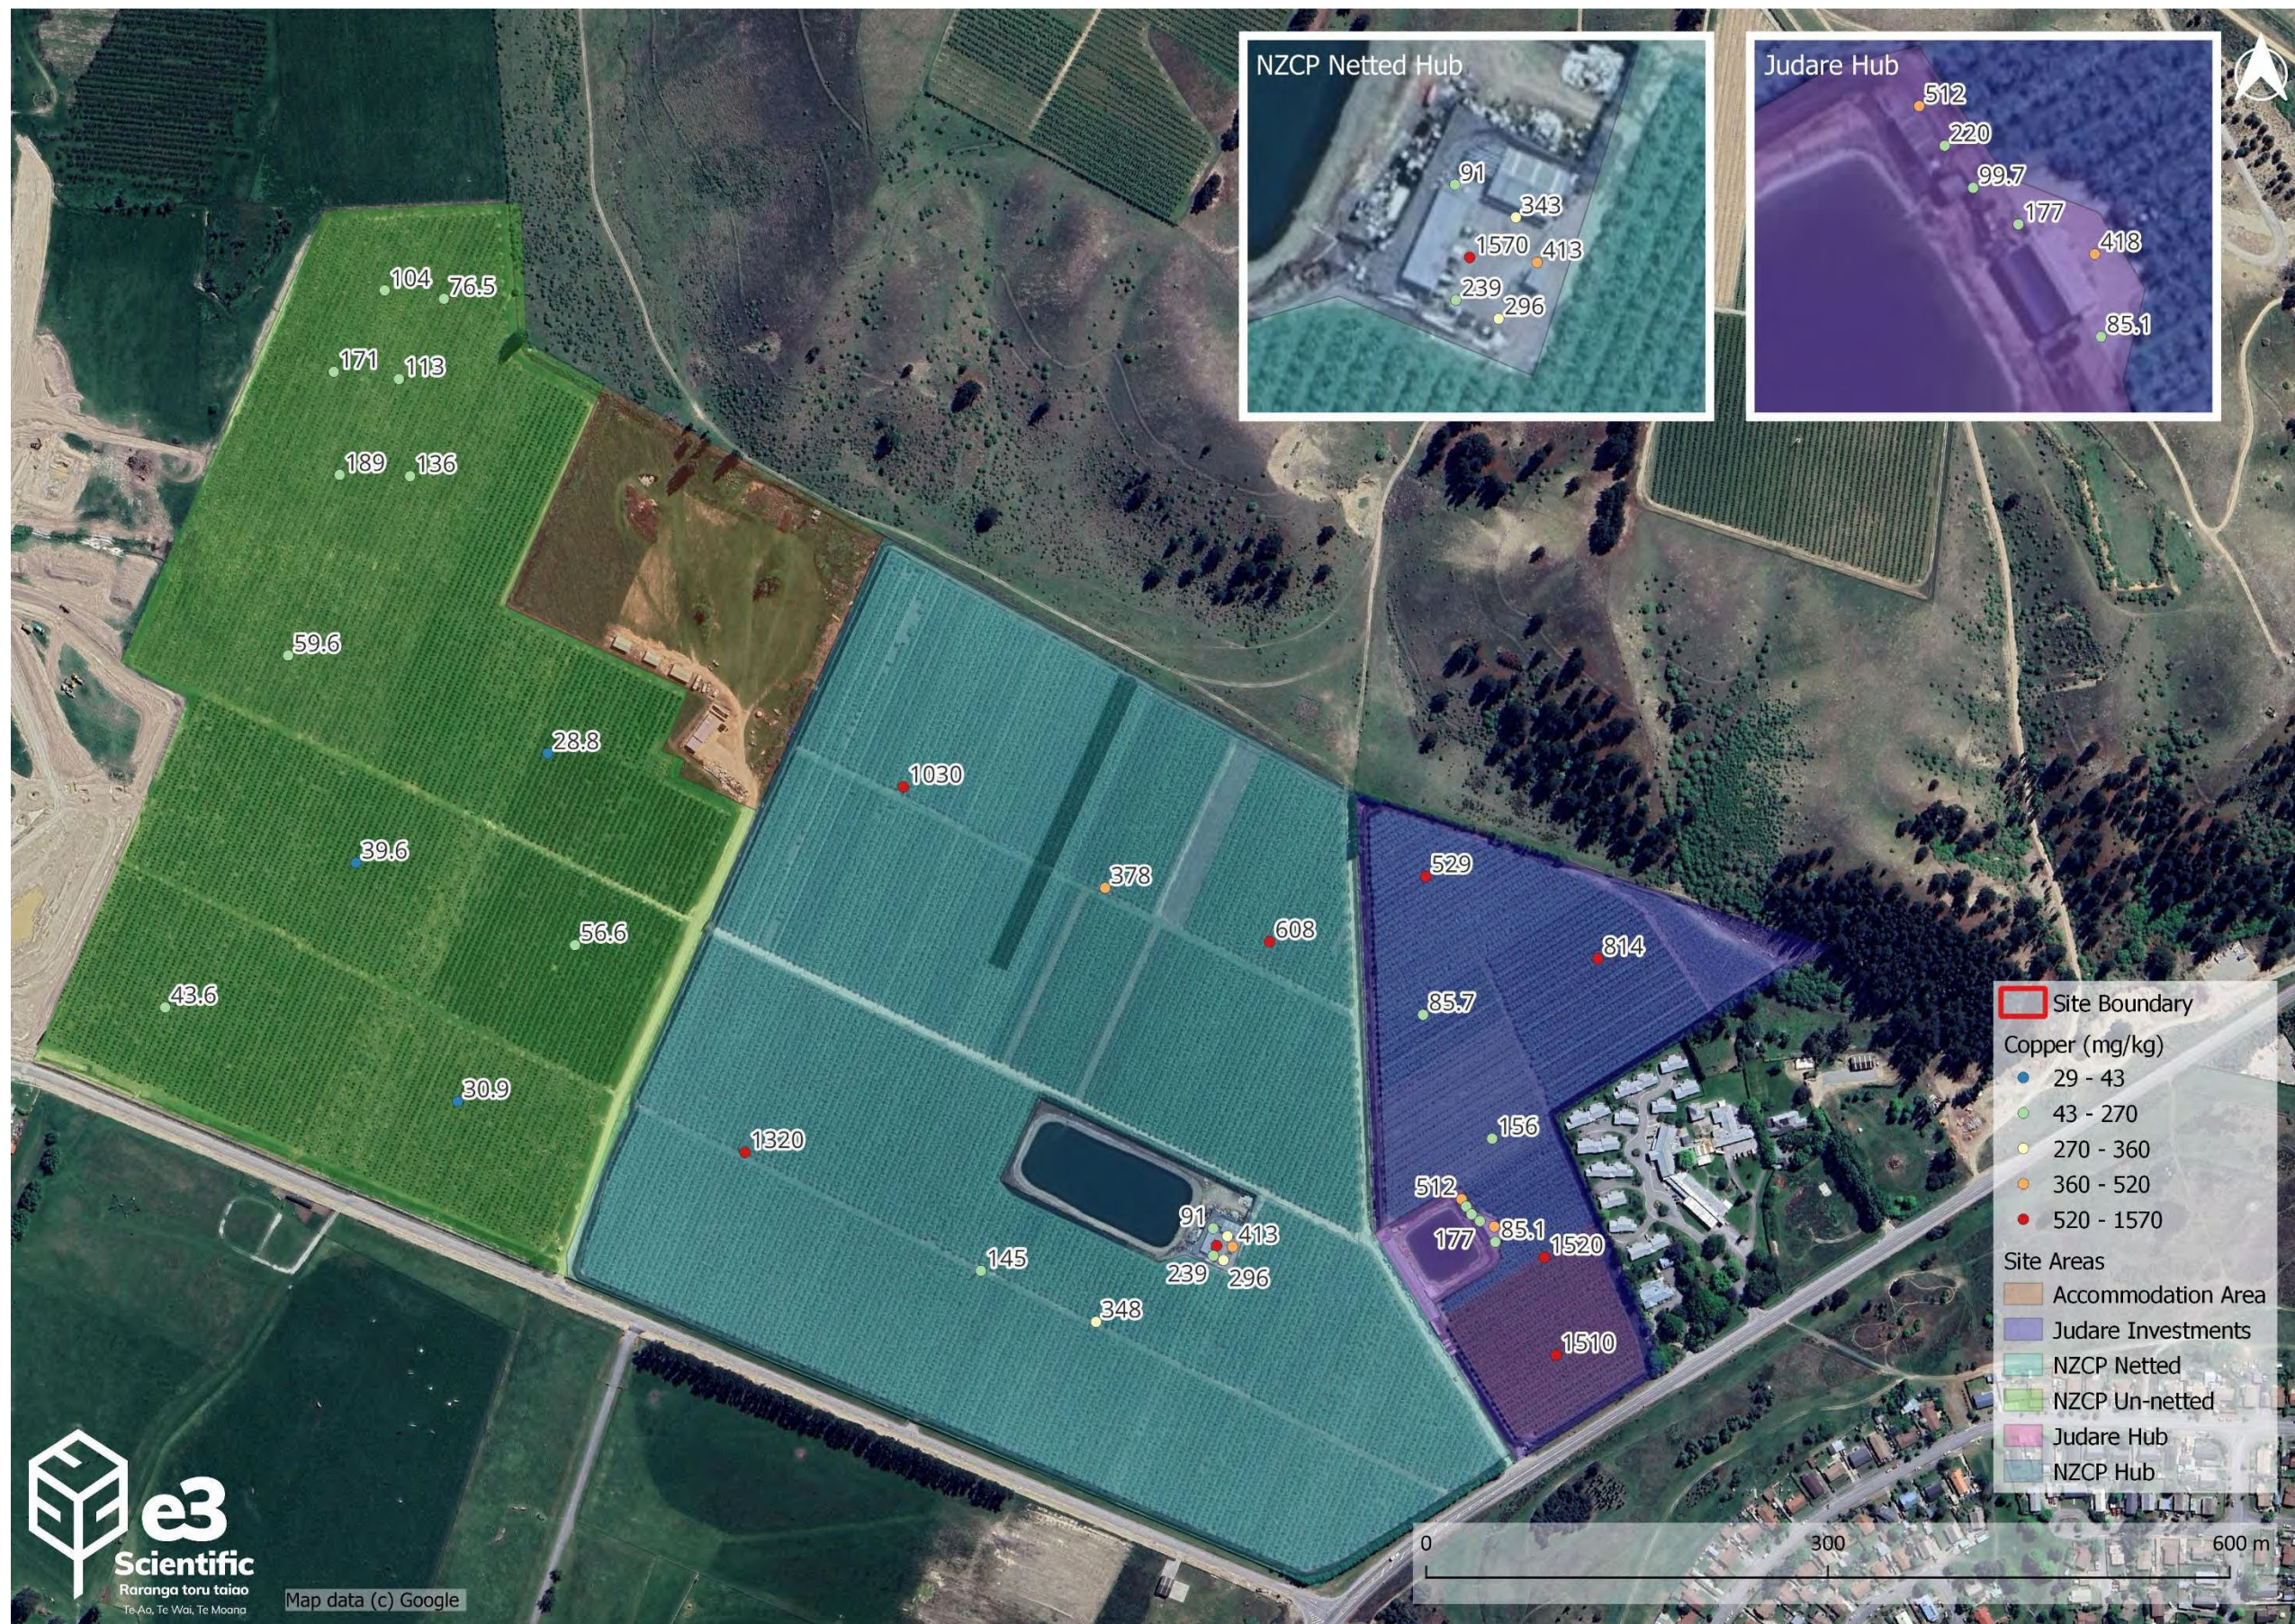
Figure 11: Copper results

The vertical profile of copper concentrations has not been delineated. Generally, we would expect concentrations to decrease within the top 20 to 30 cm of the soil profile, particularly where high organic matter is present.

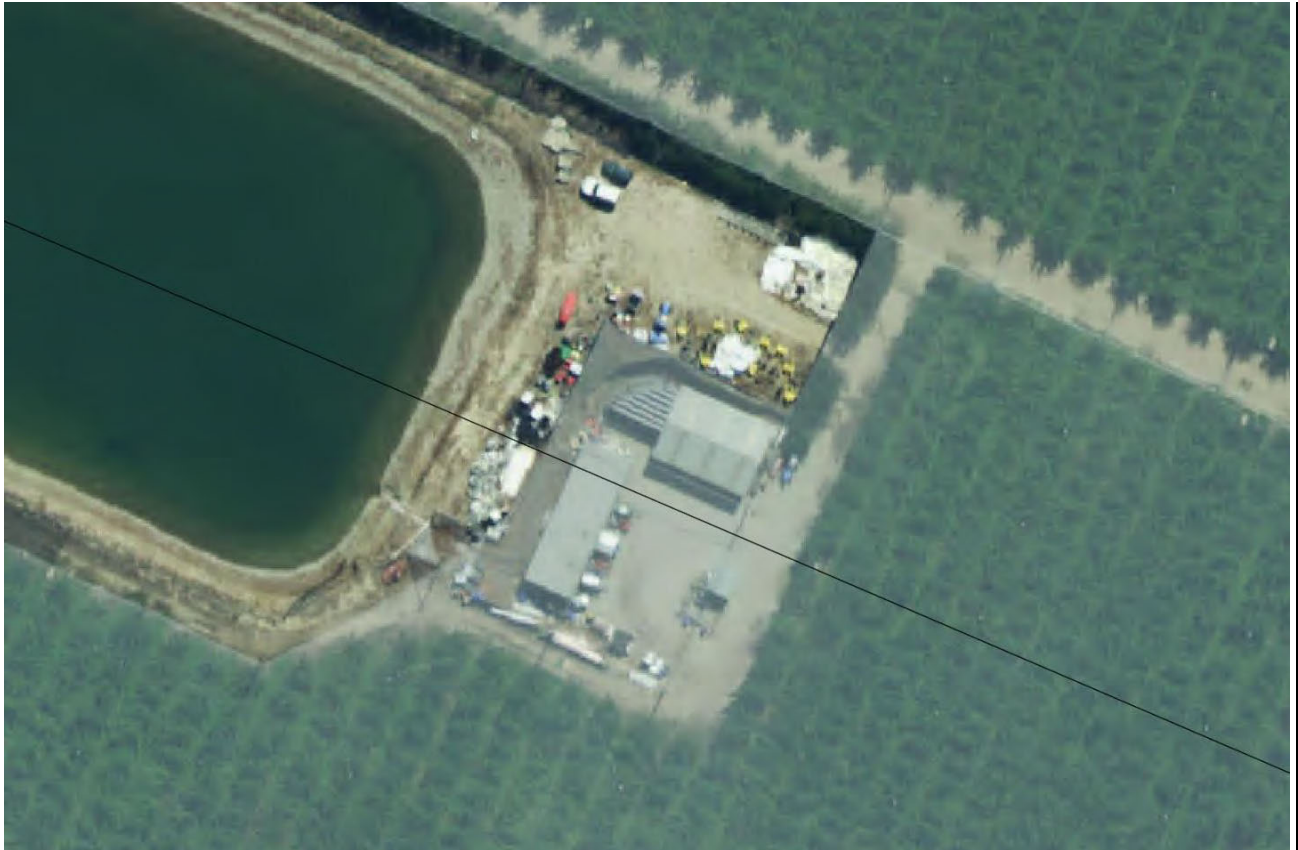
Additionally, aerial photographs show unknown materials storage around the shed on the site. This may include bulk storage of chemicals, bulk storage of persistent pesticides or fuel tanks. These are Items A2, A10 and A17 on the HAIL respectively, and may trigger NES-CS requirements.

Figure Three: Aerial photograph dated 2025 showing unknown aerial storage around the shed.

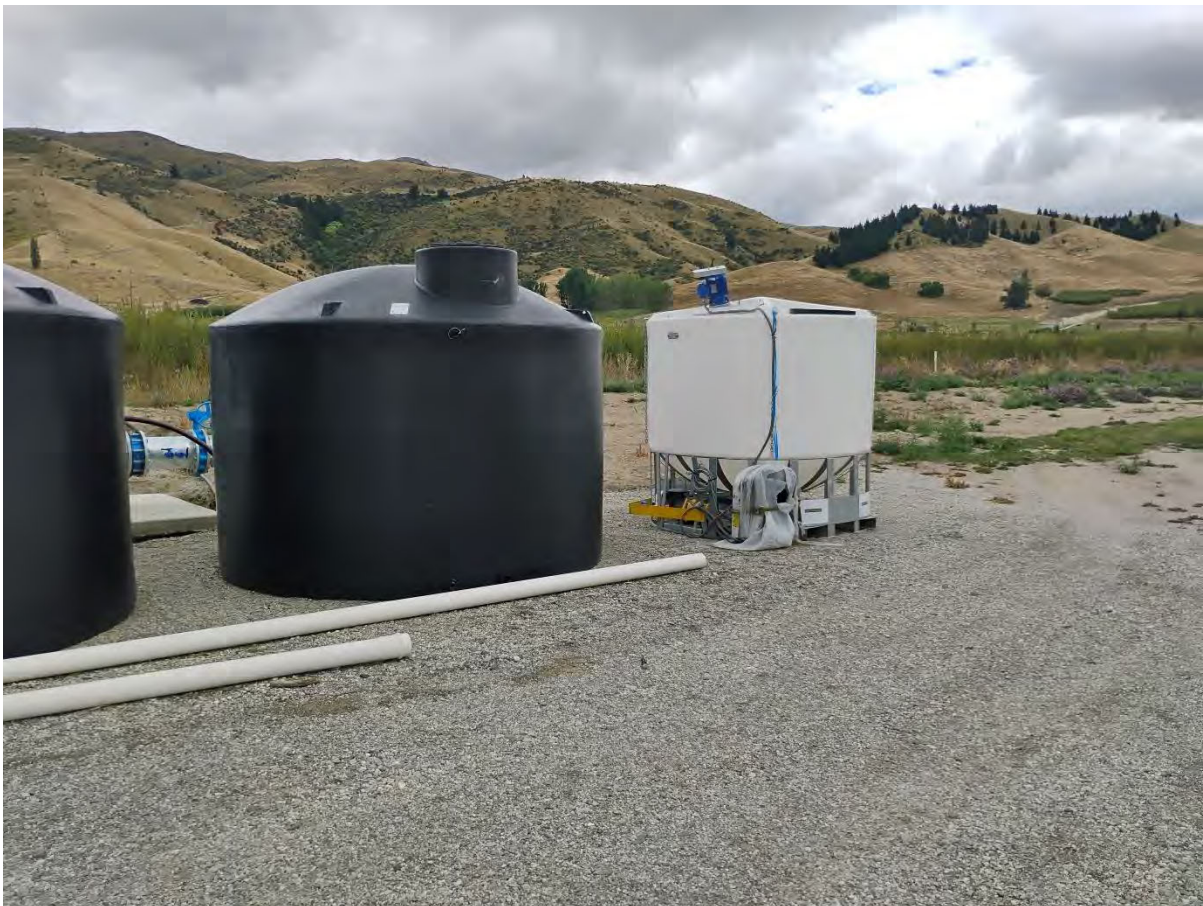
There are no significant features within this area other than two pump sheds. A new pump shed on the western boundary of the site was constructed in the last year. It contains a new transformer, and storage tanks. Fertilisers, including calcium and magnesium, are added to irrigation water for fertilisation. There was no evidence of staining or other evidence of contamination in this area other than the absence of grass along the rows of plantings which may be a result of herbicide use.

**Figure 2: Storage tanks near the new pump shed on the western boundary of the site**

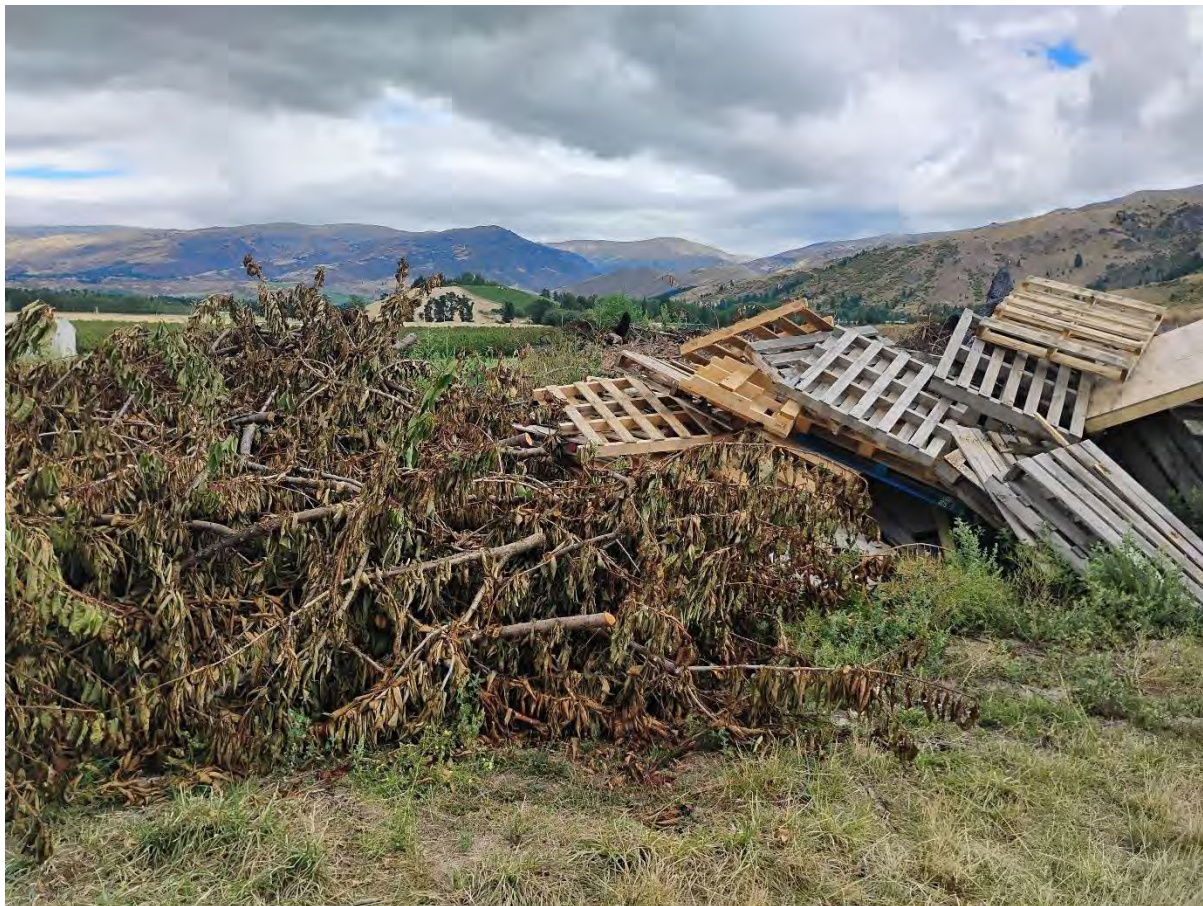
The burn piles observed within the accommodation only contained tree branches and pallets constructed of untreated timber. It is unlikely that these areas are a significant source of contamination and are not considered to be HAIL sites.

**Figure 10: Burn pile with branches and untreated wood from pallets.**

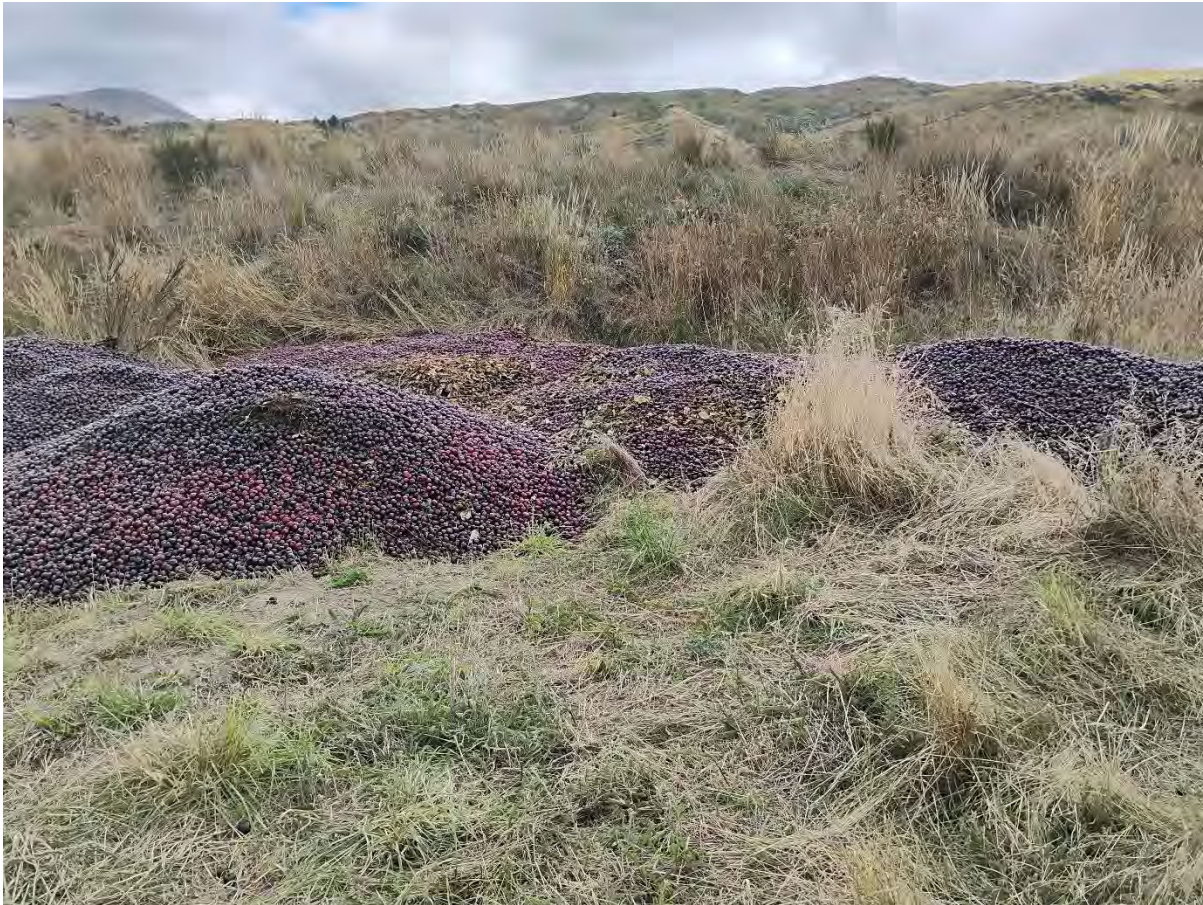
**Figure 11: Waste cherries**

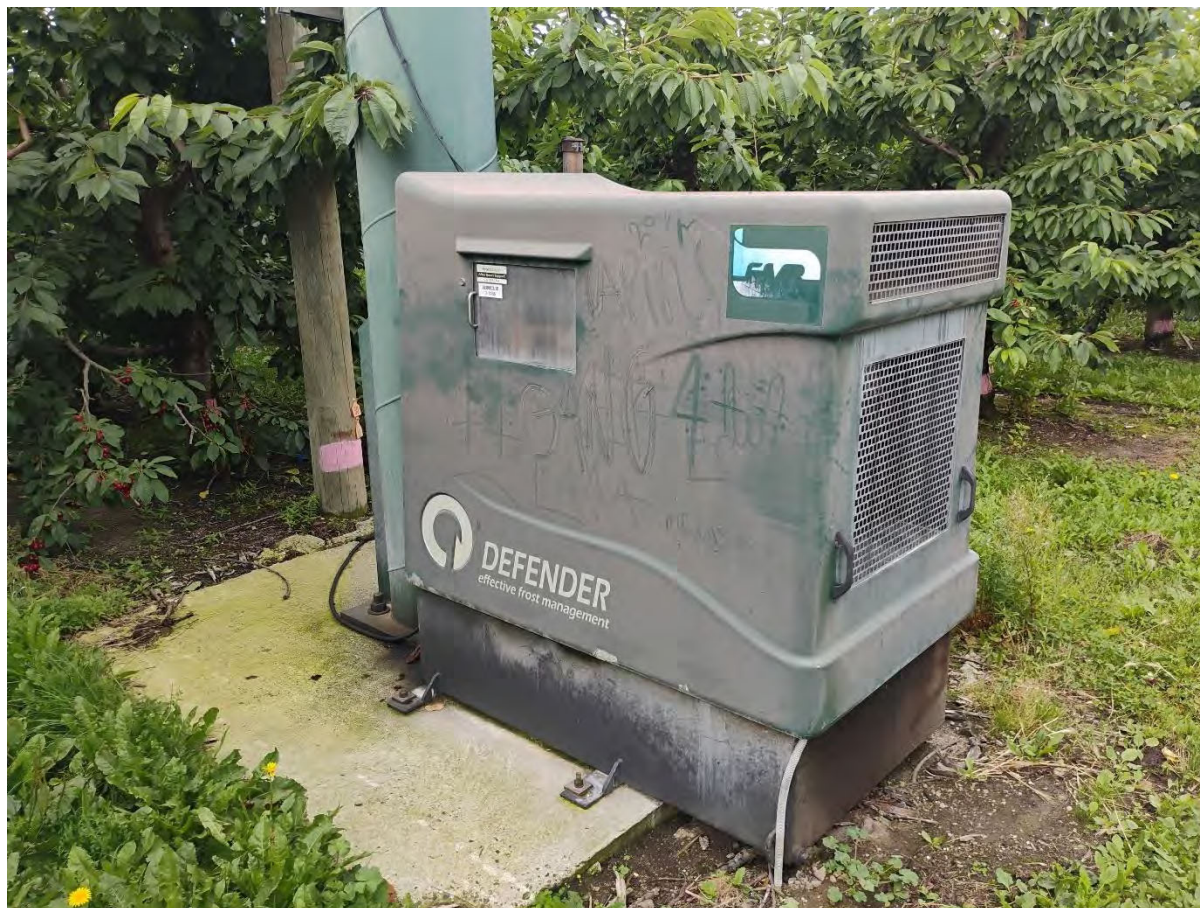
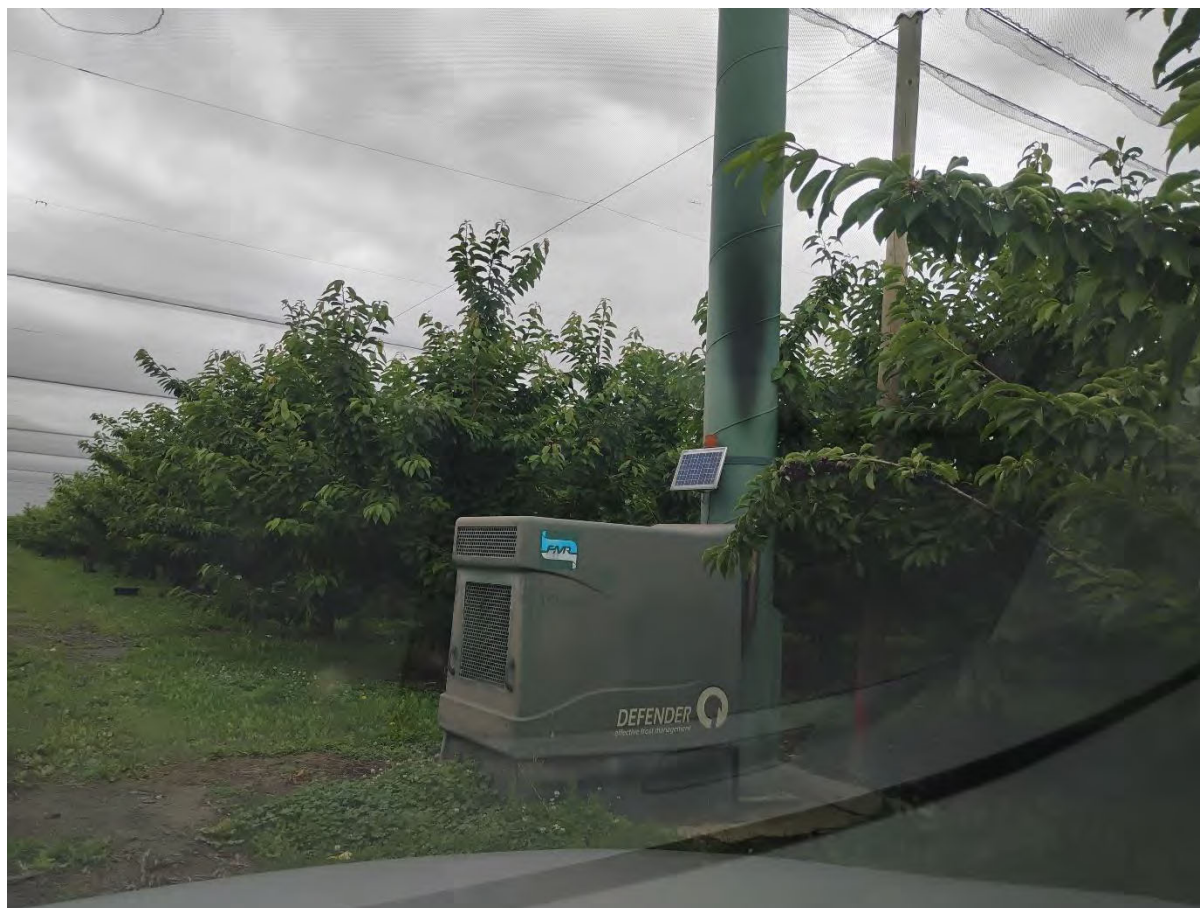
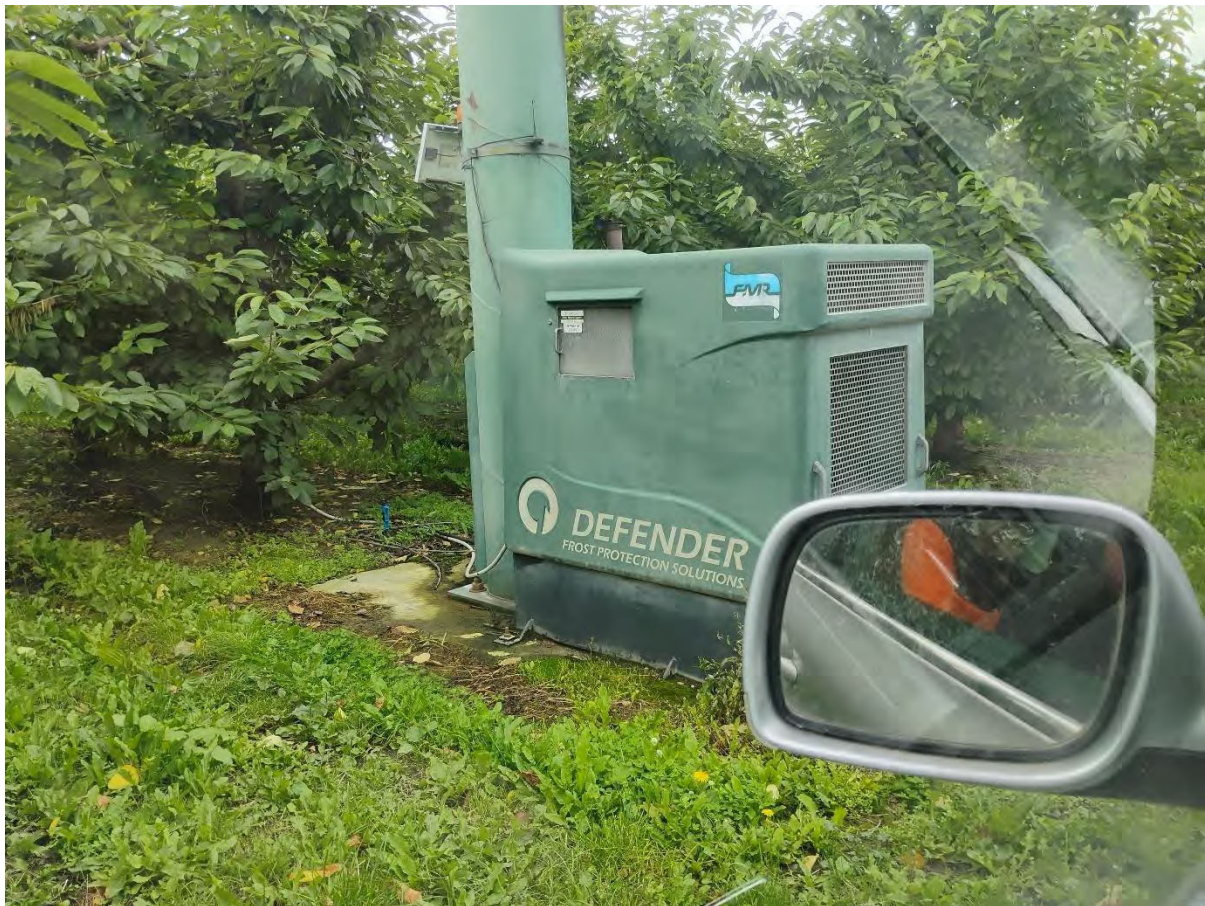
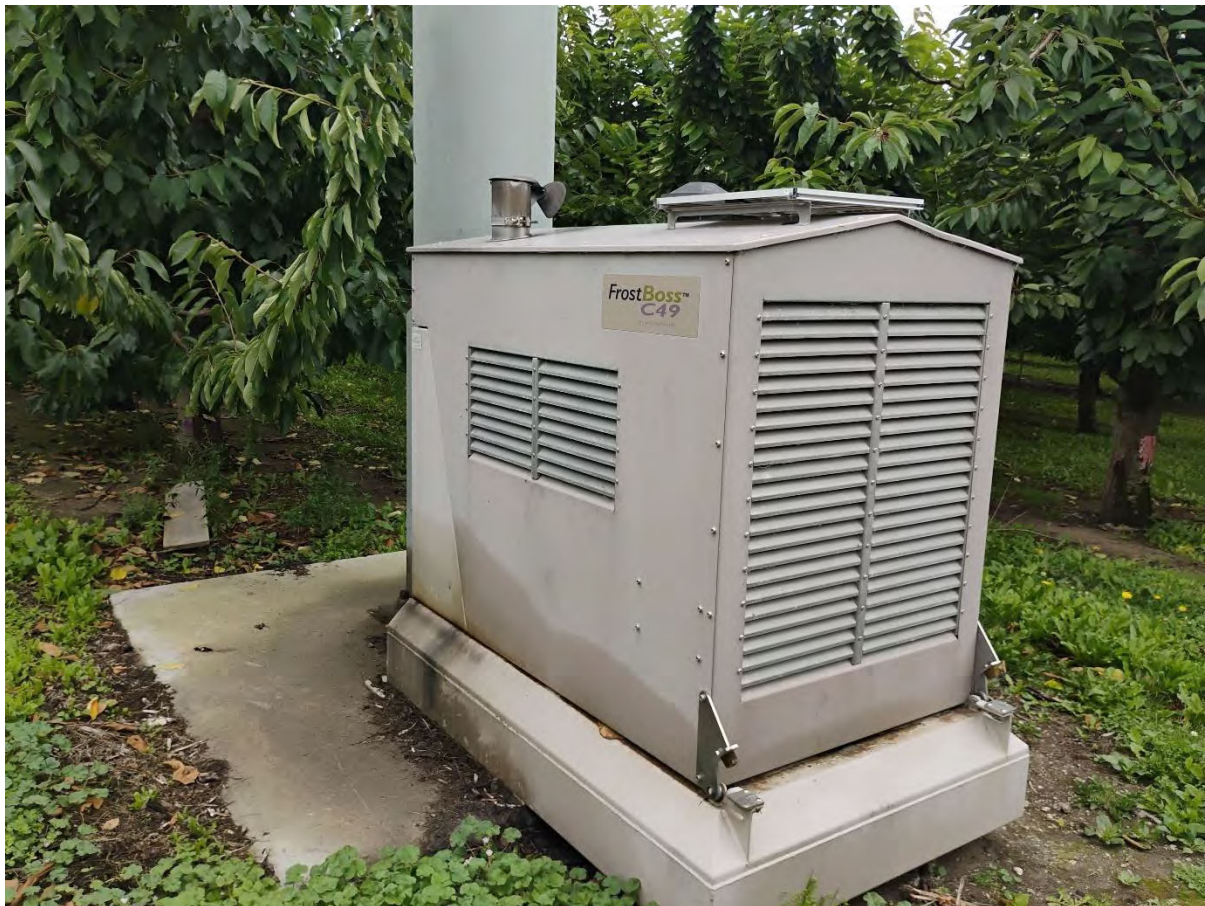
The NZCP Netted block contains four frost fans. These are powered by diesel engines and used seasonally to protect the cherries. Three of the frost fans are *Defenders* and one is a *Frost Boss C39*. These fans have self-bunded diesel fuel tanks, approximately 490 to 500 L in capacity. There was evidence of minor staining on the concrete and soil at the base of the frost fans, attributable drips of lubricating oil.

Figure 13: Frost fan

Figure 14: Frost fan

Figure 15: Frost fan

Figure 16: Frost fan

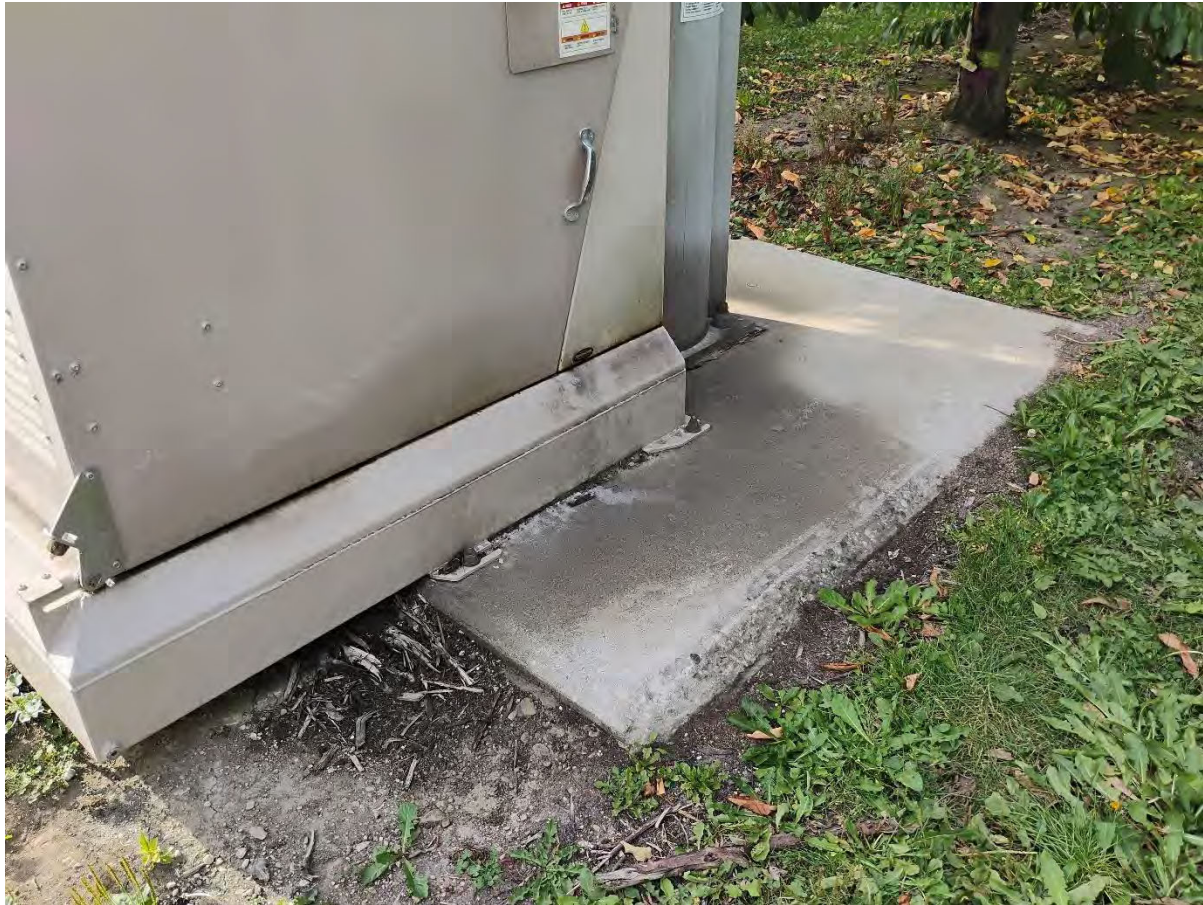
Figure 17: Minor lubricating oil staining on concrete
