**Cherry Orchard  
Development  
Preliminary and Detailed  
Site Investigation**

**Rippon Holdings Limited  
and Rippon Investments  
Limited**

*March 2026*

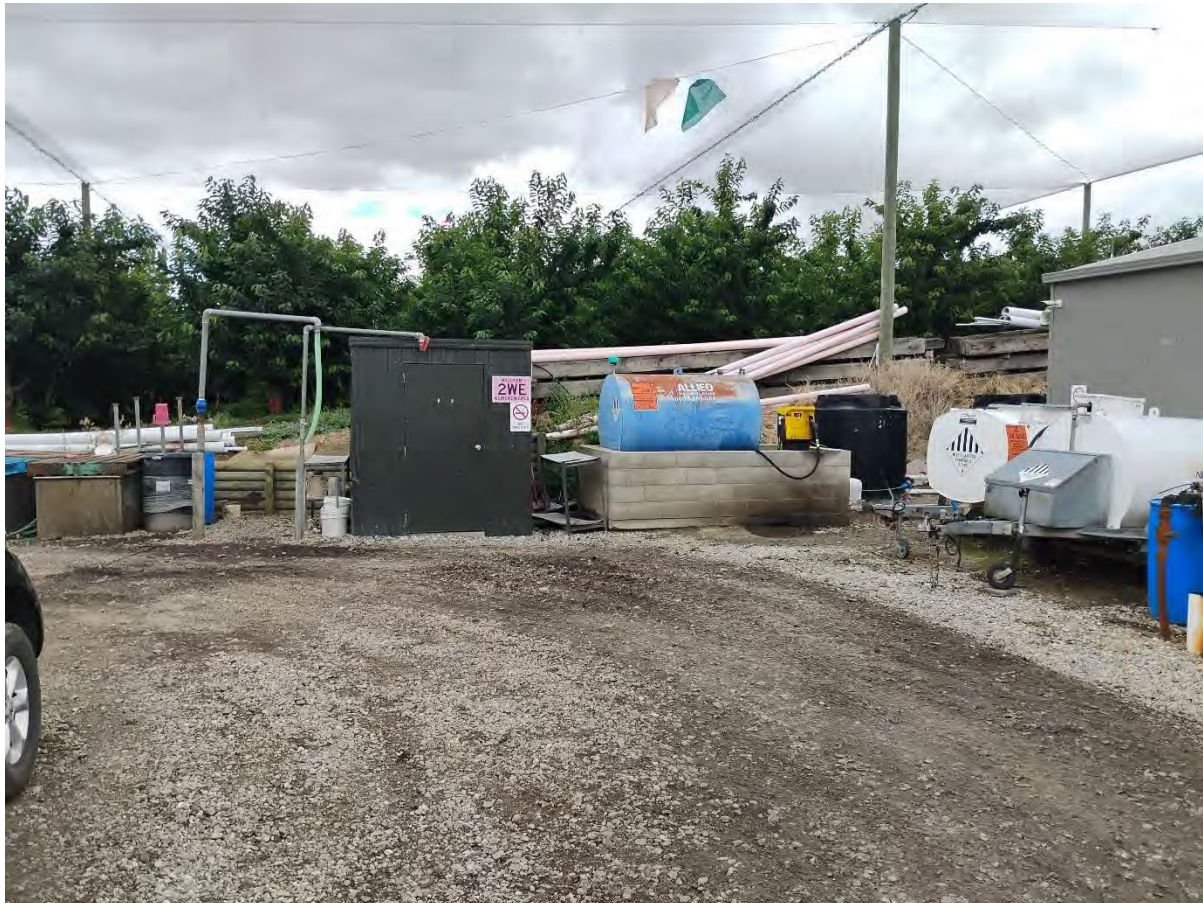
The hub for the NZCP Netted block contains an irrigation dam, two chemical storage sheds, one general storage shed, a spray mixing area adjacent to the chemical sheds, a workshop, and irrigation pumps. Two mobile fuel trailers were parked outside of the pump shed. The chemical storage sheds were in good condition, with solid concrete floors. Chemicals were stored in plastic tubs, and there was no evidence of spillage. The workshops and pump shed were in generally good condition, with some bulk storage of waste materials, such as netting and empty containers. A small electrical transformer is present near the workshop. The general storage shed was constructed of painted steel weatherboard and was likely relocated to the site from elsewhere.

Figure 18: Mixing area, chemical storage shed and above ground diesel tank

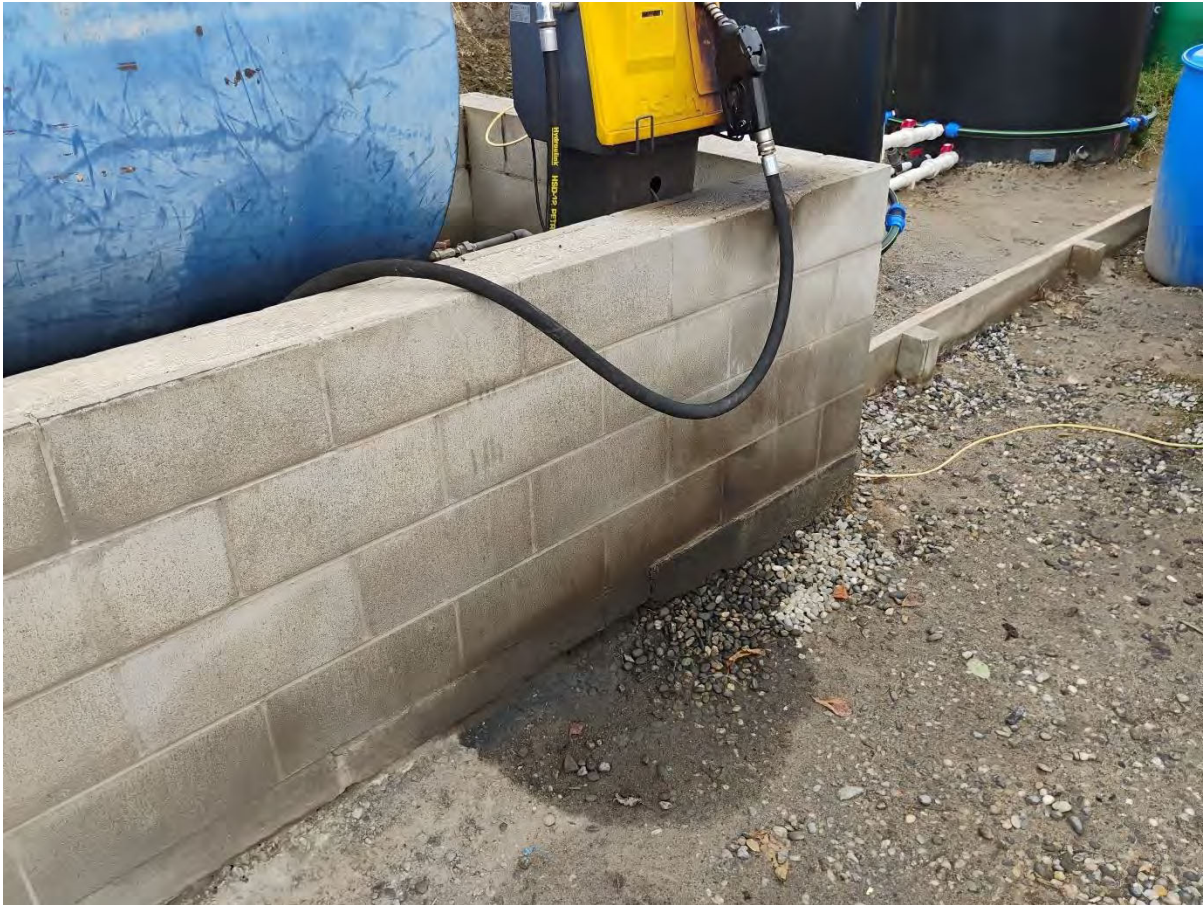
There were isolated areas of oil staining ( $<0.5 \text{ m}^2$ ) and some diesel staining beneath the dispenser the above ground tank. An intermediate bulk container (IBC) containing waste oil and a stack of empty oil containers was located behind one of the sheds; minor soil staining was apparent beneath these containers from drips of oil.

**Figure 23: Minor staining beneath the diesel dispenser.**

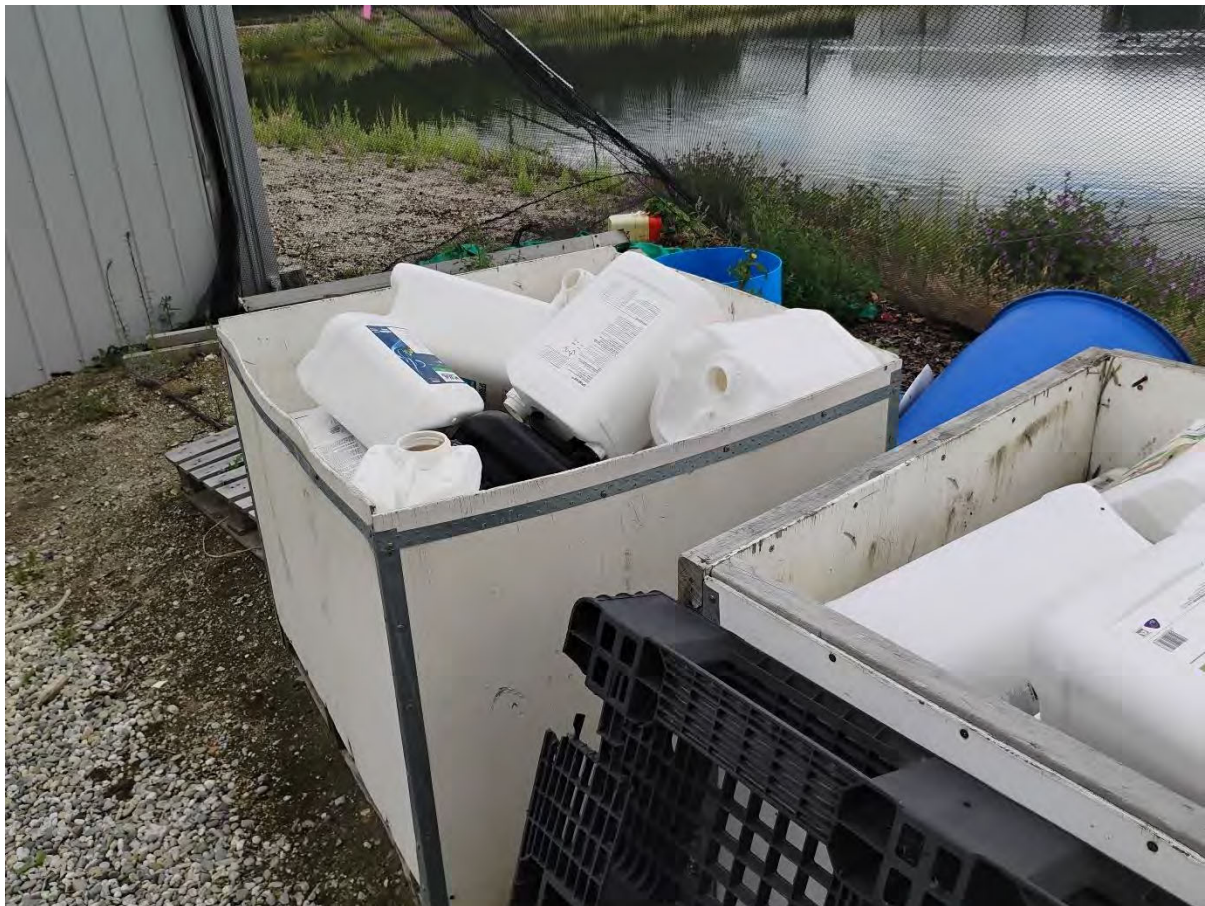
**Figure 35: Empty chemical containers for recycling**

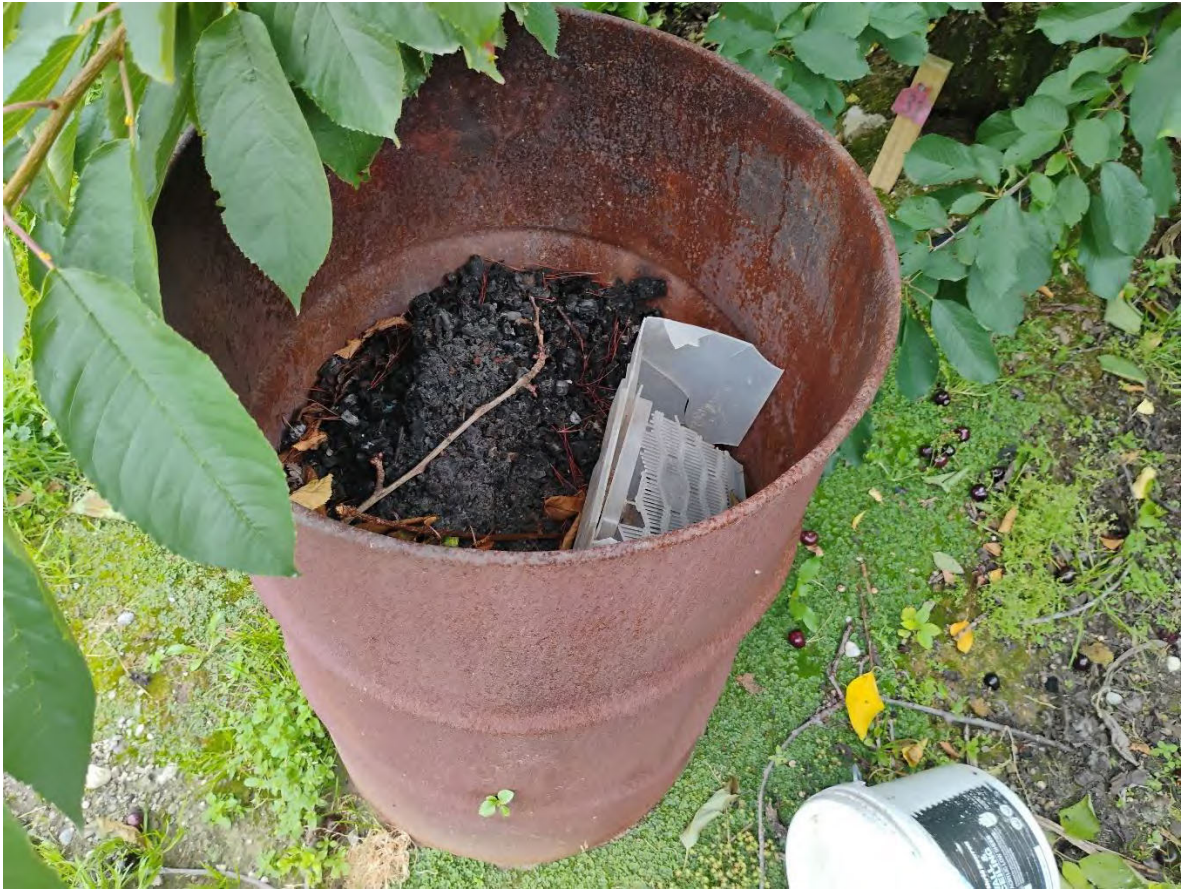
There were two 44-gallon drums near the workshop that had been used for burning branches.

**Figure 36: Burn barrel under the trees near the workshop**

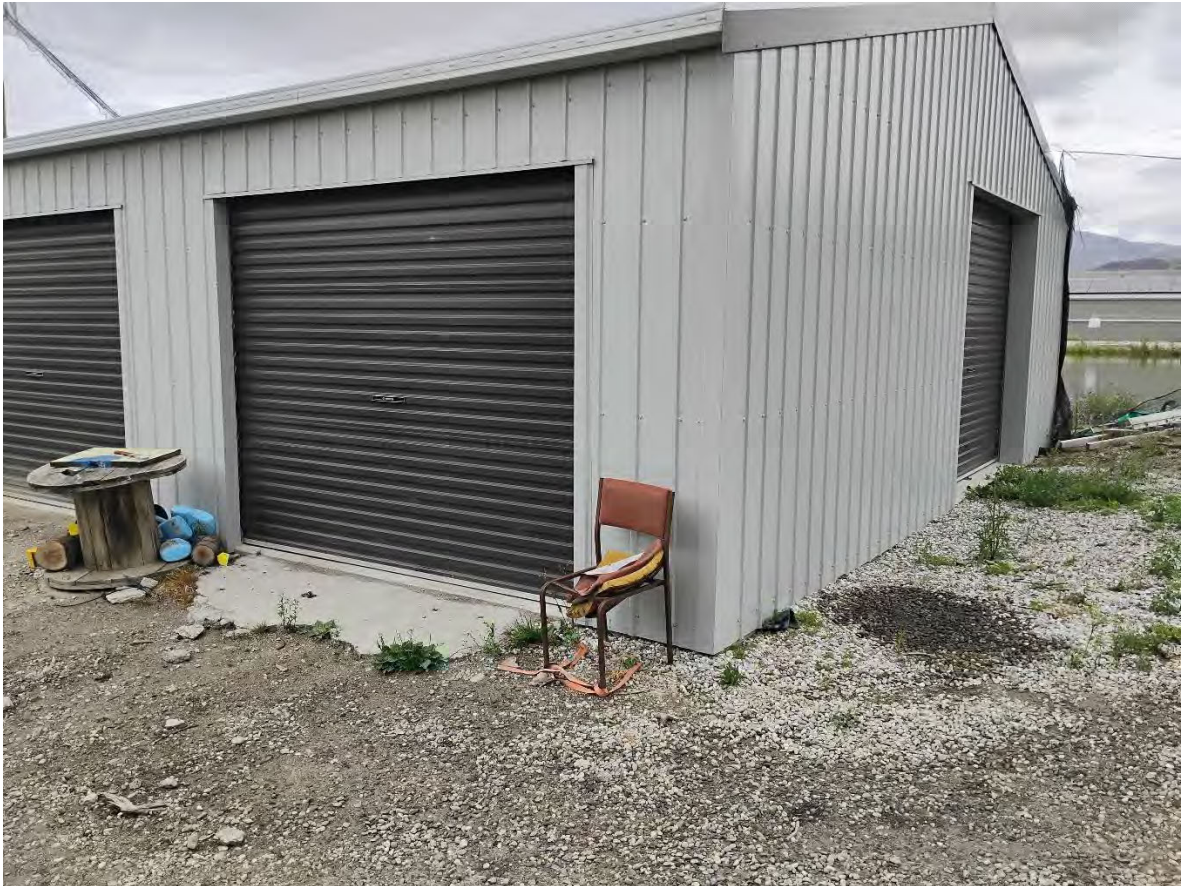
The site and sheds were generally tidy, with only one minor patch ( $<0.25 \text{ m}^2$ ) of visible oil staining adjacent to the workshop. There was some hydrocarbon sheen in the bunded area below the diesel tank, but this was contained within the bund.

**Figure 37: Minor patch of oil staining.**
