# GEOTECHNICAL INVESTIGATION REPORT

Milldale Stages 14-17 Water Reservoir

Fulton Hogan Land Development Ltd  
AK26-027AD Rev.1

7 August 2026

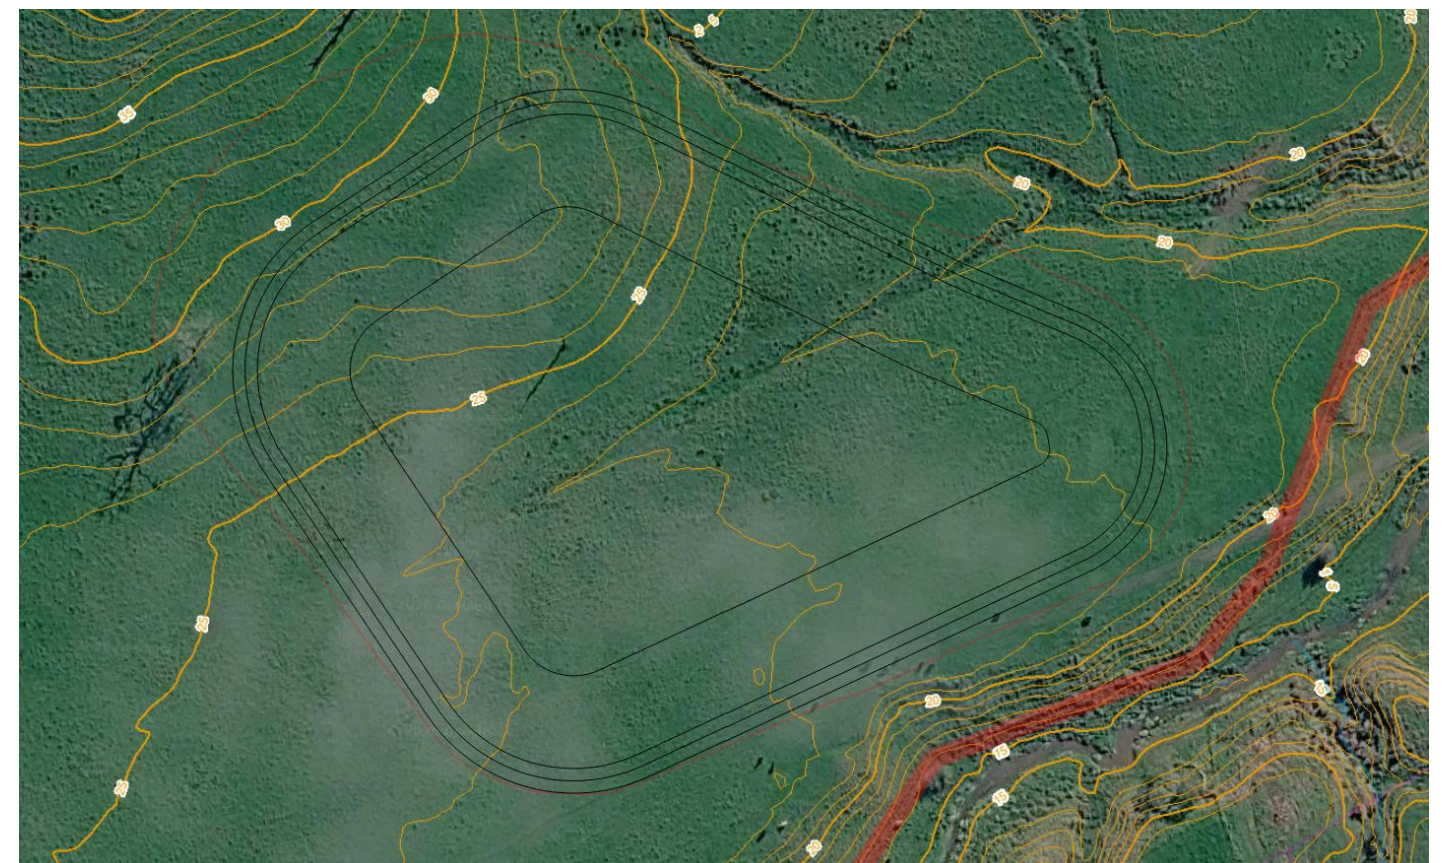
Figure 2: Proposed Reservoir Layout

The earthworks design by Woods depicts cut volumes of 128,295m<sup>3</sup> and fills of 8,188m<sup>3</sup> with the excess cut to be removed from site.

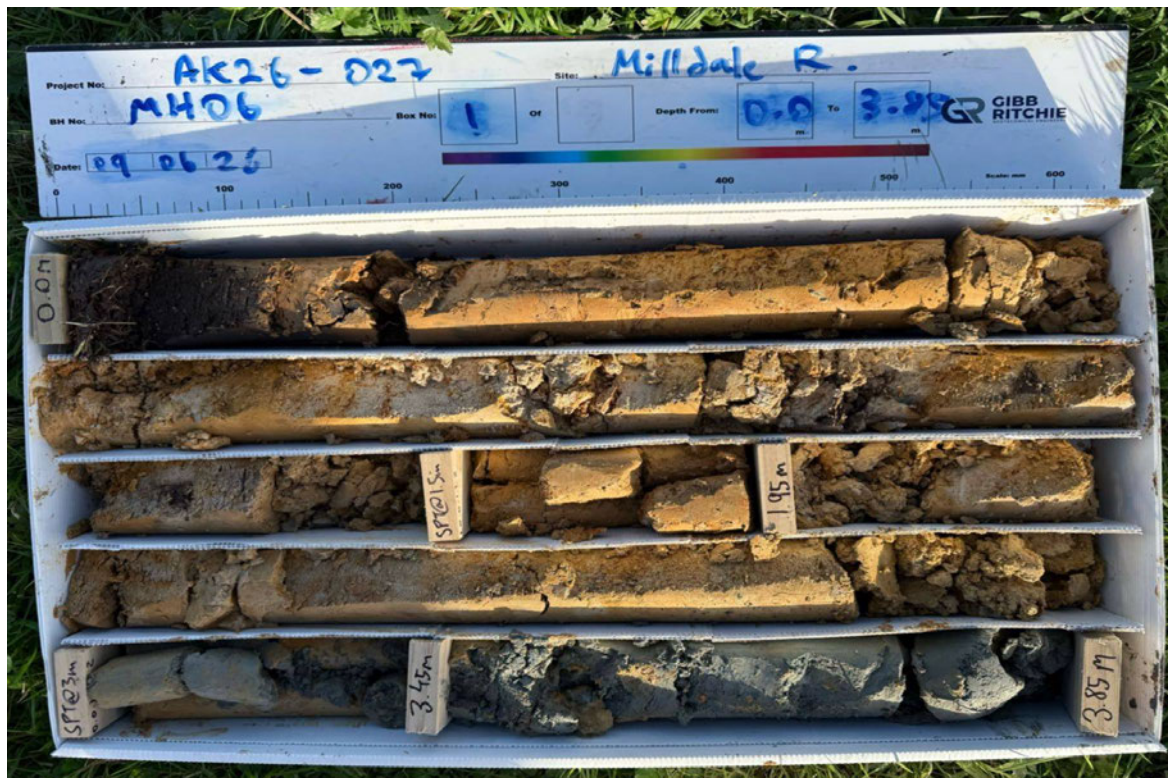
MH06 - Milldale Reservoir

0.0m -  
7.2m

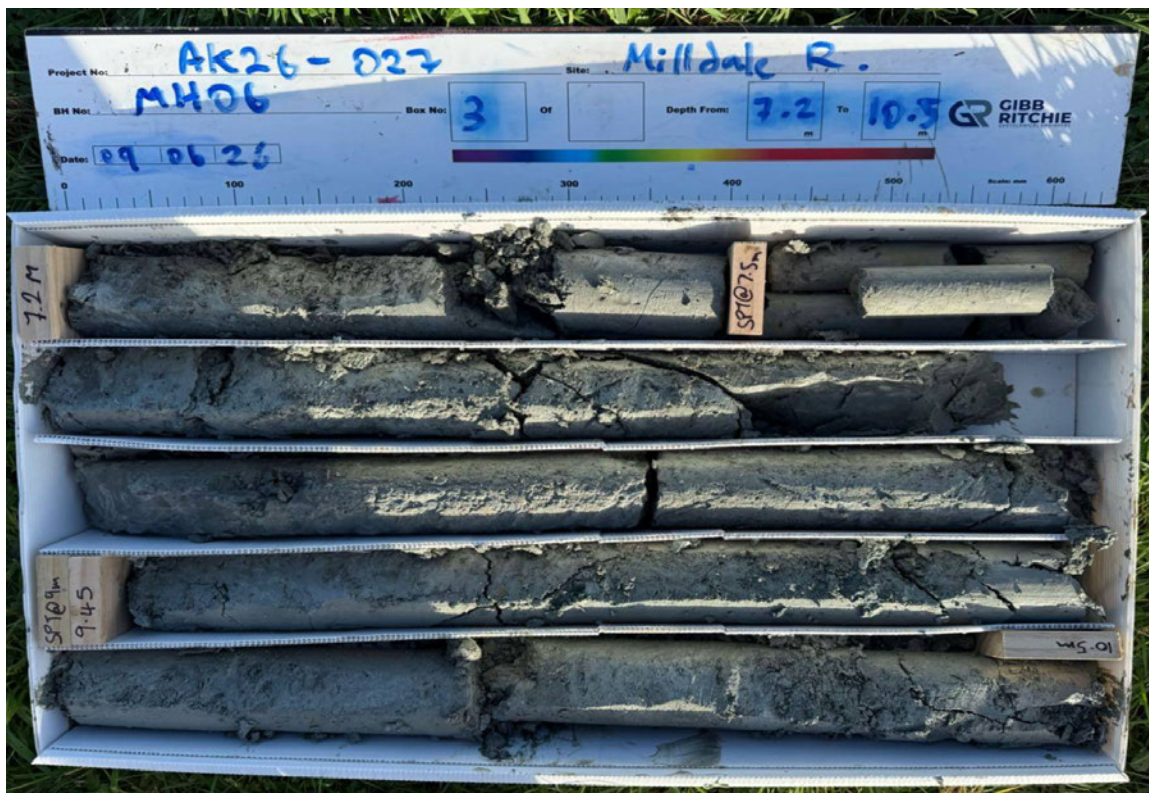
| Photo description | MH06 - Milldale Reservoir | | |

| Photo description | MH06 - Milldale Reservoir | | |
|---|---|---|---|
| BH No | MH06-26 | BH Depth | 7.2m - 14.5m |

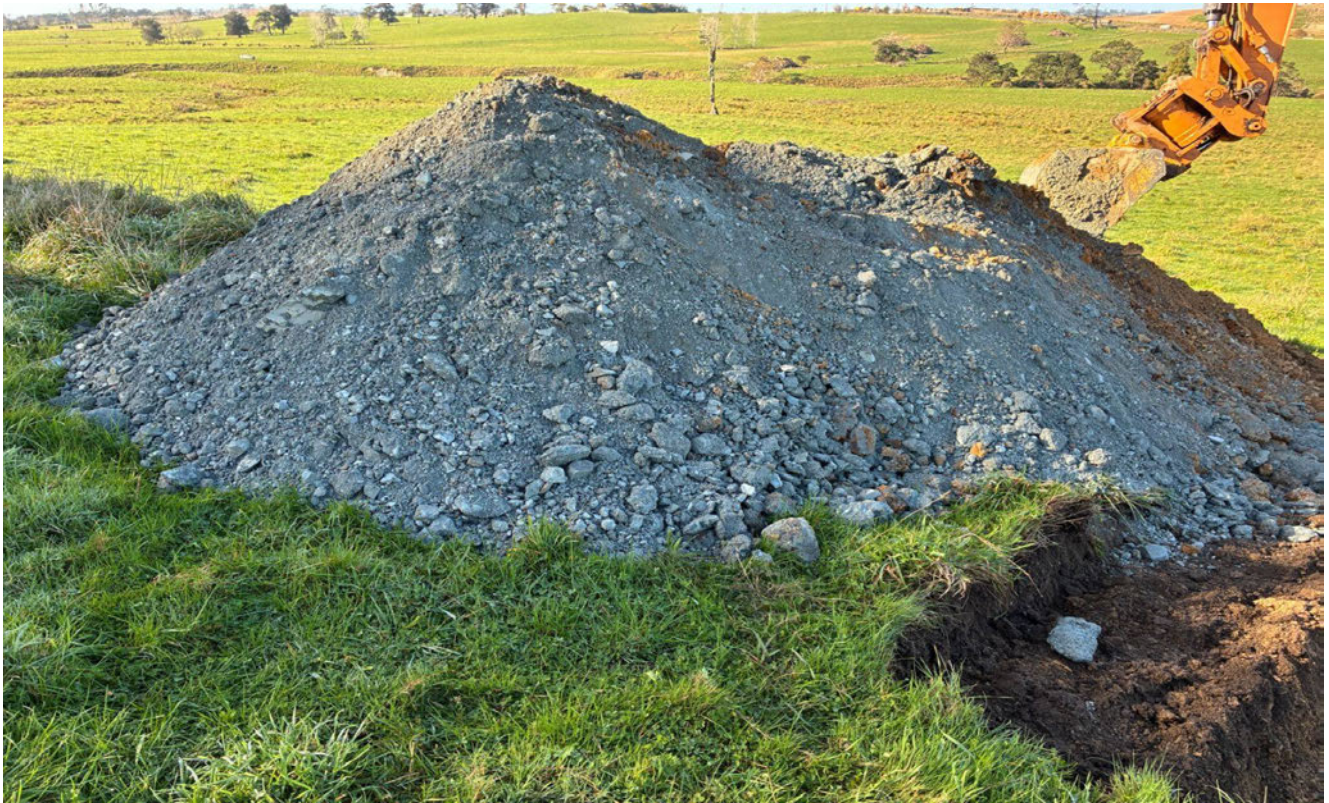
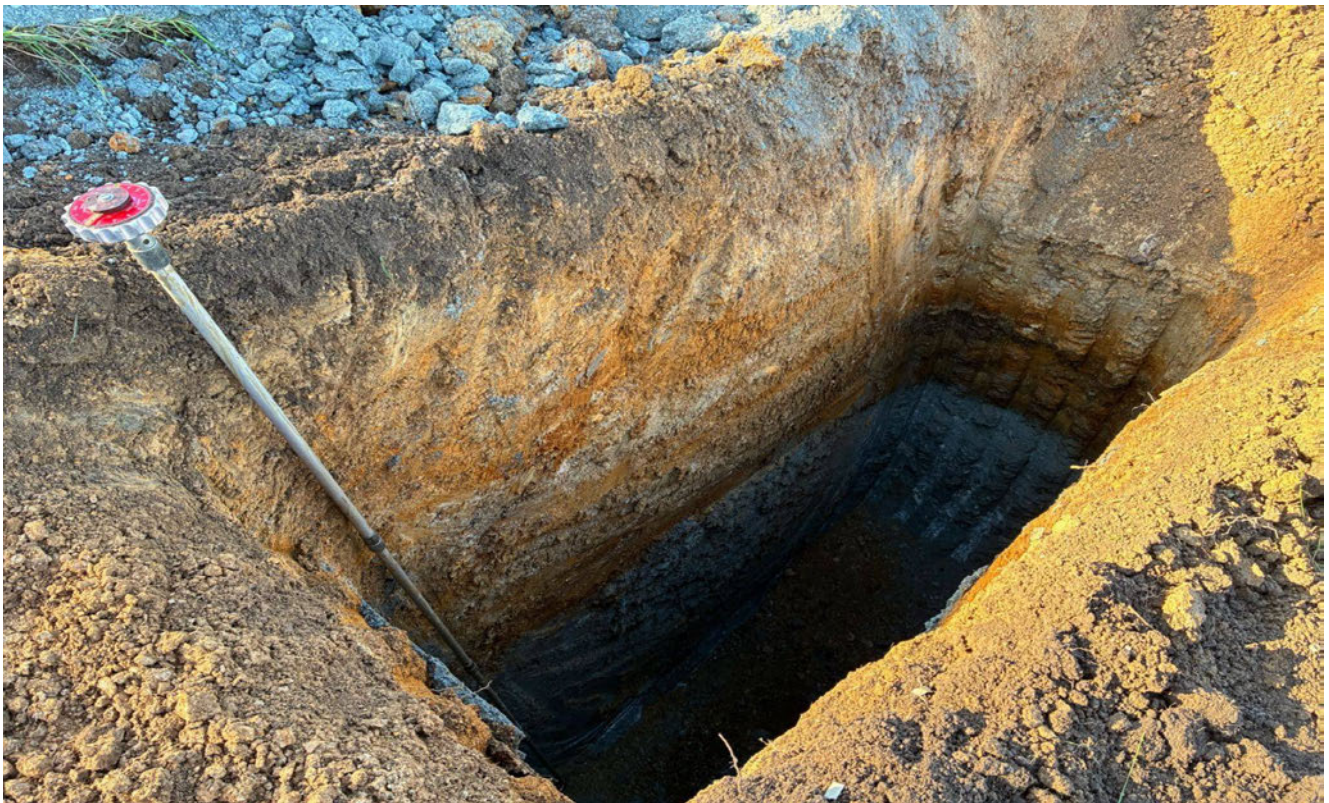
| <b>Photo description</b> | TP58-26 | | |

| Water | Depth (m) | Soil Origin | Graphic Log | Classification Code | Material Description | Moisture | Consistency | SV (Peak) ●<br>SV (Residual) ▽ | Elevation (m) | Remarks |
|---|---|---|---|---|---|---|---|---|---|---|
| | | | | | TP58-26 Refusal at 4.1 m | | | | | |

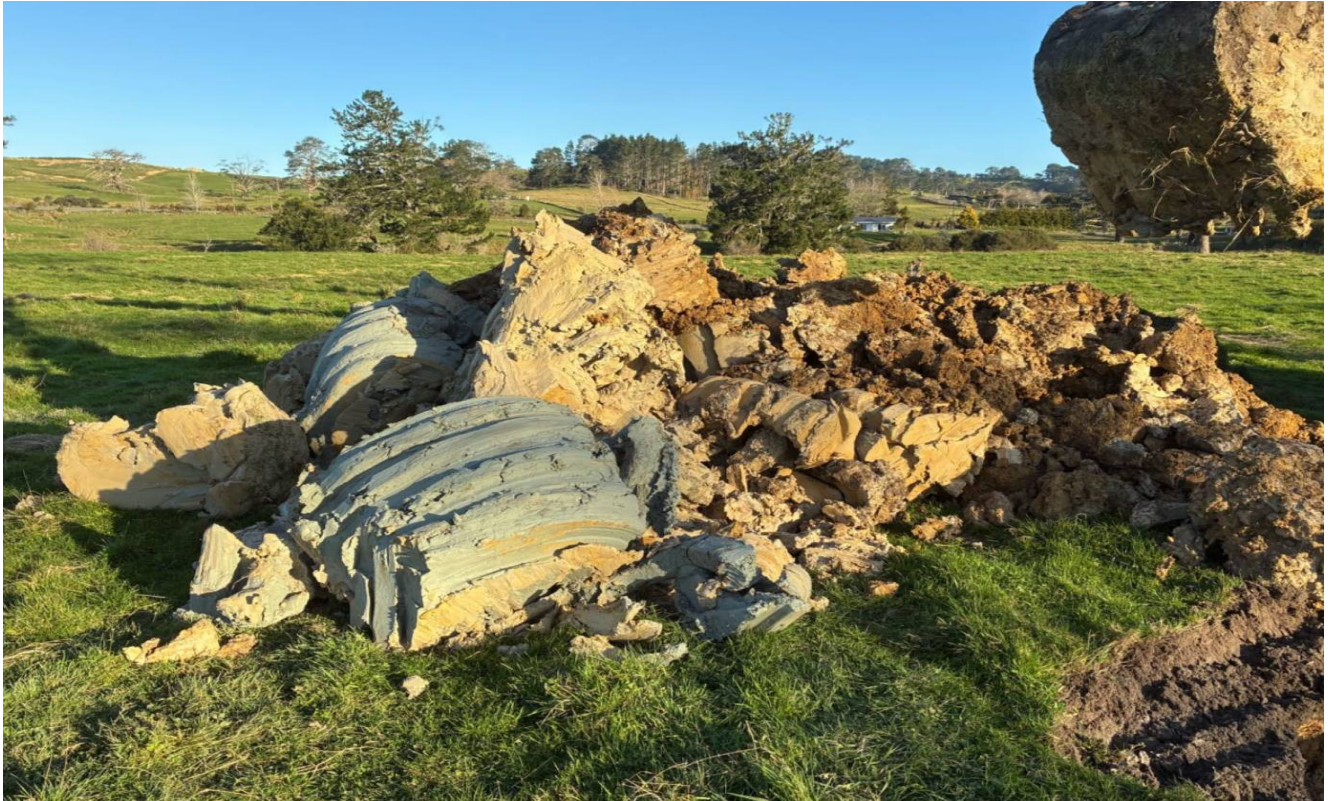
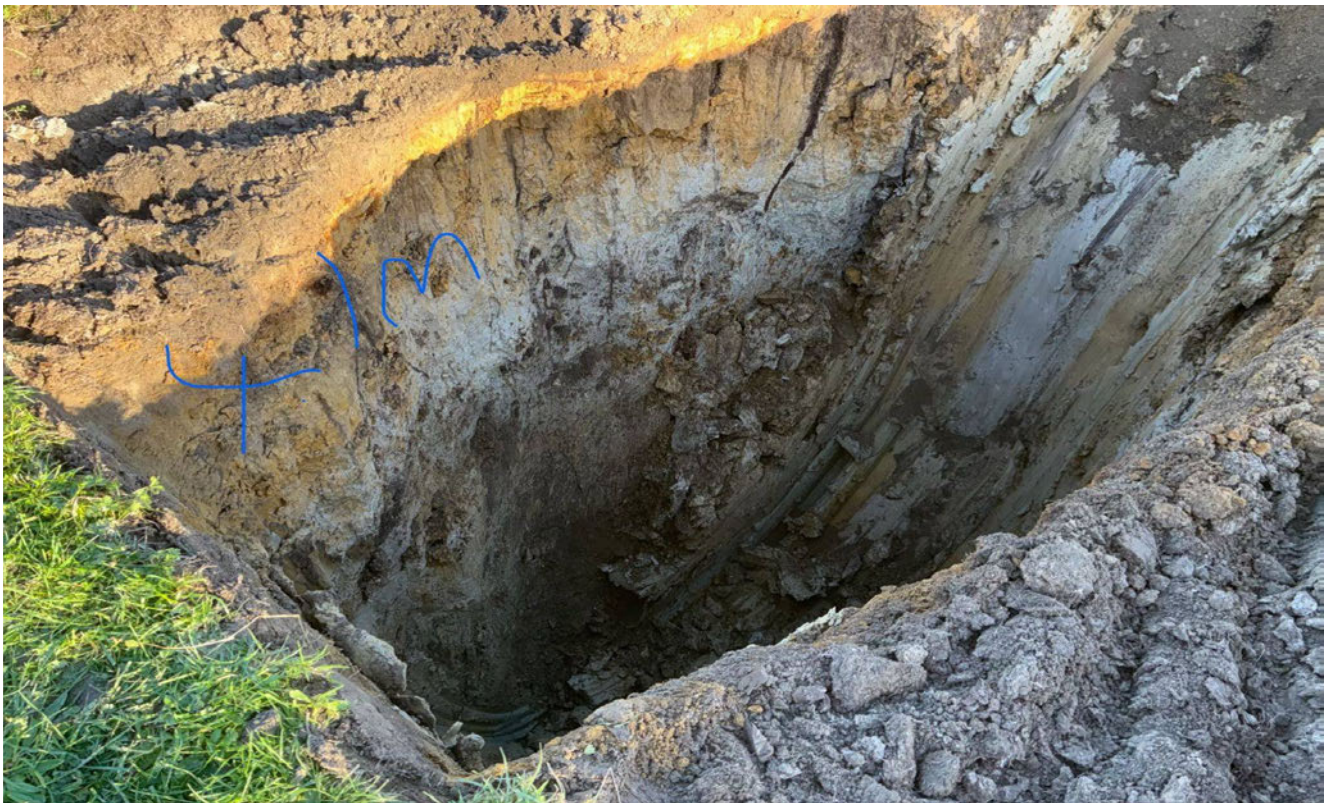
| <b>Photo description</b> | TP60-26 | | |

| Water | Depth (m) | Soil Origin | Graphic Log | Classification Code | Material Description | Moisture | Consistency | SV (Peak) ●<br>SV (Residual) ▽ | Elevation (m) | Remarks | |
|---|---|---|---|---|---|---|---|---|---|---|---|
| | | | | | TP60-26 Terminated at 4.1 m (Excavation Wall Instability) | | | | | | |

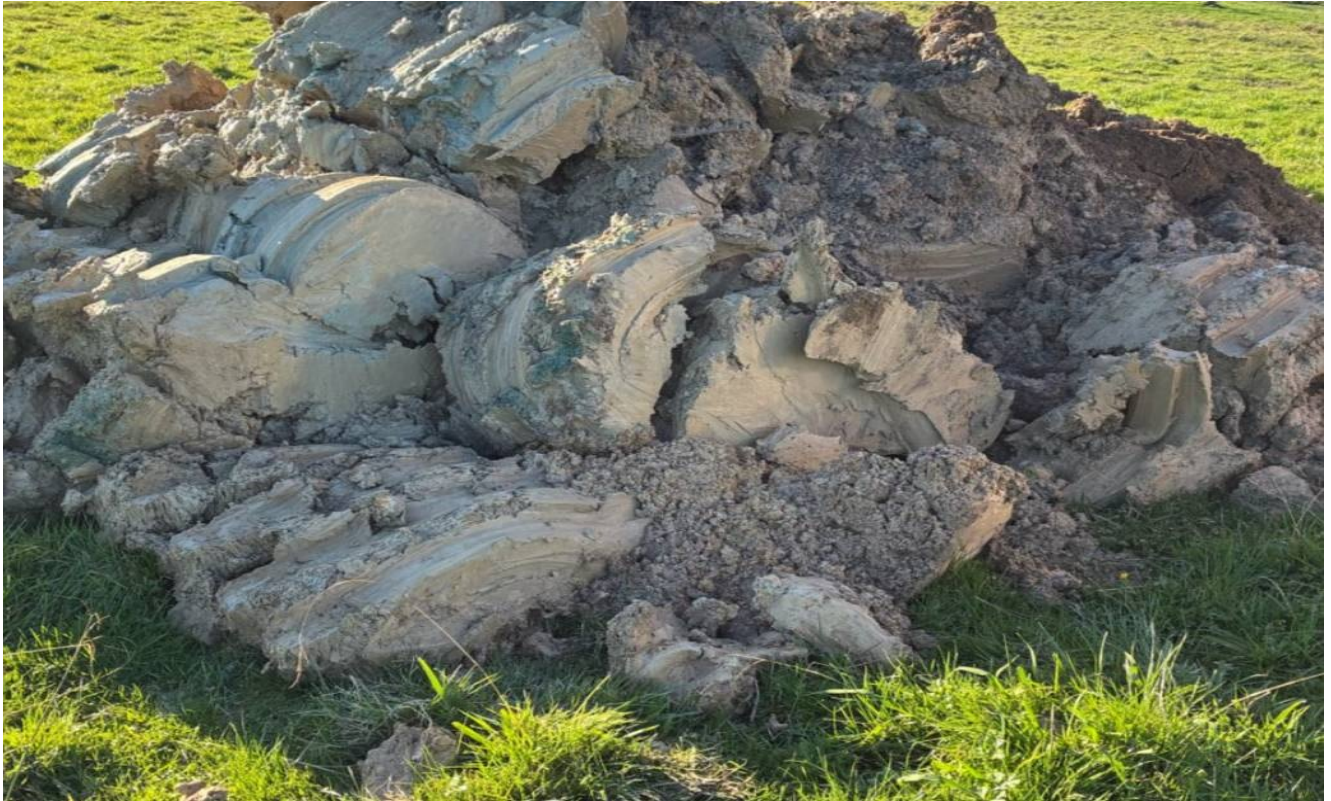
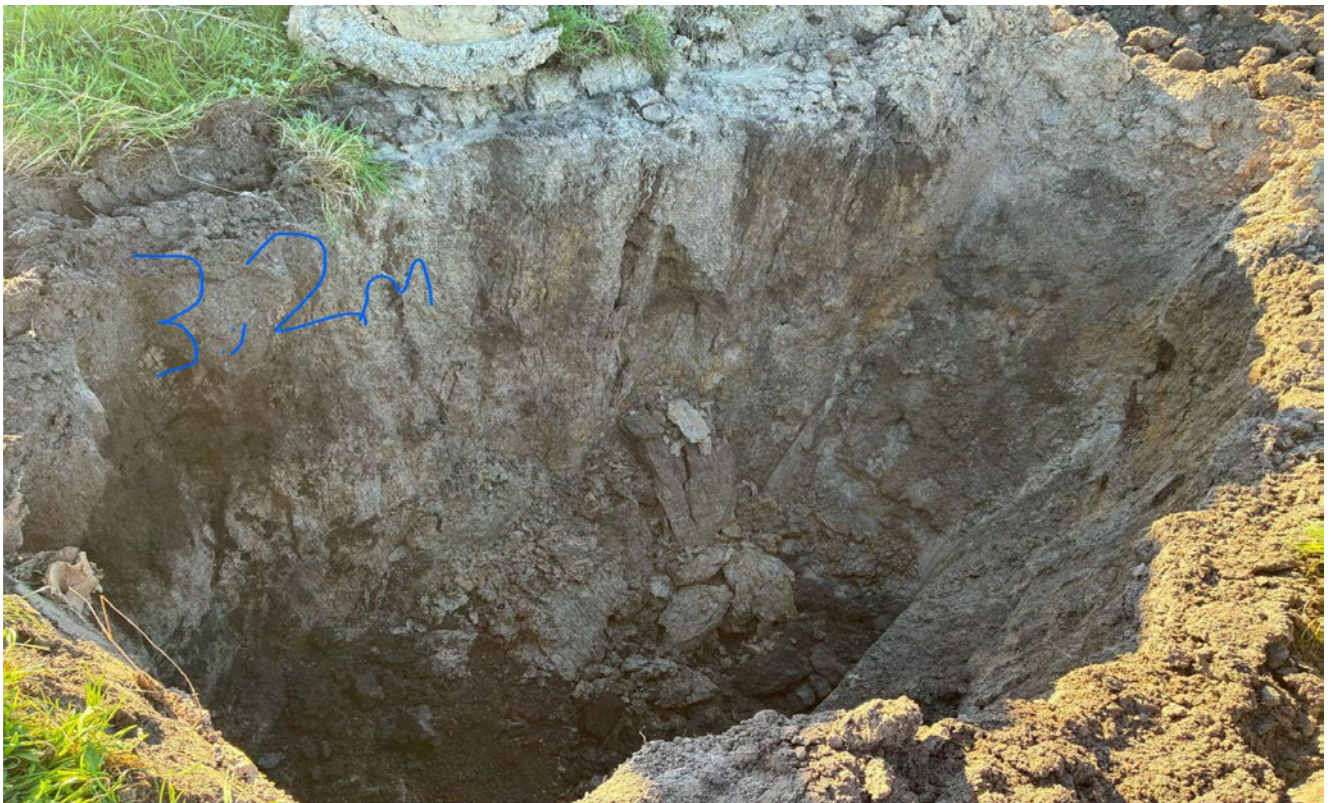
| <b>Photo description</b> | TP61-26 | | |

General comments: pit dimensions 0.9m wide 4.0m long

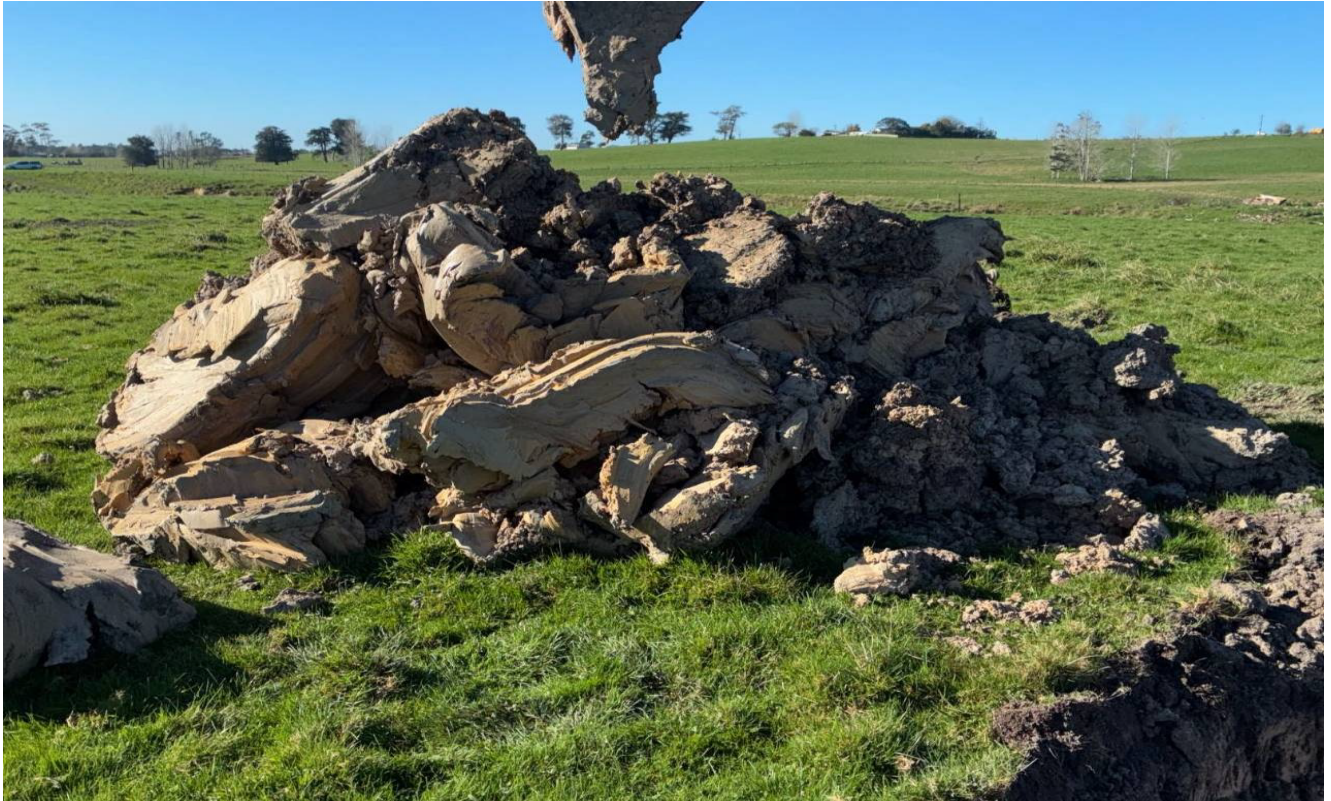
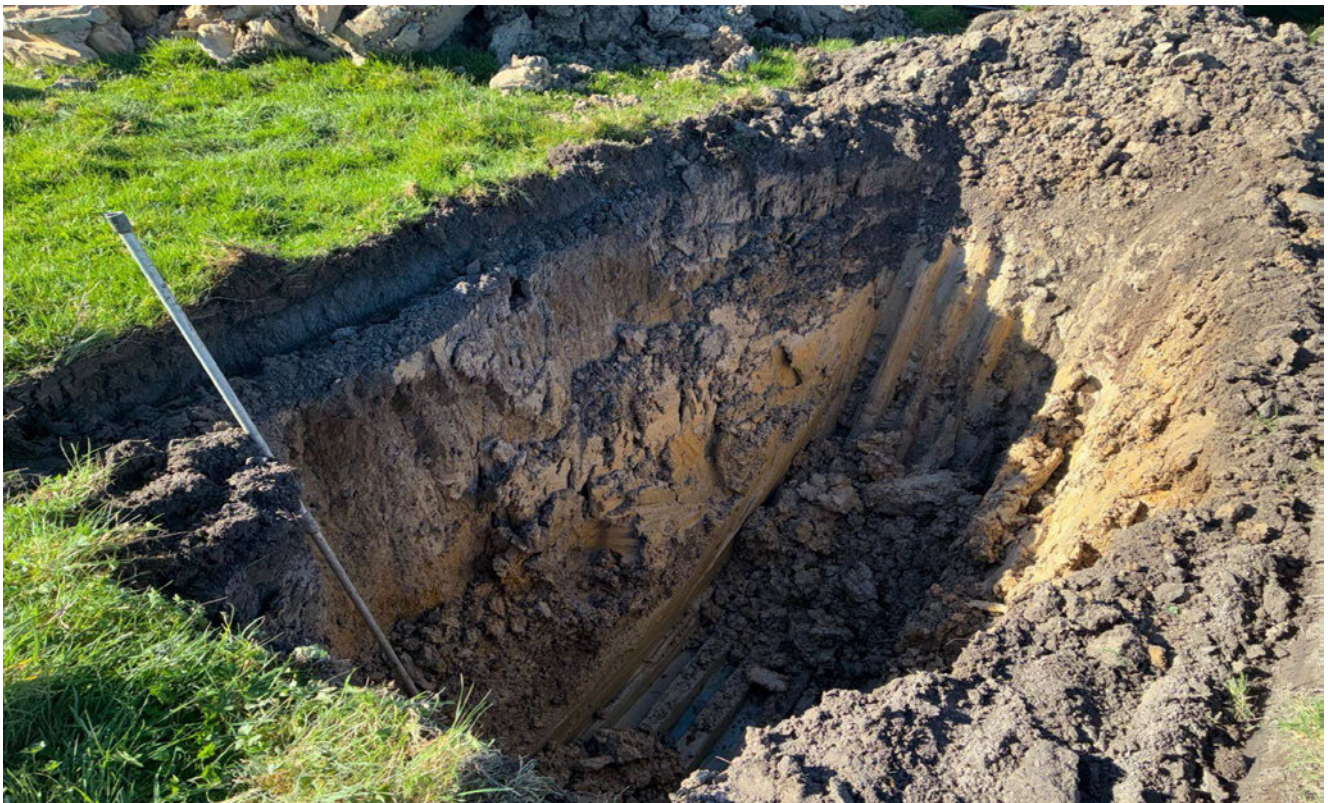
| <b>Photo description</b> | TP63-26 | | |

| Water | Depth (m) | Soil Origin | Graphic Log | Classification Code | Material Description | Moisture | Consistency | SV (Peak) ●<br>SV (Residual) ▽ | Elevation (m) | Remarks |
|---|---|---|---|---|---|---|---|---|---|---|
| | | | | | TP63-26 Terminated at 2.5 m (wall instability) | | | | | |

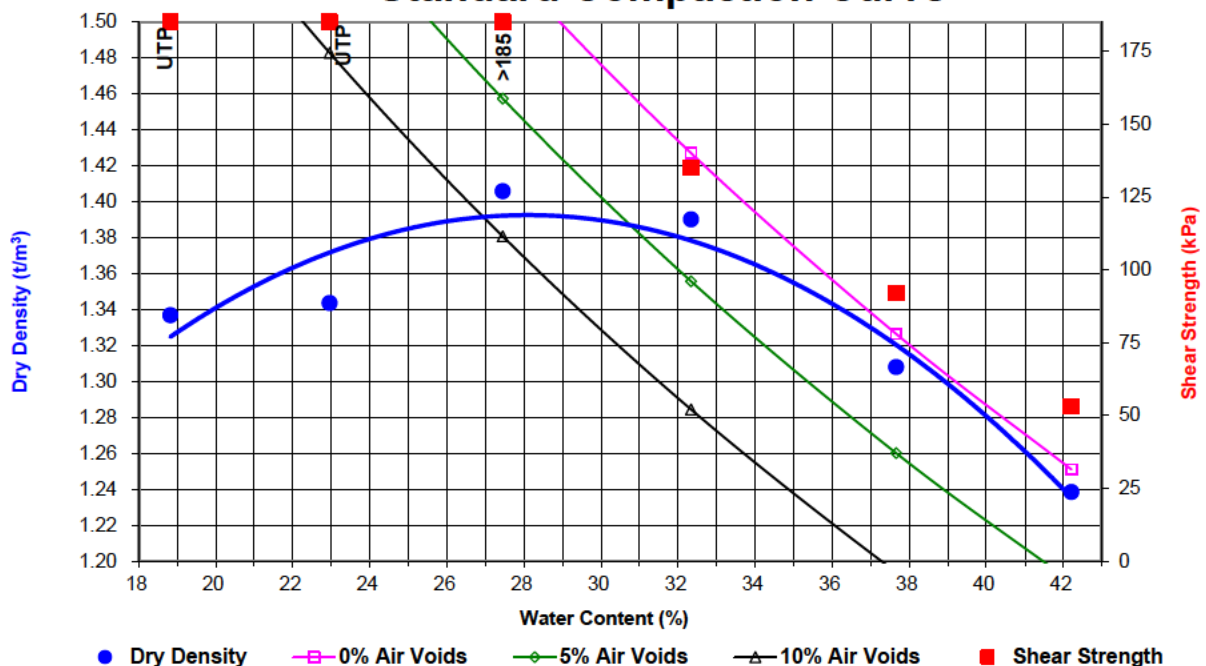
**Standard Compaction Curve**

**Maximum Dry Density:** **1.39 t/m<sup>3</sup>** **Optimum Water Content:** **28 %**
