## Memorandum

<b>Date:</b>	20/11/2025
<b>To:</b>	Vineway Ltd
<b>From:</b>	[REDACTED]
<b>CC:</b>	[REDACTED]
<b>Project Number:</b>	P05513
<b>Reviewed by:</b>	[REDACTED]
<b>Released by:</b>	[REDACTED]

### Subject: Delmore Development Geomorphic Assessment

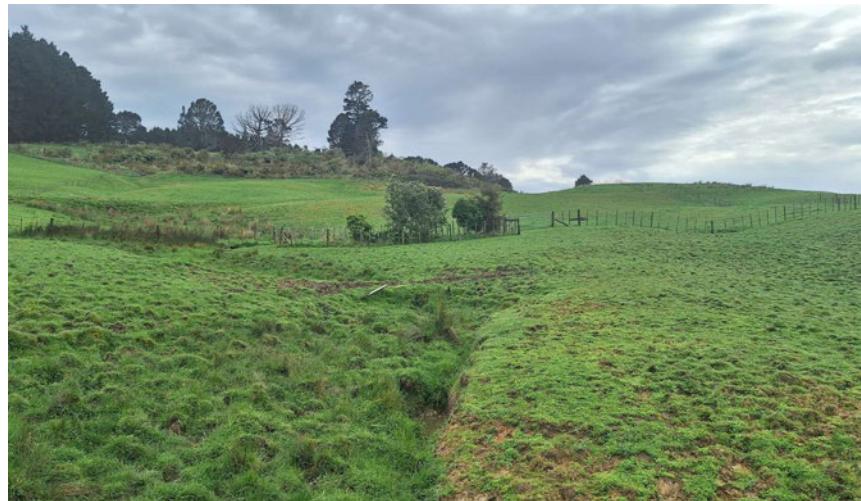
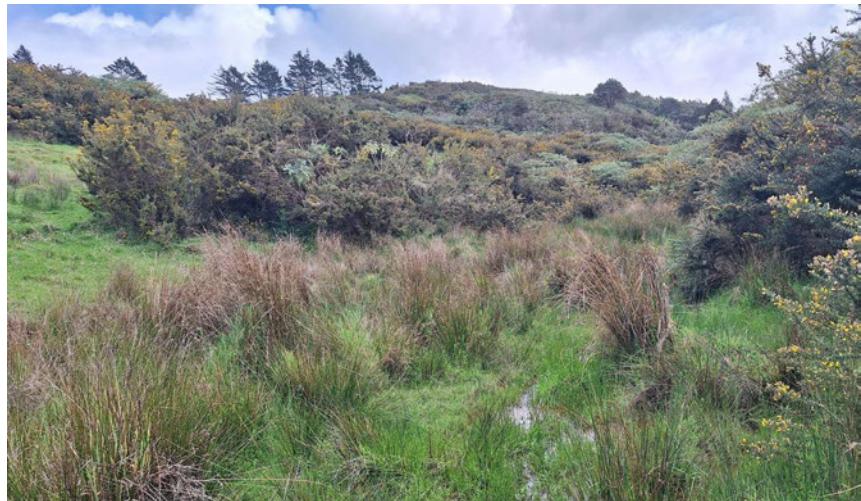
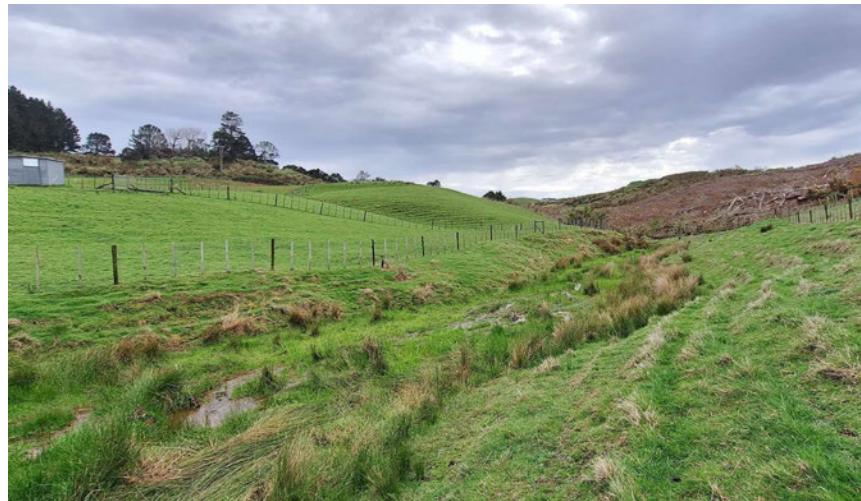
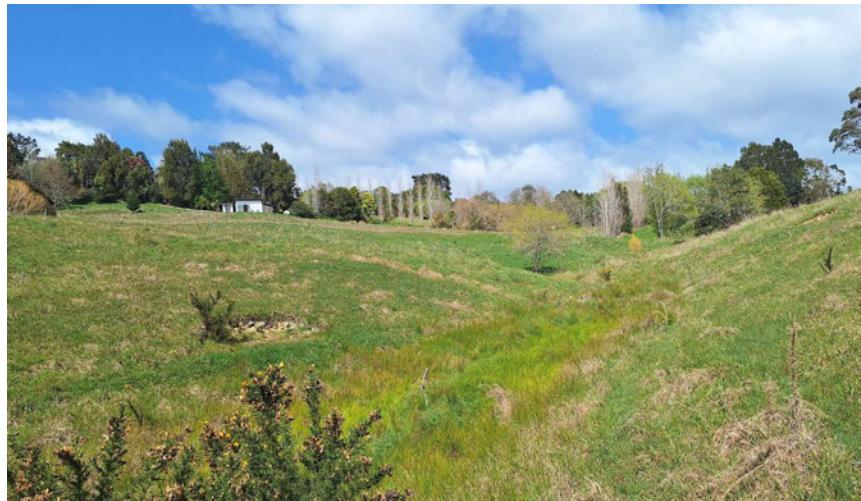
### Type 1 reaches

- RGEA score: All reaches show moderate instability.
- Wide valley floor infilled with sediment and diffusive flow.
- No erosion.
- No risk or lateral adjustment.
- Potential for upstream knickpoint migration which could channelise the flow and convert the wetland to a defined stream channel.

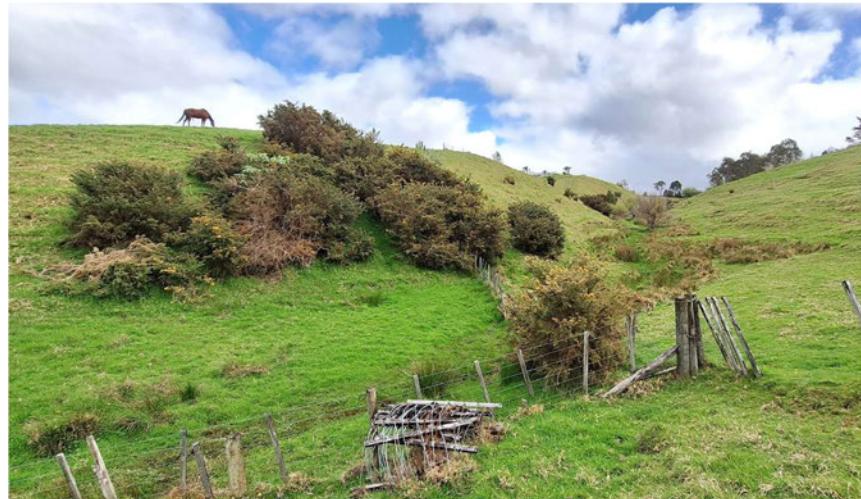
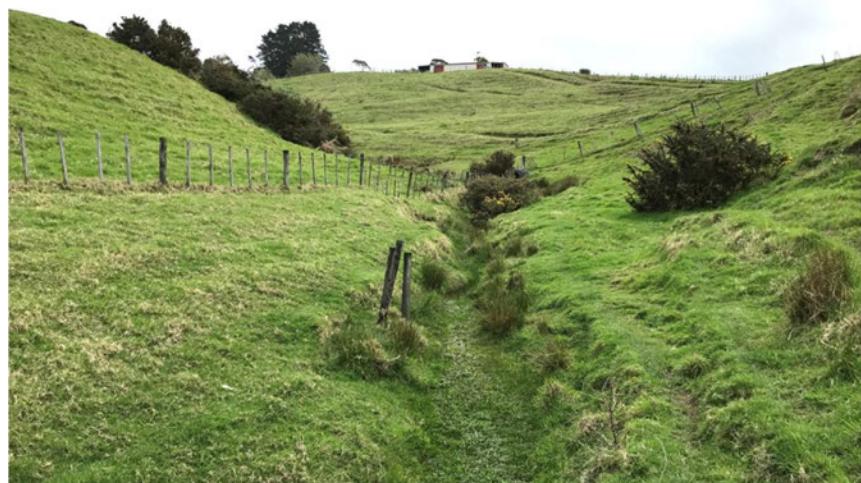
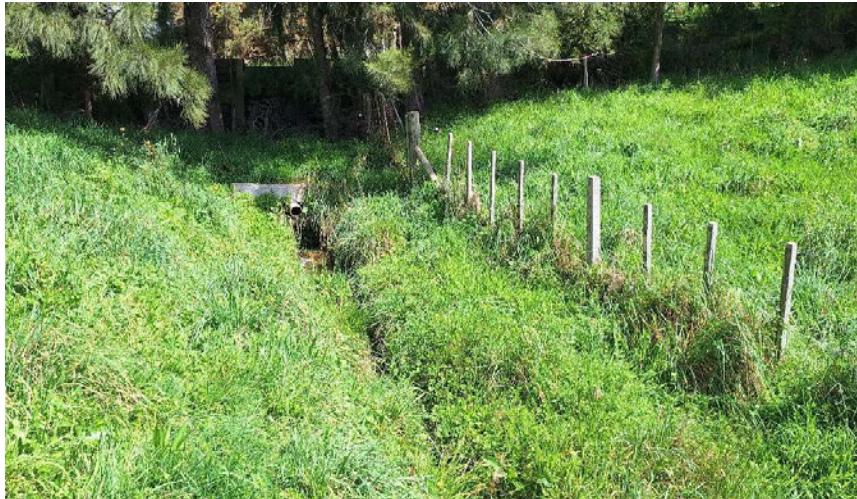
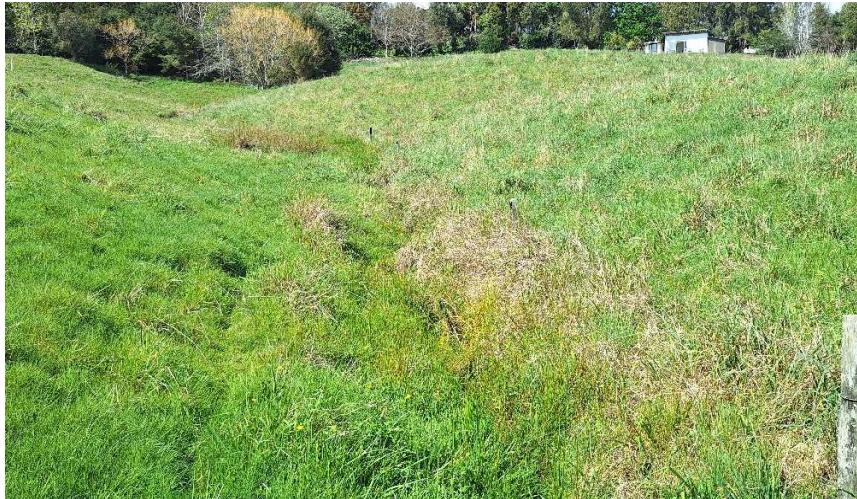
## Type 2 reaches

- RGEA score: All reaches show moderate instability.
- Narrow, shallow channels (less than ~0.6 m deep) that have started to incise into the valley floor.
- Generally small tributaries with relatively steep gradients.
- Very low lateral adjustment potential, but incision is expected to continue.

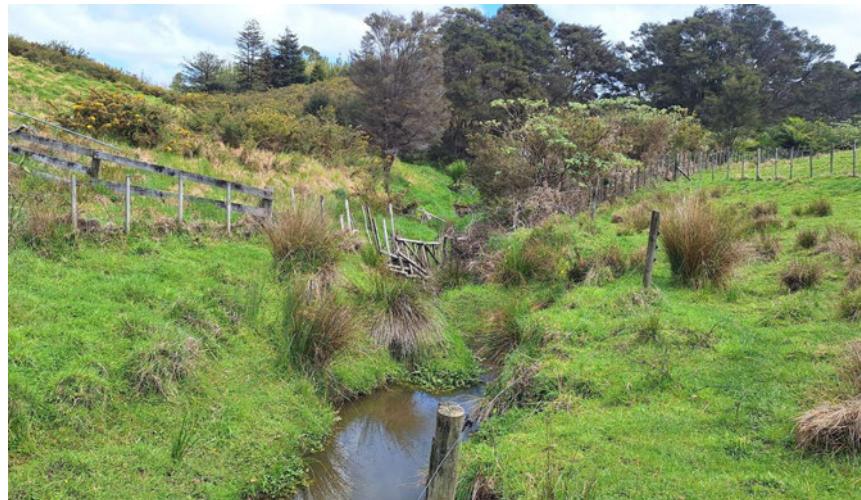
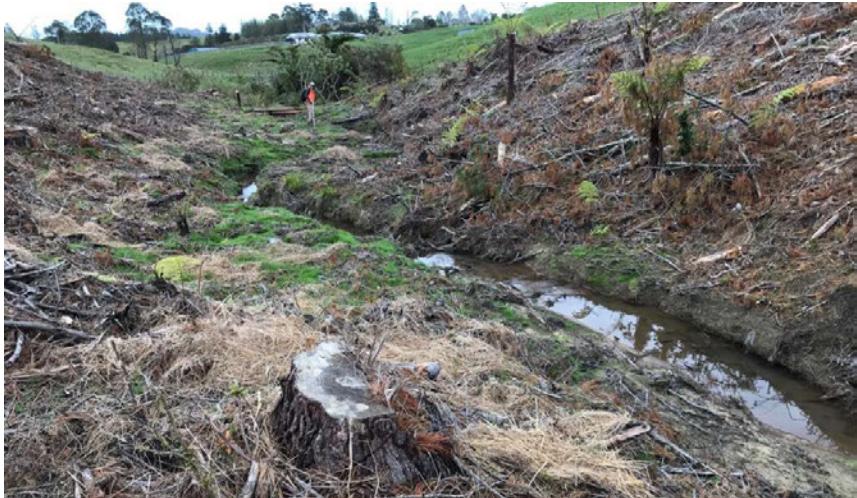
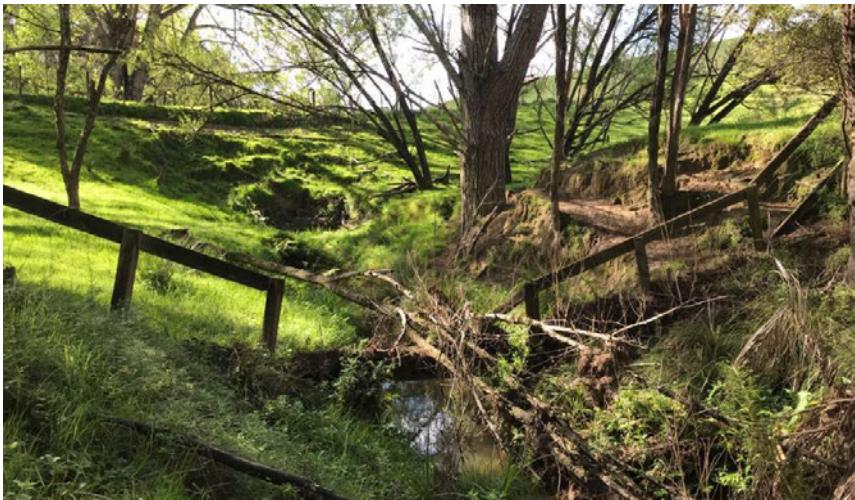
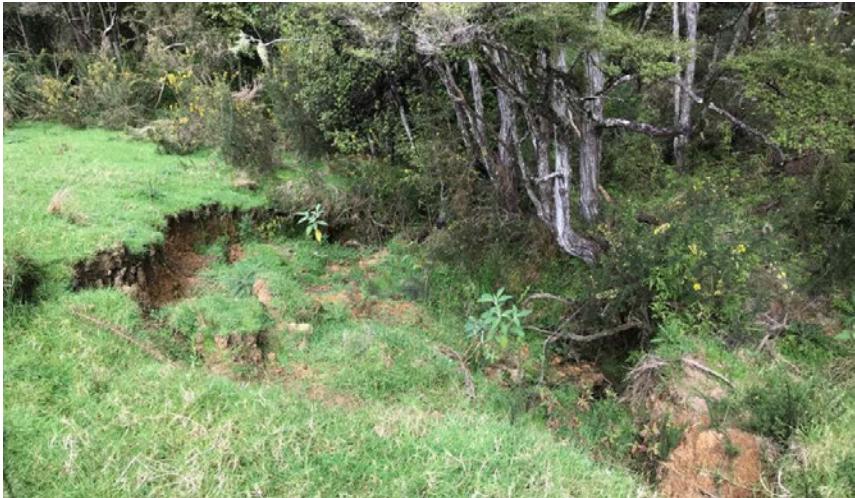
### Type 3 reaches

- RGEA score: Reaches show moderate instability, with some reaches showing considerable instability.
- Streams are downcutting, but there is currently little widening in the form of mass slumping.
- Occasional floodplain pockets on the valley floor that are engaged in higher flows.
- Lateral adjustment potential is low, but there will be overall widening to the channels from scouring of the stream banks which will be exacerbated on outside bends.
- Knickpoints are common, confirming ongoing bed incision

Reach	Key Risk / Condition	Offset Adequacy	Relevant Geomorphic Notes
<b>2 (forestry section)</b>	Recently cleared, with multiple knickpoints, active erosion. Rapid widening and deepening are expected. The valley floor is wider in this location, and the channel location may adjust from where it currently is as it widens.	Acceptable Addressed through geotechnical design	Geomorphic assessment identified incision, knickpoints and potential channel widening across the broader valley floor. These inputs were provided to the geotechnical team and have been incorporated into the geotechnical stability modelling.  Setback adequacy and stabilisation requirements are now addressed under the geotechnical design.
<b>36 (critical)</b>	Scouring below culvert; lots within 10 m, bank erosion risk.	Acceptable Addressed through geotechnical design	The potential for incision and toe erosion was identified as a key geomorphic driver in this reach. These inputs were provided to the geotechnical team and have since been incorporated into geotechnical stability modelling.  Setback adequacy and stabilisation requirements are now addressed under the geotechnical design.

<b>23</b>	Meandering reach with floodplain pockets and several knickpoints. Stream erosion will likely be asymmetrical, concentrating on out bends.	Acceptable Addressed through geotechnical design	Geomorphic assessment identified asymmetrical erosion potential associated with knickpoints and meander geometry. These considerations were provided to the geotechnical team and have been incorporated into their stability modelling for this reach.  Setback constraints for this reach are now managed through the geotechnical design.
<b>24 (landslide complex)</b>	Active landslides of the upper hillslopes with colluvium currently infilling the valley with loose sediment. This material will be easily mobilised, and the stream will incise back to the pre-landslide form.	Acceptable Addressed through geotechnical design	Geomorphic assessment identified active colluvial infill, potential for further incision toward the pre-landslide surface, and sensitivity of this reach to toe erosion. These considerations were provided to the geotechnical team and incorporated into their updated stability modelling, which includes an allowance for an incised channel.  Setback management for this reach is now addressed through the geotechnical design.

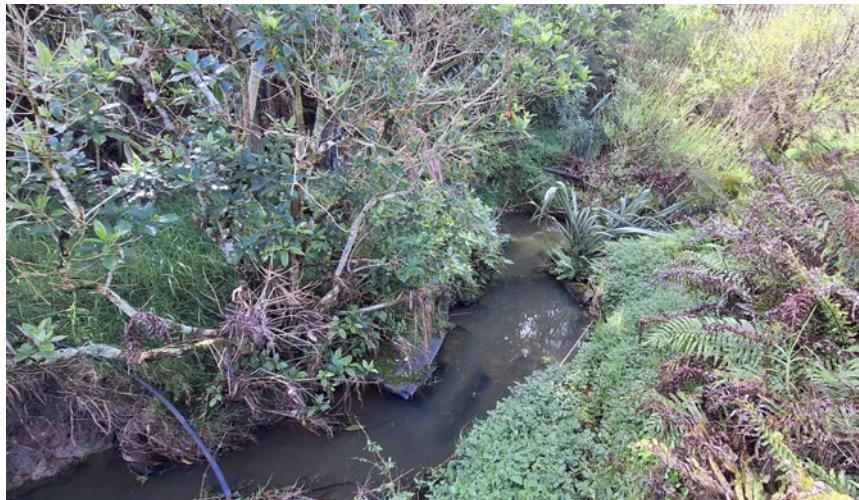
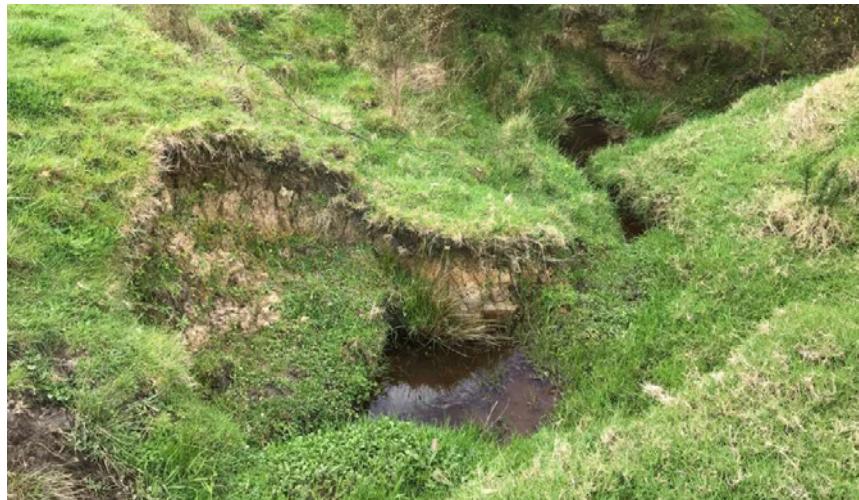
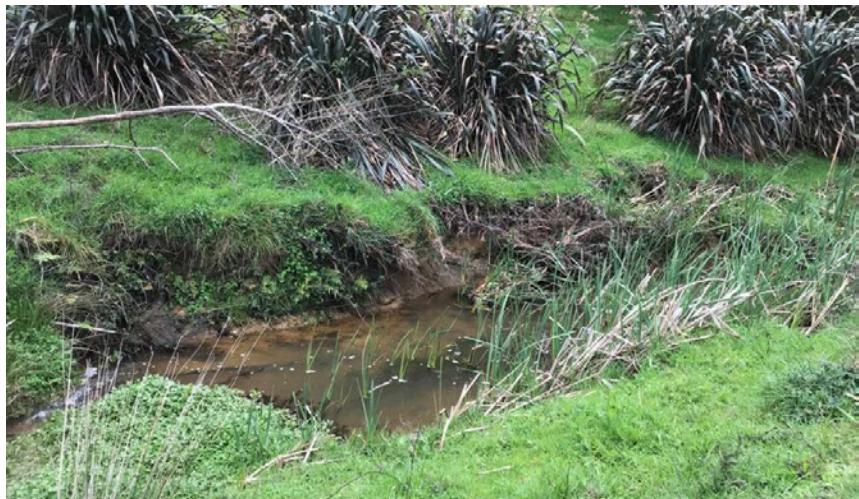
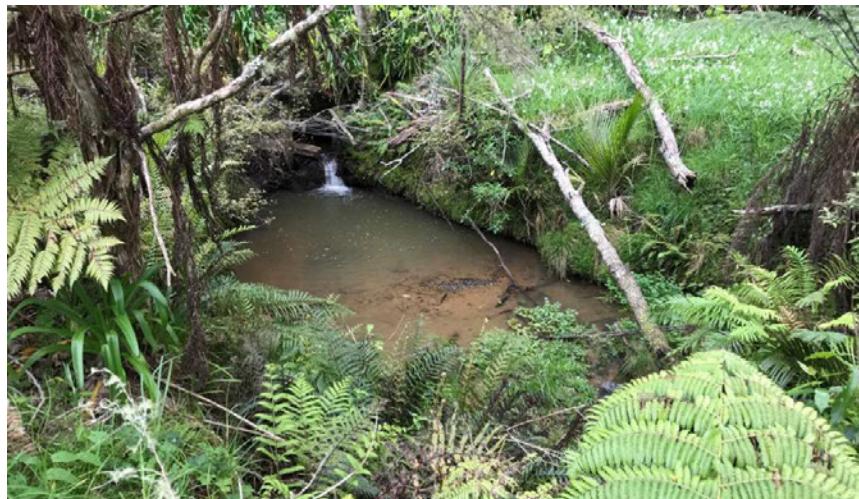
#### Type 4 reaches

- RGEA score: Reaches show moderate instability and considerable instability.
- Streams are downcutting and widening by mass slumping.
- Where bedrock is exposed, stream widening progresses faster as bed incision slows.
- Knickpoints are common. Those flowing over clay will migrate upstream at a faster rate than those flowing over bedrock.
- Low lateral adjustment capacity, though overall widening will continue
- Risk of undermining the toe of the adjacent steep slopes that may lead to geotechnical instability.

Reach	Key Risk / Condition	Offset Adequacy	Relevant Geomorphic Notes
15	Moderate instability with works sufficient distance from the stream.	Acceptable	—
34 – 35	Lower reach has incised up to the culvert with bedrock exposed in places. Upstream of the culvert, there is a shallow channel which transitions to wetland. Little development in this area so unlikely to have much change in hydrology (as part of this development).	Acceptable	Maintain wetland hydrology.
16	Incising. Lots are at sufficient distance from the stream that any adjustment will not impact them.	Acceptable	—
17	Incising. There is the potential for upstream incision to continue and extend into the lots, particularly if stormwater is allowed to discharge directly into this stream.	Acceptable	Check stormwater discharges into this stream and if there is any residual risk of increased overland flow post earthworks.
18	Incised down to bedrock. Earthworks will occur over an ephemeral flow path.	Acceptable.	Check drainage from road does not result in changes to the hydrograph. Check that proposed earthworks do not cause flooding/ponding or result in increased overland flow where the ephemeral channel is modified.
