Preliminary Site Investigation - Twizel Solar Project

for Nova Energy Ltd.

Rev B1 - 19/12/2025

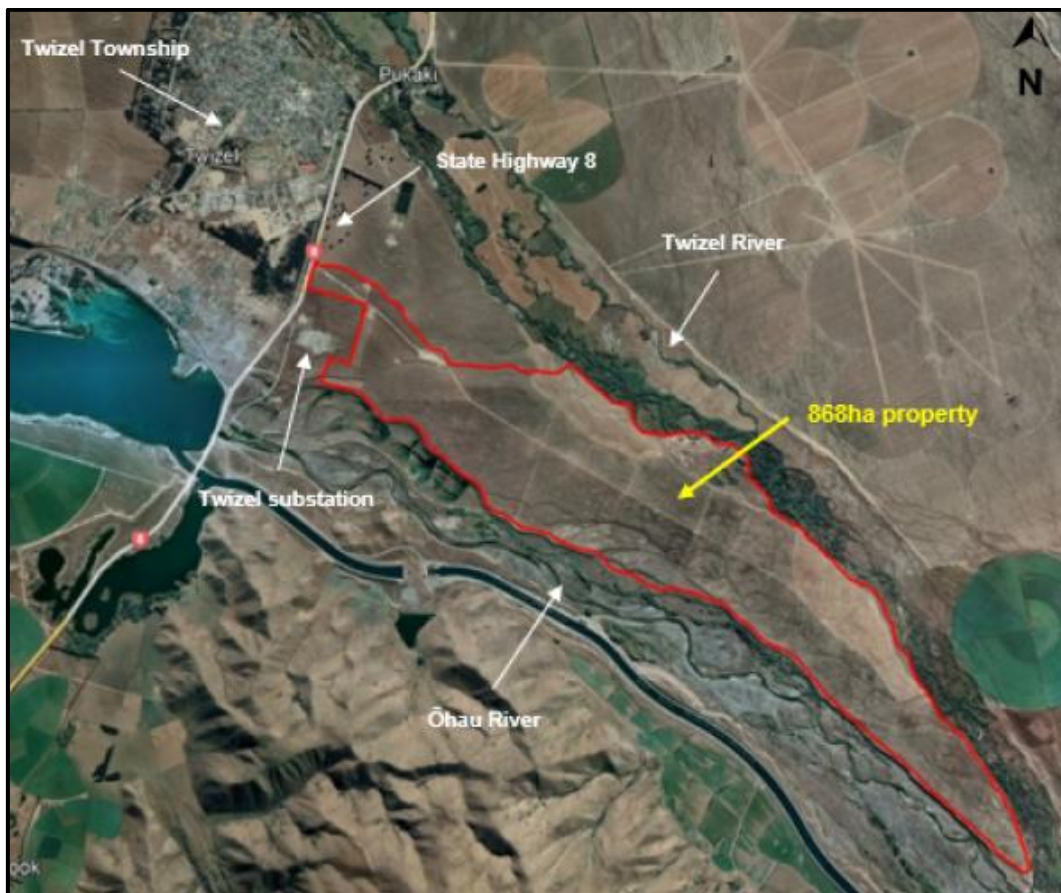
Figure 1.1: Aerial image of the site boundary and the location. Sourced from: Nova Energy Limited.

The site is a large area bound between the Twizel and Ōhau Rivers, on the eastern side of the SH8 and the Twizel township. The entire site is contained within one land parcel of Lot 3 DP 422901. The site is approximately 868 Ha. The site is located under General Rural Zone⁶ according to the MDC plan. See Table 2.1 for further details and Figure 1.1 for an aerial imagery of the site.

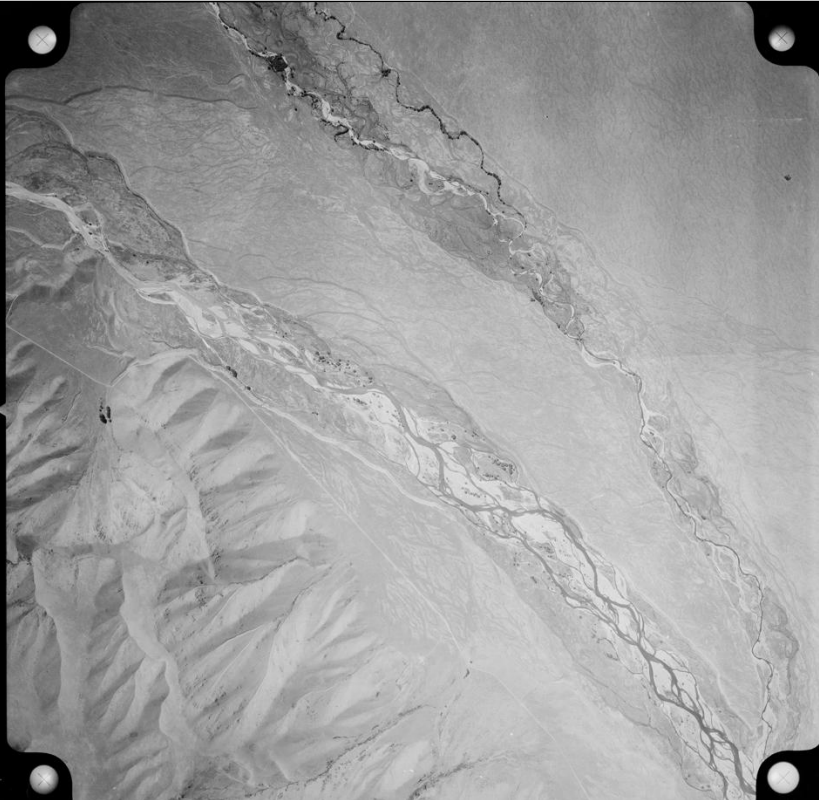
Year	Site Imagery
<p>1959 (Retrolens)</p>

Year	Source	Description
1959	Retrolens	The site looks barren with few ephemeral tributaries running from the top end of the site towards the tail end in the southeast direction.
1978		The power sub-station and the oxidation pools observed outside the site boundary. The transmission lines from the power sub-station are passing through the top northwest corner of the site. An ephemeral runoff stream from the oxidation pool flowing over the northwest corner of the site.
1979		
1980		The stream originating from the oxidation pool is observed on the site.
1984	Canterbury Historical Images	No key discernible changes. The stream originating from the oxidation pool is observed on the site.
1985	Retrolens	No key discernible changes. The stream originating from the oxidation pool is observed on the site.
1989	Canterbury Historical Images	No key discernible changes. The stream originating from the oxidation pool is observed on the site.

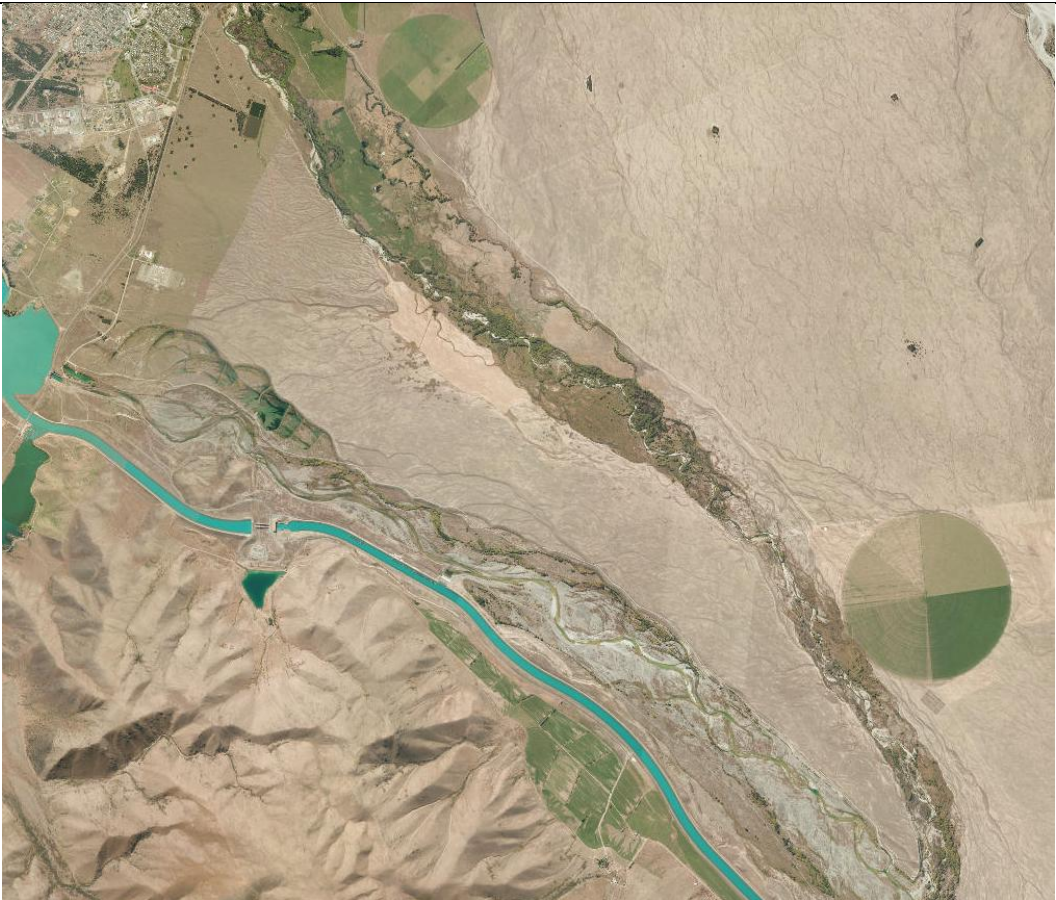
<p>2015 (Canterbury Historical Images)</p>

2004 to 2010		No key discernible changes. The stream originating from the oxidation pool is observed on the site.
2011	Google Earth Pro	No key discernible changes. The stream originating from the oxidation pool is observed on the site.
2015	Canterbury Historical Images	No key discernible changes. The stream originating from the oxidation pool is observed on the site.
2016	Google Earth Pro	A quarry is observed within the top end of the site. Some silage bales are also observed to be stored on the site making it appear like a farmland.
2018		A smaller area close to the power sub-station and near the mid-north boundary of the site observed to be a farmland. Silage bales observed to be stored on the site.
2019		Larger farmland area with livestock and silage bales observed in the centre of the site. Quarry appears to be fully functioning.
2021		No farmland area or livestock observed on the site.
2023		No key discernible changes observed on the site.

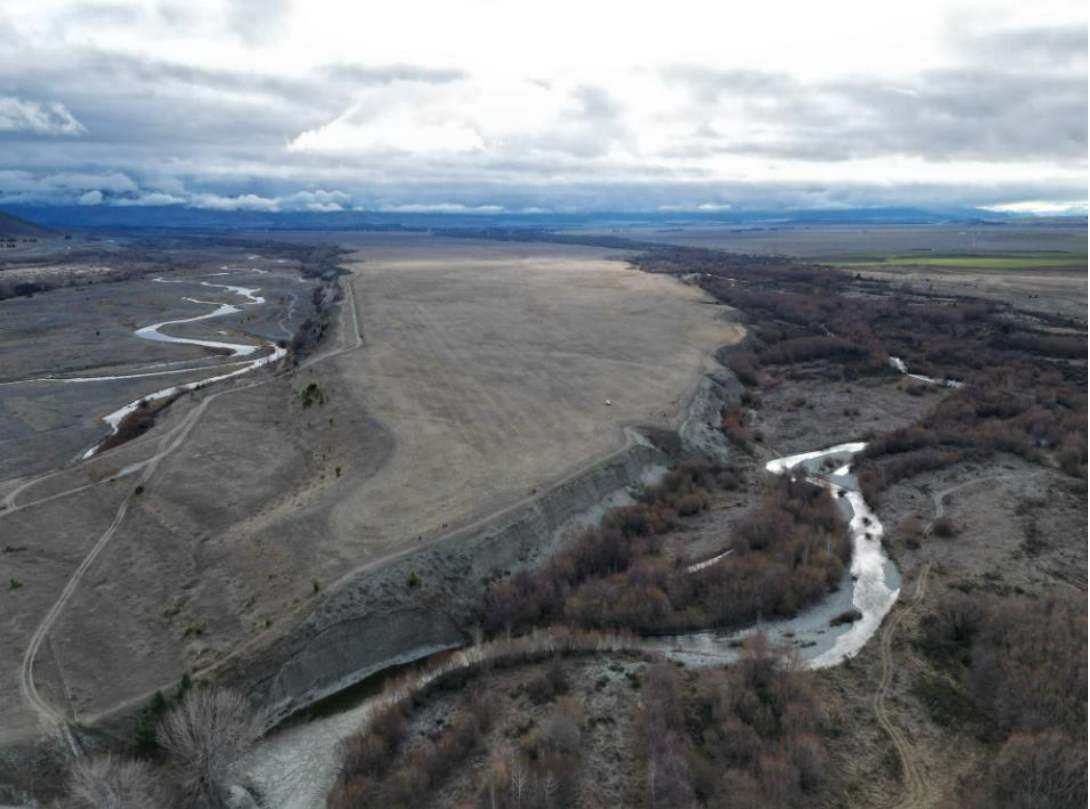
Year	Site Imagery
<p>The tail end of the site with Twizel River on the right and Ōhau River on the left.</p>

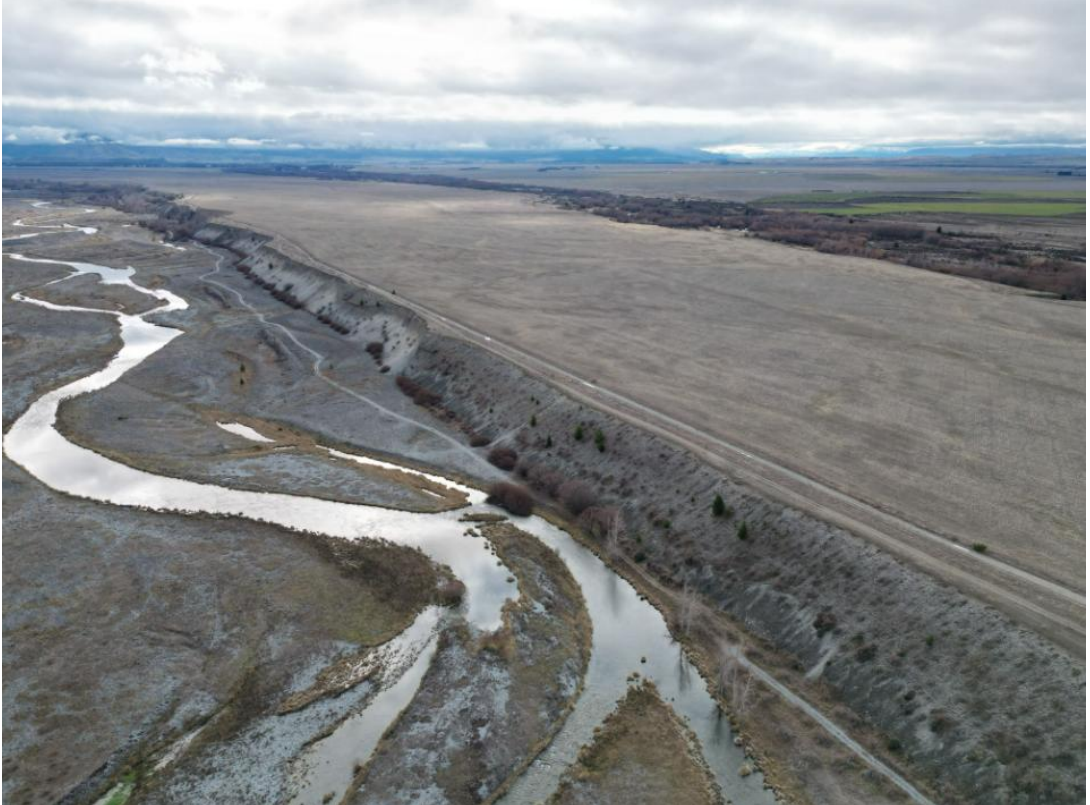
<p>Mid-section of the site.</p>

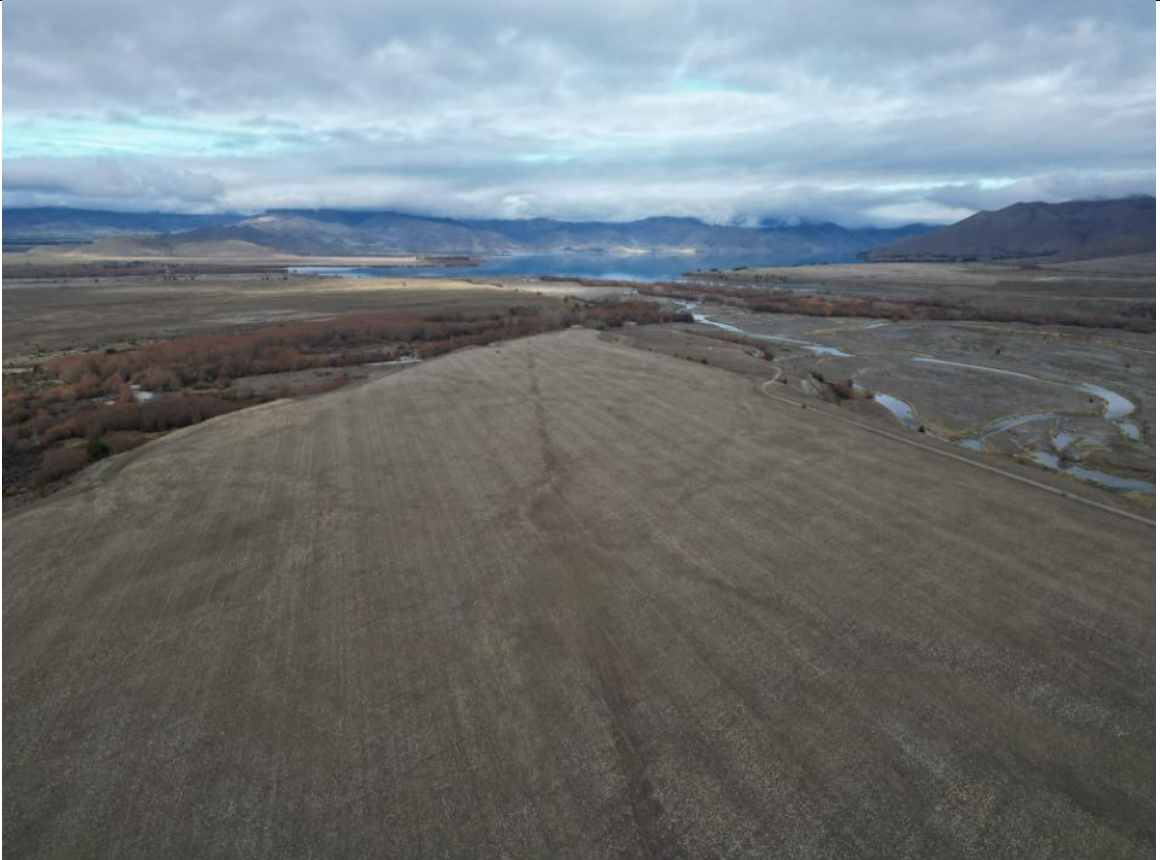
The tail end of the site with Lake Benmore in the background.

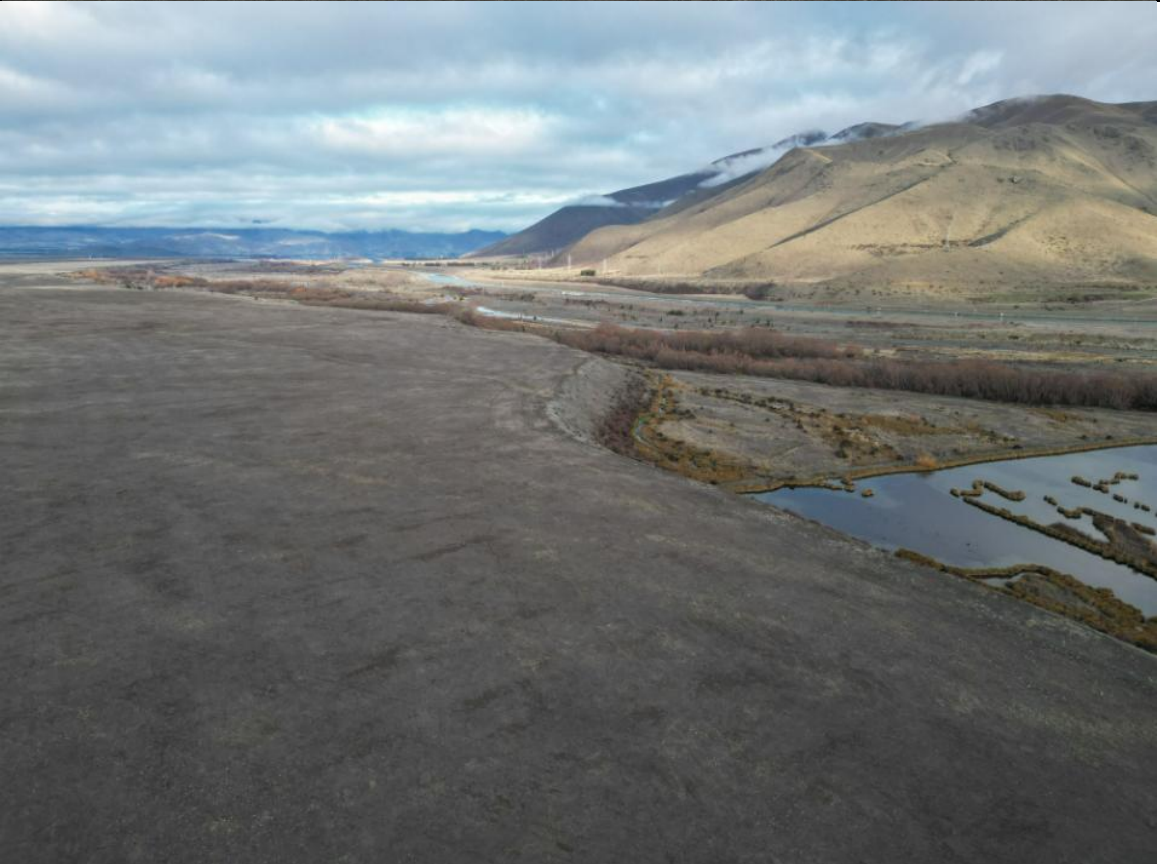
- The transmission lines from the Twizel power sub-station passes through the top northwest corner of the site.
- There is a gravel road running through the centre of the entire site to the tail end of the site, giving access to vehicles on the site.

Top northwest corner of the site, showing the transmission lines running in the background.

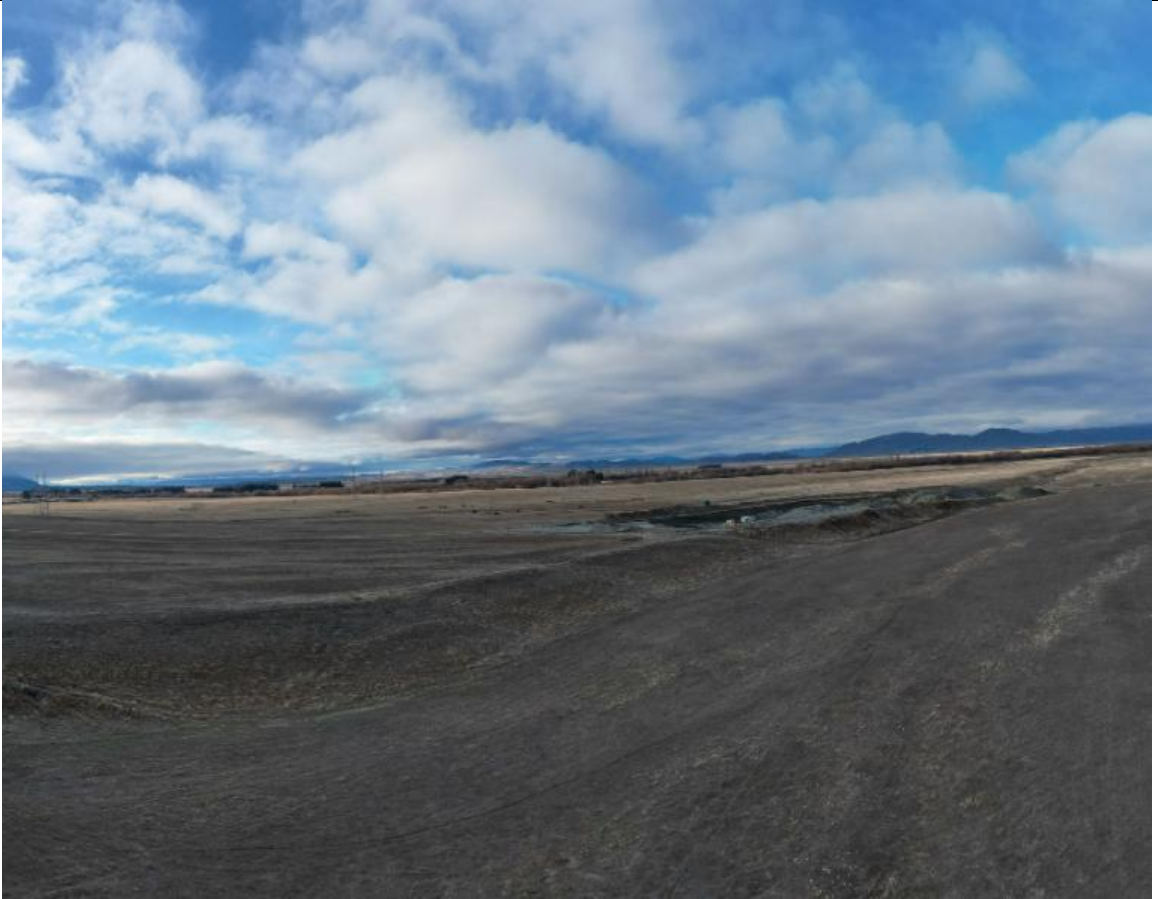
- The site is operating as farmland. The current surface cover is approximately 85% grasslands, red clover and ryecorn.
- There is a functioning quarry located within the site, close to the northwest boundary of the site. However, the quarry is operated by a lease and does not form a part of the site for the solar farm project.

The quarry located close to the top end of the site.

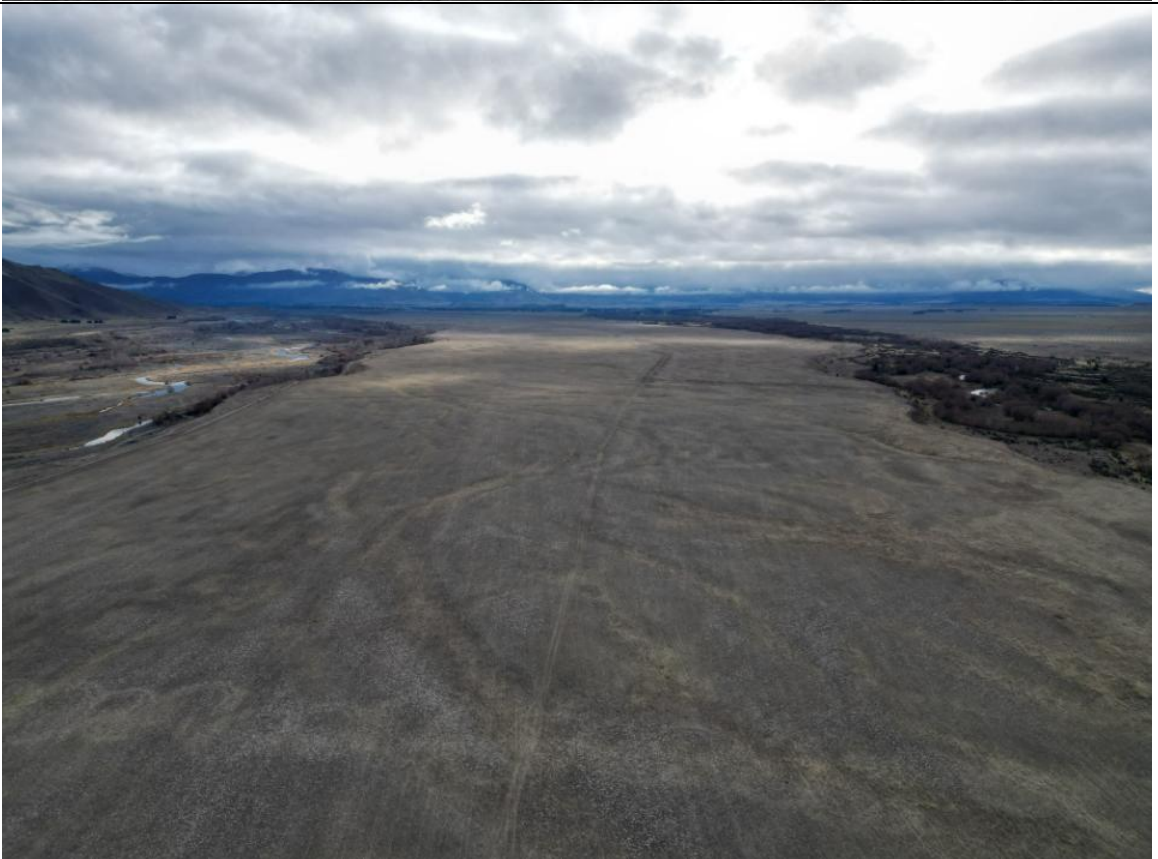
An aerial view of the mid-section of the site.
