## **Sigma Consultants Ltd**

**Geotechnical report**

**66 Mcfetridge Drive**

Report Number: 9047.1

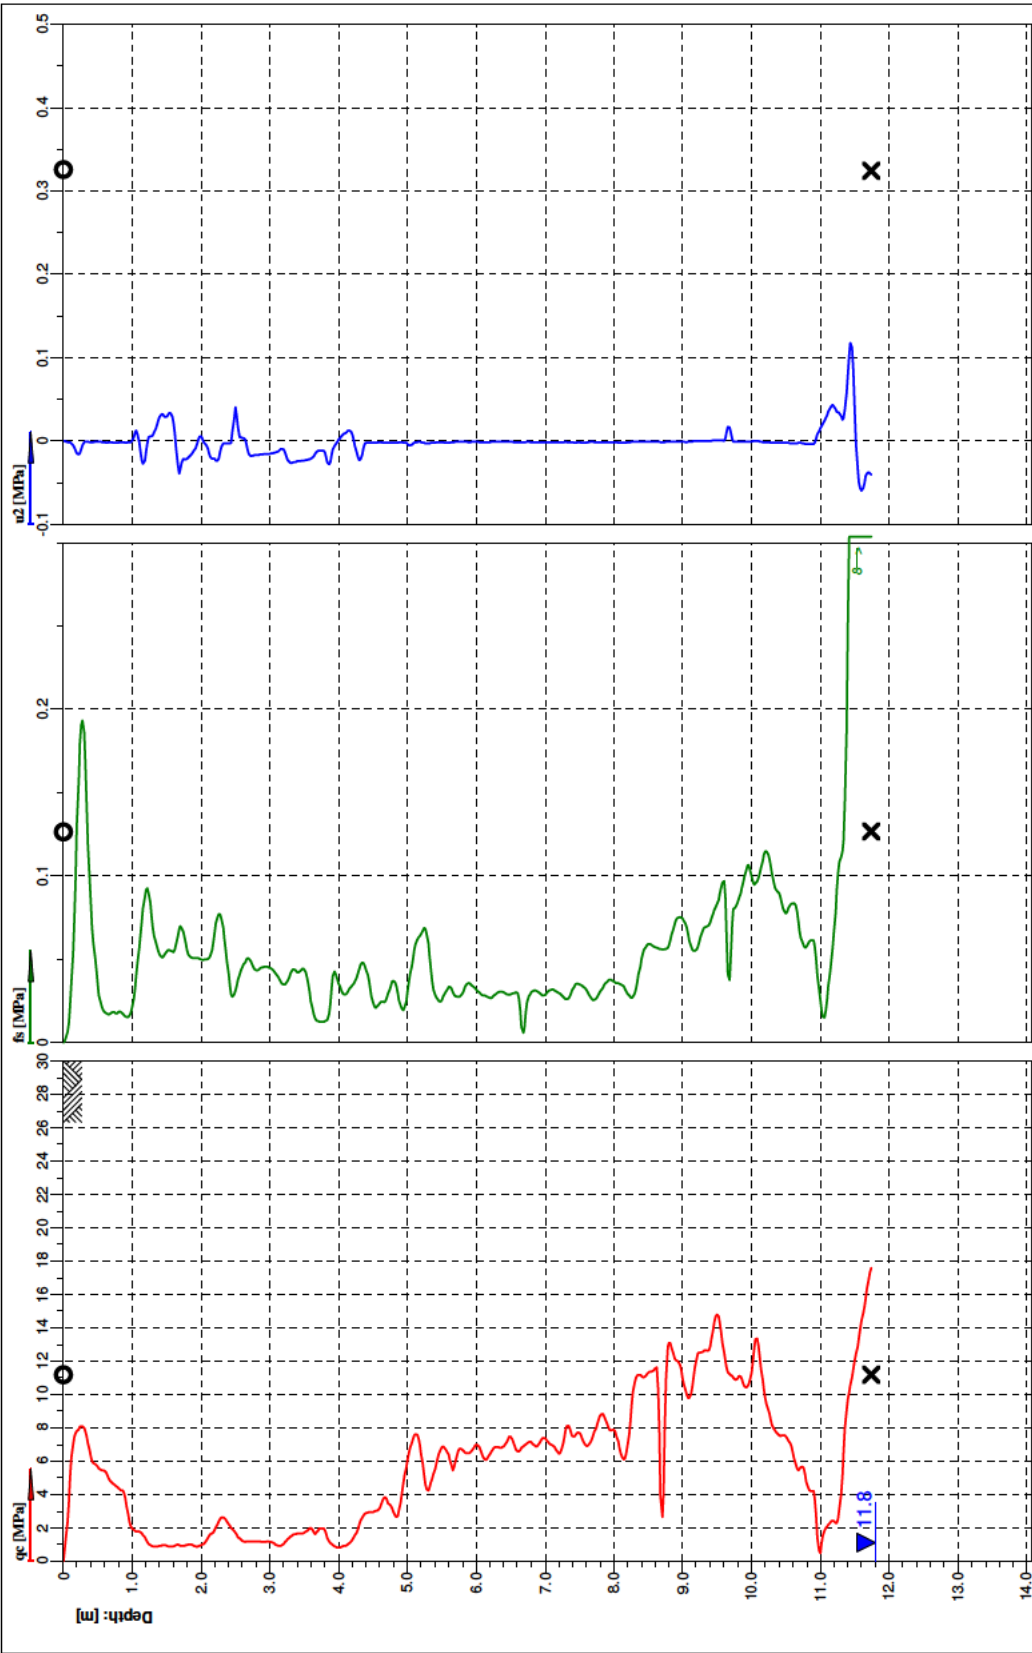
| Location: Hamurana | | Position: X: 0.00 m, Y: 0.00 m | Test No.: CPT10 |

| Project ID: S38.03331 E176.20993 | Client: Sigma Consultants Ltd | Date: 7/07/2022 | Scale: 1 : 89 |
