Detailed Site Investigation (DSI) at Brymer Road, Rotokauri

for Brymer Farms Limited

Rev 2 - 30/07/2021

210406
Rev 2 - 30/07/2021

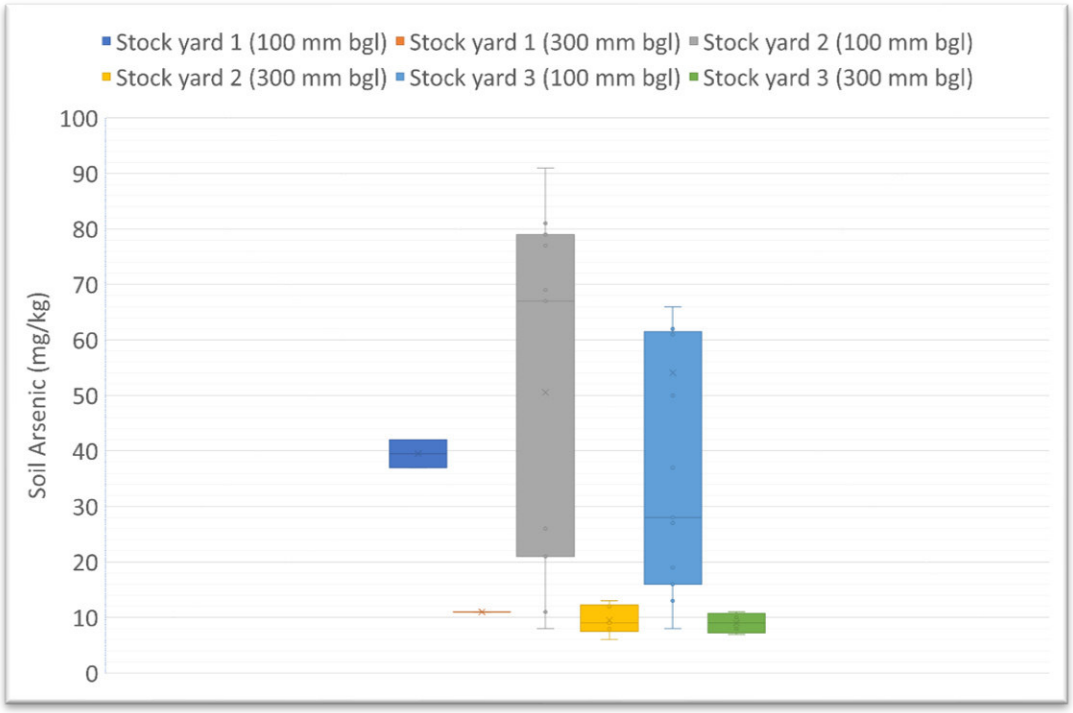
Figure 5.2: Box plots of all soil arsenic concentrations (mg/kg) at the three stockyard sites in soil surface (0 – 100mm) and sub-surface (250 – 300 mm) samples. At stockyard three an outlier of 300 mg/kg has been removed for graphical clarity.

The controlling pathway for arsenic to human health risk is via soil ingestion, followed by produce consumption. Dermal pathway is insignificant for arsenic. Arsenic was found at concentrations presenting a risk to human health, albeit dependent on the development activity and end land-use. Therefore, as the source-pathway-receptor linkage is complete, the stockyard sites are flagged as a piece of land (see Appendix E). It is recommended that arsenic is further quantified and delineated, and a management plan is developed alongside the site development plan as part of a Remedial Action Plan (RAP). Additionally, a Site Management Plan (SMP) should be developed for commercial workers. The 95% UCL at stockyards 2 and 3 were below commercial worker exposure SCS (with outlier sample removed from Stockyard 3 data). At Stockyard 3, a hot spot of arsenic of 300 mg/kg

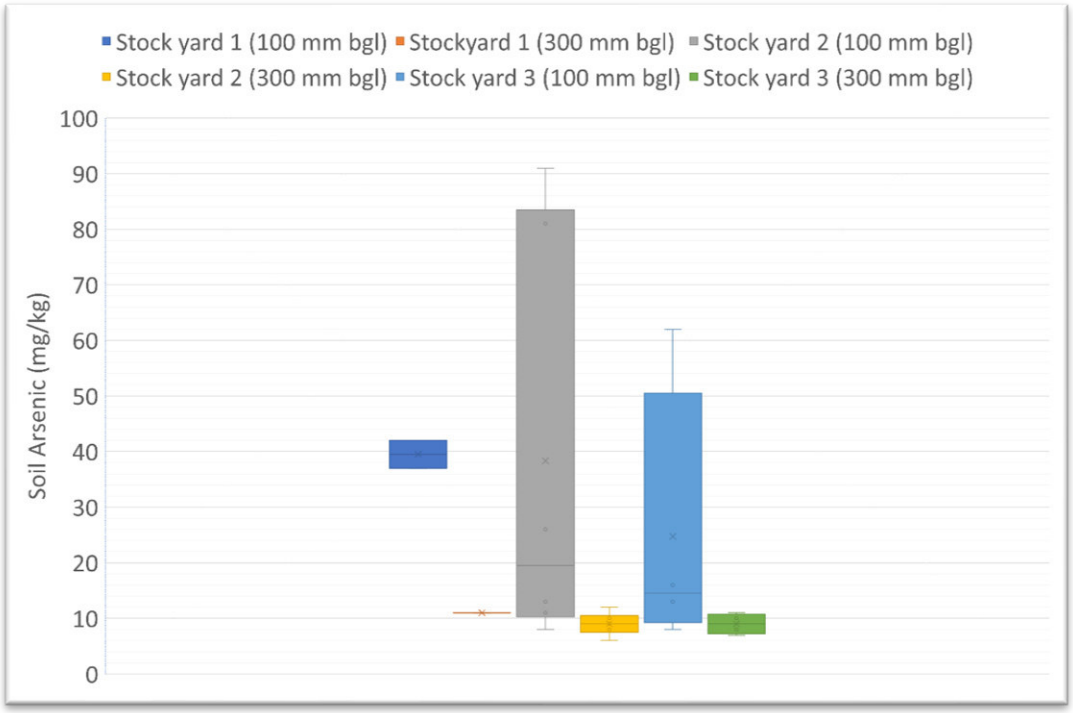
Figure 5.3: Box plots of paired surface and sub-surface soil arsenic concentrations (mg/kg) at the three stockyard sites. At stockyard three an outlier of 300 mg/kg has been removed for graphical clarity.

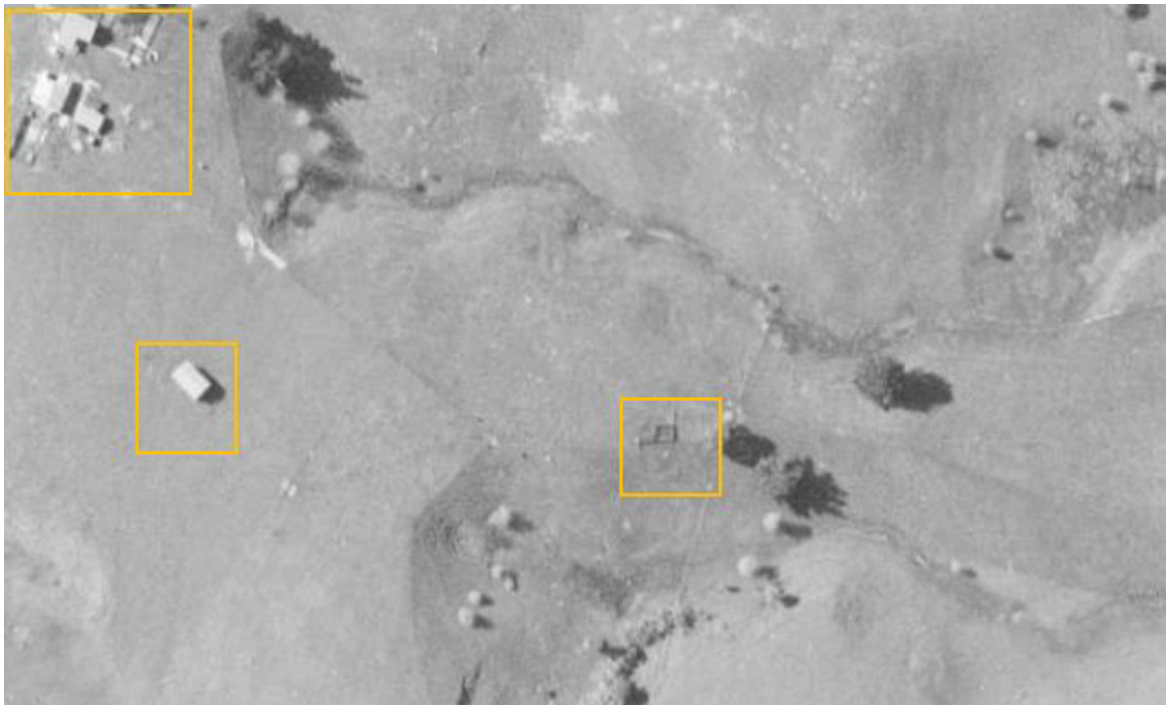
Figure A 4: 1953 aerial imagery. Yellow boxes highlighting Stockyard 2, and features to the north outside the site boundary. Source: Retrolens.

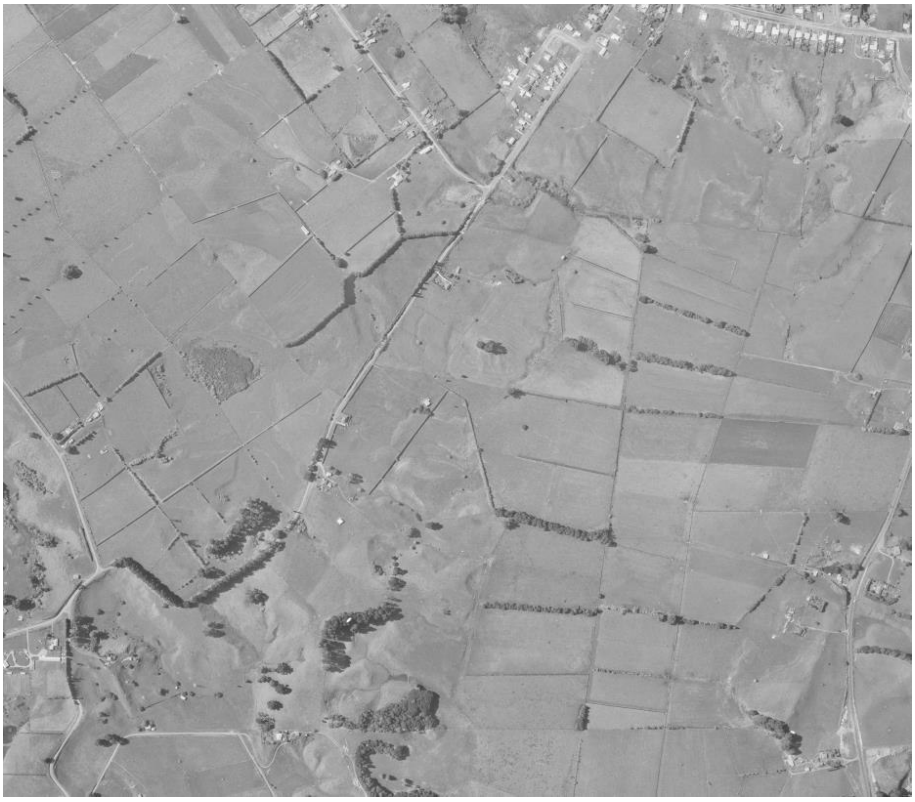
Figure A 5: 1971 aerial imagery of the site. Source: Retrolens.

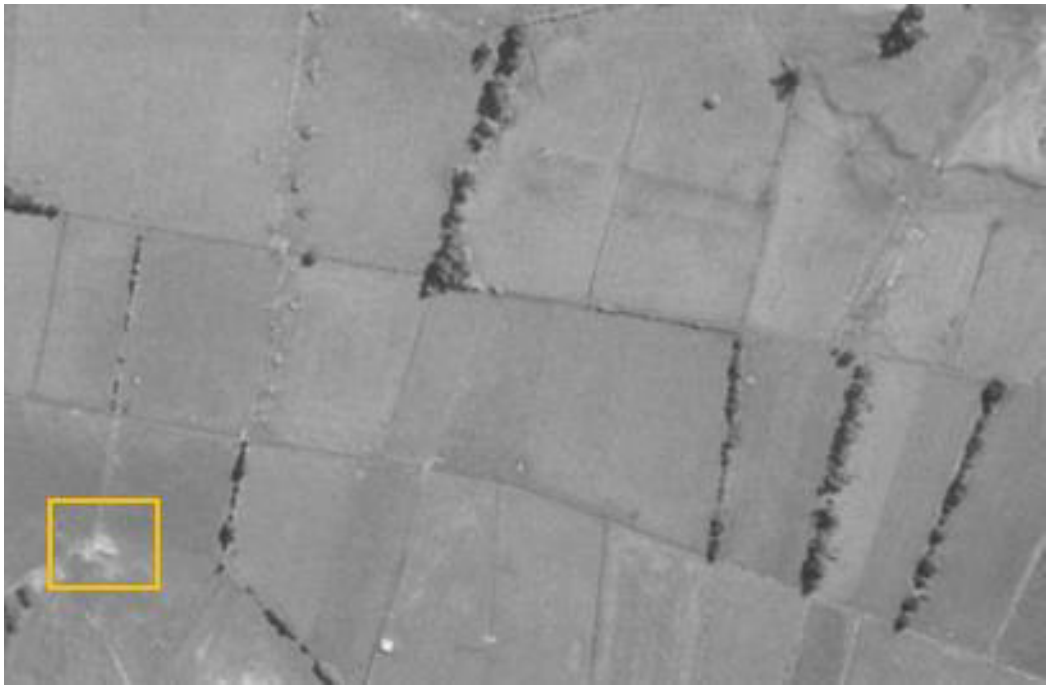
The historical imagery highlights a structure present on the site in 1943 and removed between 1953 – 1971. This structure was located close to the residential building referred to as the farmhouse. During a site visit, visual surface assessment test pits were completed in the area of the structure footprint and found no evidence of building material or building platform. In addition, limited intrusive sampling was completed to provide supplementary data for asbestos and lead risk assessment. No asbestos was detected and lead was well below the most conservative guideline value. Therefore, the unknown structure is highly unlikely to pose a risk to human health.

Figure A 7: 1974 aerial imagery. Yellow box highlighting removal of unknown structure. Source: Retrolens.

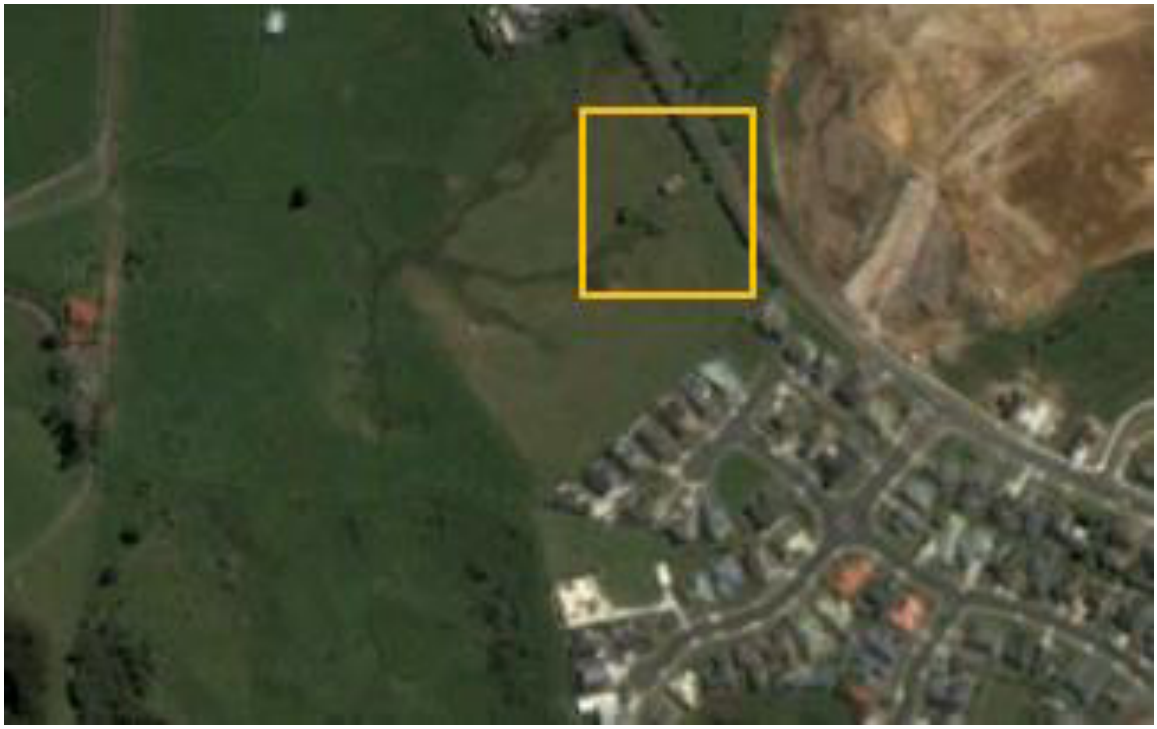
At Stockyard 1, soil arsenic is therefore likely derived solely from CCA leaching from wooden posts creating 'micro-hotspots'. The arsenic depth profile and surrounding arsenic concentrations are conducive to using soil mixing[18] as a remediation option (depending on proposed end land-use) that would be required if subdivision, soil disturbance, and / or change of land-use is to occur at this location. At stockyards 2 and 3, arsenic concentrations exceeding 60 mg/kg were found at distance, or in absence of, wooden posts, see Figure 7.1. Subsequently, the hypothesis is that the source of soil arsenic at stockyards 2 and 3 is derived from both CCA treated wood and historical use of arsenic-based insecticide for treating sheep.

Figure A 13: 2004 aerial imagery. Yellow box highlighting Stockyard 1.
