Preliminary Site Investigation

Bendigo-Ophir Gold Project

J-G-NZ0005-001-R-Rev3

MATAKANUI GOLD LIMITED

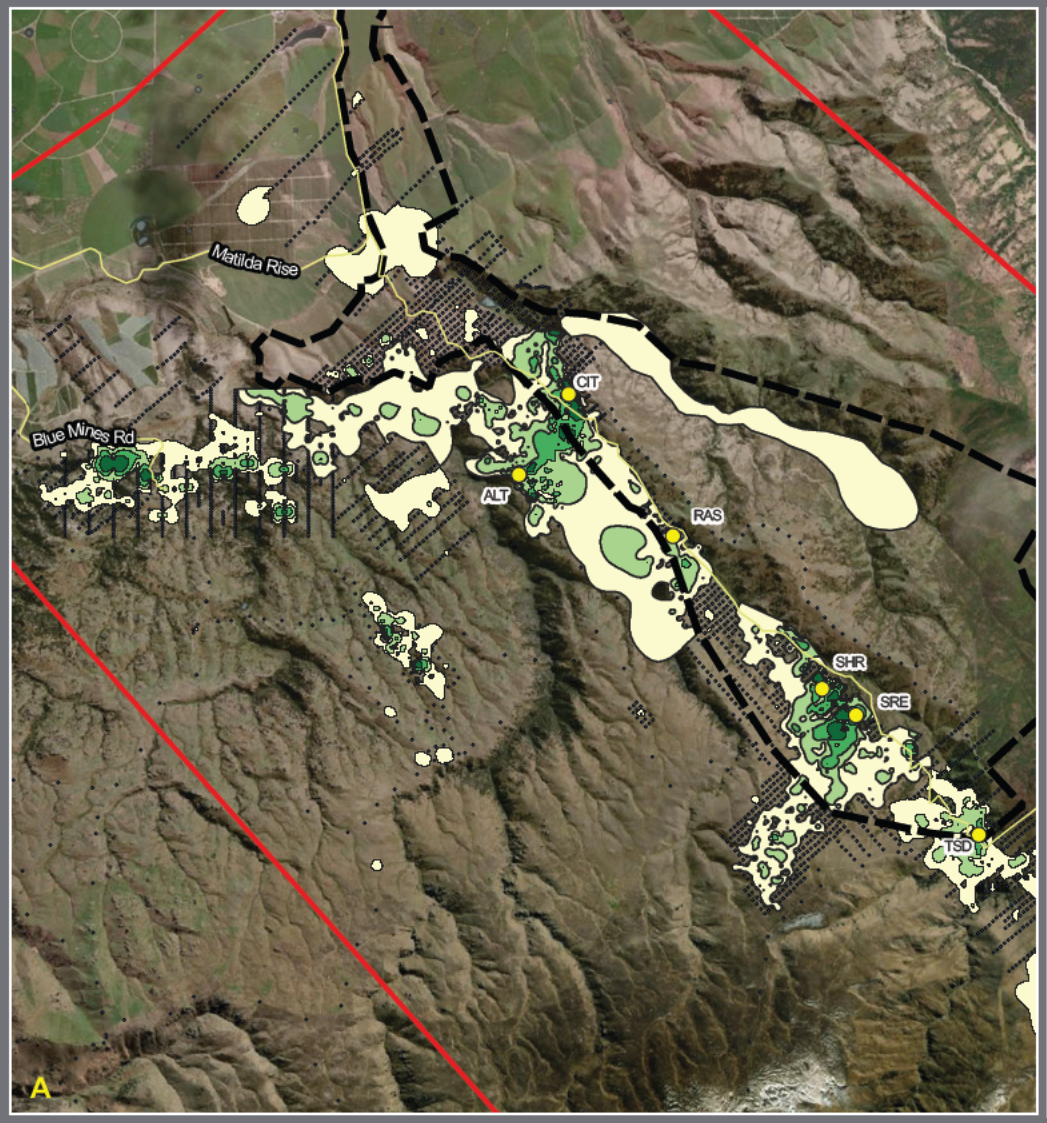
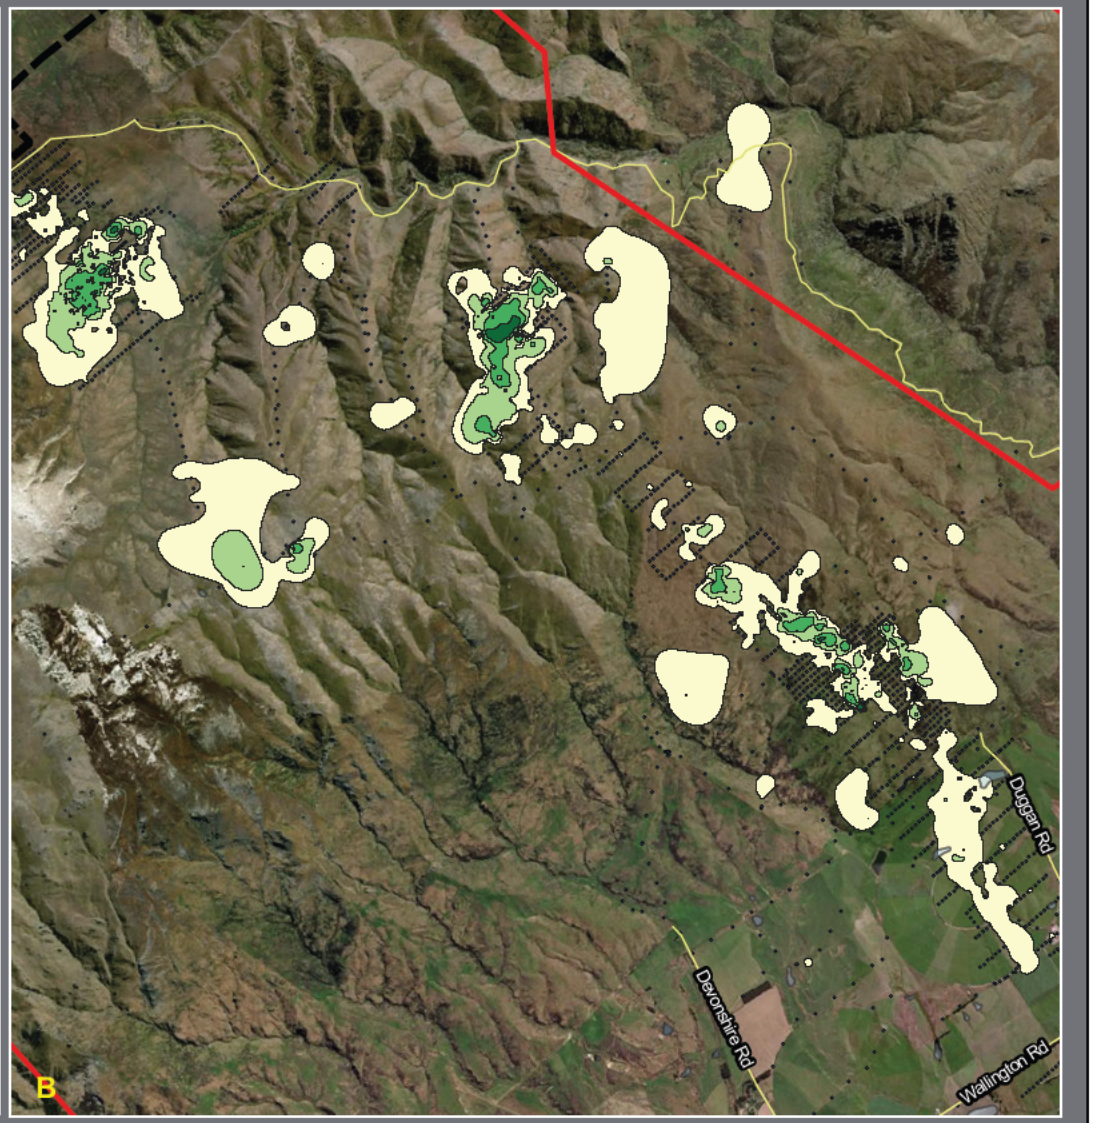
Soil arsenic concentrations (ppm)

- Arsenic (As) has been identified at concentrations above industrial land use human health protection criteria and above 60% and 80% Eco-SGV in shallow soils within the Project area, predominantly within the historic mining areas. Potentially complete exposure pathways may result from the disturbance of these soils during future mining activities. Cadmium (Cd) was found extensively above 80% Eco-SGV and may also warrant management during operations to meet post-closure land use objectives; and

Further evaluation of the soil dataset is recommended to differentiate between endemic and anthropogenic metals concentrations in the Rise and Shine valley, and if required, derive appropriate ecological background metals concentrations for the Project area. Given the duration of time that has passed since historic mining activities, it is possible that ecological populations within the catchments have adapted to historic mining impacts. Notwithstanding, deriving background metals concentrations in disturbed and undisturbed areas of the Project area will assist in the development of appropriate monitoring requirements and trigger values to assess potential effects on ecological receptors within the Project area during operations.

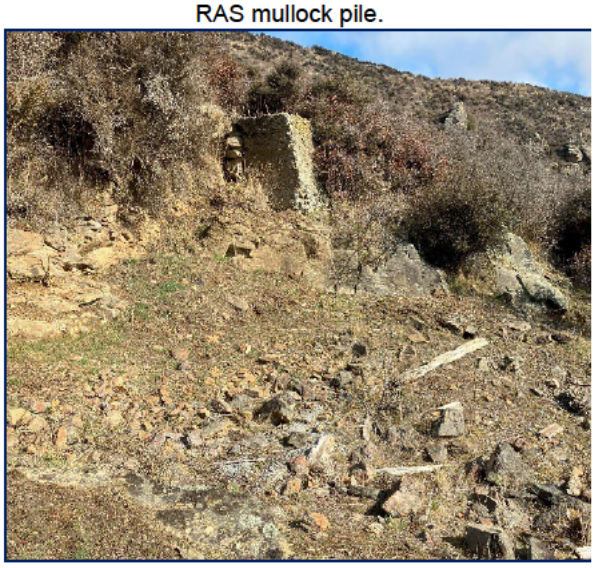
- The former RAS battery area is located further upstream along Rise and Shine Creek and includes evidence of the battery foundations, adits, mullock piles, and evidence of tailings and workings scattered around the RAS battery and upstream beside the Rise and Shine Creek. (Photos C6 to C11); and

Photo C10: Historic RAS battery location

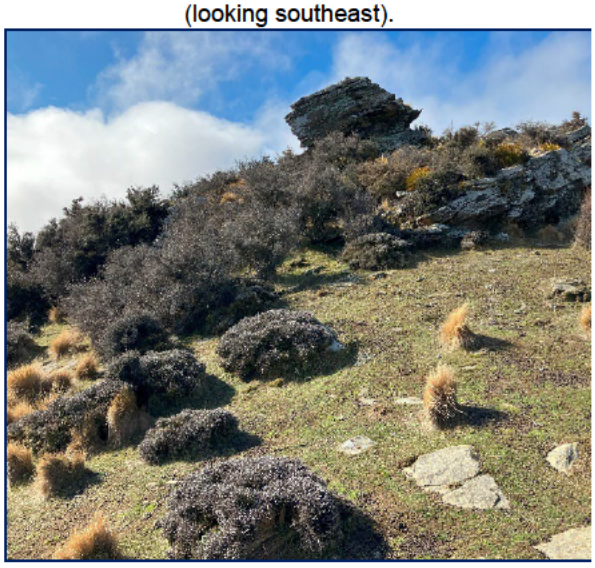
Photo C23: Schist outcrop on ridge peak at SE end of proposed mine development area.
