Preliminary and Detailed Environmental Investigation at 922 Luggate-Cromwell Road (SH6), Cromwell

Prepared for:	Fulton Hogan Land Development
Date:	23/10/2026
Our Reference Number:	24019_3
Report prepared by:	Claude Midgley CEnvP, MSc.
Authorised by:	Jana Kruyshaar CMEngNZ, CPEng

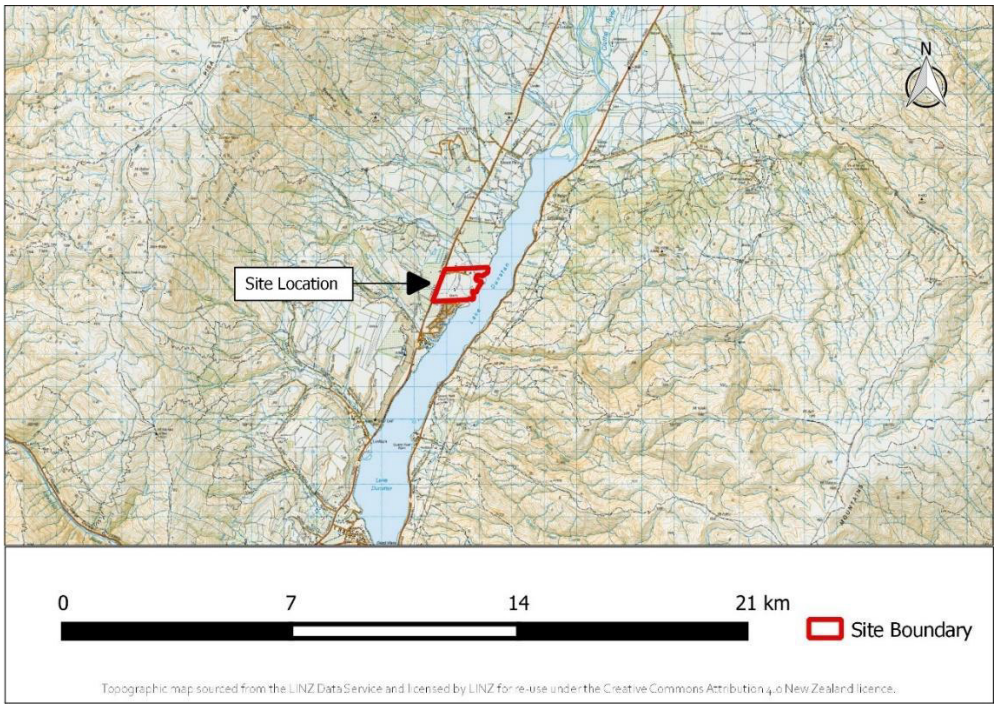
Figure 2: Site Location (topographic)

The area under investigation (the site) is located at 922 and 922A Luggate-Cromwell Road (SH6) (see Figures 2 and 3). The site is situated between Lake Dunstan and the state highway, approximately 8 km north of Cromwell.

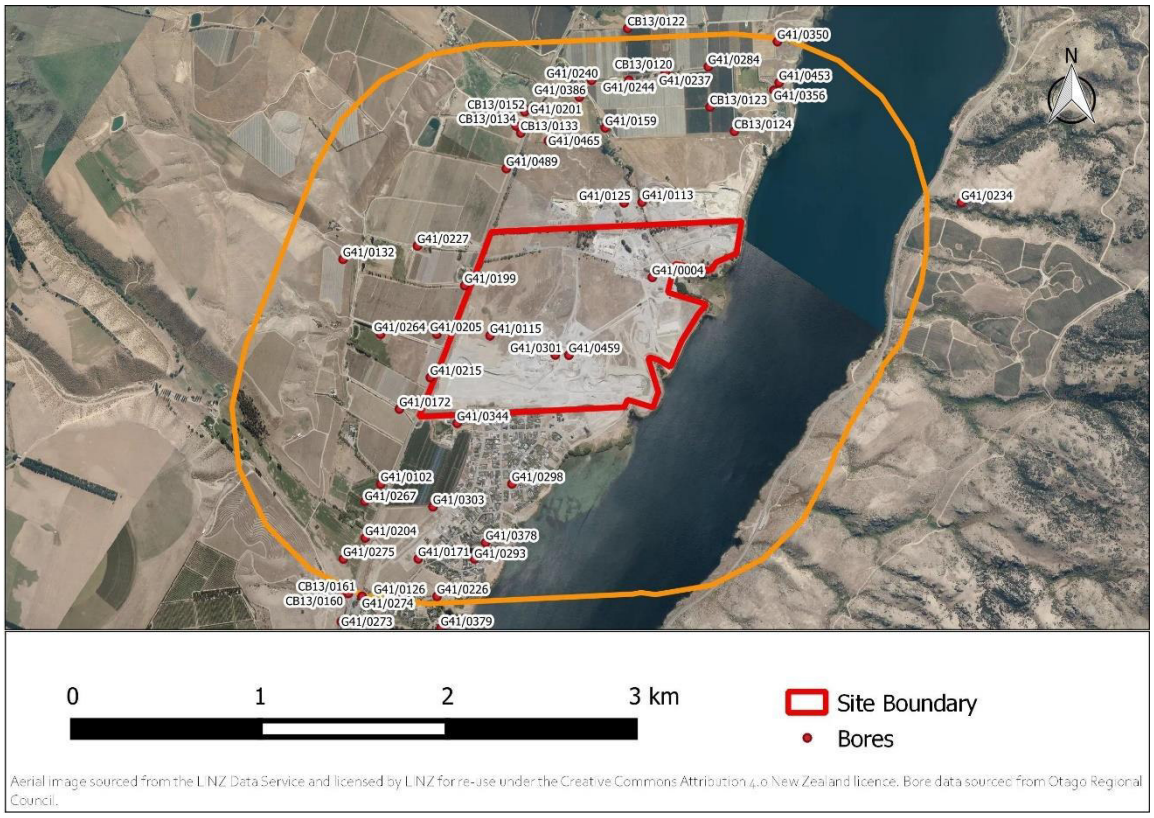
Figure 4: Registered bores within 1 km of the site

There are 36 recorded bores within a 1km radius of the site's location (Figure 4). Of these bores, the primary usages are: 14 for Irrigation, 16 for domestic use, 3 for community supply, 2 for commercial/industrial, 1 for investigation, and 1 is unknown.

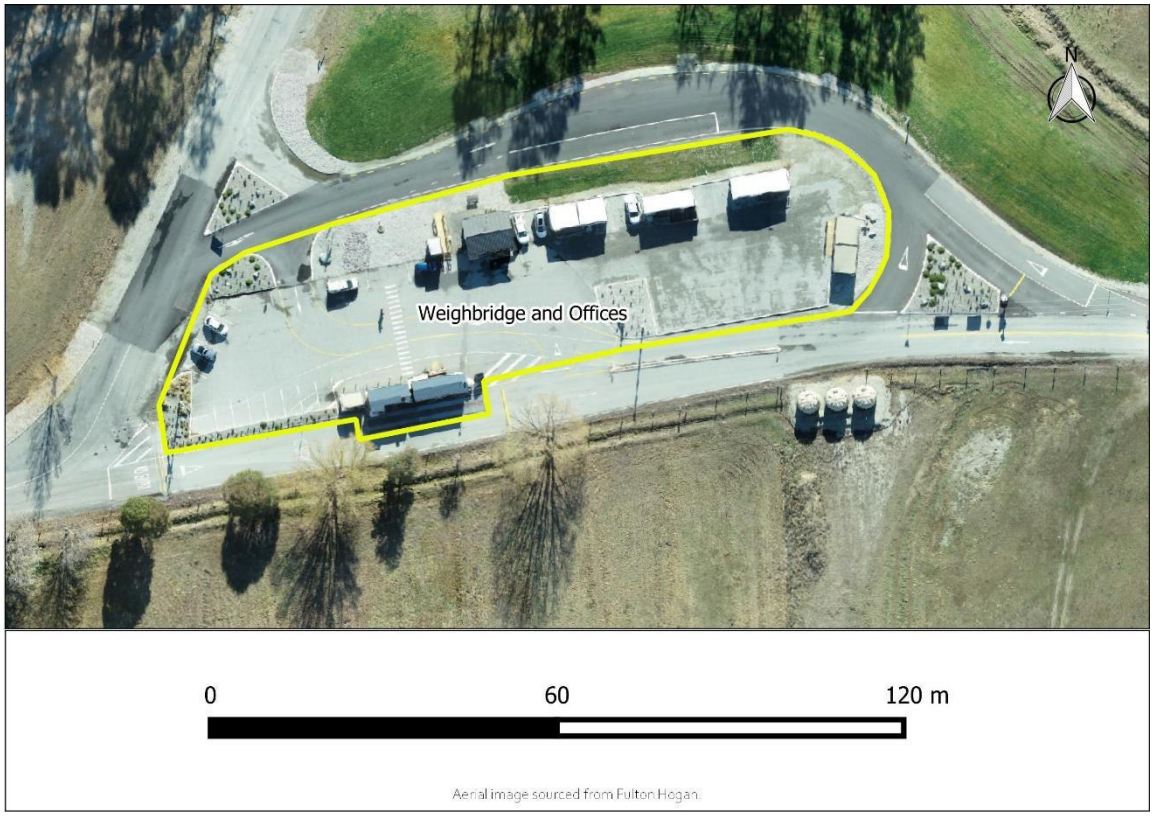
Figure 6: Weighbridge and offices

There are five Portacom style buildings in addition to the weighbridge. All buildings appeared to be in good condition. The surface cover is predominantly hard stand, gravels, and landscaped areas (Figure 66).

There was no evidence of any hazardous substance use or storage in this area.

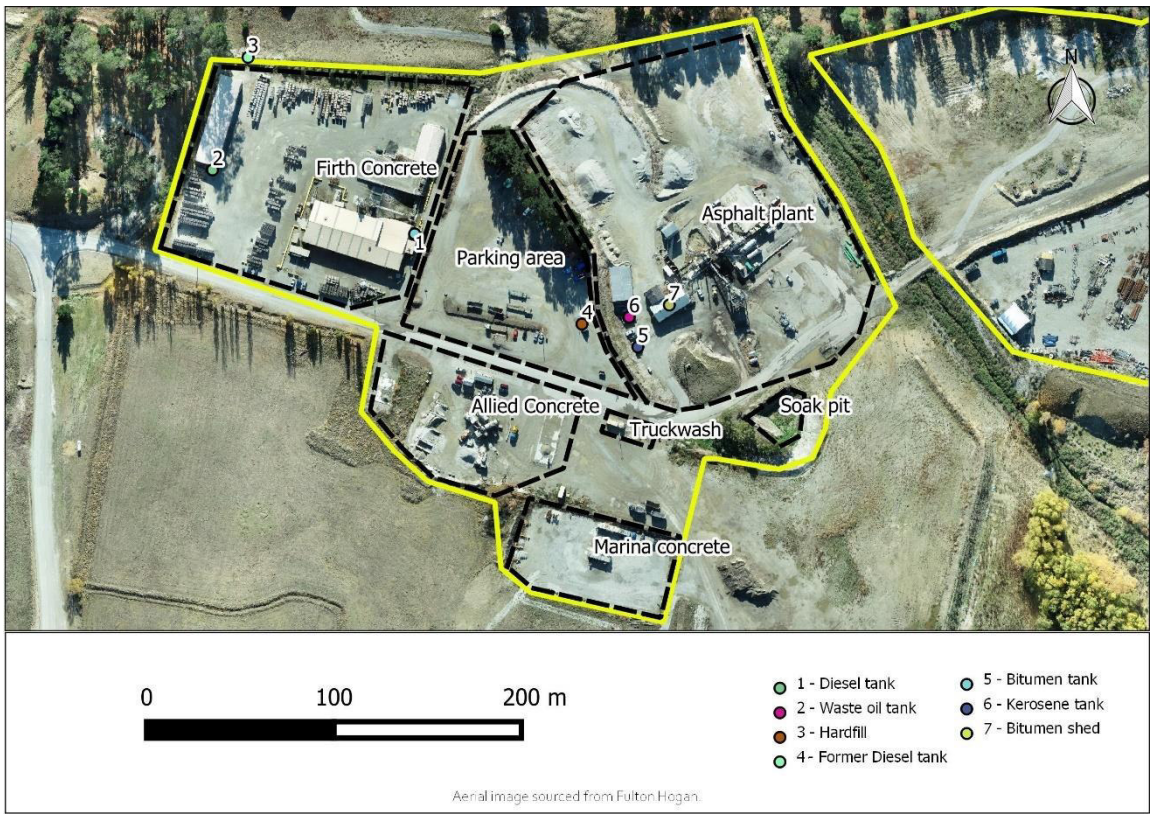
Figure 7: Industrial area activities

Activities in this area include: the Firth Concrete block manufacturing facility, the Fulton Hogan asphalt plant, the Allied Concrete batching plant, a yard formerly

used for producing pre-cast concrete panels for the Frankton Marina, a truck wash, and truck parking area (Figure 77).

The Firth Concrete block manufacturing facility is located on the western end of the industrial area. The gravel yard was generally tidy and well kept. A 10,000 L diesel tank is located to the east of the manufacturing building (1). An open storage shed is located along the western boundary of this area. A small, waste oil 'igloo' was present to the south of the open shed (2). There was no staining around the waste oil tanks. Several empty drums of concrete retardant (Sika Retarder) were stored behind (west of) the open shed. Hardfill, consisting of broken concrete tiles and blocks was deposited over the landscape bund, north of the factory (3).

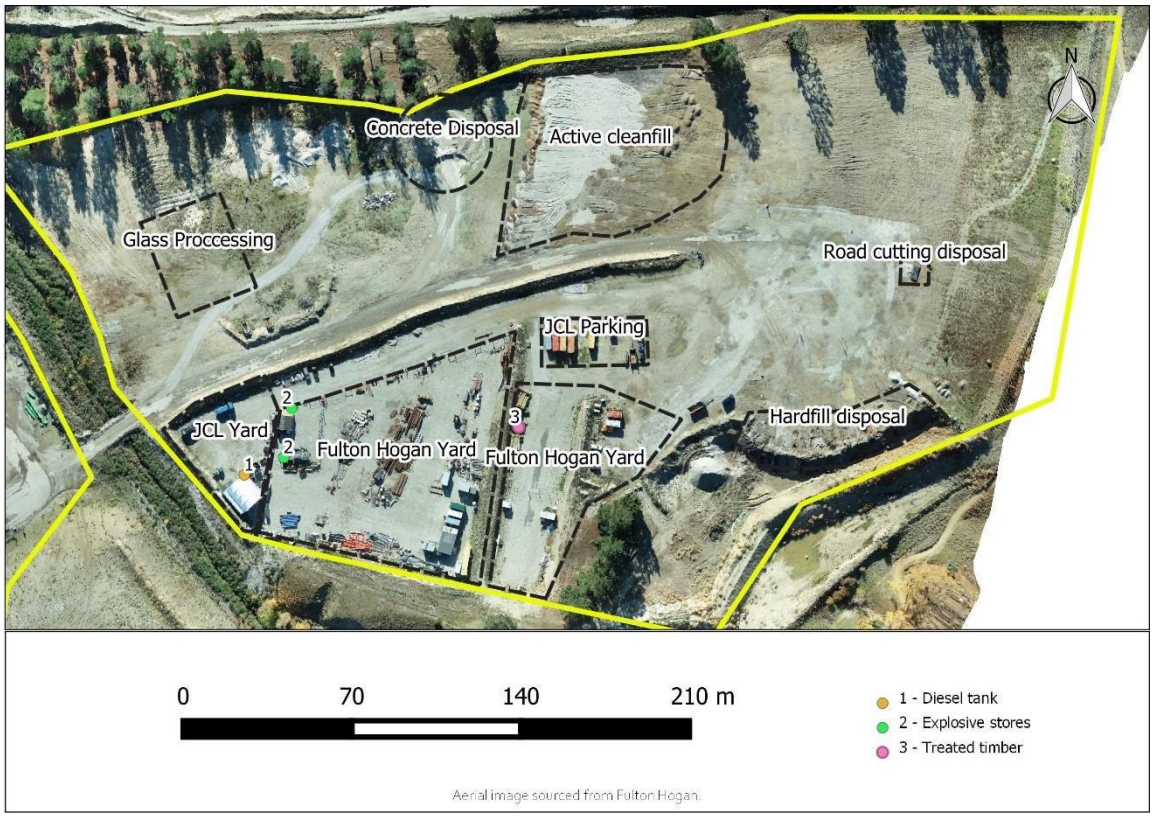
Figure 8: Cleanfill and yards area

On the opposite side of the Park Burn, an area of past quarrying is now used for cleanfill disposal and for outdoor yards used by JCL Asphalt Limited and several divisions of Fulton Hogan (Figure 8).

A new shed, which will be used for crushing and storage of recycled glass, has been constructed. This building was consented under RC210112. During the site inspection, drainage work was being completed, but storage and crushing of glass had not yet commenced.

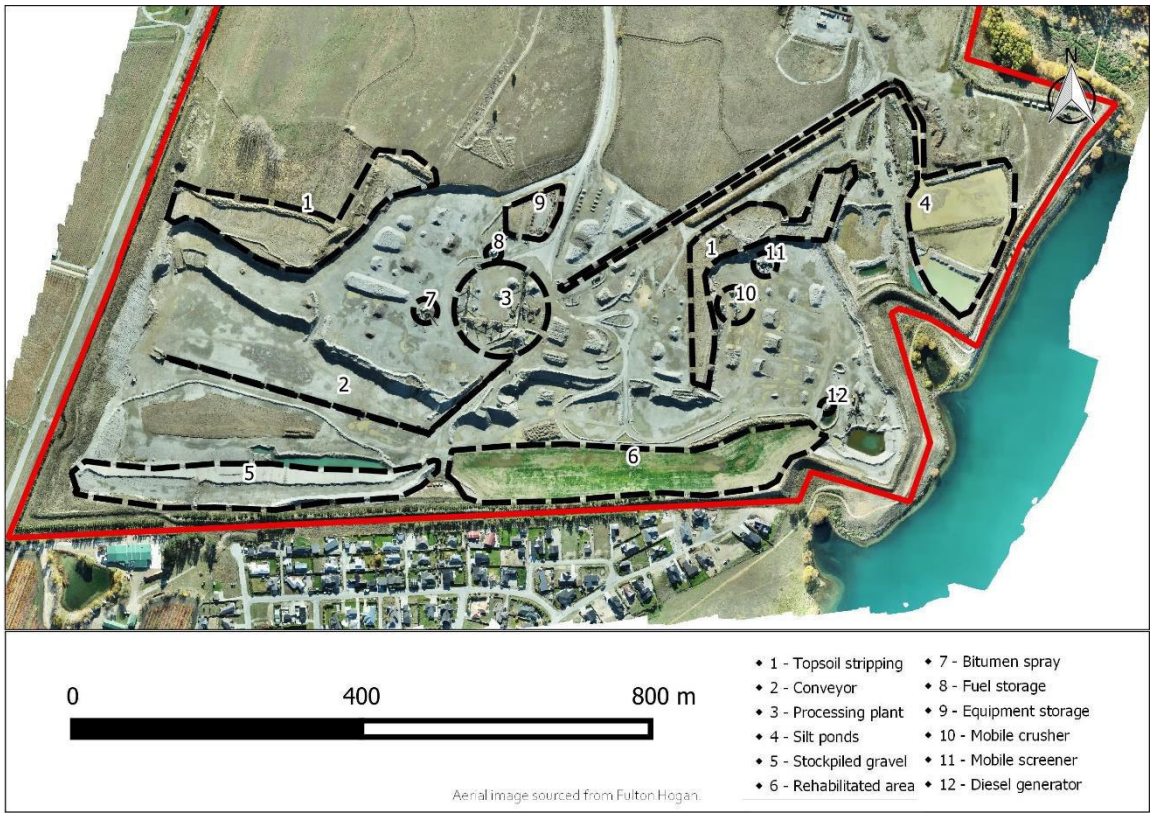
Figure 9: Quarry layout

The active quarry occupies approximately 60 hectares over the southern half of the site. Extraction of sand and aggregate within the eastern two-thirds of the site is allowable under the Scheduled Activity designation in the district plan. Quarrying in the western third of the site is authorised by RC070216, which was issued in 2007. The current layout of the quarry is shown in Figure 99 below.

Topsoil and overburden are stripped from the natural ground surface in advance of the active quarry faces (1). Within the consented quarry area, the extracted material is transported, using a conveyor belt system (2), to the crushing plant (3). Water is sprayed over aggregate as it passes through the plant on a screened conveyor. Debris and sediments are washed off the gravels, and wash water from the processing plant is discharged through a sludge channel to a series of silt ponds (4), which remove sediment from the water. No flocculants are used in this process. Water evaporates or infiltrates through gravels at the base of the ponds. After processing, the sorted material is stored at the site prior to dispatch.

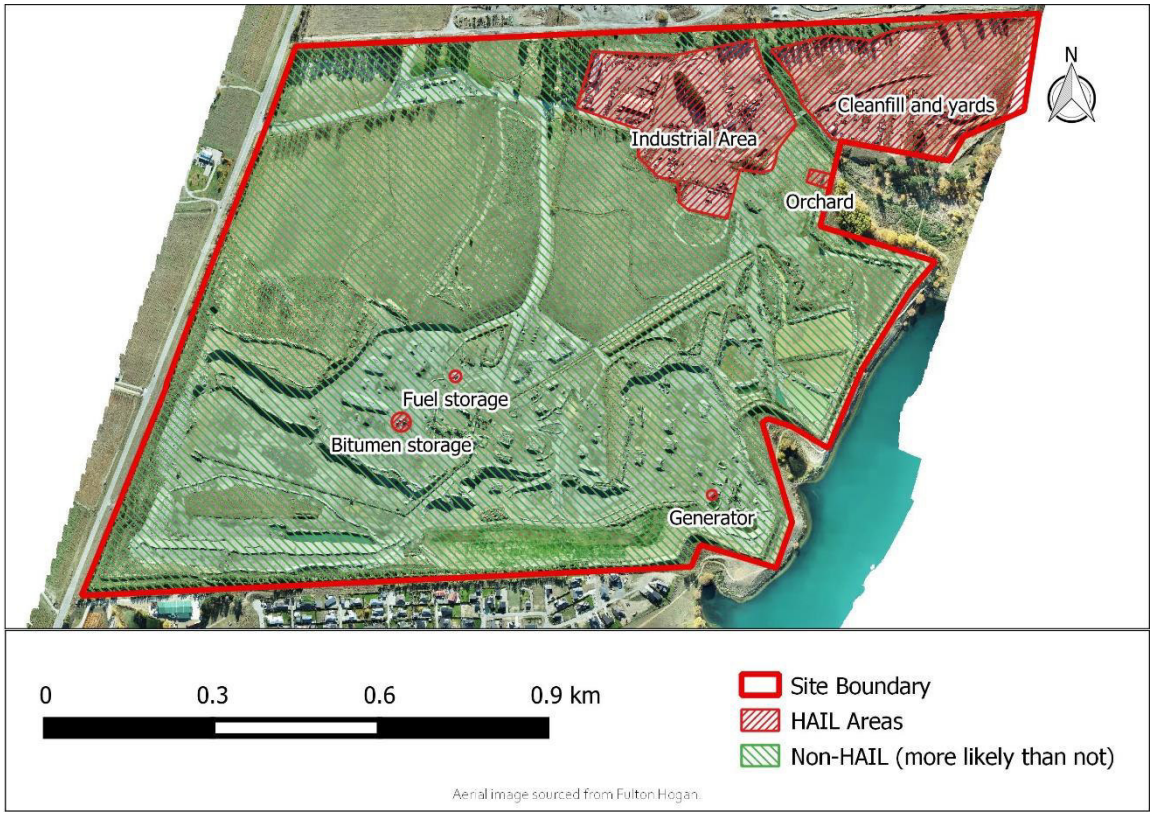
Figure 10: Approximate spatial extent of HAIL areas

Outside the areas identified in Section 5.1, it is more likely than not that *no* activities or industries listed on the HAIL have occurred. The approximate spatial extents of HAIL and non-HAIL areas are shown in Figure 10.

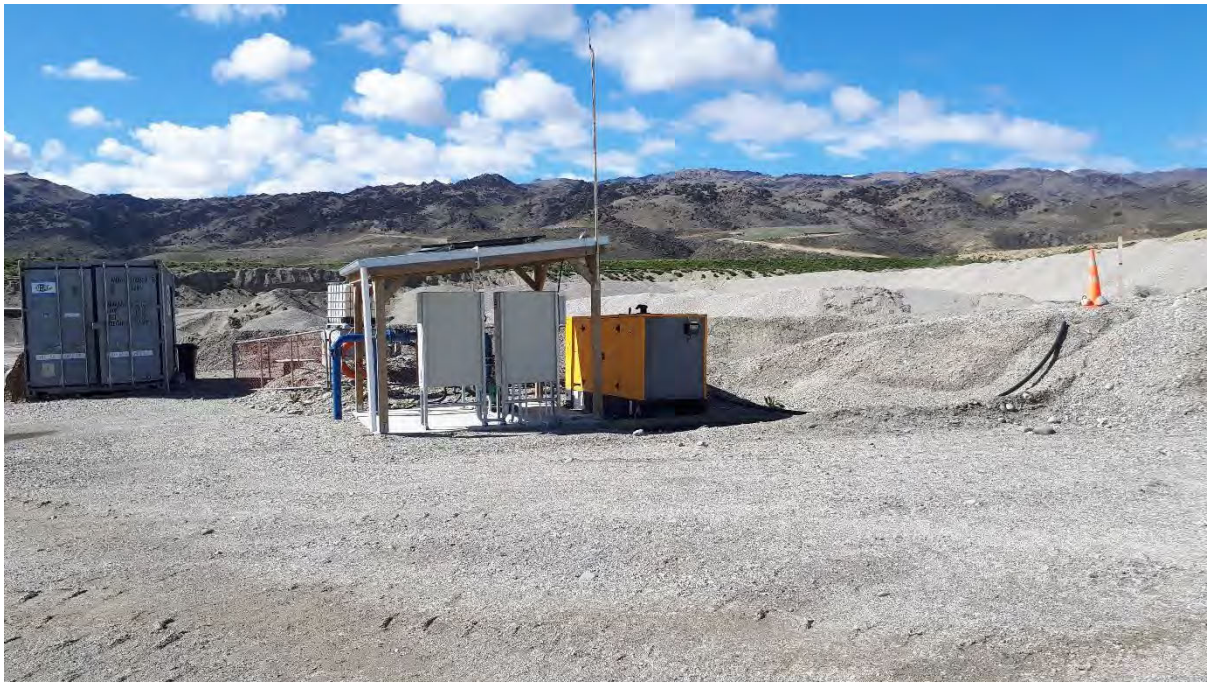
Figure 4: Diesel generator with in-built fuel tank in quarry.

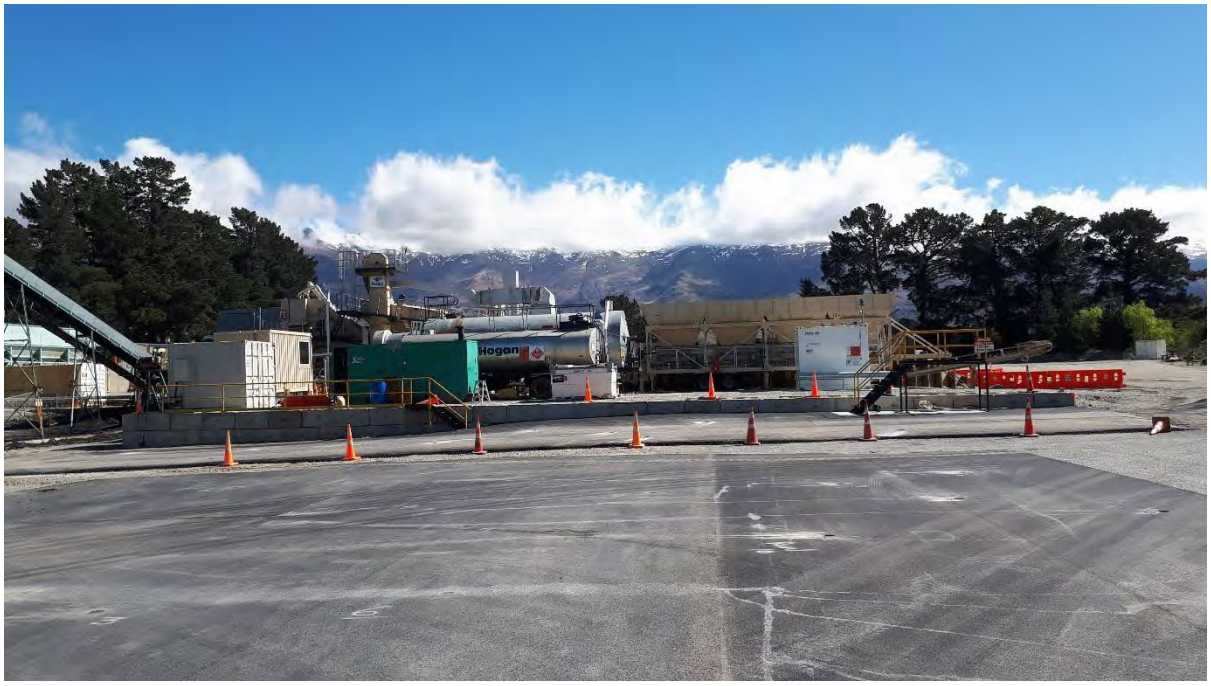
Figure 9: Asphalt plant

Figure 10: Bitumen storage at the asphalt plant.

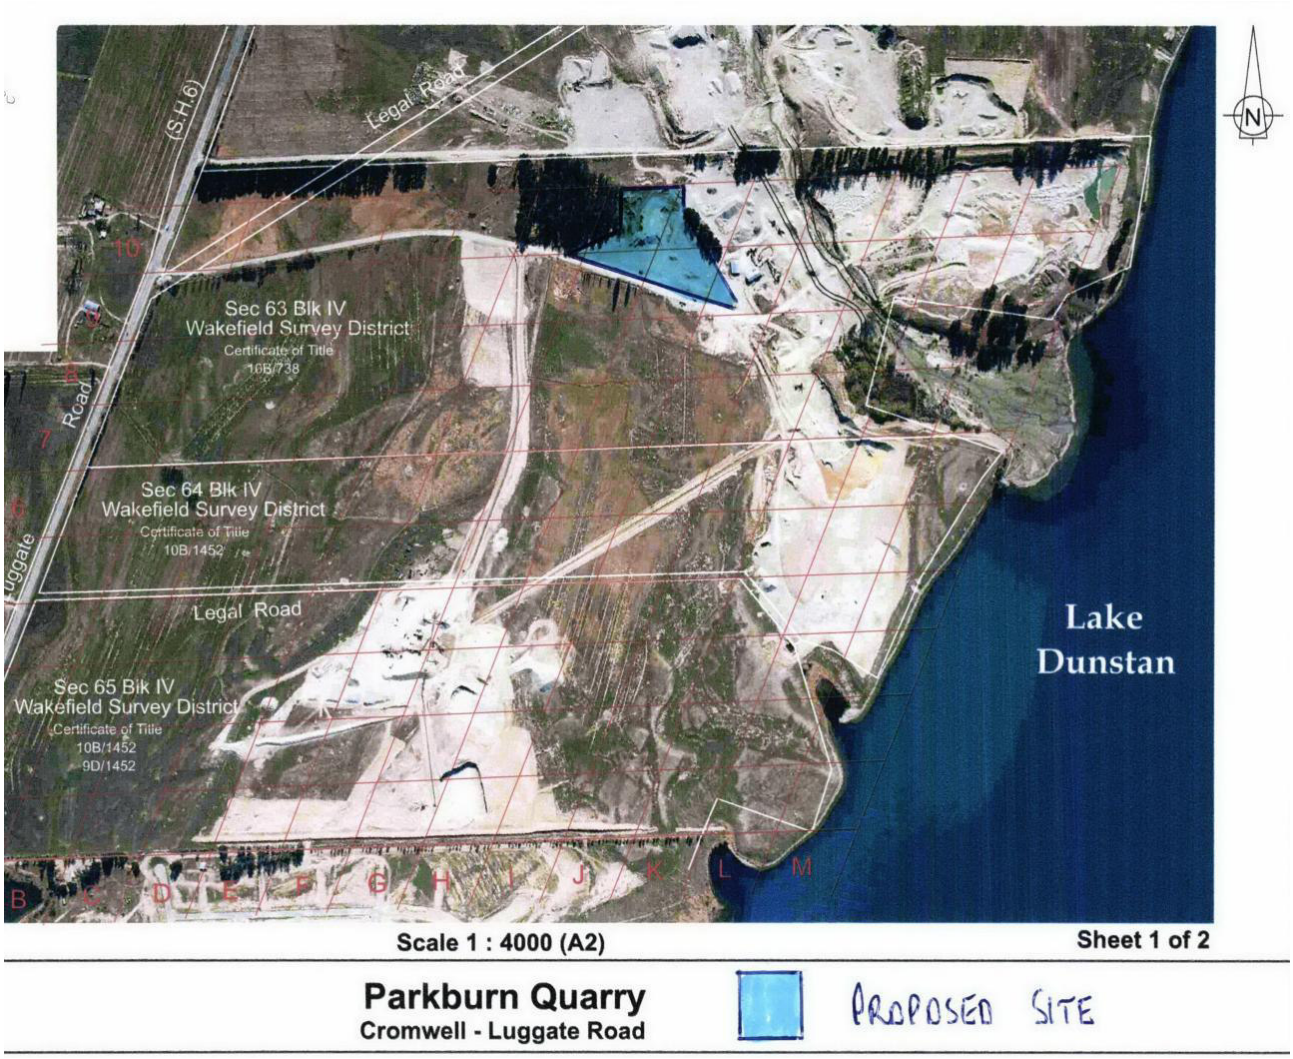
Figure Two: Extract from application showing location of concrete block plant.

Information provided with the application indicates the presence of an asphalt plant and concrete block manufacturing plant. Asphalt manufacture or bulk storage and commercial concrete manufacture are items E2 and E4 on the HAIL and may trigger NES-CS requirements.

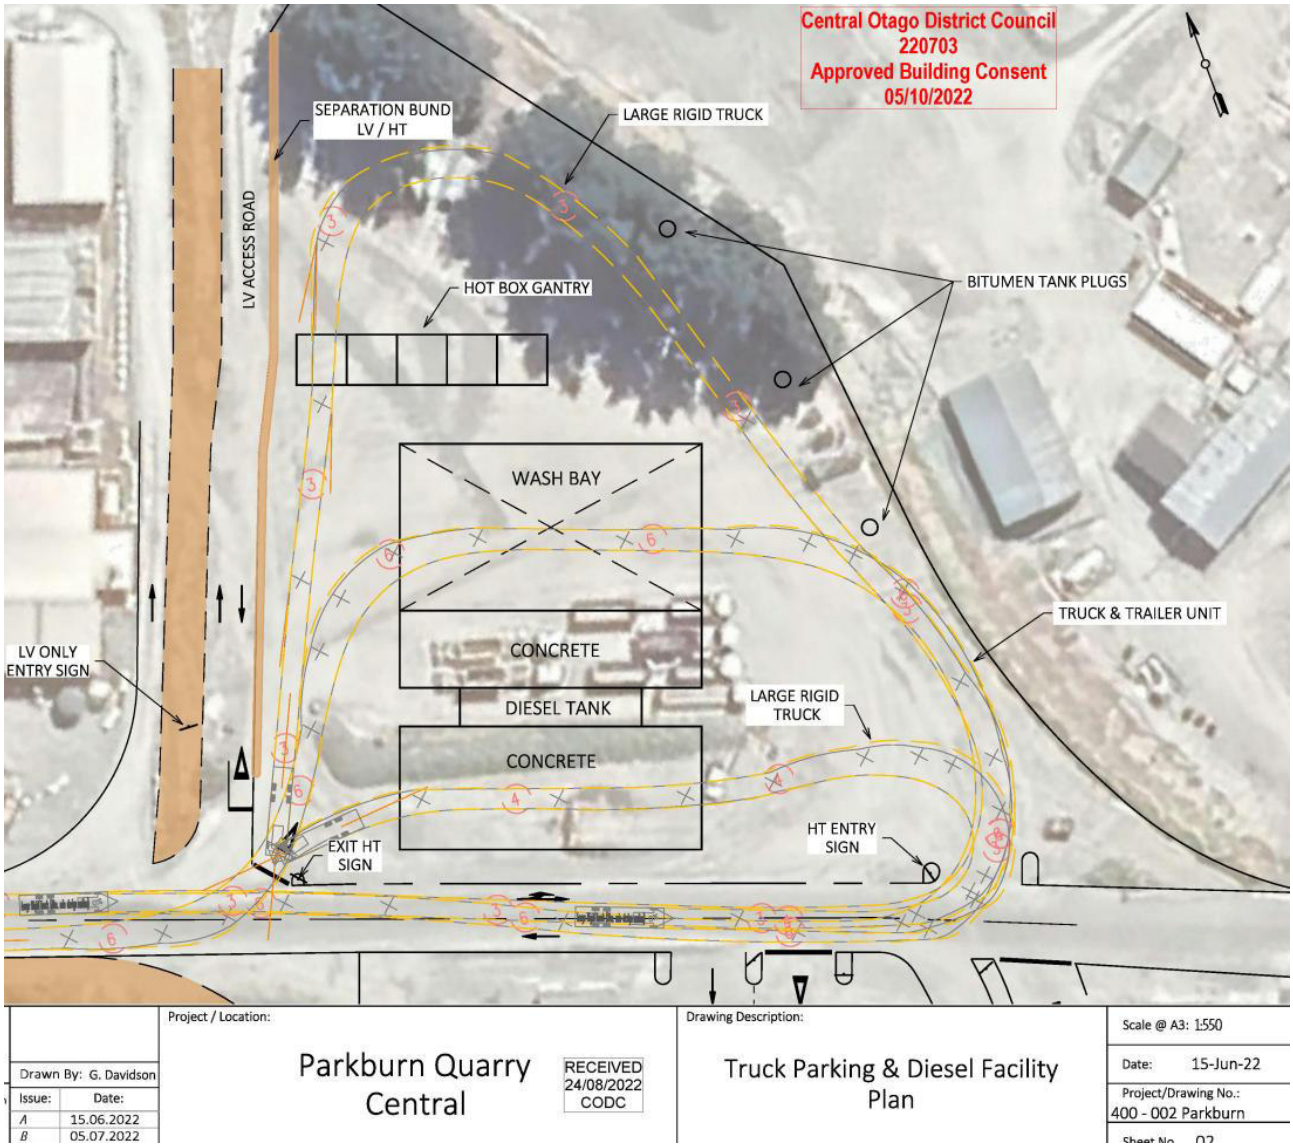
Figure Three: Extract from application showing location of diesel and bitumen tanks.

Information provided in support of this application indicates presence of diesel storage tanks and bitumen storage. Tanks for fuel and bitumen bulk storage are Items A17 and E2 on the HAIL respectively, and may trigger NES-CS requirements.

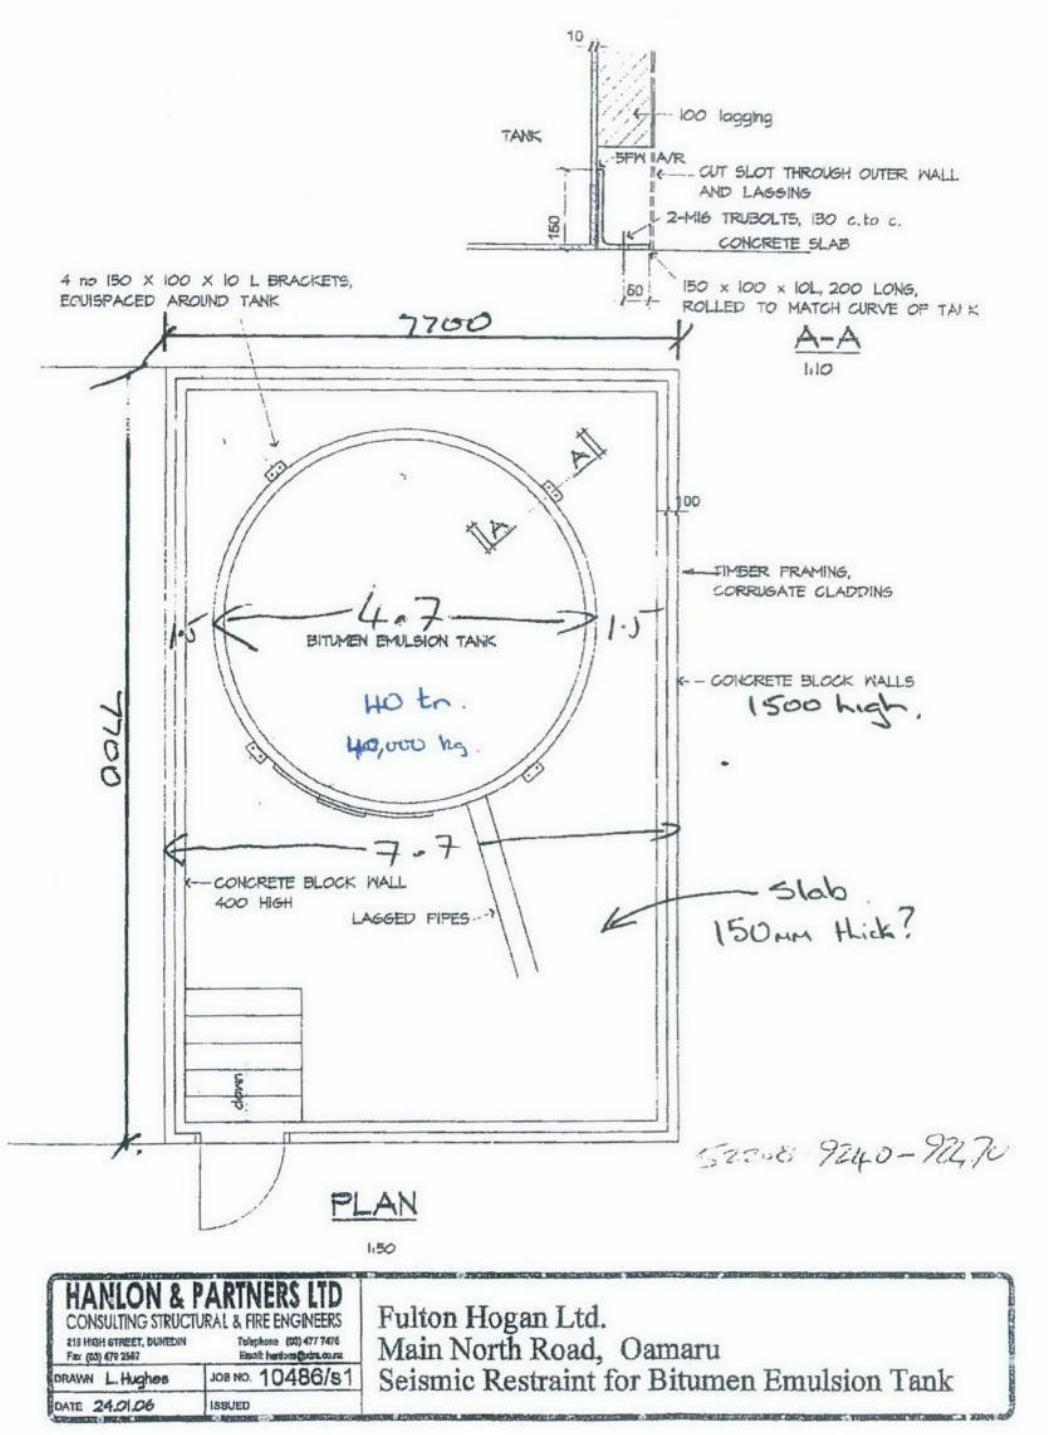
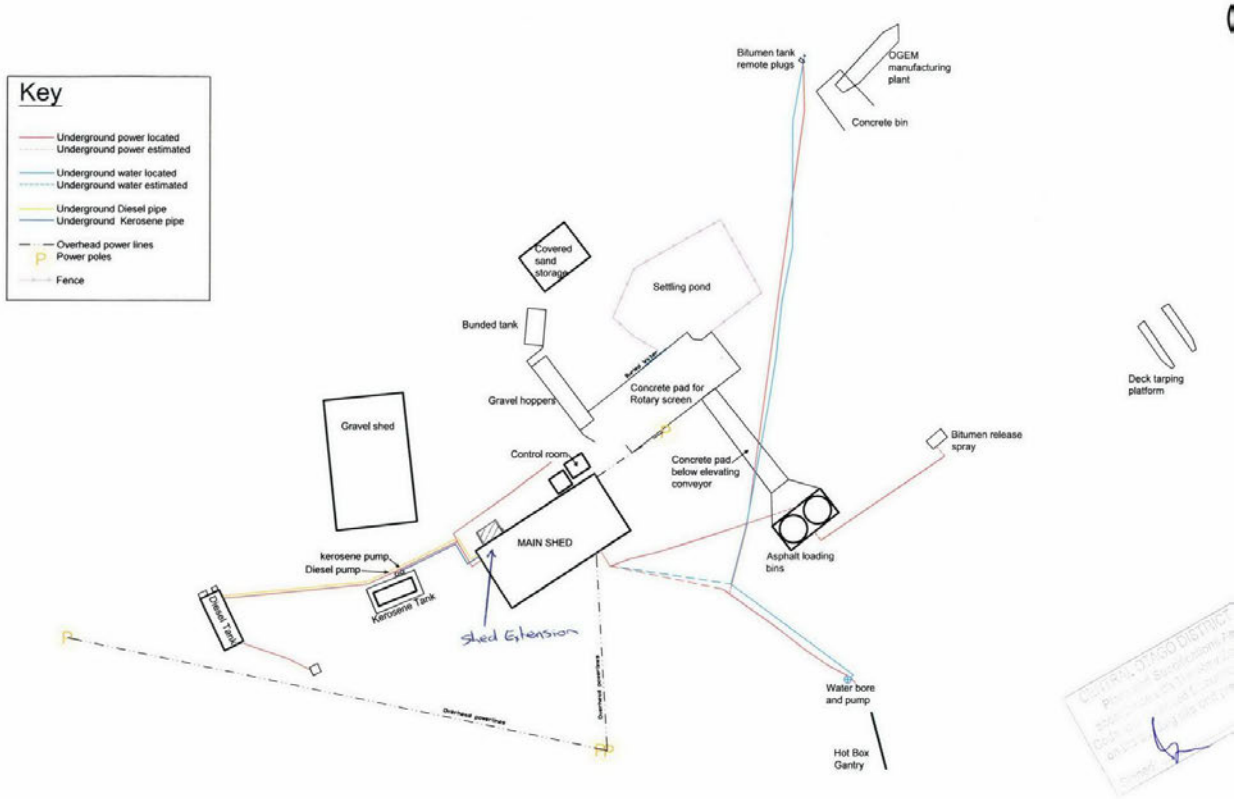
Figure Four: Extracts from application showing bitumen and fuel tanks

9/11/16	BC 160880: Foundations & site works for relocated office/smoko room *No information in relation to HAIL activities could be found on this record.*
30/11/15	BC 150689: Erect a new storage shed *No information in relation to HAIL activities could be found on this record.*
30/07/15	BC 150440: Additions to existing shed *Information provided in support of this application indicates the presence of bulk bitumen storage tanks and above ground fuel tanks. Asphalt or bitumen manufacture or bulk storage and fuel storage tanks are Items E2 and A17 on the HAIL respectively and may trigger NES-CS requirements.*

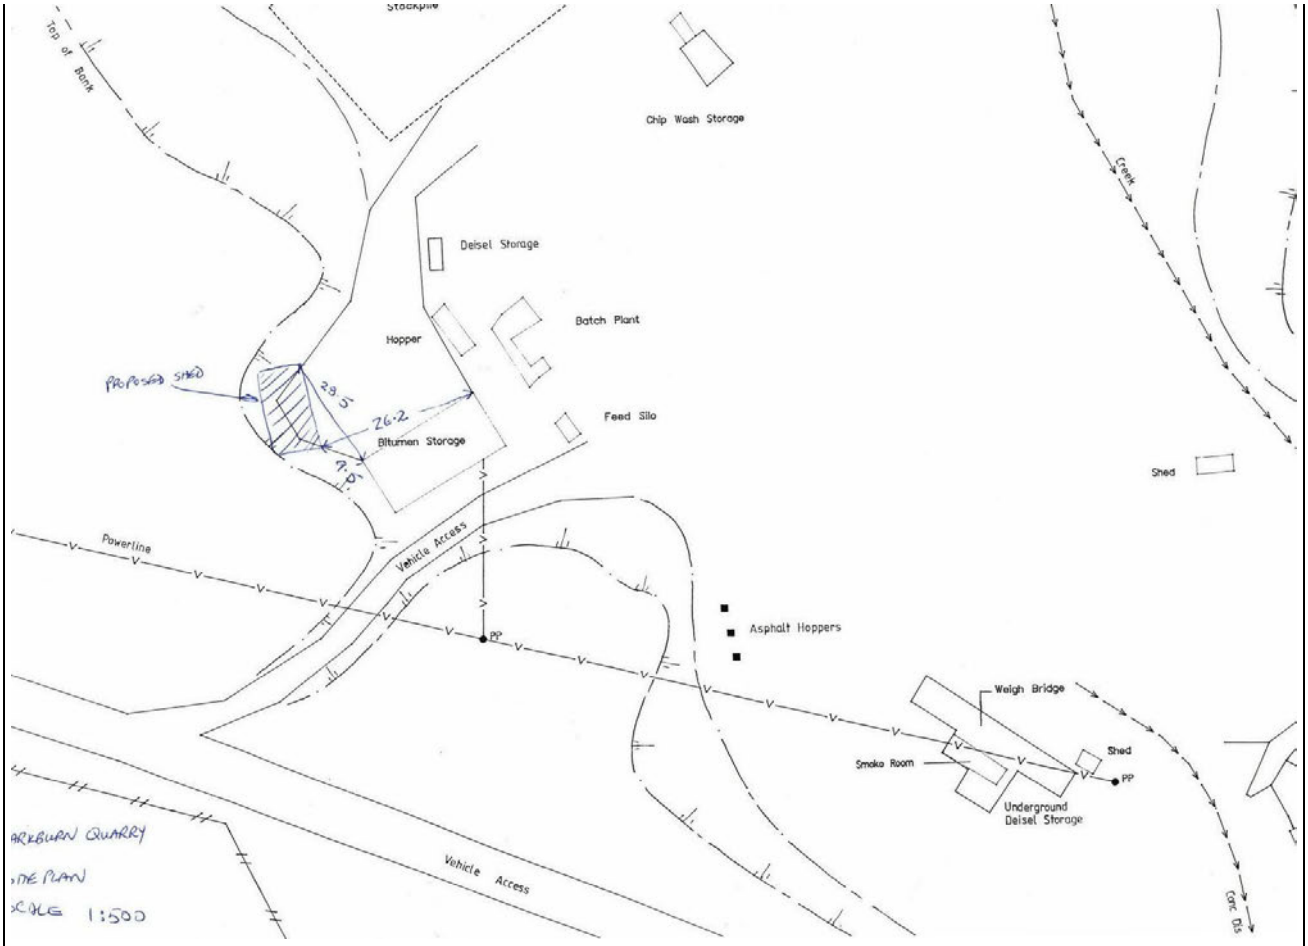
Figure Five: Extract from application showing bitumen storage and fuel tanks

Information provided in support of this application indicates the presence of bulk bitumen storage tanks and above ground fuel tanks. Asphalt or bitumen manufacture or bulk storage and fuel storage tanks are Items E2 and A17 on the HAIL respectively and may trigger NES-CS requirements.

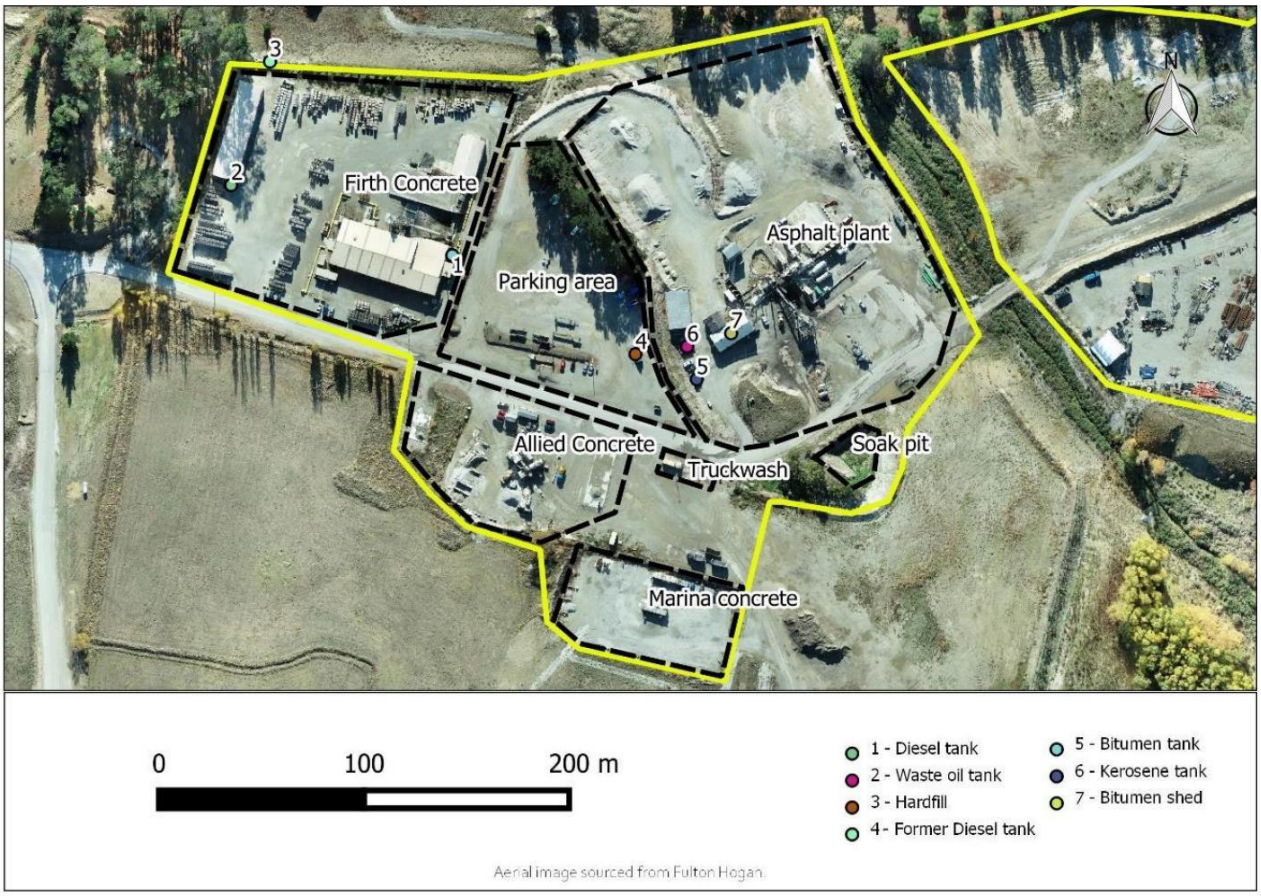
Figure Six: Extract from PSI showing activities in the industrial area of the site.

HAIL Activity	Dates	Comment	Likelihood
E4. Commercial concrete manufacture or commercial cement storage	2005 - present	Concrete block manufacturing facility	Certain
E2. Asphalt or bitumen manufacture or bulk storage (excluding single-use sites used by a mobile asphalt plant)	1987 - present	Asphalt plant	Certain
A17. Storage tanks or drums for fuel, chemicals or liquid waste	<1990-2004	Various fuel storage	Possible
A10. Persistent pesticide bulk storage or use including sport turfs, market gardens, orchards, glass houses or spray sheds	<1958-~1985	1000 m^2 of orchard	More likely than not
A18. Wood treatment or preservation including the commercial use of anti-sapstain chemicals during milling, or bulk storage of treated timber outside	~2020 - present	250 m^2 of treated timber storage	Certain
G5. Waste disposal to land (excluding where biosolids have been used as soil conditioners)	1987 - present	Cleanfill	Likely

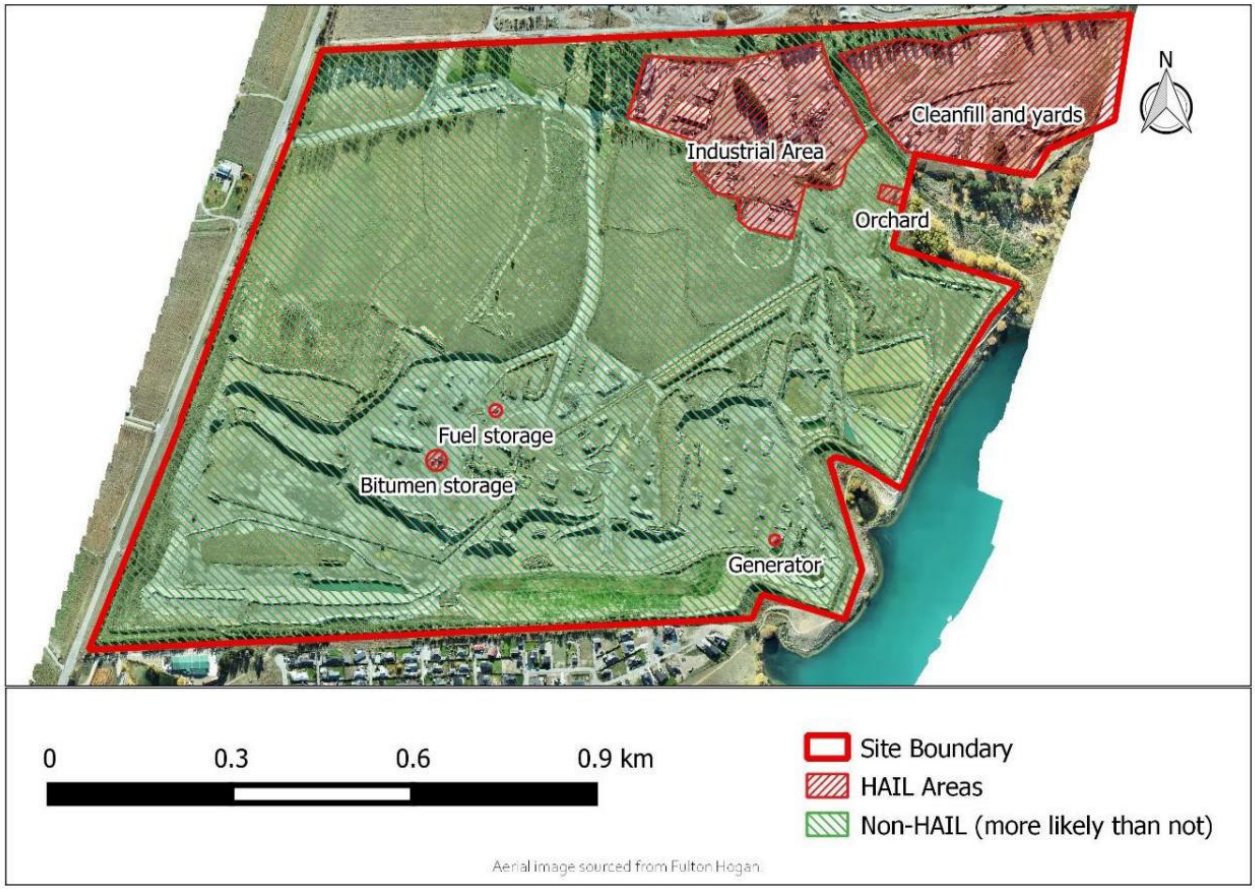
Figure Eight: Extract from PSI showing areas considered likely to contain HAIL activities.

The PSI concluded that it was unlikely that contaminants in soil associated with concrete manufacture, persistent pesticide use, and treated timber storage would pose a risk to human under the commercial/industrial land use proposed for these areas as part of the plan change. It recommended that additional investigation upon decommissioning or closure of any potentially contaminating land uses, Given the on-going use of the site for many of these HAIL activities.
