24-06-2026
Reference: NZL-WSP-6-XH078.00.0215

Parkburn Quarry - FHLD Parkburn FTAA – Substantive Application

Further to instructions received from Walt Denley (CODC) and Louise Taylor (Taylor Planning) we have now completed an independent review of supplied geotechnical reports associated with a fast track planning application for a residential development of the Parkburn Quarry site in Cromwell.

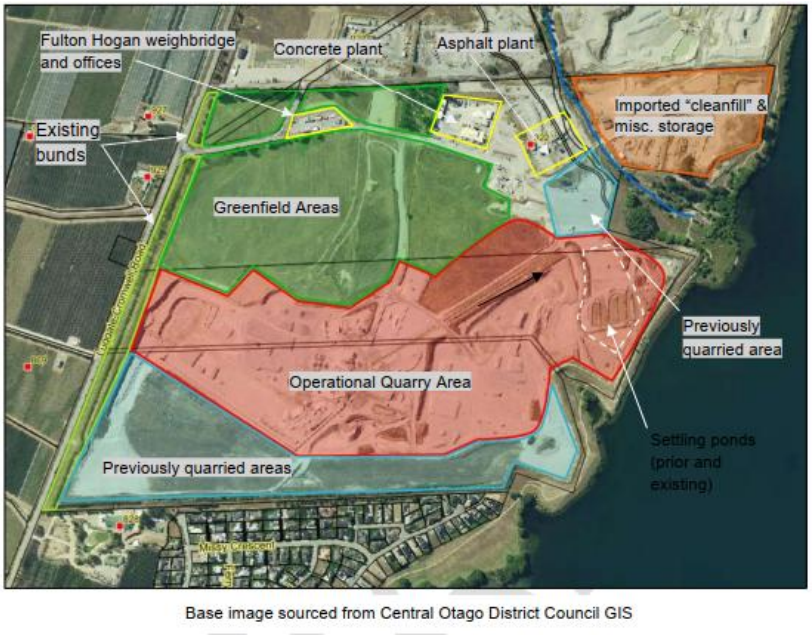
Figure 2: General site layout - taken from IE report, 2026.
