Ardgour Rise Road Safety Review

Alternate Alignment Safety Review

Prepared for:
Santana Minerals Ltd

Project/File:
310206156

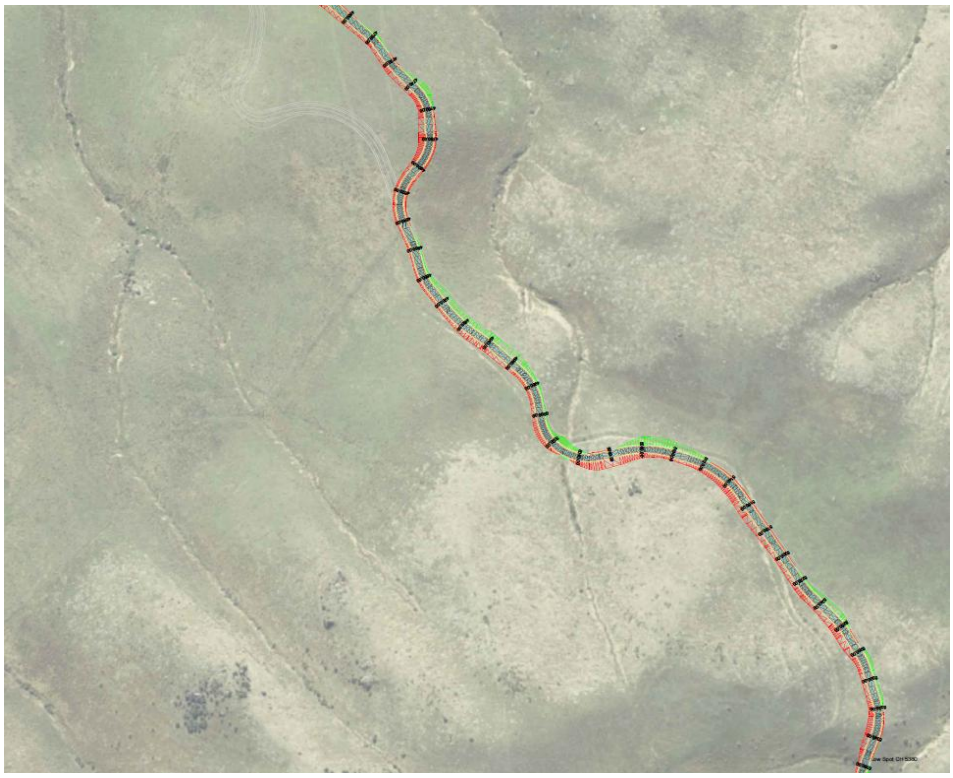
Figure 9: Example of original design

A revised design was submitted on Monday 27th July 2026, with further discussions with the designer that same day. This revised design revealed an alignment from CH 4880 to CH 5440 with a gradient on average of below 12.5%. This was achieved through traversing further into gullies, and a general shift utilising a longer distance for the grade change. It is considered that this style of change is demonstration that a redesign of the alignment further in detailed design would result in a more suitable gradient.
