**REPORT PREPARED FOR:  
Fulton Hogan Land Development Ltd**

**PRELIMINARY SITE INVESTIGATION  
TE KOROWAI O MARAEARIKI  
WAINUI**

**Prepared by:  
Groundwater and Environmental Services  
PO Box 190  
Cambridge  
7 August 2026**

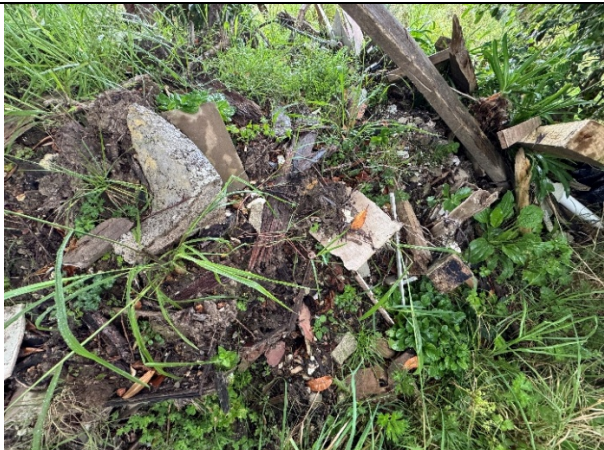
| Location | Aerial Observations | Walkover Observations |
|---|---|---|
| 1 | Former dwelling/shed location by east boundary in northern section of property – 1980. Removed by 2024.<br>(Partly on paper road and 231 Upper Orewa Road) | <p>Soil, demolition material, and household rubbish stockpiles around former dwelling location. Material includes <b>fibrolite cement sheet pieces</b>, timber, and soil. Some grass-covered. Nine asbestos cement pipe sections (&lt;2 m long) stacked next to the first stockpile.</p> <p><b>Sample 003 (red 0.4 cm thick fibrolite cement sheet with coating) – No asbestos detected</b></p> <p><b>Sample 004 (white 0.5 cm thick fibrolite cement sheet with coating) – No asbestos detected</b></p> <p><b>Sample 005 (white 0.3 cm thick fibrolite cement sheet) – No asbestos detected</b></p> <p><b>Sample 006 (asbestos cement pipe fragment) – Asbestos detected.</b></p> |

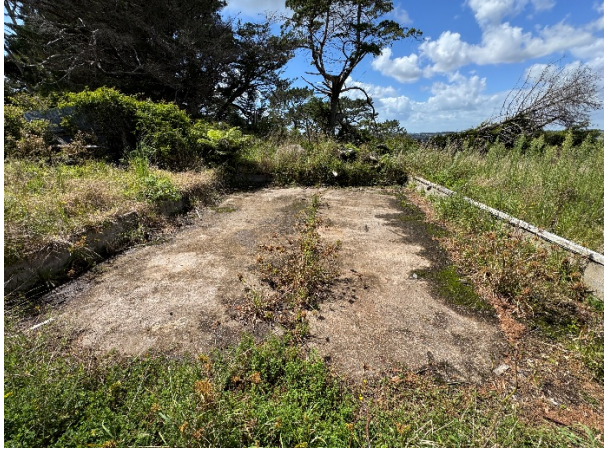
| 7 | <p>Dwelling in NW corner (south of sheds/glasshouses on the adjacent property to the north) – 1950s</p> <p>Most sheds on property to north removed by 1980s</p> <p>Dwelling removed by 2024</p> | <p>Former dwelling location. Large concrete water tank and power pole remain. Remaining garage Slab and footing – concrete demolition material placed outside east end of former garage.</p> |
