12 January 2024

## **UPDATED - SUTTON BLOCK EXTENSION TO DRURY QUARRY - PRELIMINARY SITE INVESTIGATION**

Pattle Delamore Partners Limited (PDP) has been engaged by Stevenson Aggregates Limited (SAL) to undertake a Preliminary Site Investigation (PSI) of the Sutton Block, which comprises part properties located at 1189 Ponga Road, 121 MacWhinney Drive and Quarry Road, Drury, Auckland (collectively referred henceforth as 'the site'; refer white outline of property parcels in Figure 1). It is understood that that works proposed in the Sutton Block are to extend the current Drury Quarry with similar quarry operations including stripping of overburden and mining of aggregate, along with ancillary quarrying activities (refer to Section 1.1 below for a summary of the 2023 revised Sutton Block pit extension proposal). Key areas of interest for the further use of the two properties are the future quarry pit extension (refer to Figure 1), which is expected to cover:

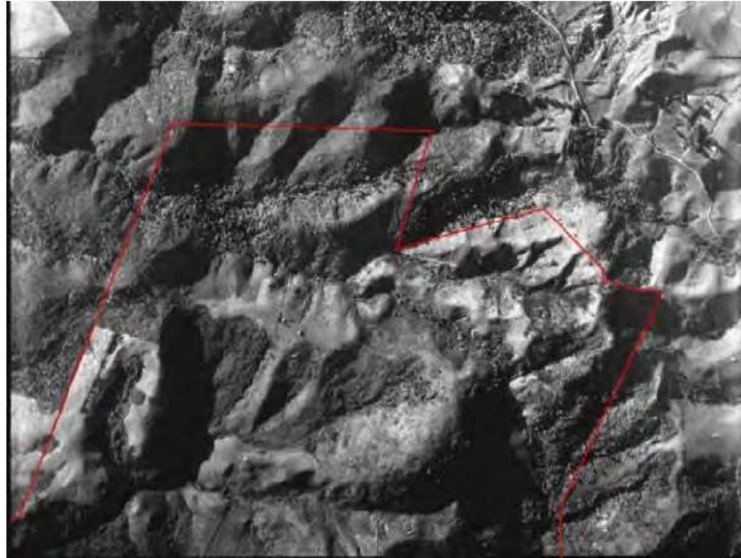
**1942 Northern Aerial**

The 1942 aerial is the oldest photograph available for the site, no aerial photograph exists covering the entirety of the site and therefore two images were chosen, one covering the northern part and one covering the southern part of the site. The northern part of the site appears to be largely scrubland/pastoral land. Two structures (a main dwelling and shed) are visible on the northern part of 1189 Ponga Road.

The surrounding land to the north and east appears to be shrub/pastoral use with rural/residential dwellings sparsely present around the area.

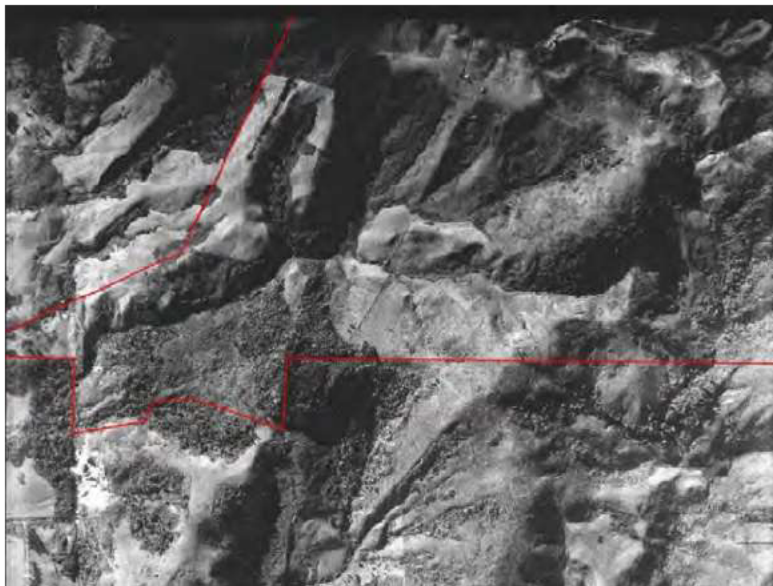
**1942 Southern Aerial**

The southern part of the site appears to be scrubland/ pastoral land.

The surrounding land to the west, east and south appears to be shrub/pastoral use with rural/residential dwellings sparsely present around the area.

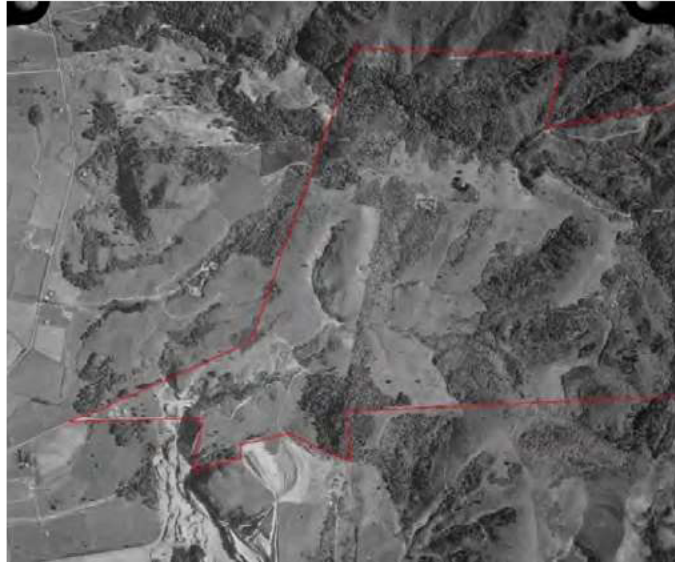
**1961 Aerial**

1189 Ponga Road remains largely as described in 1942. However, several developments including four dwellings and ancillary structures were established in the southwestern corner of the site (not part of the future quarry pit extension) and one structure was established in the central part of 121 MacWhinney Drive.

Quarrying operations of the Drury Quarry have commenced to the south-west of the site. The remainder of the surrounding land is largely as described for 1942.

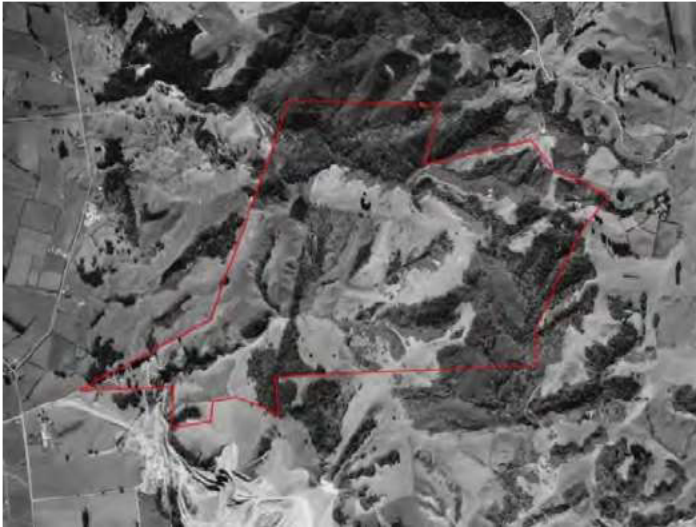
**1969 Aerial**

The site is largely as described in 1961. However, two additional dwellings were established at the western tip at 121 MacWhinney Drive (not part of the future quarry pit extension) while the dwelling in the central part of 121 MacWhinney Drive, previously visible in the 1961 aerial image appears to have been demolished/removed.

The surrounding land is largely as described for 1961, however, it appears that the quarry operations have been intensified and the number of residential properties has slightly increased.

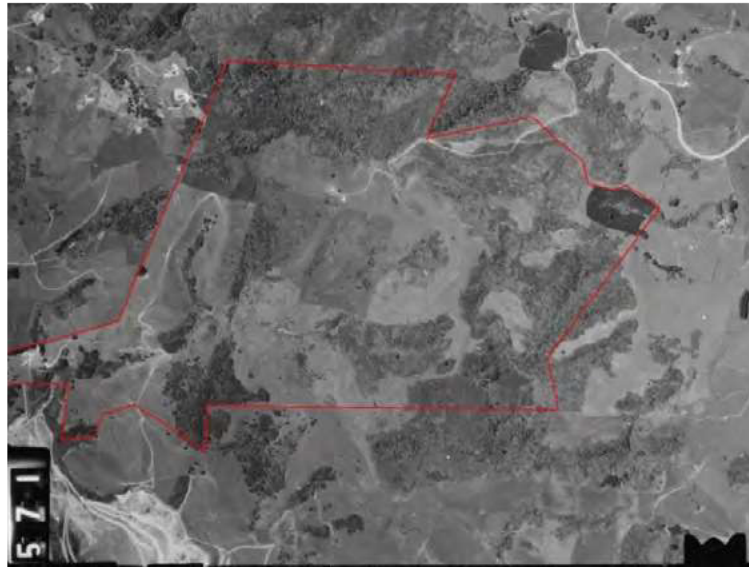
**1977 Aerial**

The site remains largely as described for 1969.

The surrounding land is largely as described for 1969.

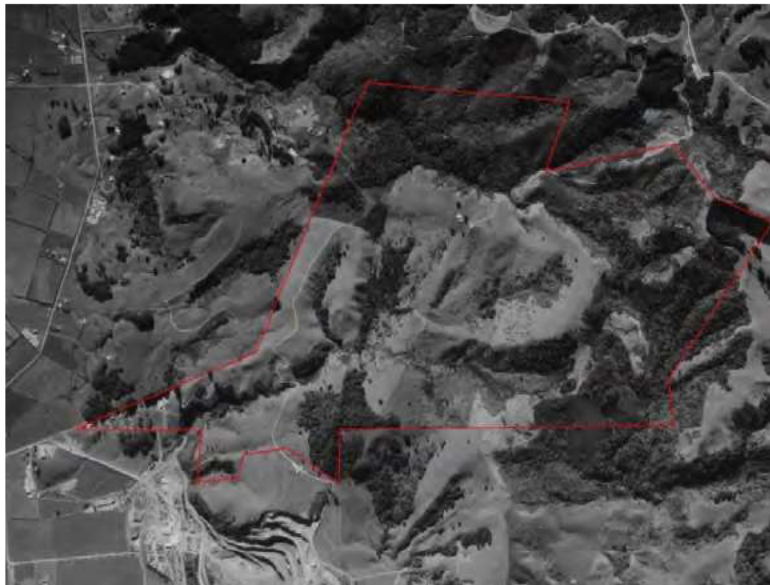
**1981 Aerial**

Two sheds (Storage Shed 2 and 3) have been constructed to the south of the main dwelling and a wooden structure has been constructed to the east of the shearing shed at 1189 Ponga Road. Three additional structures have been established in the western tip of 121 MacWhinney Drive (not part of the future quarry pit extension). The remainder of the site is largely as described for 1977.

The surrounding land is largely as described for 1977.

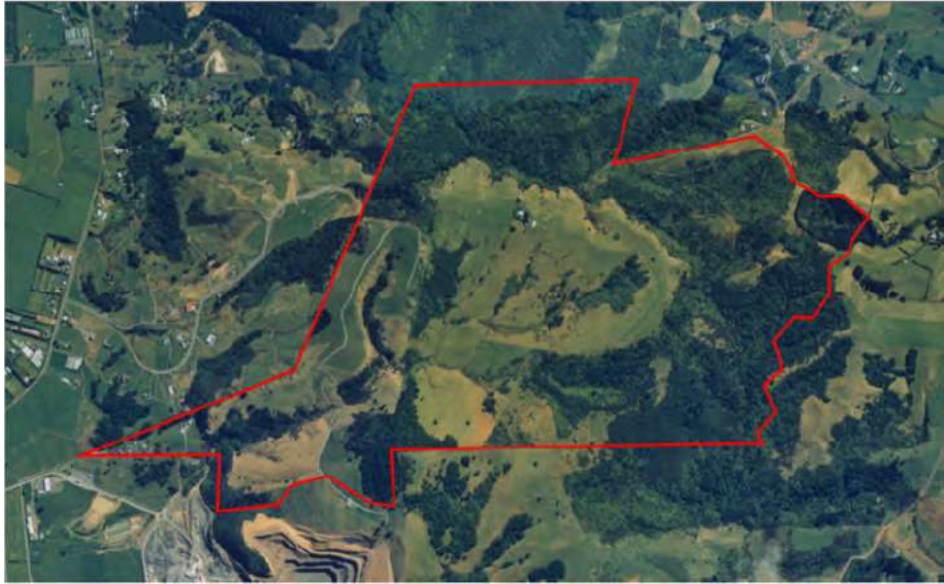
**1996 Aerial**

The site remains largely as described for 1981 apart from the construction of an additional shed (Storage Shed 1) to the southeast of the main dwelling at 1189 Ponga Road.

The surrounding land is largely as described for 1981, however, it appears that the Drury Quarry operations have been intensified and the number of residential properties present to the west has slightly increased.

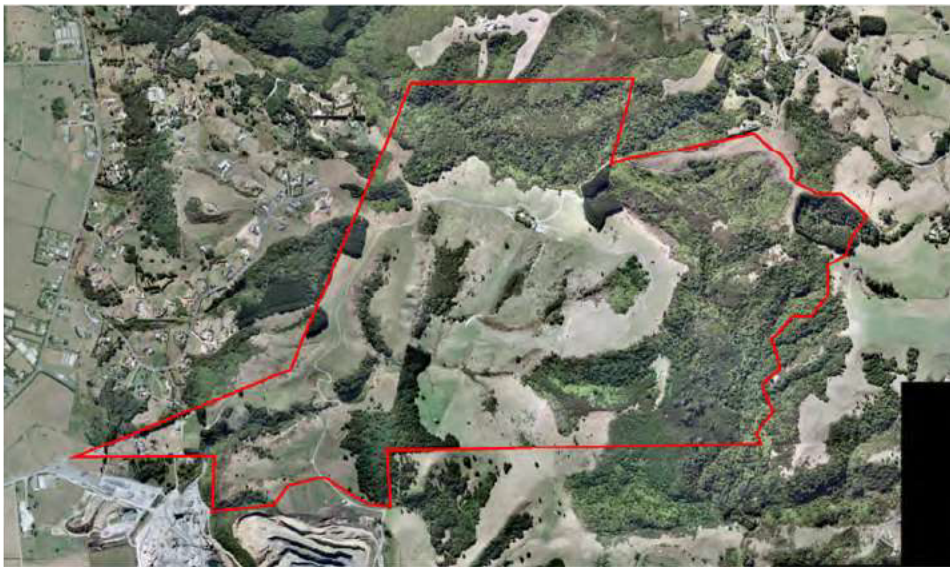
**2008 Aerial**

An additional wooden structure has been built to the west of the main dwelling at 1189 Ponga Road. One structure has been built on the north-eastern part of 121 MacWhinney Drive and five structures have been removed from the western part of 121 MacWhinney Drive (not part of the future quarry pit extension).

The surrounding land is largely as described in 1996, however, it appears that the number of residential properties present to the west has slightly increased.

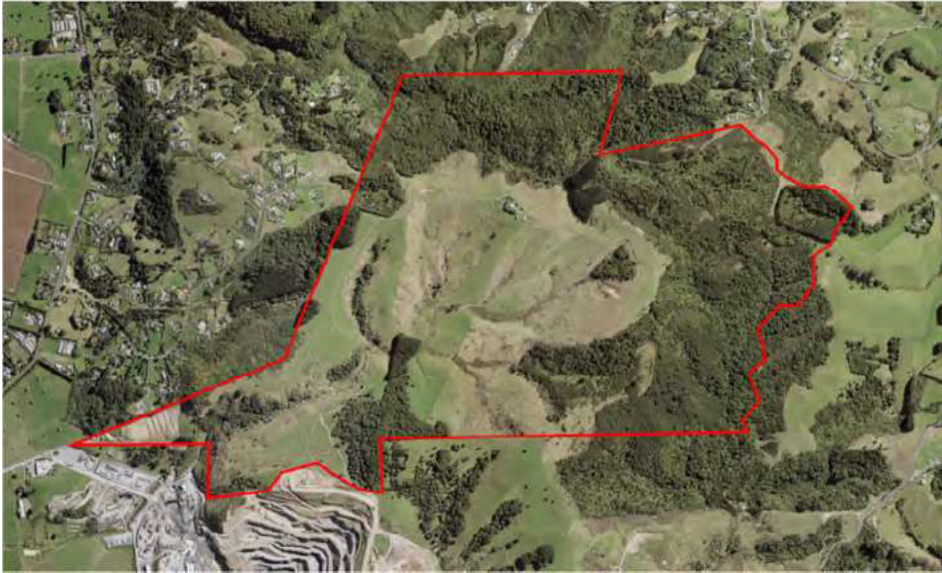
**2017 Aerial**

All buildings except for the western most shed have been removed from 121 MacWhinney Drive and earthworks appear to be taken place (not part of the future quarry pit extension), and the shed observed on the north-eastern part of 121 MacWhinney Drive appears to have been removed. The remainder of the site remains largely as described in 2008.

The surrounding land use remains largely as described for 2008, except for an extension of the Drury Quarry northward.

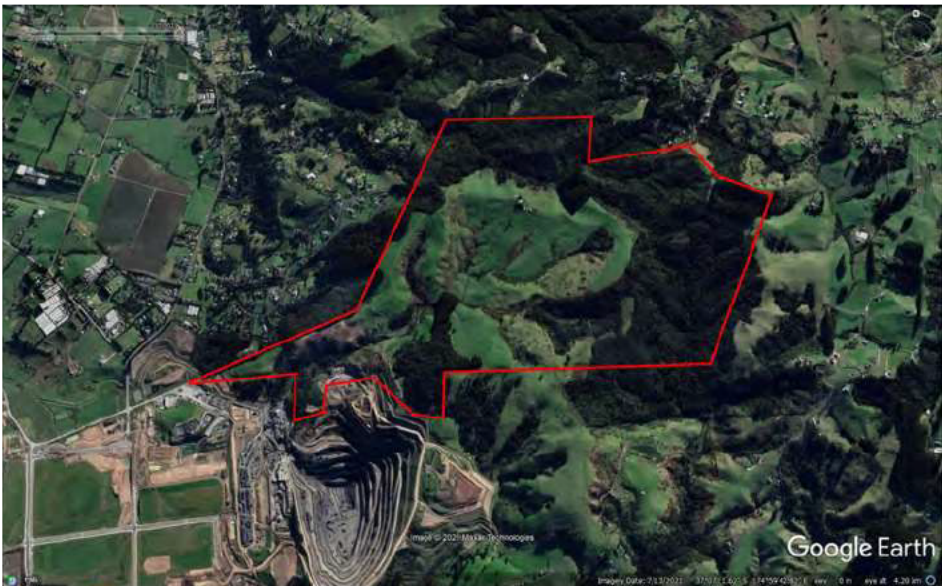
**2021 Aerial**

The site remains largely as described for 2017 apart for the demolition of the western most dwelling (not part of the future quarry pit extension) and a new building appears to have been constructed in the central part of 121 MacWhinney Drive.

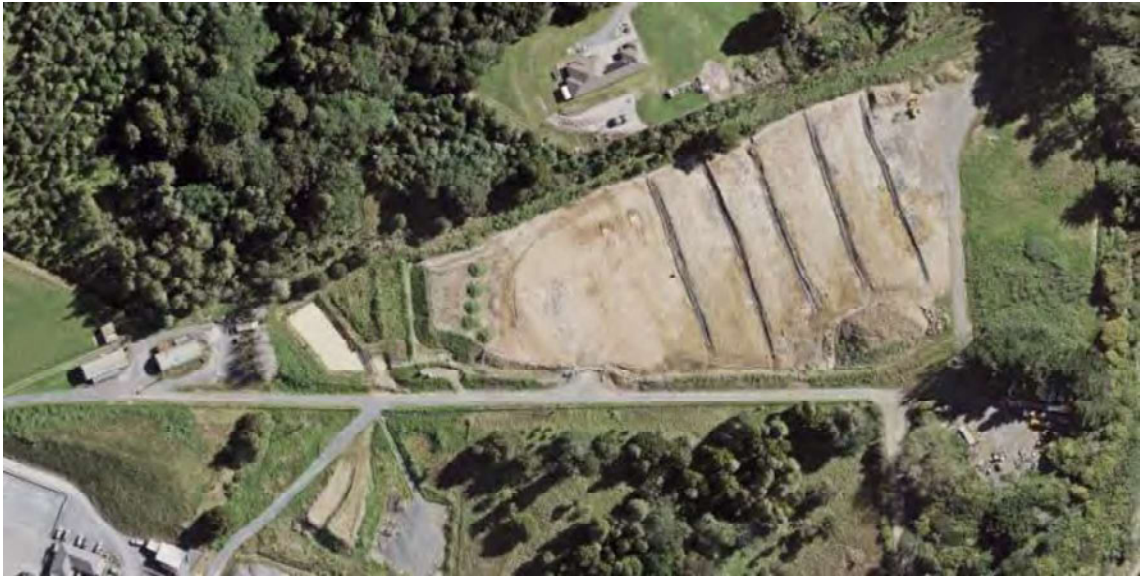
Further, the site has been consented for the disposal of managed fill to create a noise bund. This land disturbance can be seen in the aerial below:

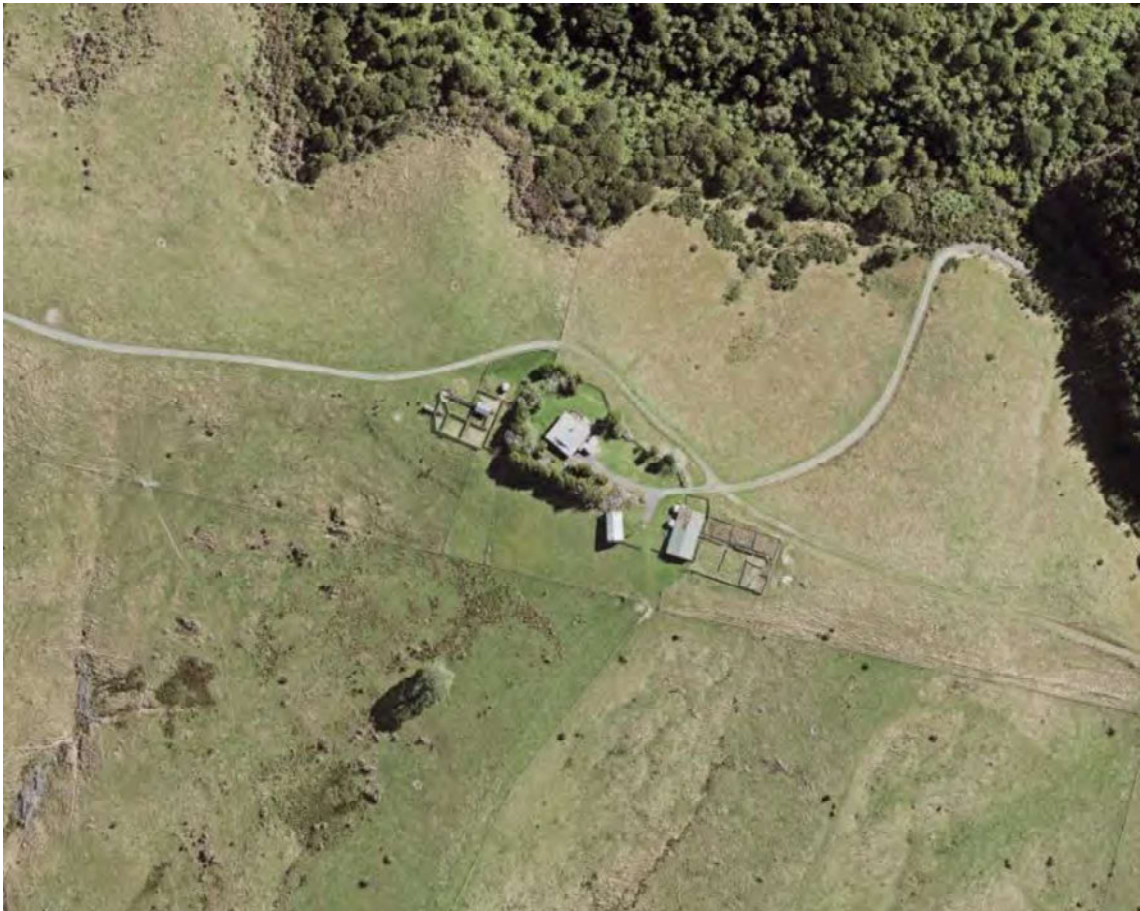
Records indicate the site 1189 Ponga Road, Drury, has been utilised for spray race and sheep dip activities. It has been noted that a former sheep dip was located in the area of the building on site.

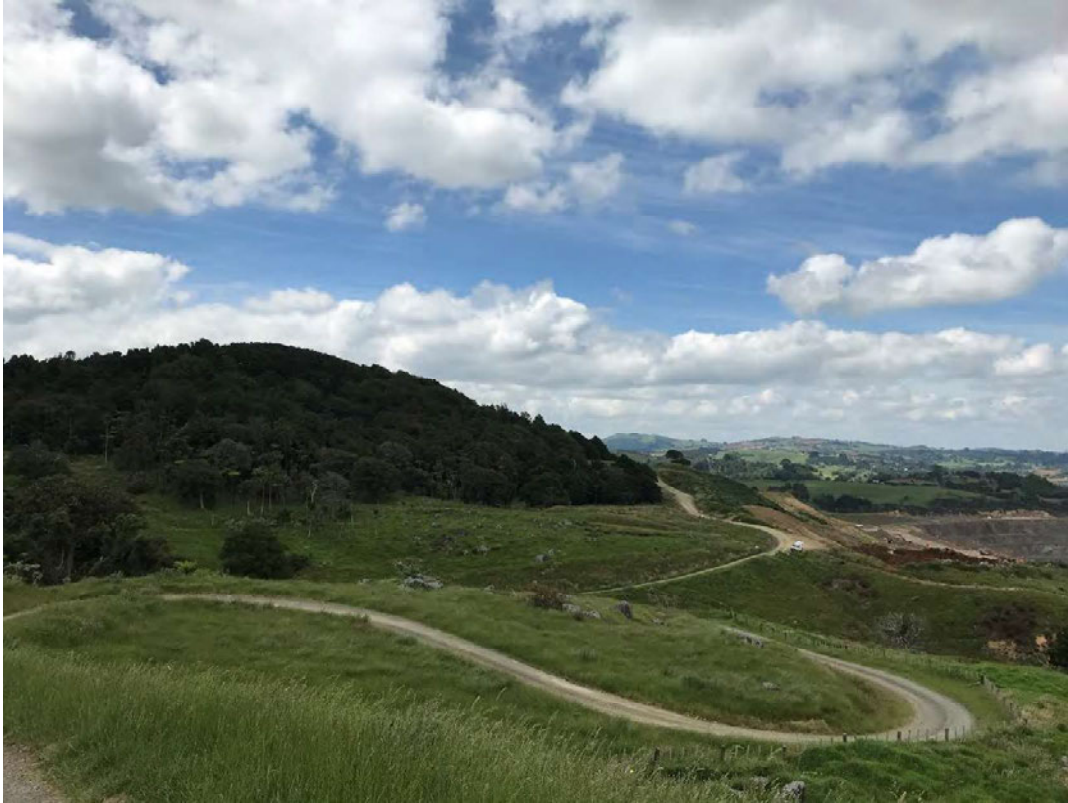
**Photograph 1:** Looking southeast at the southern section of 121 MacWhinney Drive and the northern section of Quarry Road.
