Water Ways Consulting

Homestead Bay Aquatic Ecology Assessment

Date: November 2023

Report Number:127-23

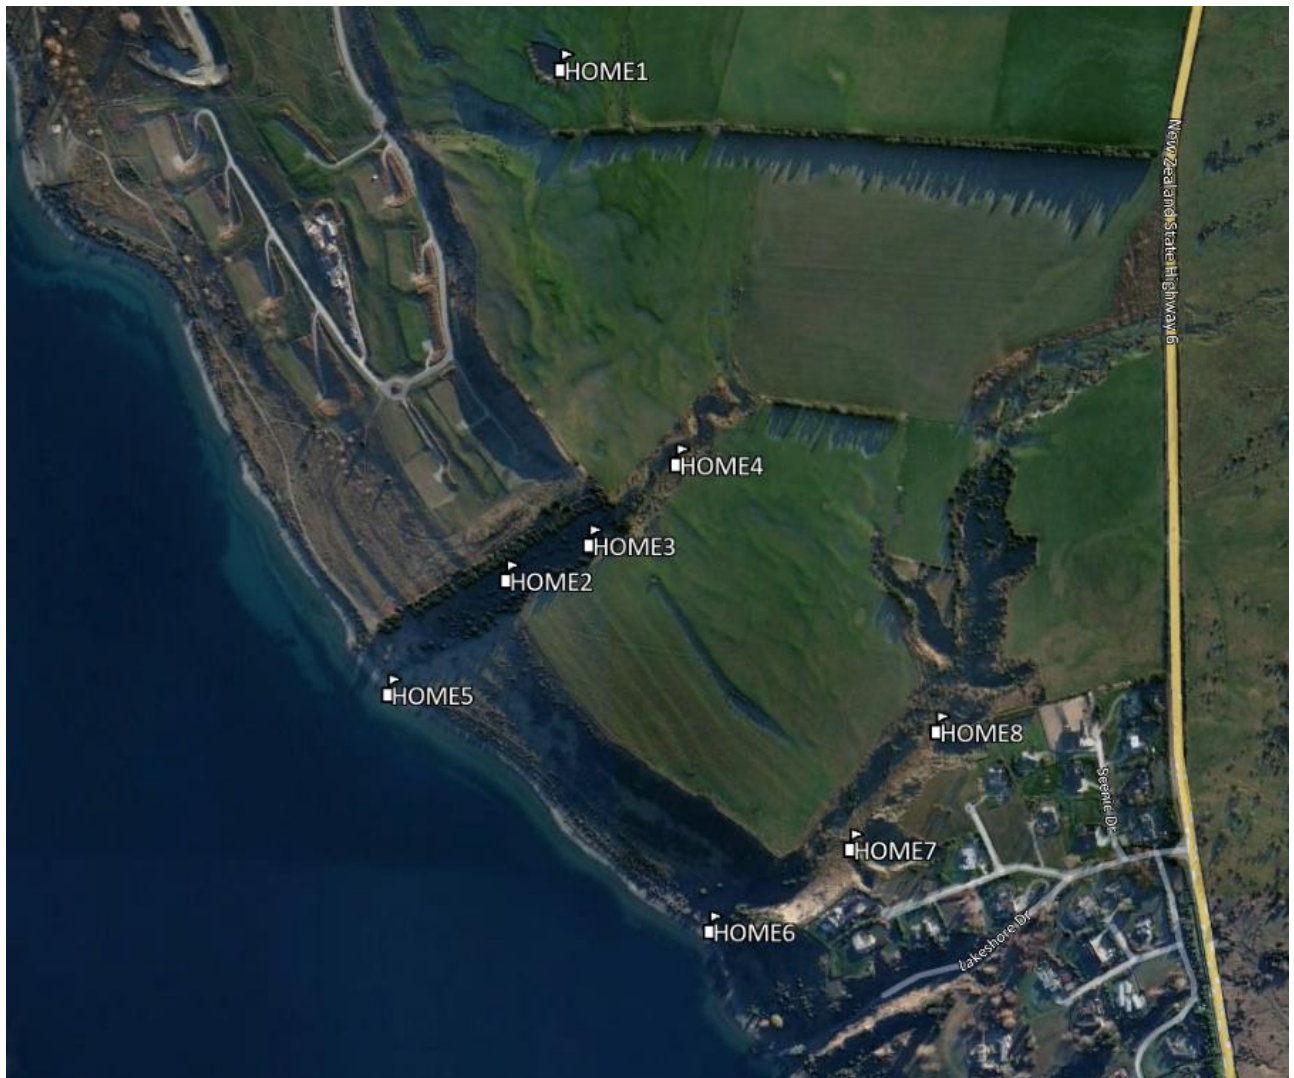
Figure 1: The Homestead Bay aquatic assessment areas.

The Homestead Bay area was visited on the 15 March 2023. The two water courses and a pond on the property were all visited (Figure 1). The habitat at each site and the permanence of water in the water courses was assessed. For wetted sites the potential for fish residence and fish passage was checked and the likely macroinvertebrate communities determined.
