Waihi North Project

Preliminary Site Investigation (Ground Contamination)

**WAI-985-000-REP-LC-0026_RevC.1
TECHNICAL REPORT
Waihi North Project - Preliminary Site
Investigation - Ground Contamination
GENERAL AREA 000**

17 December 2024

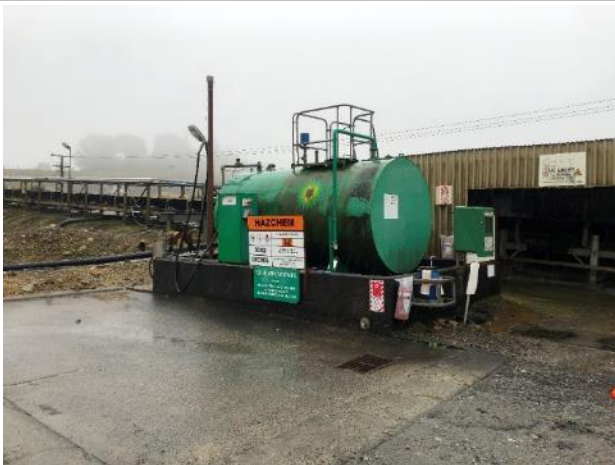
- Portable diesel storage tanks (up to 20,000 L each) (**Photographs 7 and 8**) are located adjacent to the Favona portal and the conveyor.
 - Components of explosives used within the mines are stored separately for safety purposes. Magazines are stored in the northwest of the processing area while IBCs storing ammonium nitrate are stored to the northwest of the WTP (**Photograph 18**).

Photograph 7. Bunded diesel tank next to the conveyor.

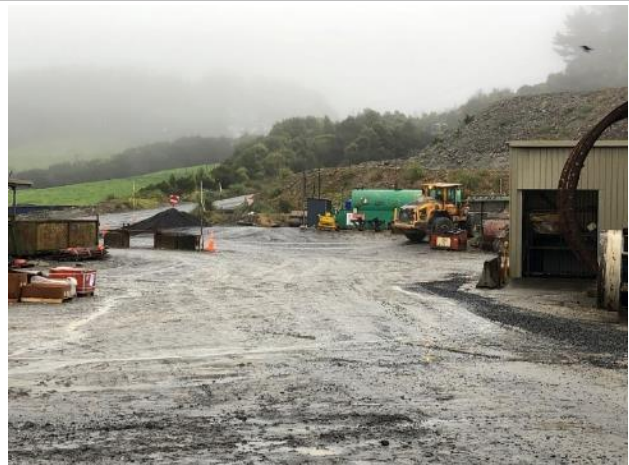
Photograph 8. Bunded diesel tank near the Favona portal.

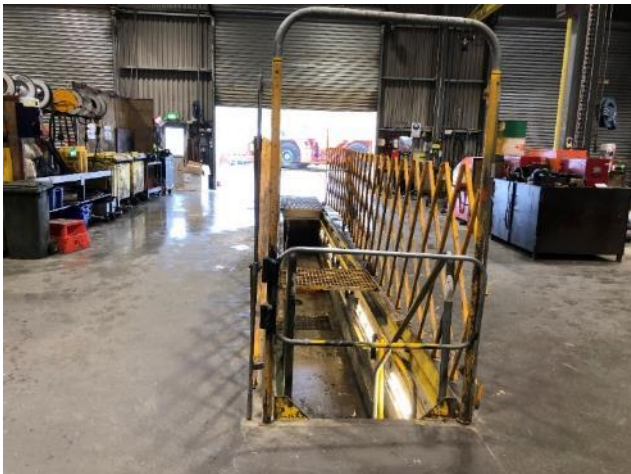
- Other chemical storage areas were observed throughout the wider Processing Plant and WTP site and included:
 - Waste oil drums are in the workshops (**Photographs 9 and 10**), with a collection area southeast of the Processing Plant (**Photographs 5 and 6**). Waste oil drums and oil-soaked debris in portable bins are stored in a timber framed corrugated iron plant building with an inbuilt oil collection tray.

Photograph 9. Inspection pit within the heavy machinery workshop.

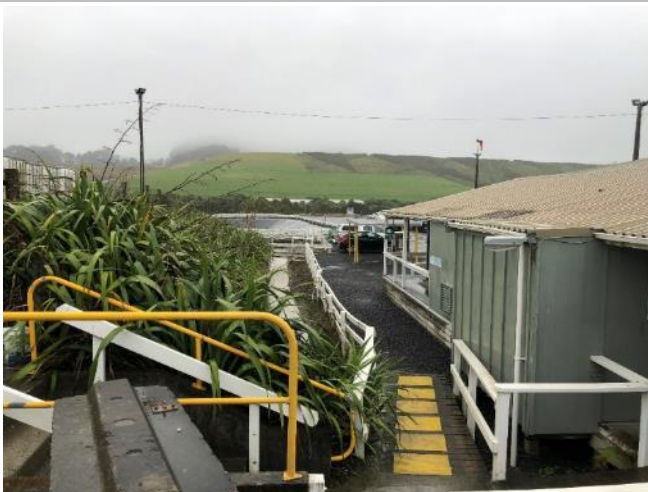
- Stormwater, including discharges from the Martha Underground Mine, are collected in a series of ponds around the eastern side of the processing area. These are directed to the WTP. Ponds and drains are predominantly synthetically lined, although unlined drains and ponds also occur (**Photographs 11 and 12**).

Photograph 11. Mines rescue building, drain to left is water from Favona portal with the collection pond beyond.

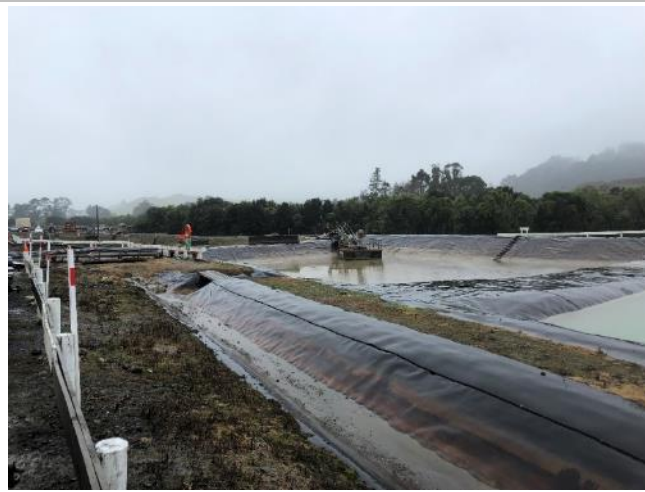
Photograph 12. Collection ponds for water from underground mine and site stormwater.

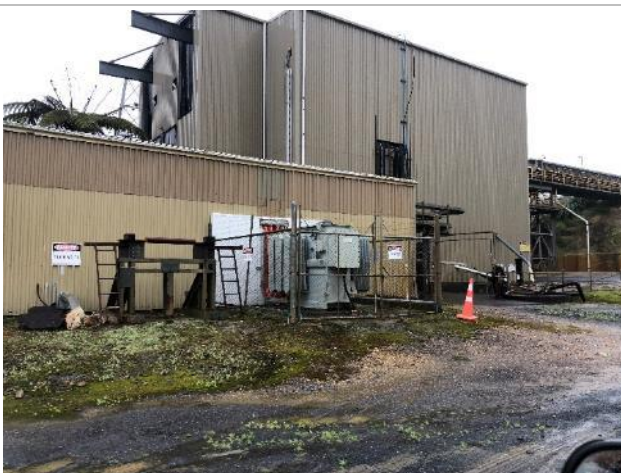
- A single electrical transformer was noted adjacent to the conveyor plant (**Photograph 17**) although it is expected other similar transformers may occur in other areas, i.e., associated with the site wide electrical infrastructure.

Photograph 17. Transformer at the rear of the conveyor.

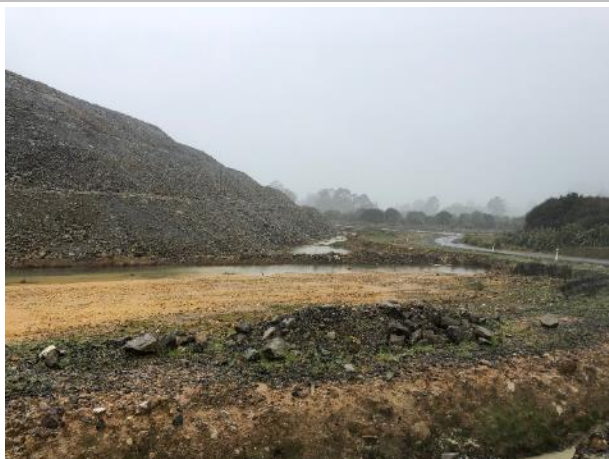
- On the north-eastern side of the stockpile are two settlement/containment ponds, fed by collector drains around the base of the stack (**Photograph 21**). These discharge to the WTP.
- A vent and emergency access portal for the underground mine are immediately northeast of the process expansion area at the top of the slope.
- The farmed areas in the north-western half of the site are accessed via Moore Street, the termination of this road being at a gated entrance to the processing area (**Photograph 20**).
- The farmed areas rise steeply up to the northeast. Old mine workings were visible on the hillslope on the eastern side of Moore Street.
- On the western side of Moore Street is remnants of a former pond/water storage reservoir (**Photograph 22**). The clay embankment has been breached and it no longer holds water. The pond and surrounds are pasture.

Photograph 21. Western side of the Polishing Pond Stockpile and water collection drains.

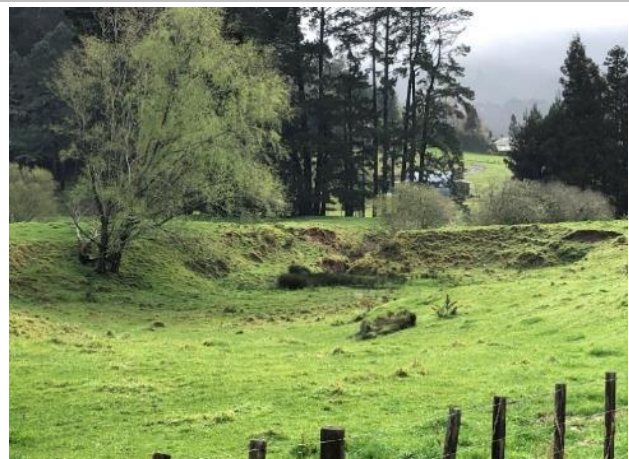
Photograph 22. Former water storage pond/ reservoir.

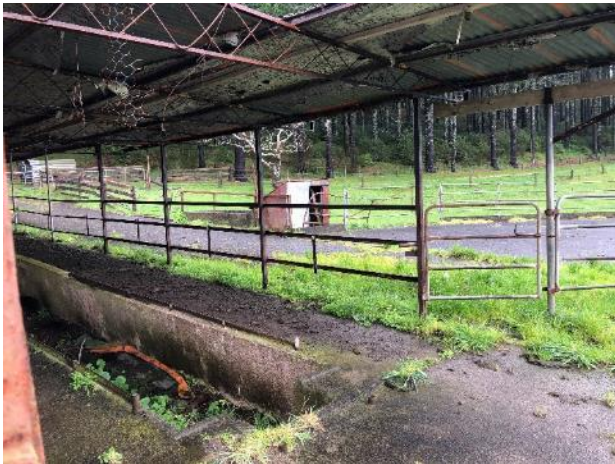
A derelict dairy shed (**Photograph 23**), yards (**Photograph 25**), and an old brick wall (**Photograph 24**) are located to the west of, and outside, the GOP site, not far along the farm track accessed from the end of Clarke Street. The dairy shed is of steel and corrugated iron construction.

Photograph 23. Derelict dairy shed.

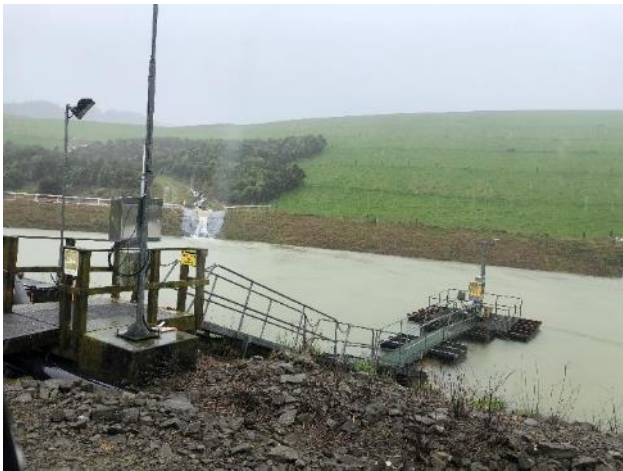
- Side slopes are predominantly grazed pasture almost to the rim, with an area of native plantings evident in the northwest of TSF2 (**Photograph 29**).
- Have drains and collection ponds around the base with pumps to return water to the WTP, and spill channels that operate under very heavy rainfall (**Photographs 29 and 30**).
- An underdrainage system collects water percolating through them in a series of manholes from which water is piped to the WTP.

Photograph 29. Water spilling off TSF2 embankment to the collection pond.

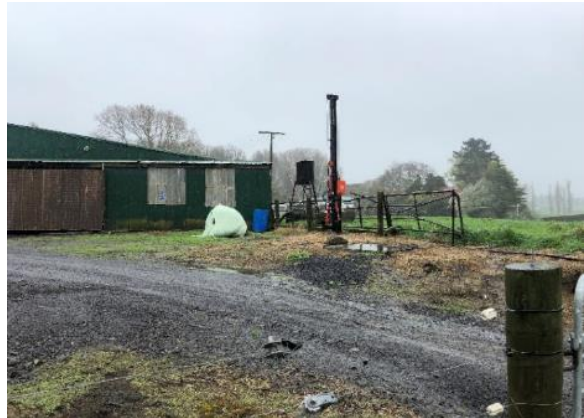
- The farm buildings are of corrugated iron and steel construction, mostly with earth floors (**Photographs 33, 35 and 36**). The cowsheds are concrete block and corrugated iron. An above-ground storage tank (AST) for diesel is located next to a dairy shed (**Photograph 32**).
- Both dwellings are weatherboard with evidence of cement board eaves and soffits, potentially containing asbestos.
- Used livestock and weed control sprays containers were visible in an implement shed between the two cowsheds. Several older tractors and equipment were also within the shed (**Photographs 33 and 34**).

Photograph 32. AST outside the northern-most dairy shed.

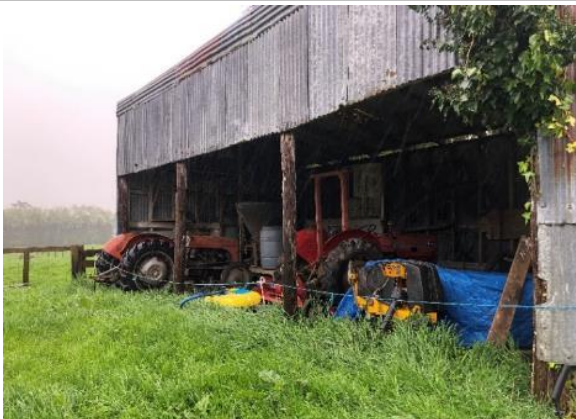
Photograph 33. Implement shed.

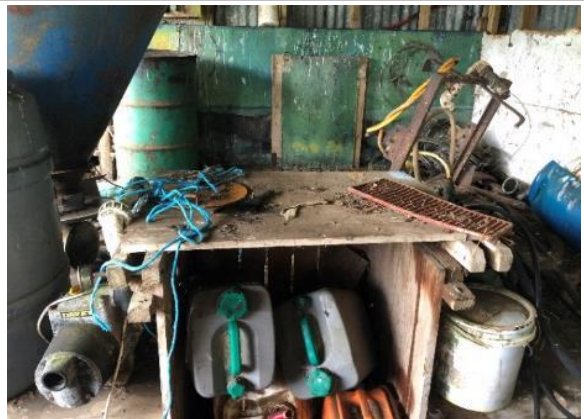
Photograph 34. Stored chemicals and drums in the implement shed.

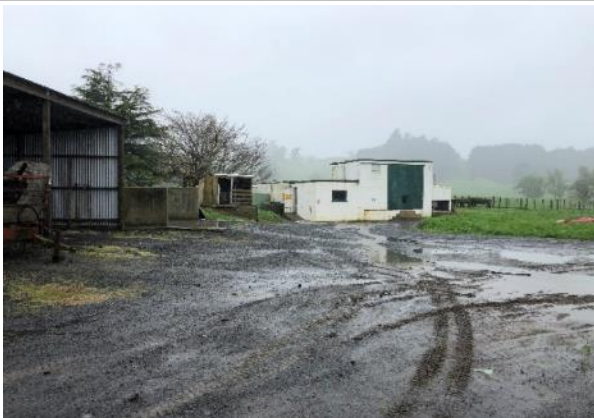
Photograph 35. Second dairy shed complex to the northeast.

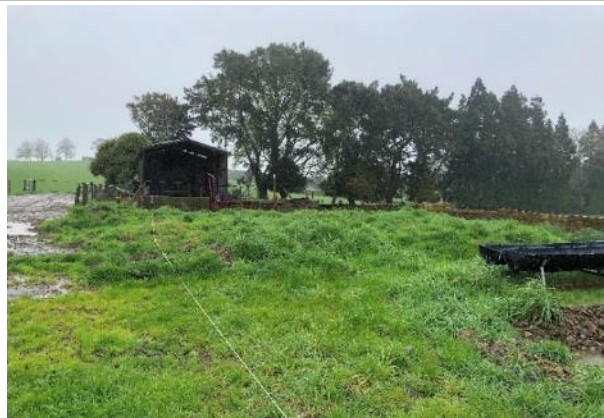
Photograph 36. Hay shed.

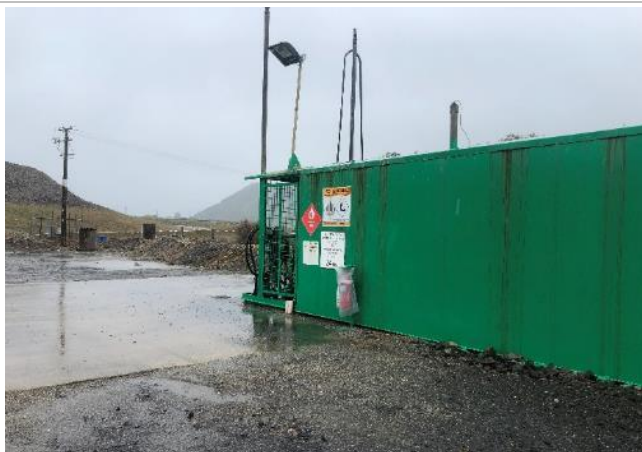
- The workshop is on a raised platform in the central south of the site (**Photograph 38**). An access road and hardstand area occur adjacent to its eastern side. A large, modern self-bunded diesel Above-ground Storage Tank ("AST") is on the western boundary of the platform (**Photograph 37**). The workshop is a large steel framed corrugated iron clad/ roofed structure. Waste oil collection vessels/ tanks are present outside the southwestern corner of the workshop (**Photograph 38**).

Photograph 37. Diesel AST adjacent to workshop.

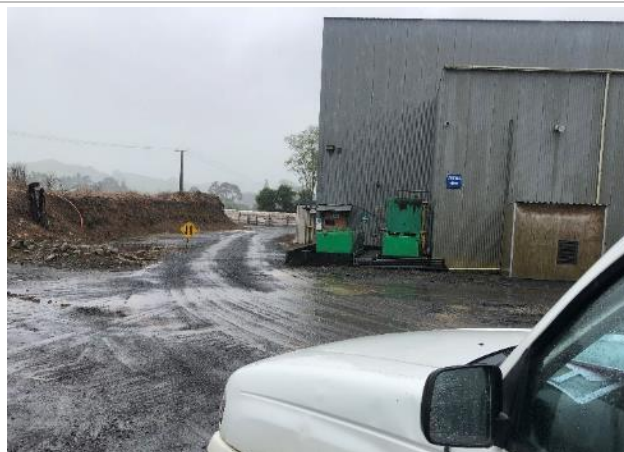
Photograph 38. Waste oil tanks at the rear of the workshop.

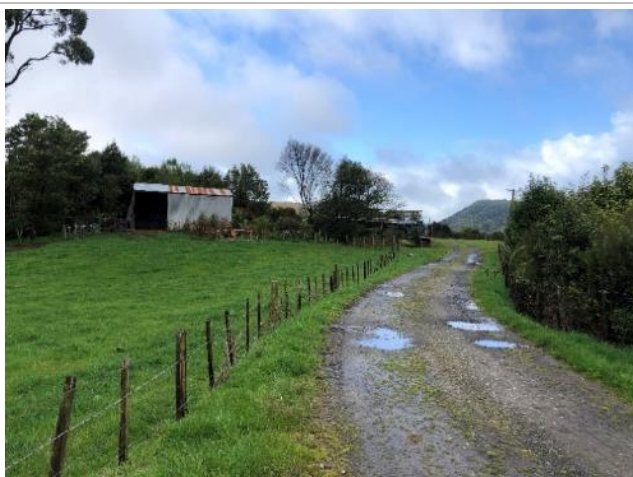
- The two sheds have earth floors and are timber framed and corrugated iron clad (**Photographs 39 and 40**).
 - The dairy shed is also of corrugated iron construction and is overgrown with vegetation.

Photograph 39. Hayshed with the derelict dairy shed to the right.

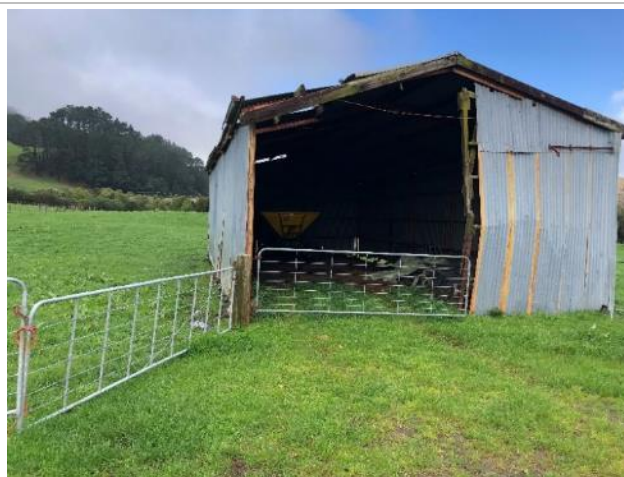
Photograph 40. Hay/calf shed.

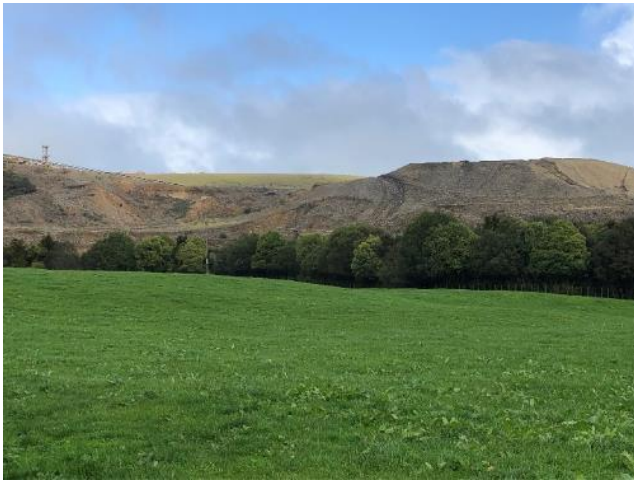
Photograph 41. Looking south towards the existing north rock stockpile (within the footprint of proposed NRS).

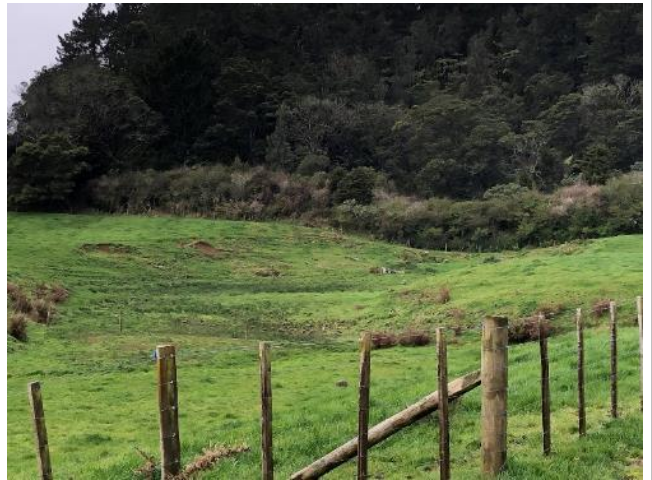
Photograph 42. Gully feature orientated east – west.

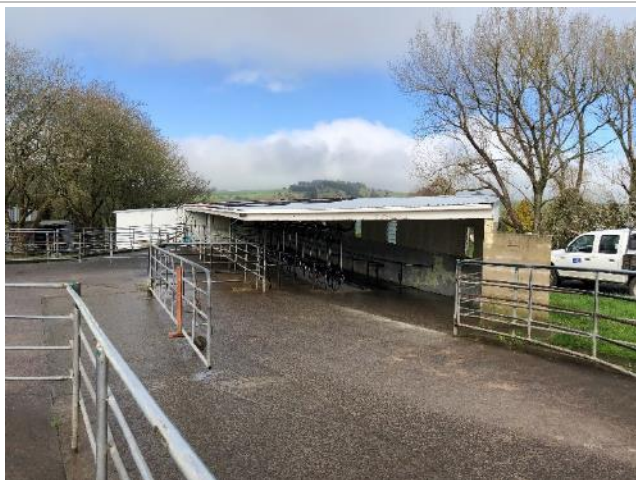
Photograph 43. Dairy shed.

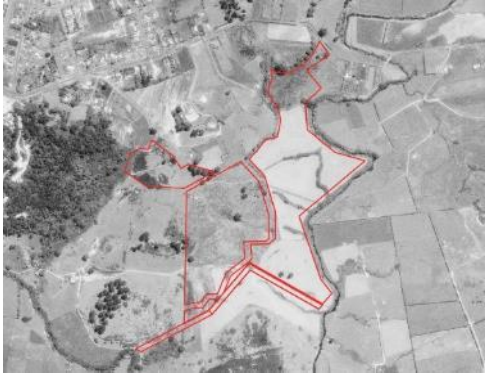
Photograph date (source)	Activities	Aerial image
1982 Retrolens (SN5944 C/6)	<p>The site is largely unchanged.</p> <p>Surrounding land densifies with residential redevelopment in the north and west with land in the south and east remaining largely unchanged.</p>

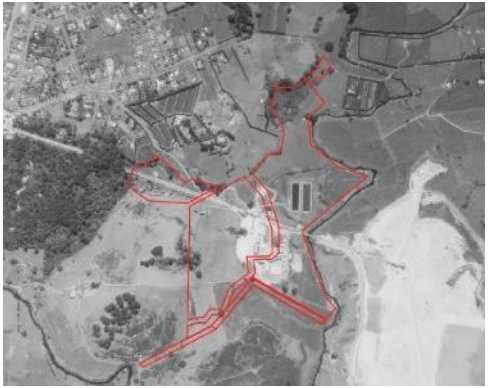
1991 Retrolens (SN9124 C/29)	<p>The site has been redeveloped into the Processing Plant which occupies the central portion of the site. Features observed include:</p> <ul style="list-style-type: none"> • Ponds associated with the WTP. • Tanks, potentially used for water treatment, storage of diesel or other chemicals (cyanide, acids) • Ore stockpile pad • Conveyor belt <p>Many of the remaining features are as they are today.</p>

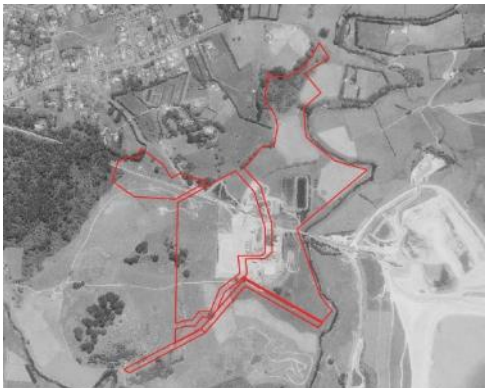
1999 Retrolens (SN12539 B/9)	<p>There are no significant changes relative to the 1991 aerial photograph.</p> <p>Surrounding land continues to densify with residential properties.</p>

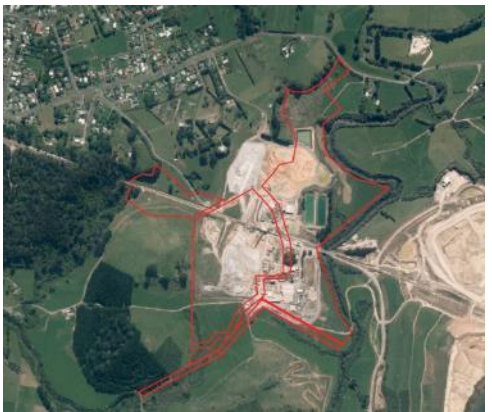
2012 – 2013 LINZ - Waikato	<p>The Processing Plant has expanded and now occupies the majority of the site's footprint. It has also expanded and encroaches onto the property to the north. A new pond is observed in the northern corner of the site.</p> <p>Surrounding land remains largely unchanged.</p>

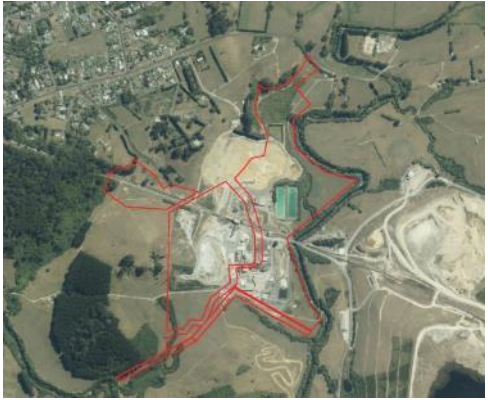
Photograph date (source)	Activities	Aerial image
2016 – 2019 LINZ - Waikato	The site and surrounding land remain largely unchanged.

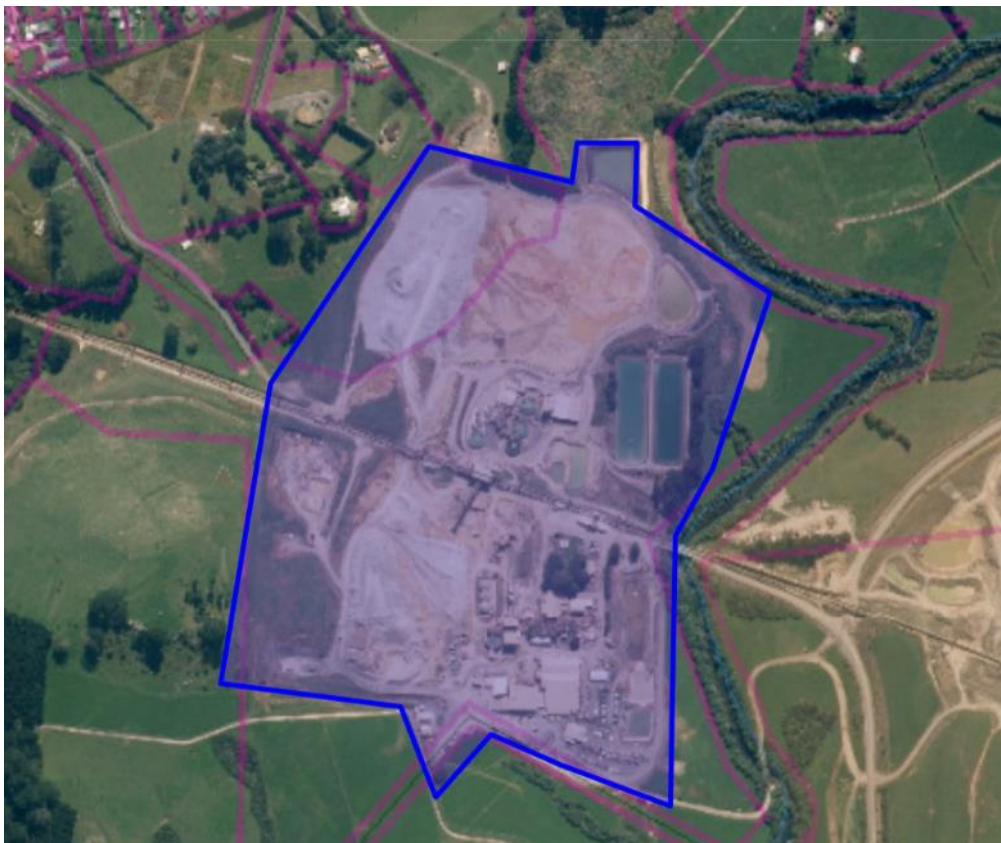
Figure B.1.1. WRC LUIR map.

- 43 Moore Street, 52 Clarke Street and Domain Road – Confirms all three properties are listed on the Land Use Information Register (ref: LUI07240), as indicated by the area shaded blue with a classification of 'Contaminated' due to land use HAIL activities: 'E7. Mining'; and 'C1. Explosive storage' associated with Newmont Waihi Gold.
- A number of documents are held under consent file 605902A.

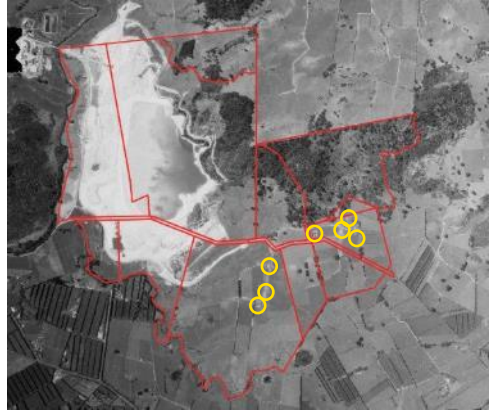
Photograph date (source)	Activities	Aerial image
1991 Retrolens (SN9124 C/31)	The structures within the western half of the site have been removed and a tailings storage pond for the Waihi (Martha) mine now occupy this area. Earthworks related to the tailings storage pond extend off the property in the north. Again, the majority of the structures have been removed from the eastern half of the site, with only the circled ones remaining. Martha mine pit and the processing plant are observed some distance to the northwest.

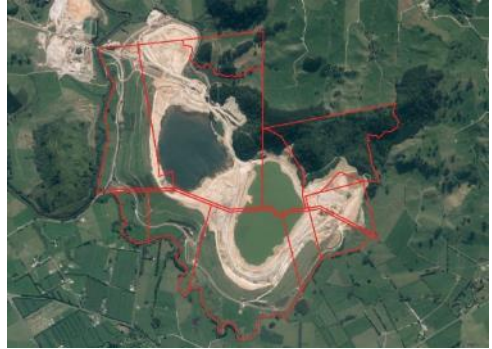
2012-2013 LINZ-Waikato	An additional tailing storage ponding and associated earthworks are observed within the eastern half of the site. Surrounding land remains largely unchanged.

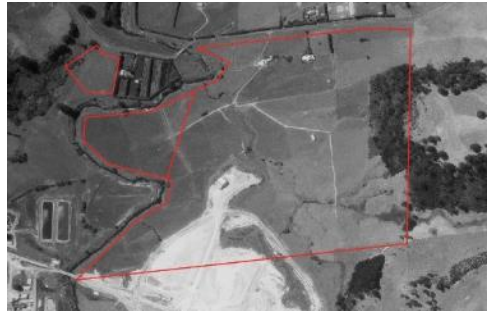
1991 Retrolens (SN9124 B/31)	The site has exposed earth and associated access roads evident in the southern part of the site relating to the Martha mine TSFs. The remainder of the site remains largely unchanged. Surrounding land to the west has undergone development in association with the mine's Processing Plant.

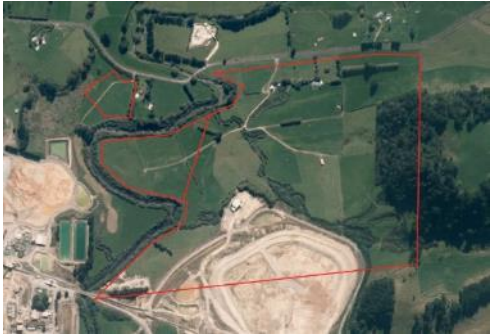
2012-2013 LINZ- Waikato	Further exposed land is evident in relation to the mine TSF2. The Processing Plant to the west of the site has expanded. The remainder of the site remains unchanged.

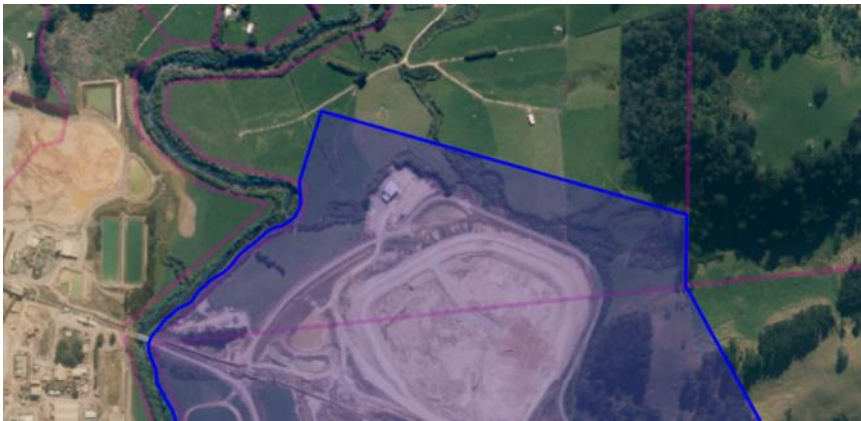
Figure A.5.1. WRC LUIR map.

- 699 Golden Valley Road – Confirms the property is listed on the Land Use Information Register (ref: LUI05625), as indicated by the area shaded blue with a classification of 'Contaminated' due to land use HAIL activities: 'E7. Mining'; 'F4. Motor vehicle workshops'; and 'A17. Storage tanks or drums for fuel, chemicals or liquid waste' associated with Newmont Waihi Gold.
- A number of documents are held under consent file 605902E (these were not provided for review)

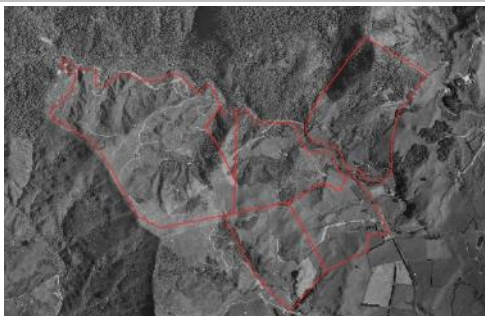
1975 Retrolens (SN3798 C/20)	The site and surrounding land remain largely unchanged.

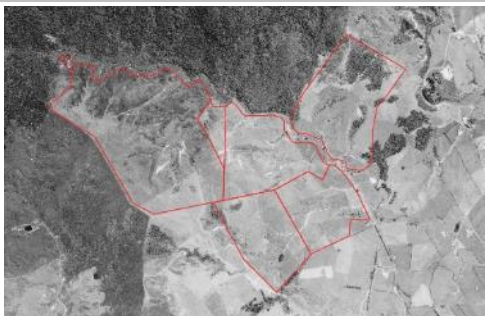
1982 Retrolens (SN5944 B/16)	A significant amount of bush in the north of the site has been cleared and converted to pasture. Two main access roads are visible; one in the southern part of the site extending from the original dwelling out to the west; the other further north, running parallel with Willows Road. The surrounding area remains largely unchanged.

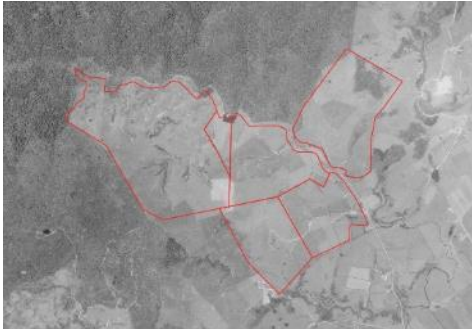
Photograph date (source)	Activities	Aerial image
1999 Retrolens (SN12539 A/9)	There is a further reduction in the amount of vegetation in the northern part of the site (bush conversion to pasture). The surrounding area remain largely unchanged.

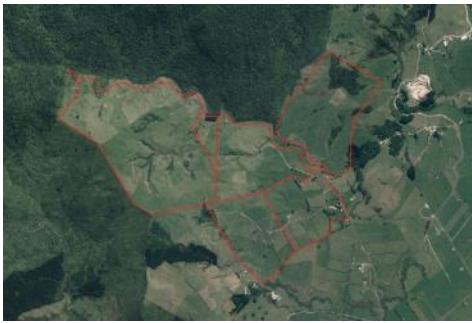
2012-2013 LINZ-Waikato	The site and surrounding land remain largely unchanged.

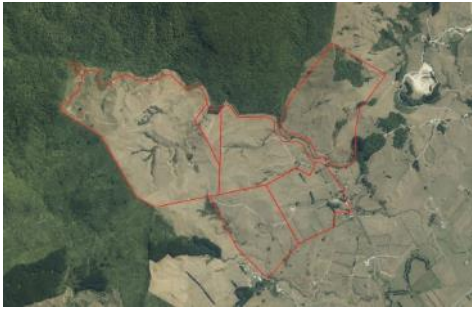
2016-2019 LINZ-Waikato	The site and surrounding land remain largely unchanged.

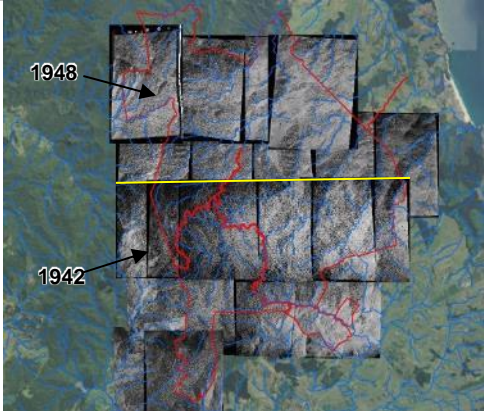
Photograph date (source)	Activities	Aerial image
1942 Retrolens (SN229 4/ 83 /25 – 27/ 29/ 31/ 32 and 484/ 28/ 29/ 31/ 33/ 34 and 485/ 27/ 28. 1948 Retrolens (SN229. 481/ 33/ 35/ 37/ 39 and 482/ 42/ 44/ 46/ 48/ 50)	<p>1942 aerial photographs were only available for the southern half of the site, with 1948 aerial photographs available for the northern half. For both years, the site is undeveloped forest land with surrounding land very much the same.</p>

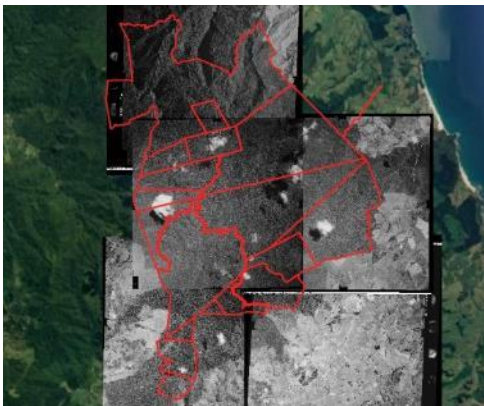
1982 Retrolens (SN5944. A/ 14/ 16 and B/ 14/ 16 and SN8163. V/ 18)	<p>The site remains largely unchanged, with no structures observed on site.</p> <p>No significant changes are observed on the surrounding land.</p>

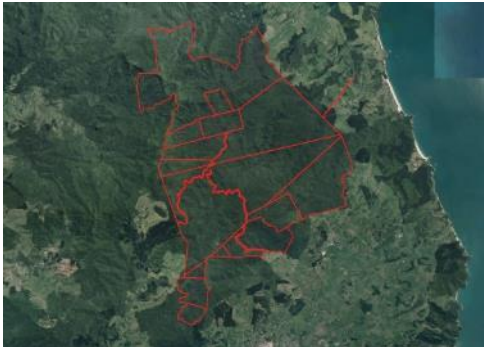
2012-2019 LINZ-Waikato Photograph used 2012 - 2013	<p>The site remains largely unchanged, with no structures observed.</p> <p>No significant changes are observed on the surrounding land, with the exception of a small dam adjacent to the western boundary of the Park observed in 2012 - 2013.</p>
