**Project Number 16998.000.002**

**Cannon Point Stage 3 Geotechnical  
Investigation for Resource Consent**

10 Cannon Point Road, Craigs Flat, Upper  
Hutt, Wellington 5018

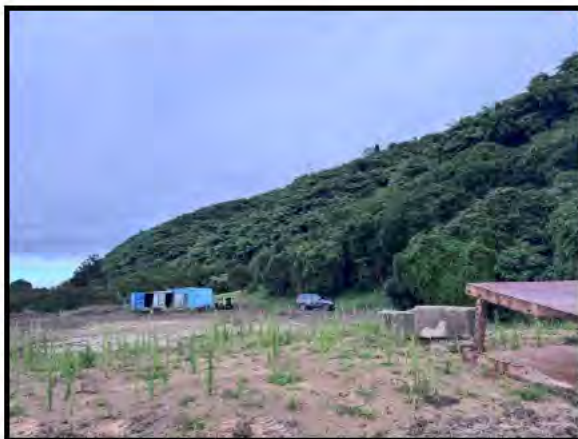
Photo 1: Untested fill stockpiling at northern end of site.

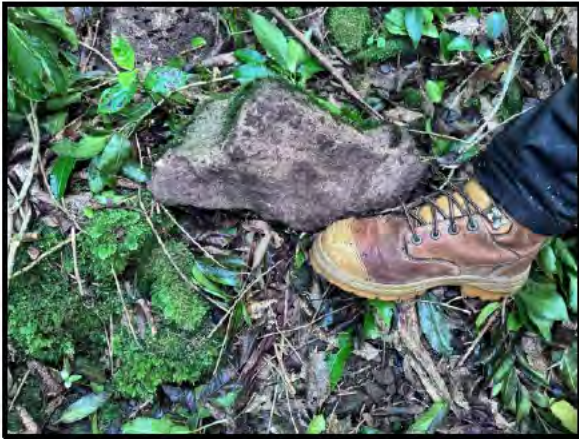
Photo 5: Largest rockfall evidence from slopes above site.

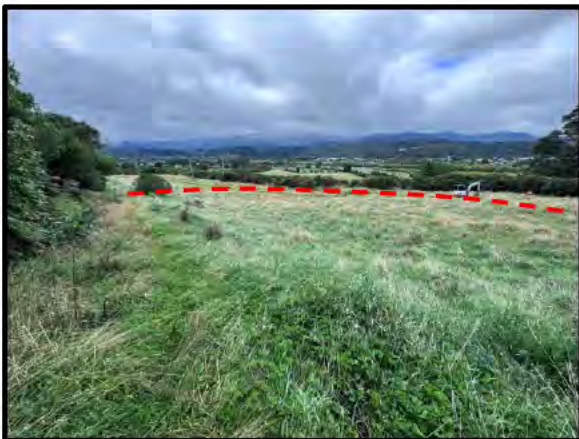
Photo 7: Terrace tread debris flow indicated by red dashed line.
