## 8.4 Archaeological Values

## 9 Golden Bar Haul Road

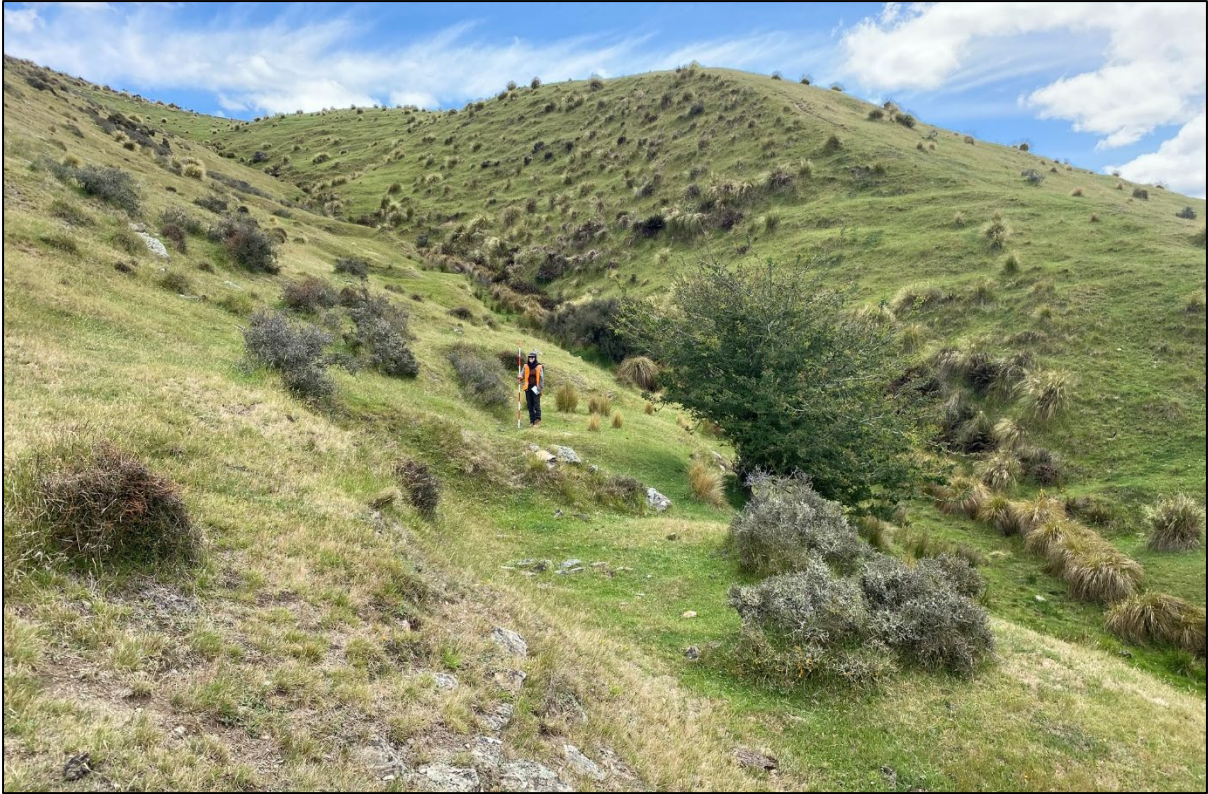
Figure 97. Building site (HT), looking south-west.

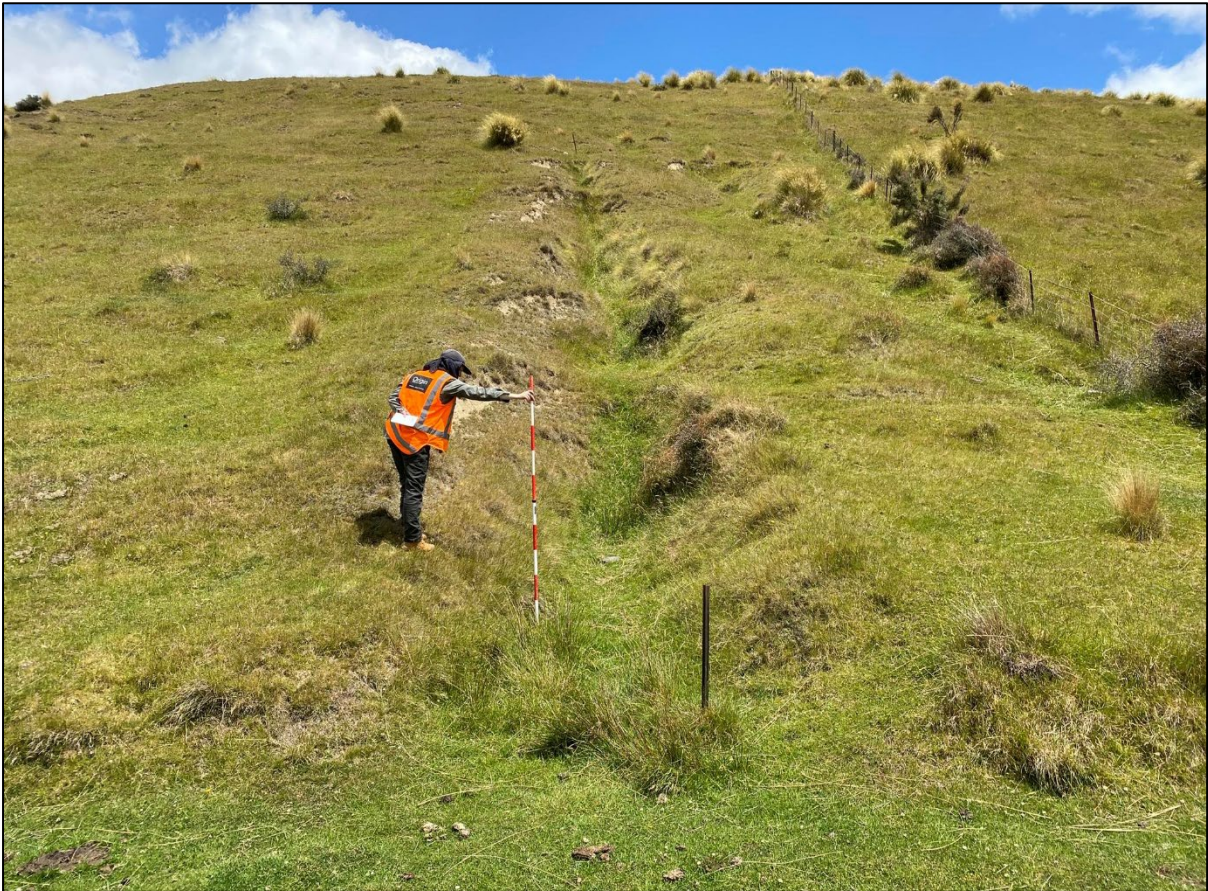
Figure 98. Bottom of P1, looking south.

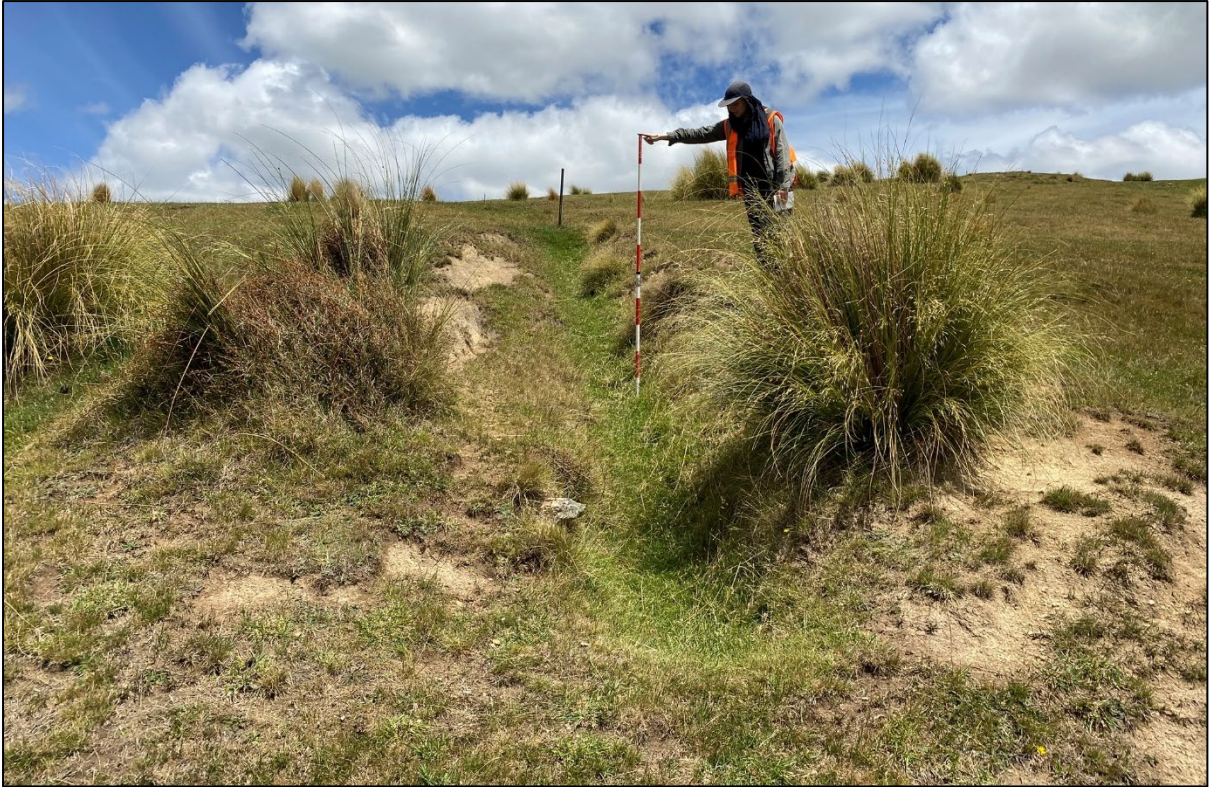
Figure 99. Bottom of prospecting trench (P2), looking south.

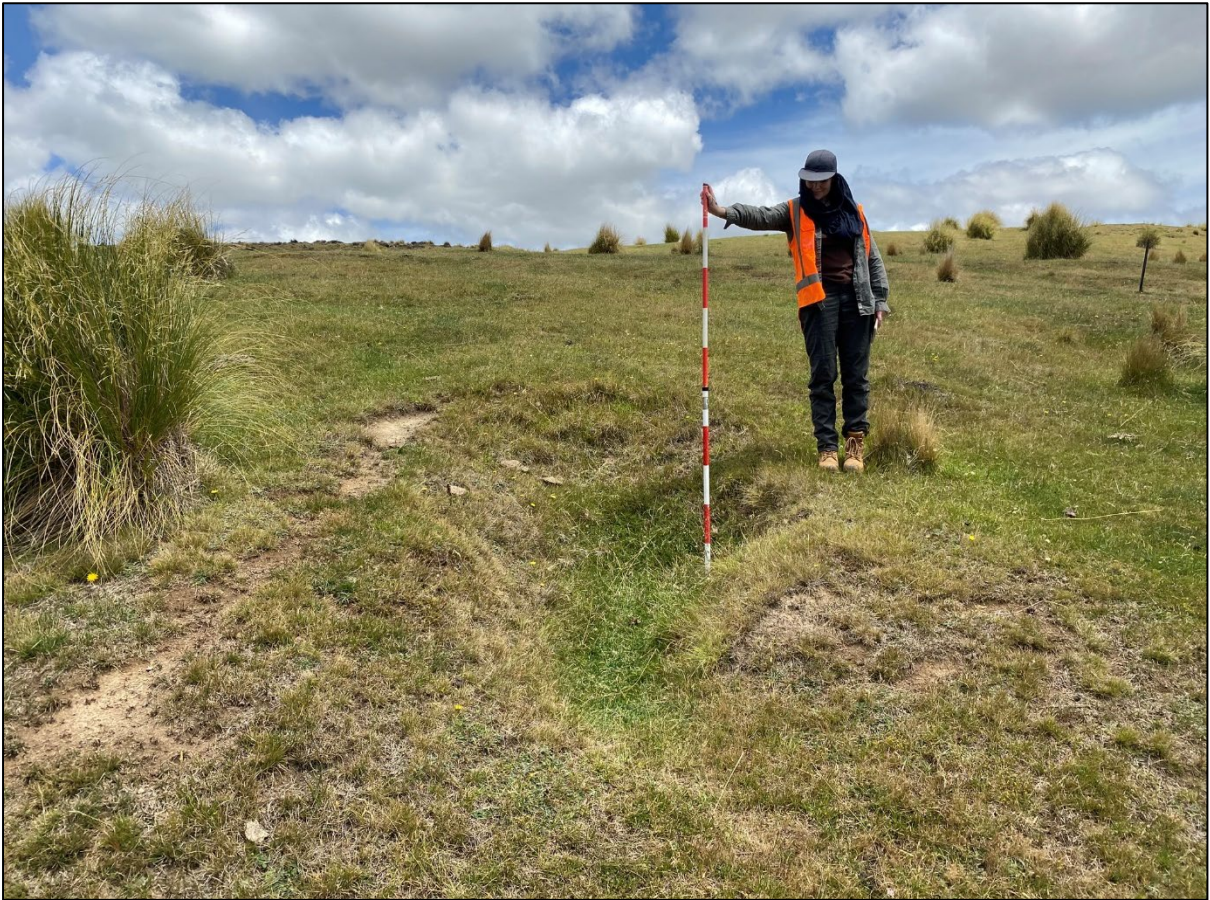
Figure 100. Prospecting trench (P3), looking south.

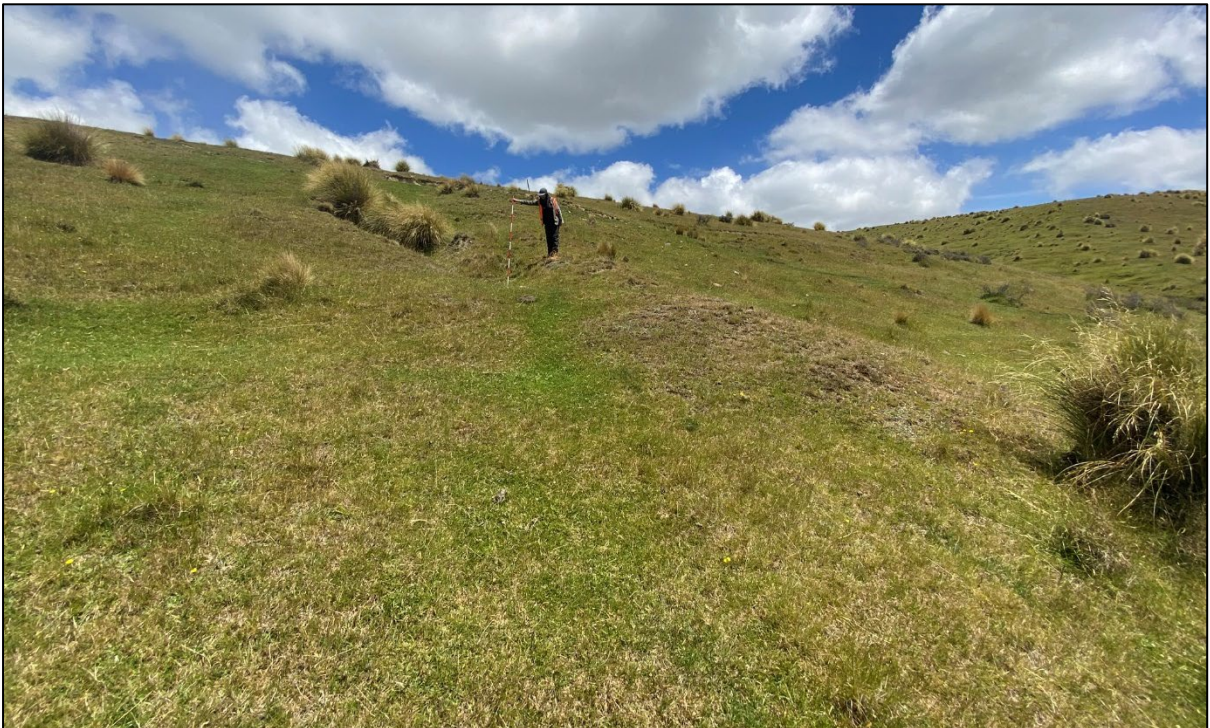
Figure 102. Mullock heap (S2), looking south-west.

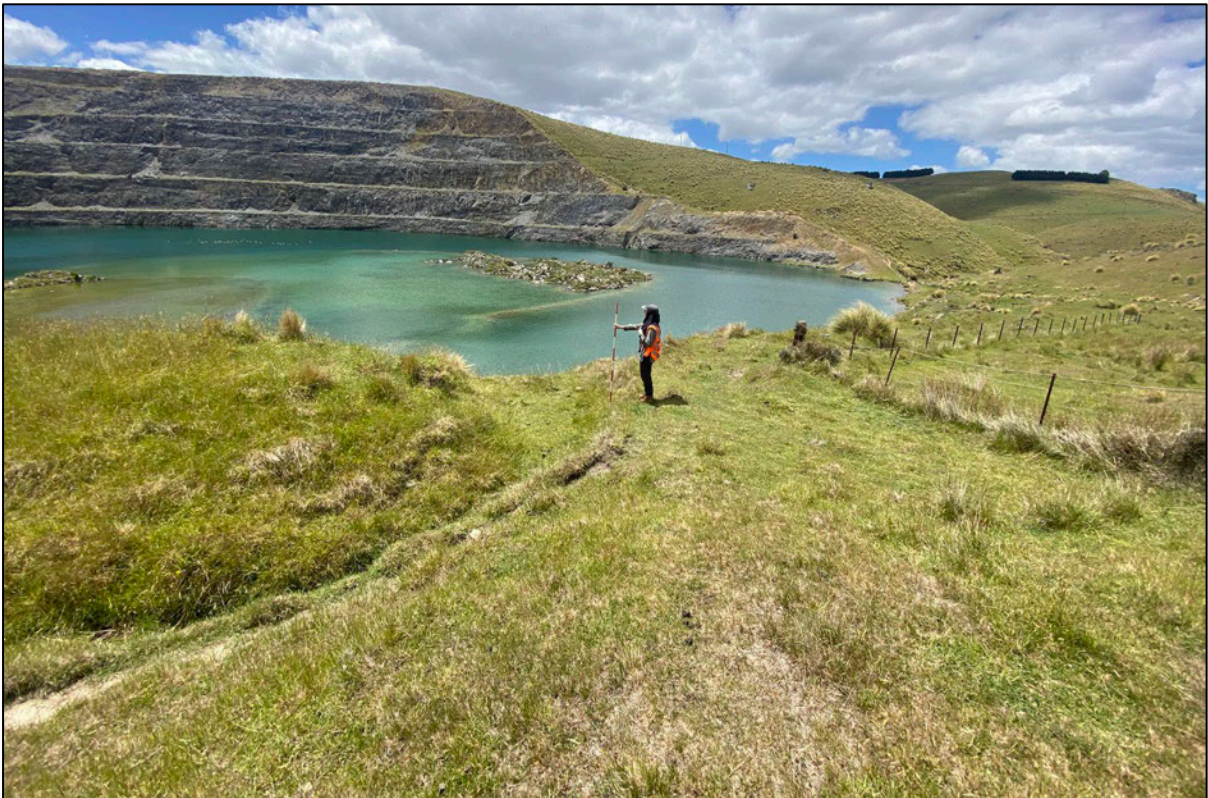
Figure 105. Scarp/terrace (S3), looking east. Former location of Adit I (AI) to the left of the scarp/terrace.

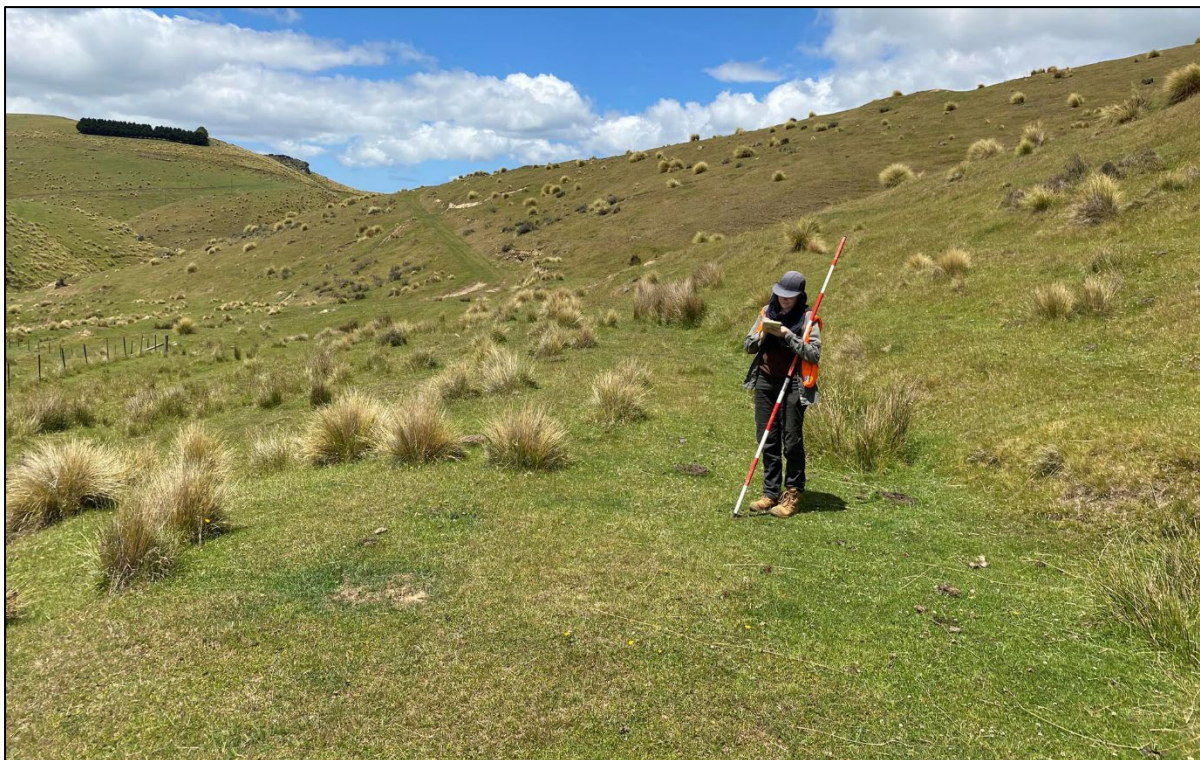
Figure 106. Widening of track at northern end below bottom of prospecting trench (ST), looking south-east.

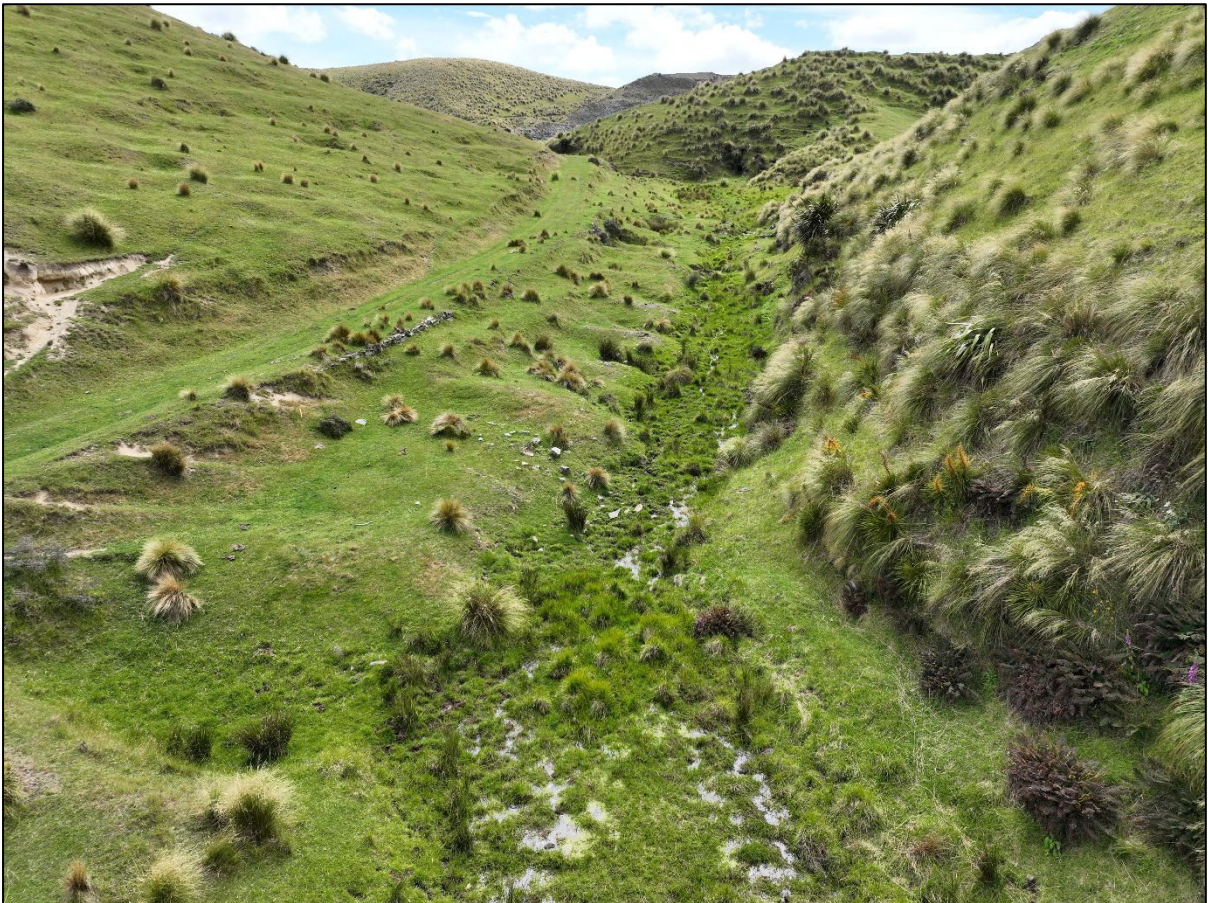
Figure 109. Revetment along track, looking north-west.

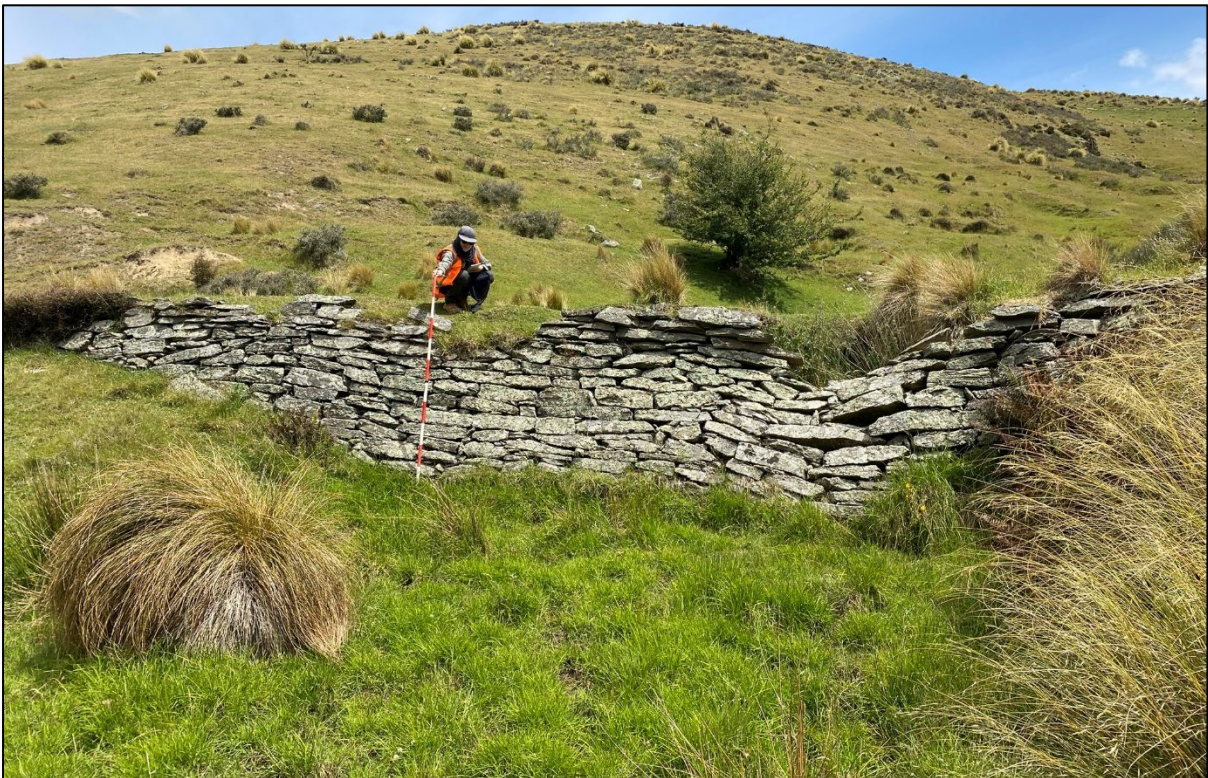
Figure 113. Major revetment along track, looking south-west.

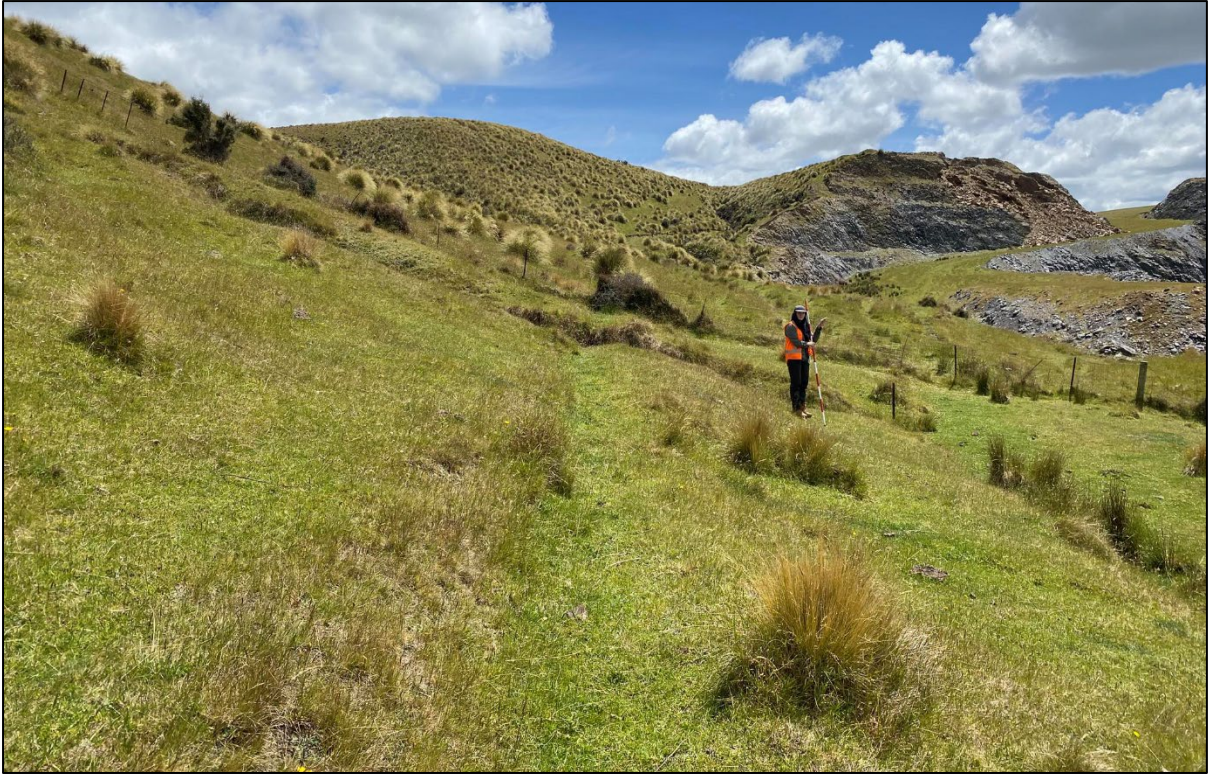
Figure 118. Looking along water race (WR), looking north-west.

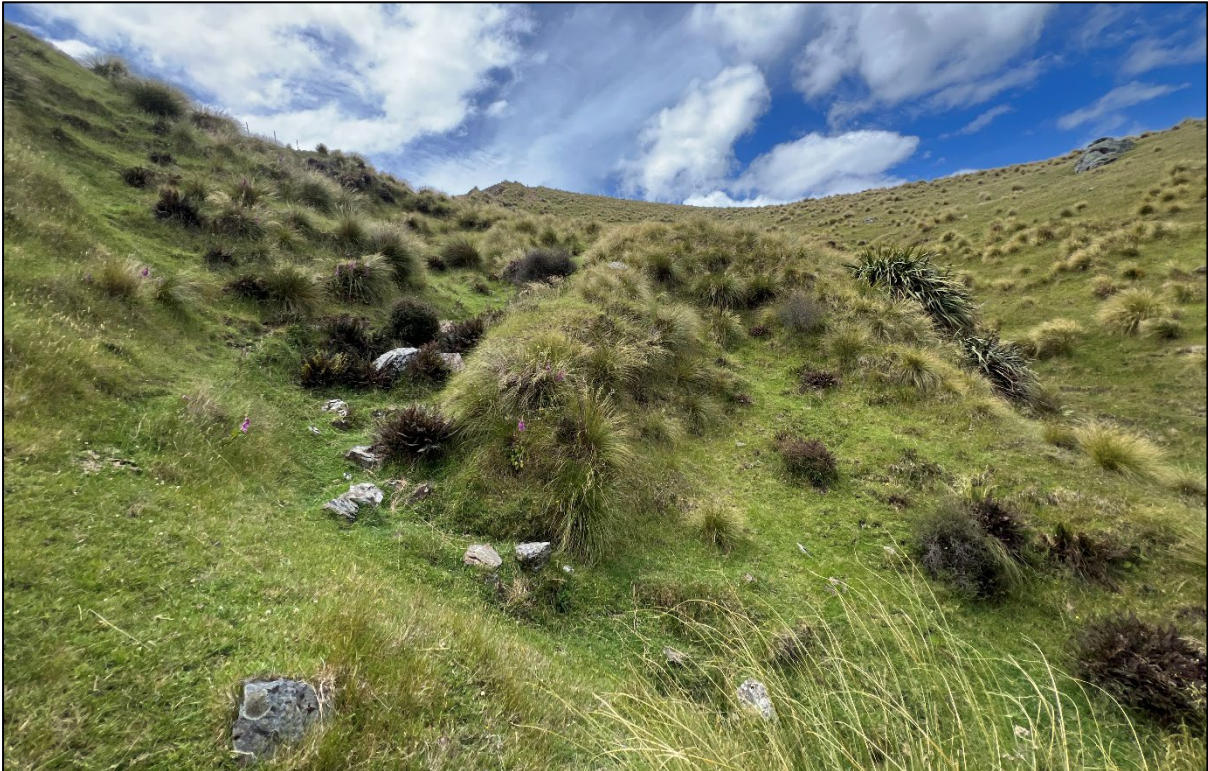
Figure 121. Bottom of slucced gully, looking north.

| Site | Value | Assessment |
|---|---|---|
| <b>Sluicings (I43/190)</b> | Condition | The site has been unaffected by the modern mining and the Golden Bar Pit. The site is largely well defined, the outer margins are covered with dense vegetation (tussock) in some areas. Areas had been impacted by stock trampling.<br><b>Assessment – Good</b> |

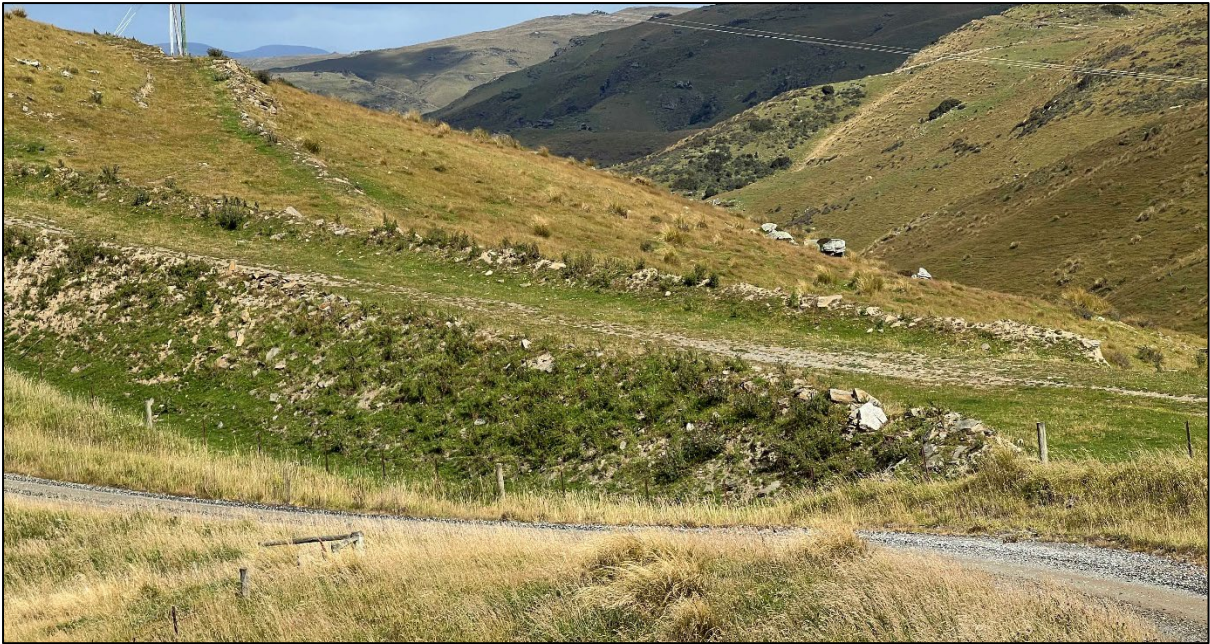
A survey of the project area was undertaken by Jeremy Moyle and Chris Jennings on 24 November 2025 with a return visit to I42/33 by Jeremy Moyle on 2 March 2026.<sup>187</sup> Figure 132 shows the general areas that were visited based on the identification of archaeological features or areas with archaeological potential during the desktop review. The area around the haul road route consists of vacant pastureland along the ridgeline between Tipperary/McCormicks Creek and Murphys Creek. The haul road project area runs immediately adjacent to Golden Bar Road. Given the history of this road, the potential for historic stone culverts was anticipated in the targeted survey, but none were identified on the ground. The length of Golden Bar Road was driven in addition to the targeted survey areas. No additional archaeological sites were identified beyond the two previously recorded sites discussed below. On site it was evident that almost all the Haul Road project area has already been significantly disturbed by past road formation (Figure 133).

Figure 133. Example of the existing haul road formation, with Golden Bar Road in the foreground.

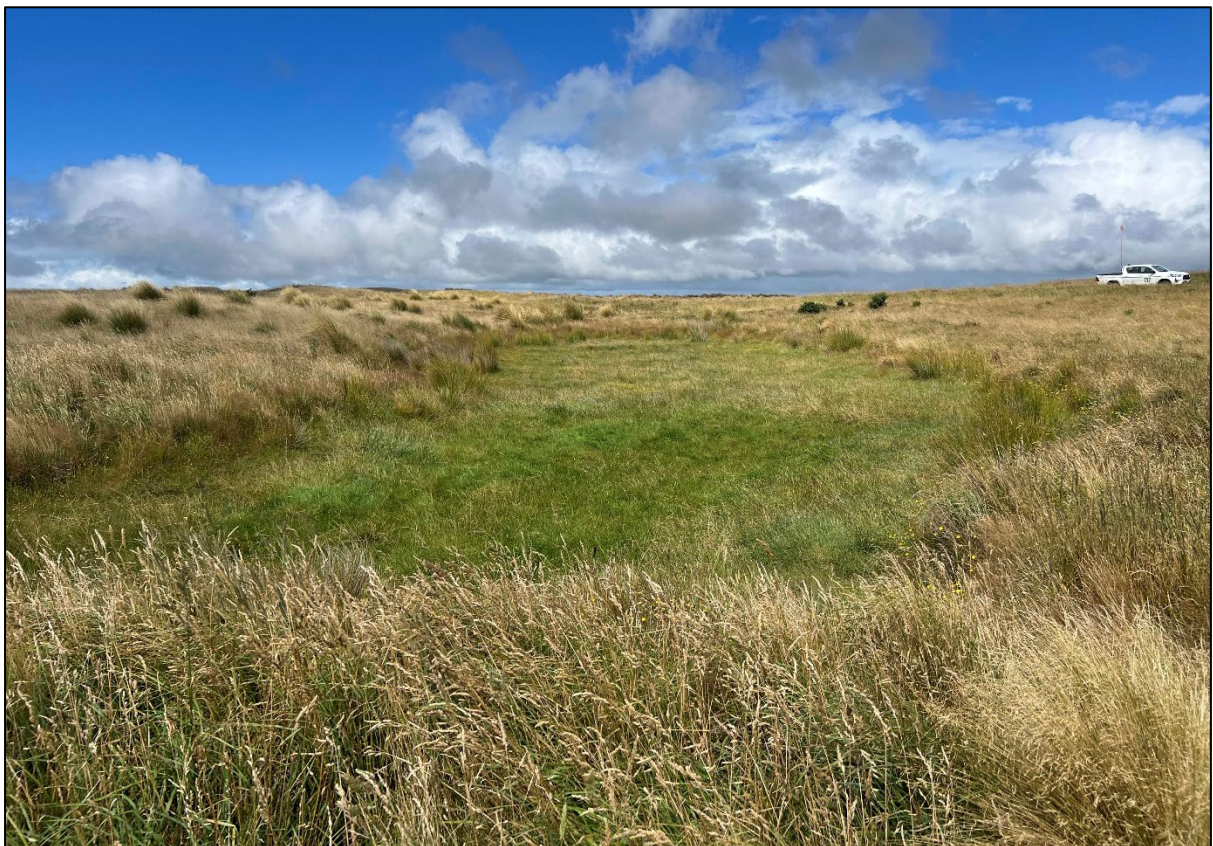
Her diagram of the site indicates a spoil heap adjacent to the deepened pit (Figure 134). At the time of the site visit there was no clear evidence of the excavated area or spoil heap, though a patch of greener grass may indicate the former (Figure 136). A kidney-shaped depression is indicated on Hamel's site record, though it appears she did not interpret this as archaeological. It is now surrounded by earthworks associated with modern mining activities (Figure 135 and Figure 137). A road passes between this depression and the dug-out pit.

Figure 136. I42/33, looking south-east.

- Since an Archaeological Authority is not required, the management of archaeological sites associated with this project component should be facilitated through resource consent conditions.
- Site I42/33 (prospecting pit) is flanked by two branches of the proposed haul road; a post and wire fence should be erected around this site – at least while the haul road is in use – to make its location apparent and protect it from any accidental damage.

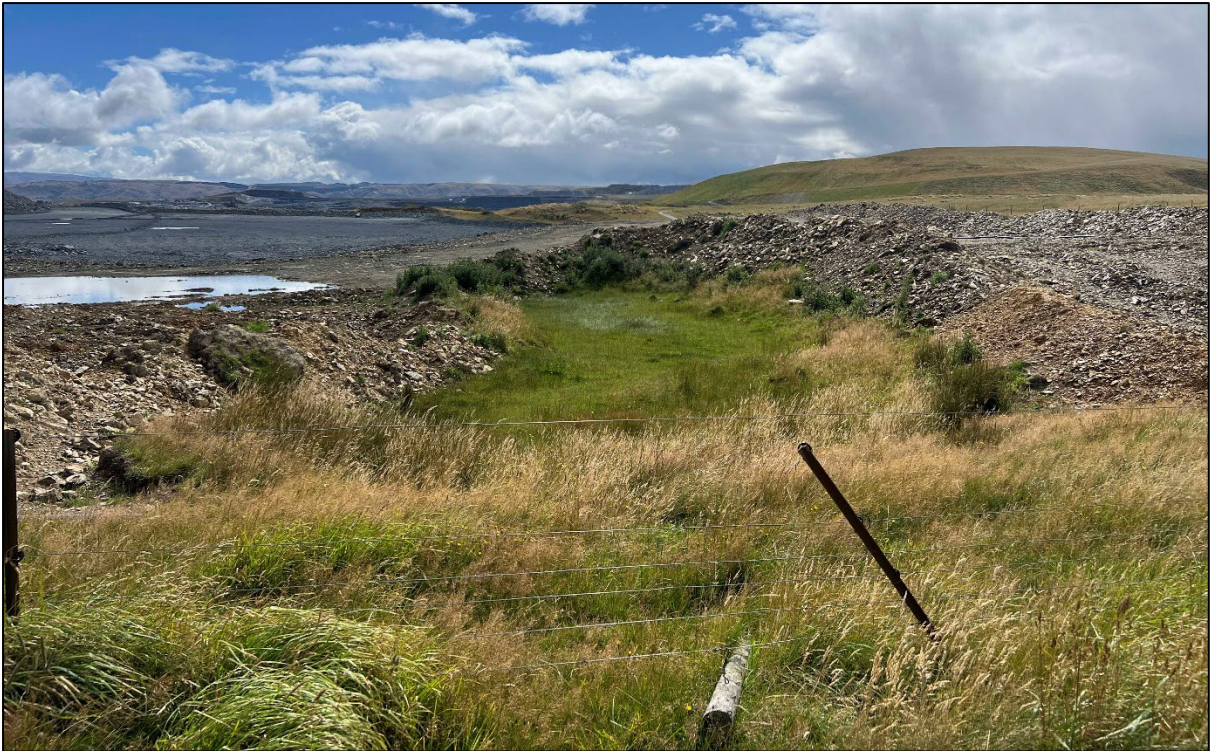
Figure 137. I44/33, looking north-west.

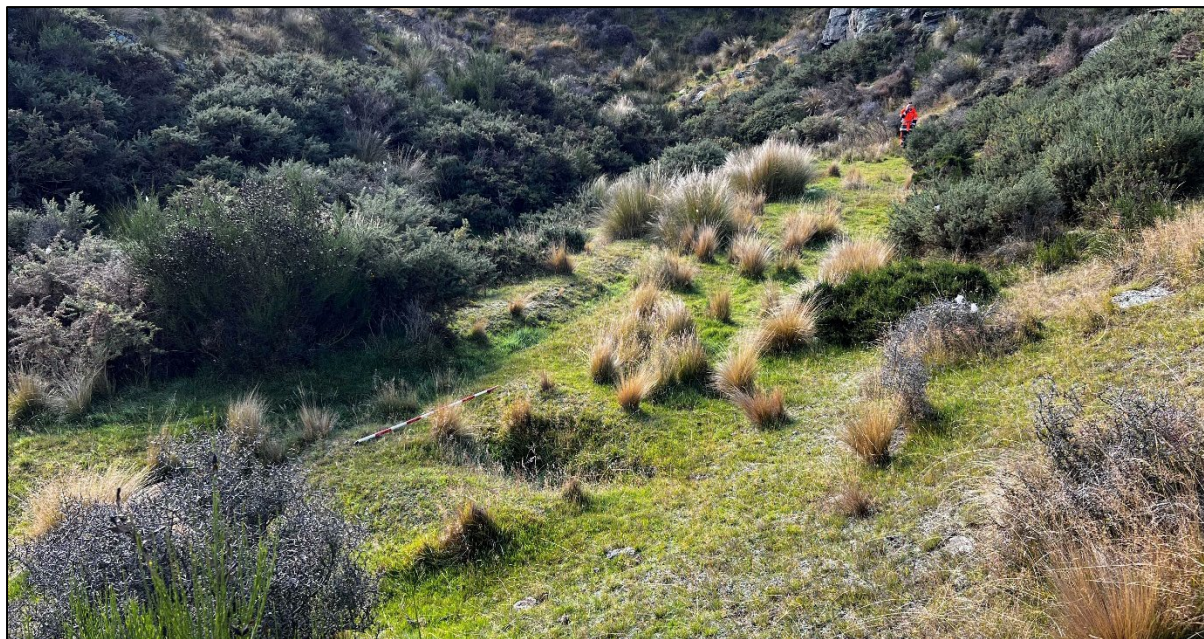
During the survey it became apparent that the water race recorded at different locations as/as part of sites I42/148, I42/149, I42/151, I42/155, and I42/156 is probably the same feature running along the true left bank of the creek (Figure 197-Figure 198). This race was not able to be found again at I42/149, I42/151,<sup>219</sup> and I42/155 as additional spinescent vegetation growth in the 16 years since the 2010 survey had made these sites inaccessible (Figure 199). The race segment recorded as I42/151 appears to be incorrectly located on ArchSite when a comparison is made to its location as plotted in figures in the 2010 survey report. A previously unrecorded section of race was identified at the bend in the river to the south-east of I42/152 (Figure 200). Where observed, the race was approximately 500mm wide.

Prospecting pits were inspected at I42/152 (one pit; Figure 201) and I42/148 (two pits). These were all approximately 2m wide and 800mm deep. The pit recorded as I42/150 was not accessible because of vegetation growth.

Figure 198. Prospecting pit and water race segment at I42/148, looking north-east.

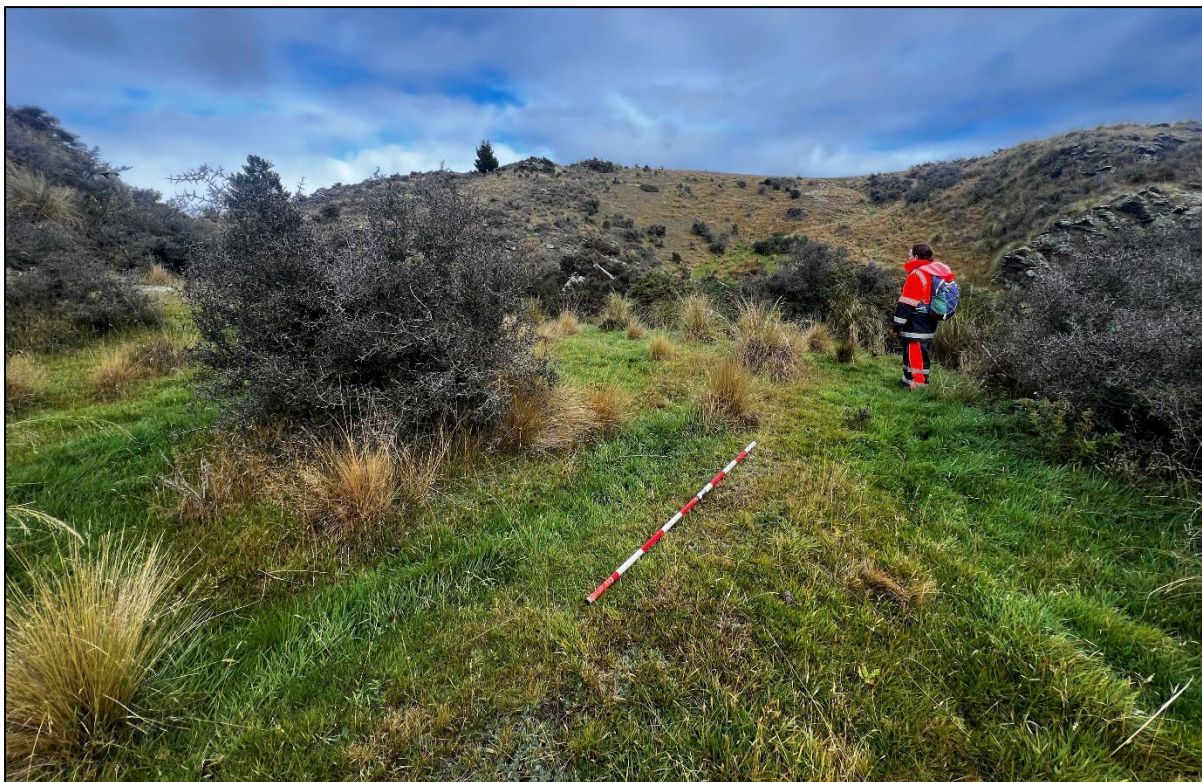
Figure 200. Previously unidentified water race segment south-east of I42/152, looking west.

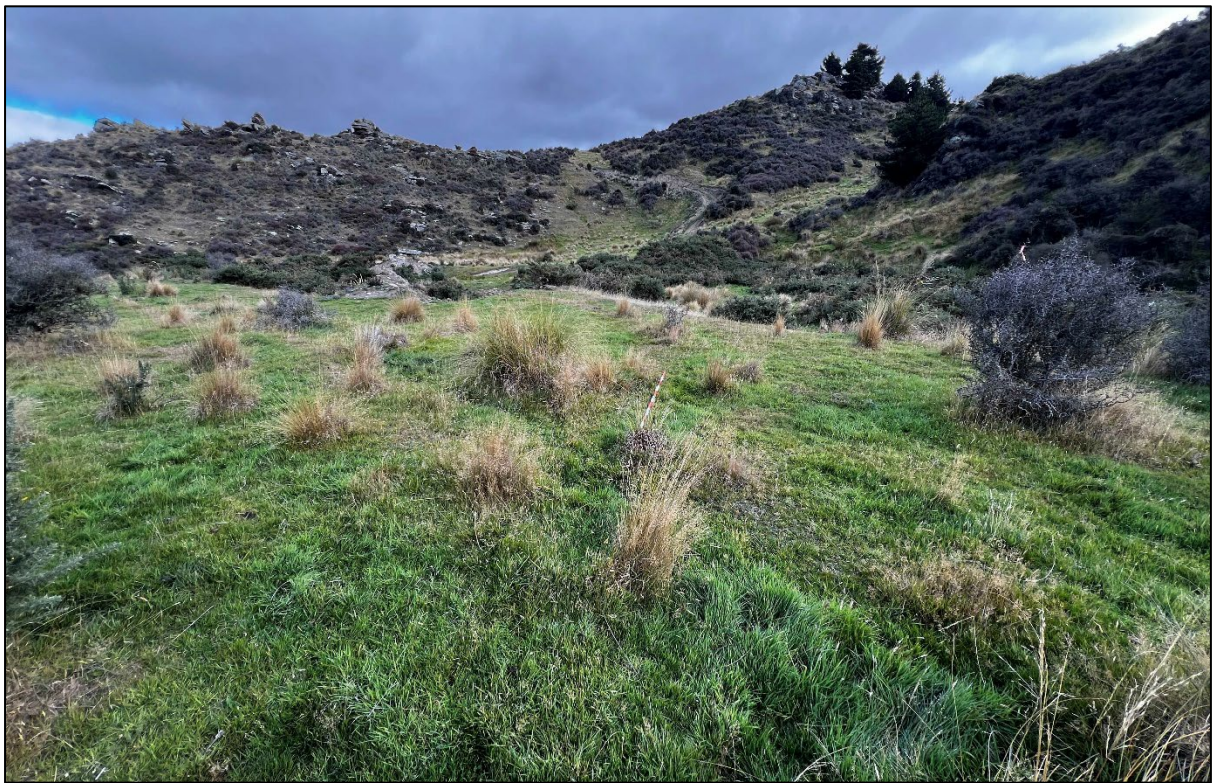
Figure 203. Water race within I42/156, looking west.
