# **Macraes Operation**

## **Preliminary Site Investigation (Ground Contamination)**

OCEANA GOLD (NEW ZEALAND) LTD

WWLA1659 | Rev. 0

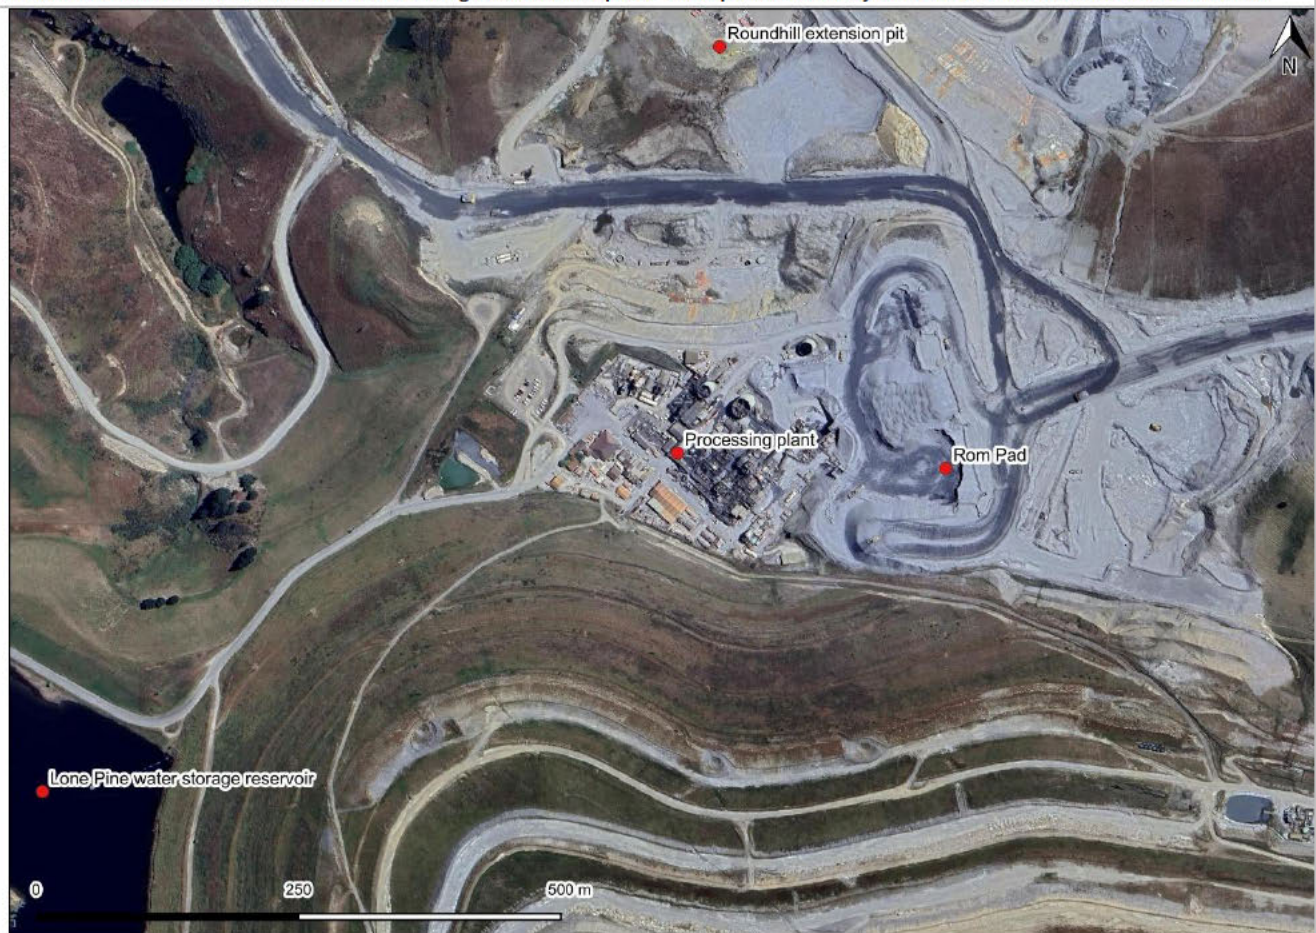
Figure 6. Ore storage (Rom Pad) adjacent to the Processing Plant

Ore is stored awaiting processing on a platform adjacent to the eastern side of the Processing Plant (labelled as "Rom Pad" on Figure 6). Sludges removed from the "Enviro Pond" (captures stormwater from the Processing Plant) are also stored temporarily in this area. In addition to this storage, low grade ores are stored at a number of locations around the wider mine site. The most recent plan of low grade ore stockpile locations is included in **Appendix B** (as provided by OGNZL). Stockpiles are subject to change frequently so **Figure B1** also includes known locations of former low grade ore stockpiles. Stockpiles collectively total several thousand tonnes of material.

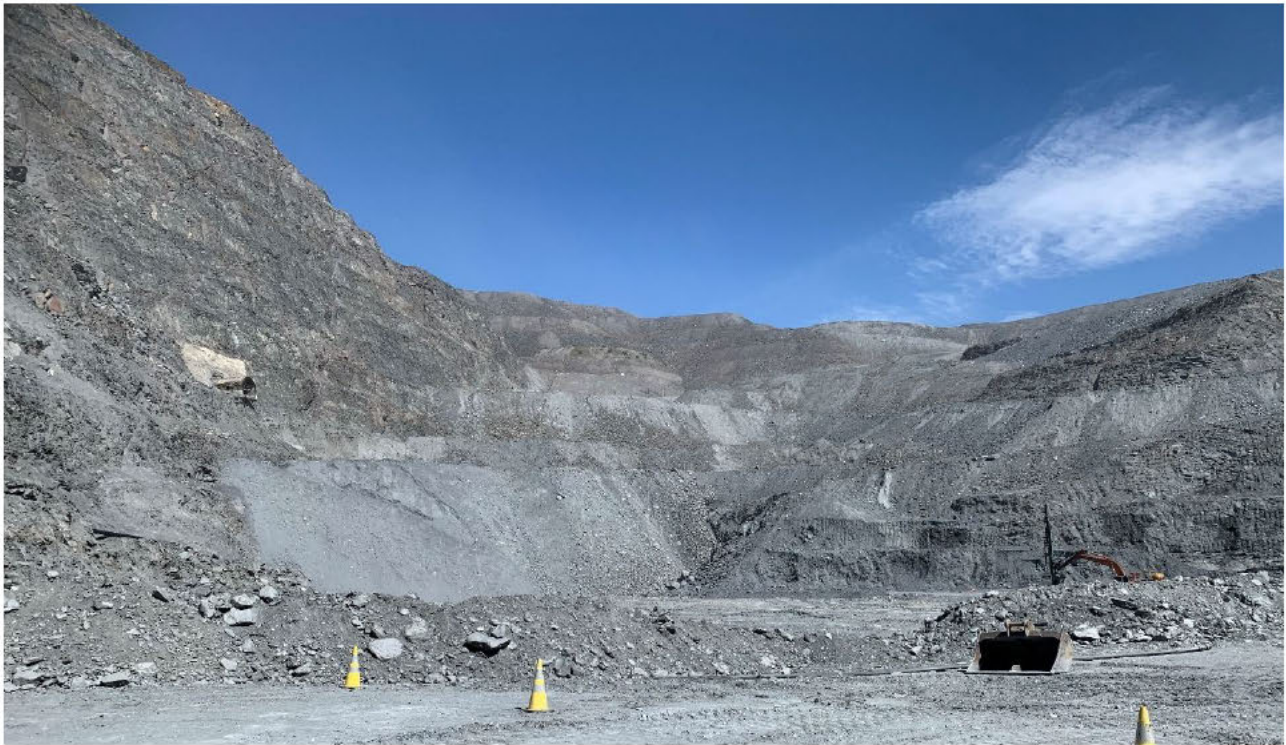
Photograph 1. Example open pit (Frasers).

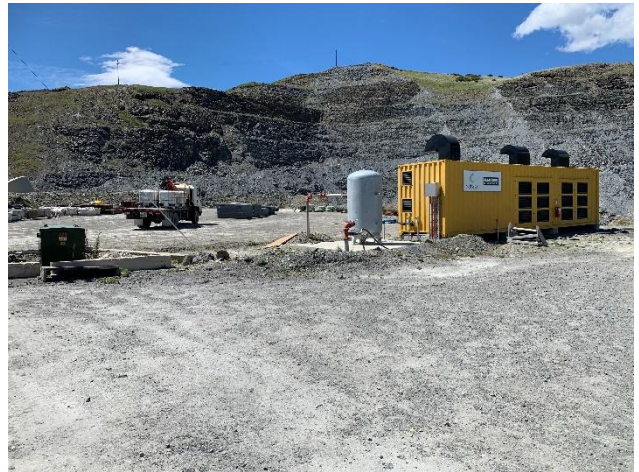
Photograph 3. Compressed air facility at Golden Point

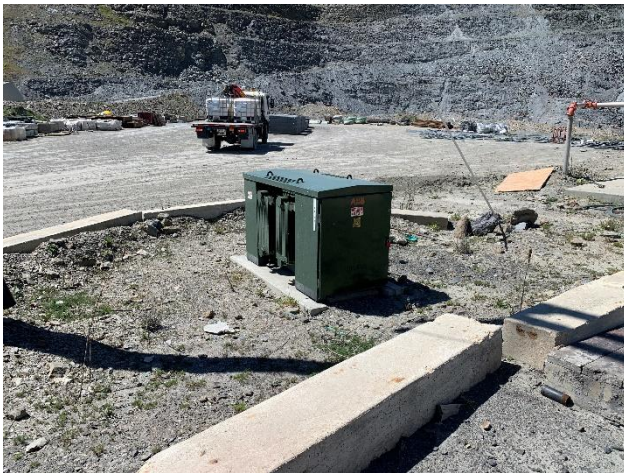
Photograph 4. Transformer at Golden Point portal

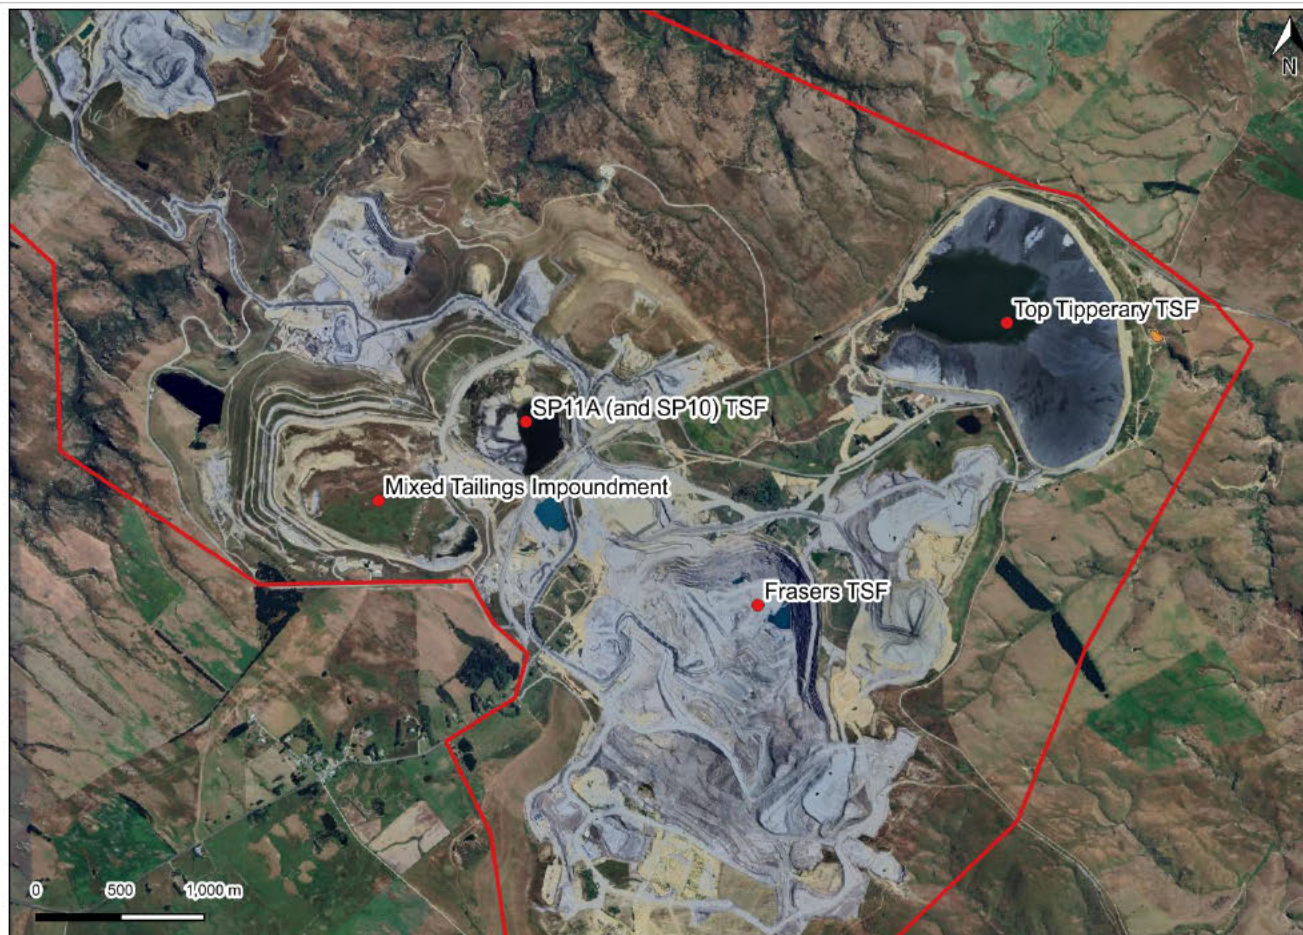
Figure 8. TSFs at Macraes Operation

TSFs generally have a robust system of water/leachate collection systems at their base, with underdrain water being collected for reuse in the Mine Water Management System to avoid uncontrolled discharge to the surrounding environment. Soils in contact with tailings leachate/water may become contaminated as a result.

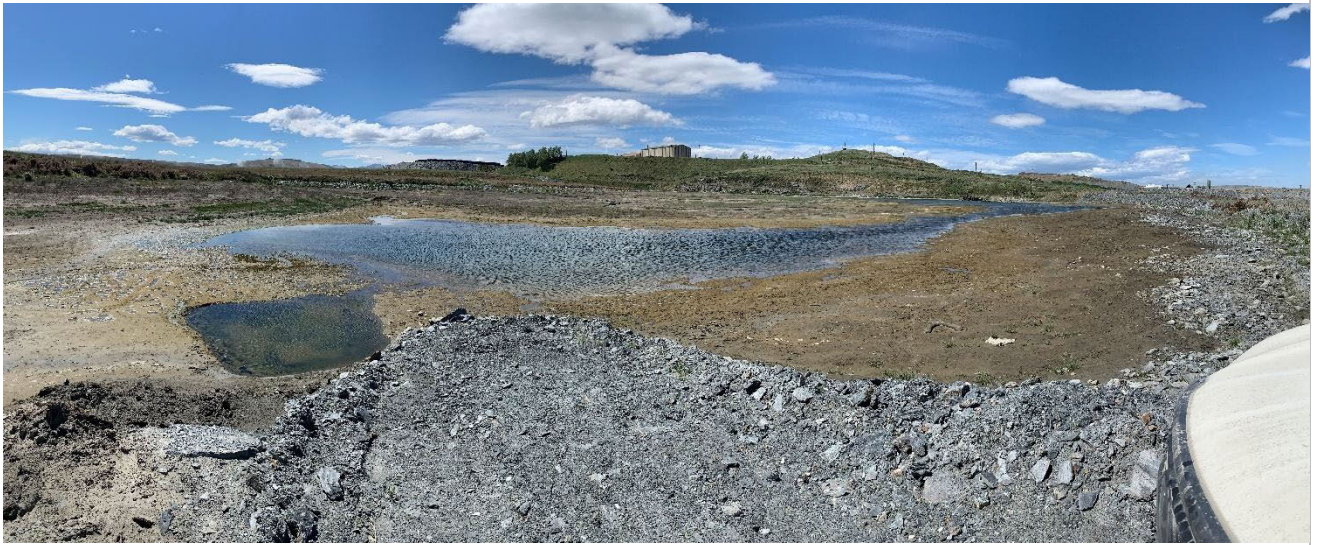
Photograph 6. MTI, looking toward the workshop

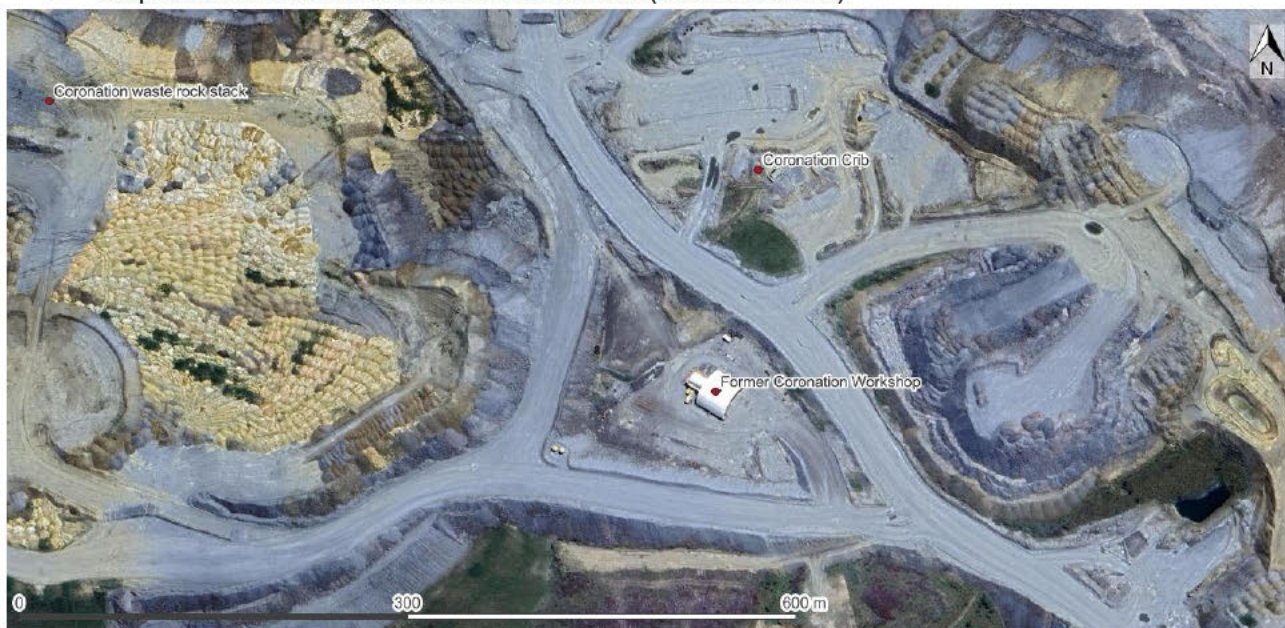
Figure 9. Coronation workshop and surrounds (image source: Google Earth)

- **The Coronation North workshop** is located in the north of the site (**Photograph 7; Figure 9**). The workshop serviced Coronation North Pit mining from 2019 to 2022. In 2025 mining in the Coronation North Pit recommenced and the workshop was reestablished. It comprises a container building with adjoining canopy and the following features.

- An oil catchment system, minor staining was visible around the system and the transfer lines (**Photograph 8**).
  - A parts washer was still on site along with miscellaneous parts and machinery.

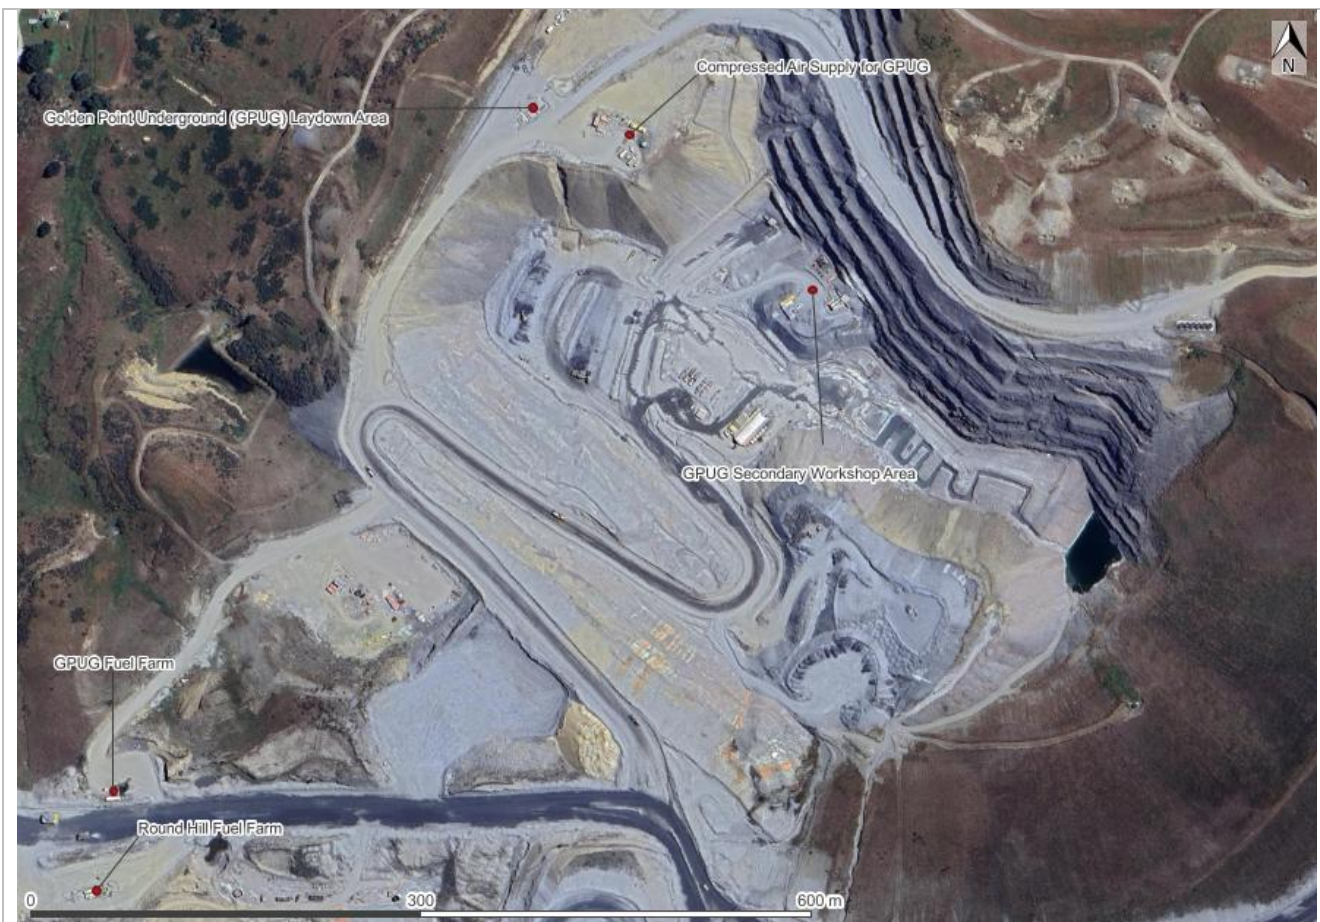
Figure 10. Golden Point secondary workshop and associated features (image source: Google Earth)

- **Secondary workshop at Golden Point** could not be accessed due to induction/permission requirements, but staff stated that only minor servicing occurs here, significant servicing work is undertaken at the main underground workshop (**Figure 10**).
  - The canopy and container building are constructed on a concrete pad with a small apron. It is assumed that typical workshop products such as minor fuels, oils, greases and solvents are stored here.
  - A truck washing area is located immediately east of the workshop and is used to wash vehicles prior to servicing. It includes sediment tanks for water treatment prior to discharge.

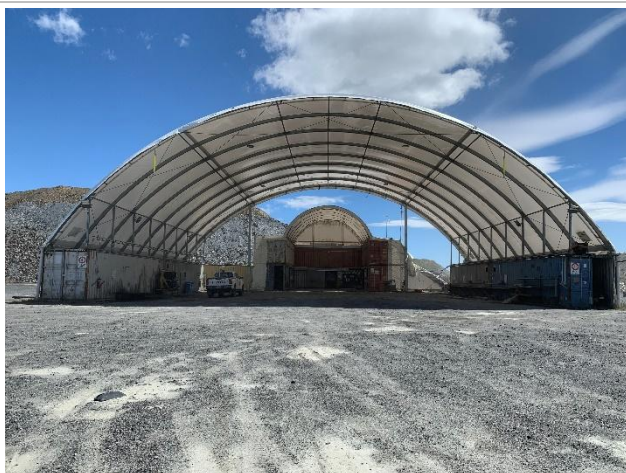
Photograph 7. Former Coronation Workshop

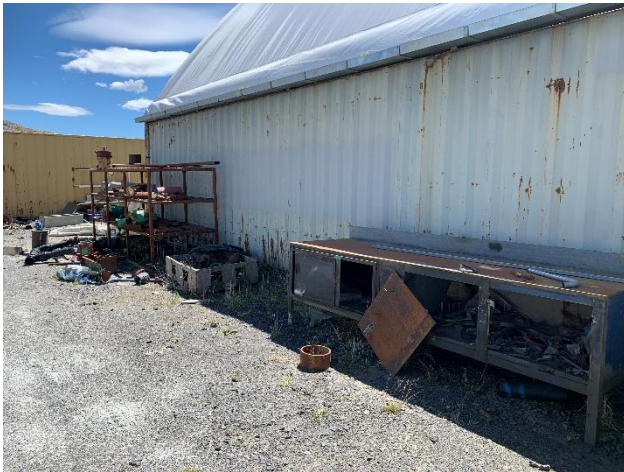
- Several bins/skips are present for waste disposal, as well as empty IBCs that had previously contained lubricants and fuel additives (e.g. Shell Tellus S3M, Adblue) (**Photograph 9 and 10**). We note that waste tyres are now (as of March 2026) being relocated to a tyre storage area, as per consents held under the National Environmental Standard for Storing Tyres Outdoors.

Photograph 9. Miscellaneous outdoor storage at Coronation workshop

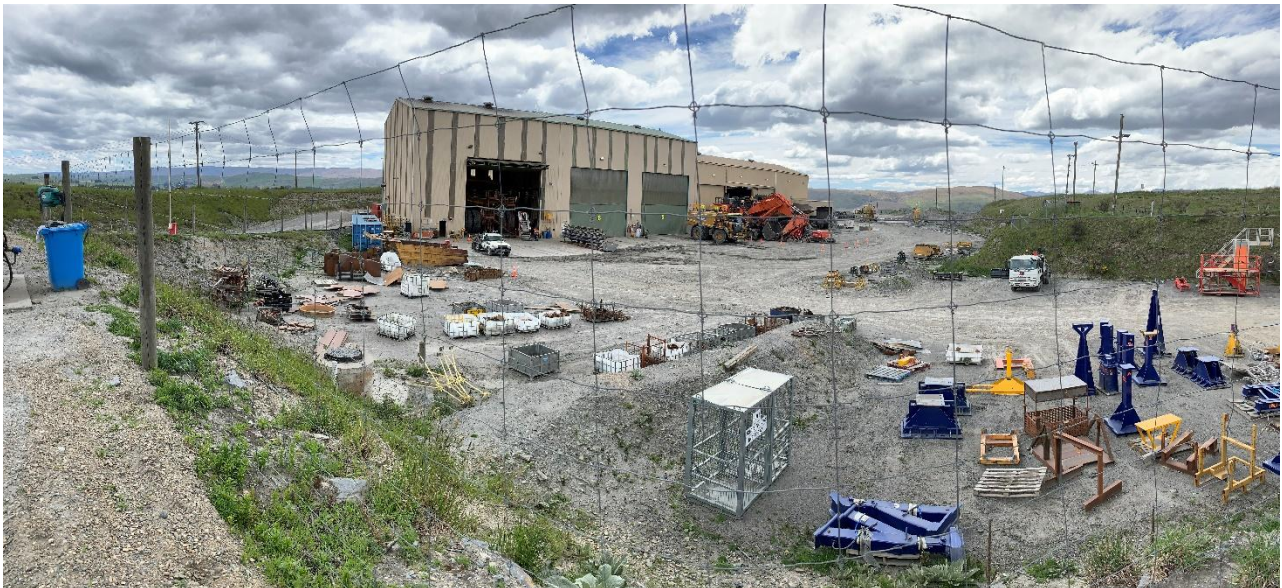
- **Mining workshop (also called the open pit workshop)** is located north of the underground workshop and is similar to the other workshops described above (**Photograph 11; Figure 11**). Key features and observations are:

Photograph 11. General view of main open pit workshop

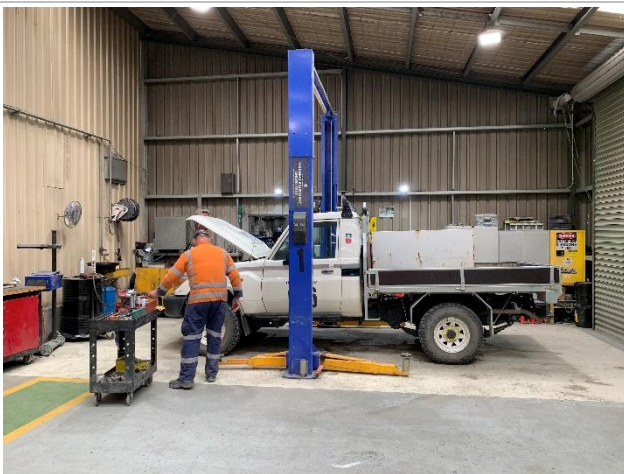
- Tidy indoor workshop areas (**Photograph 12**)
  - All bulk fuels, oils, etc are either stored in bunded areas or on/above concrete surfacing within the workshop buildings (**Photographs 13 and 14**).

Photograph 12. Tidy internal workshop areas

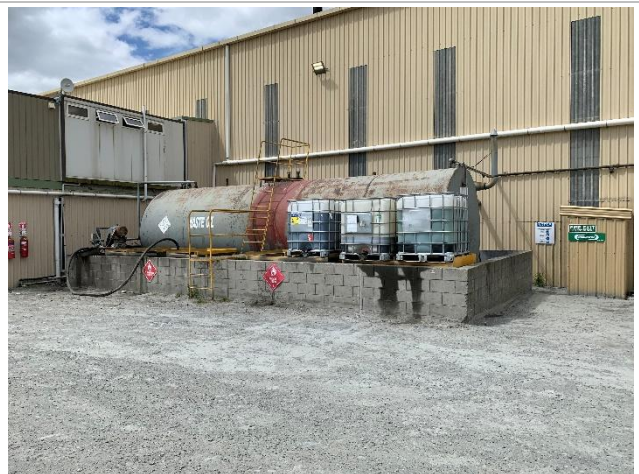
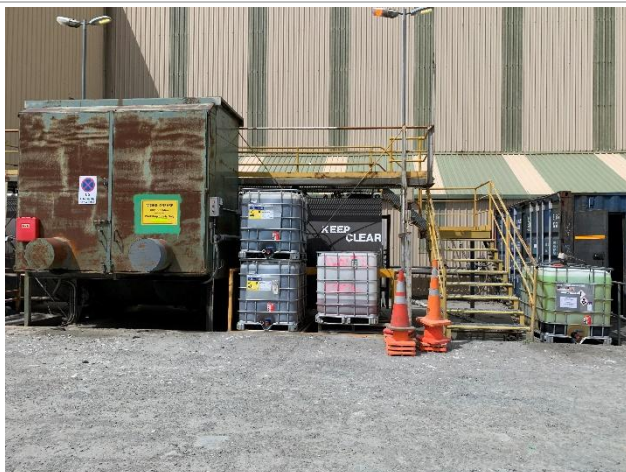
Photograph 13. Waste oil storage, banded

Photograph 14. Grease storage (left) and general storage (right) on banded concrete pad

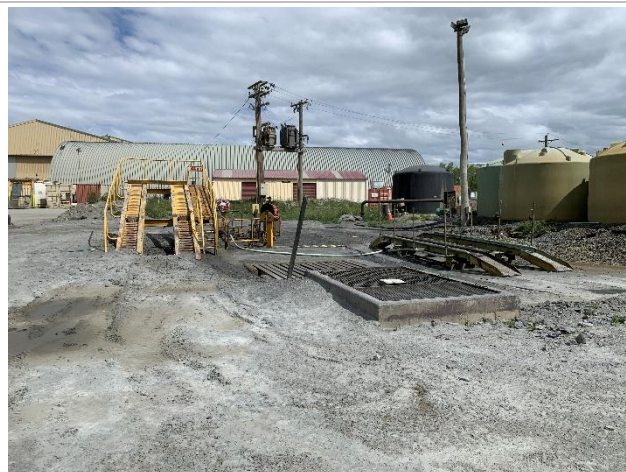
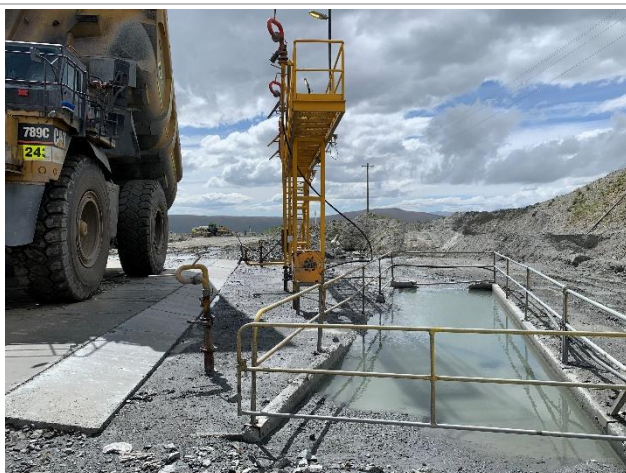
- Two truck washes are present – one for heavy vehicles (“HV”) and one for light vehicles (“LV”), (**Photographs 15 and 16**). Both washes have a sediment trap to which water drains for primary treatment. This water then drains to a combined oil-water separator that has been made out of a former truck tray (**Photograph 17**). Oil is skimmed and taken offsite periodically. Sludge/sediment from the sediment traps is allowed to dry out next to the HV wash then is disposed of offsite. This has previously been taken offsite to Green Island, and historically for short durations there has been disposal in Finger storage areas. All hydrocarbon waste is now taken offsite to a licensed disposal facility.

Photograph 15. Light vehicle wash area

Photograph 16. Heavy vehicle wash

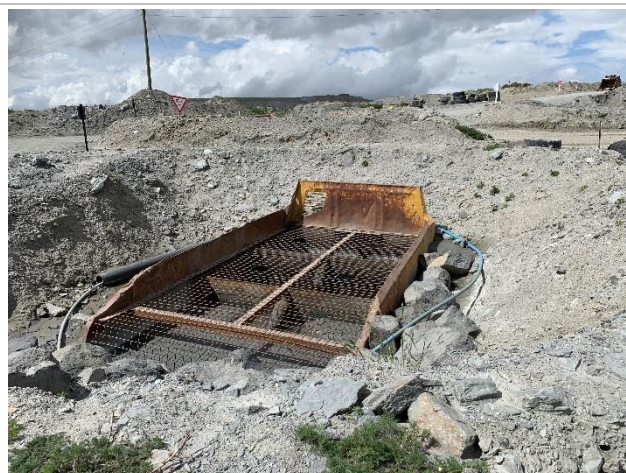
Photograph 17. Oil-water separator for both vehicle washes

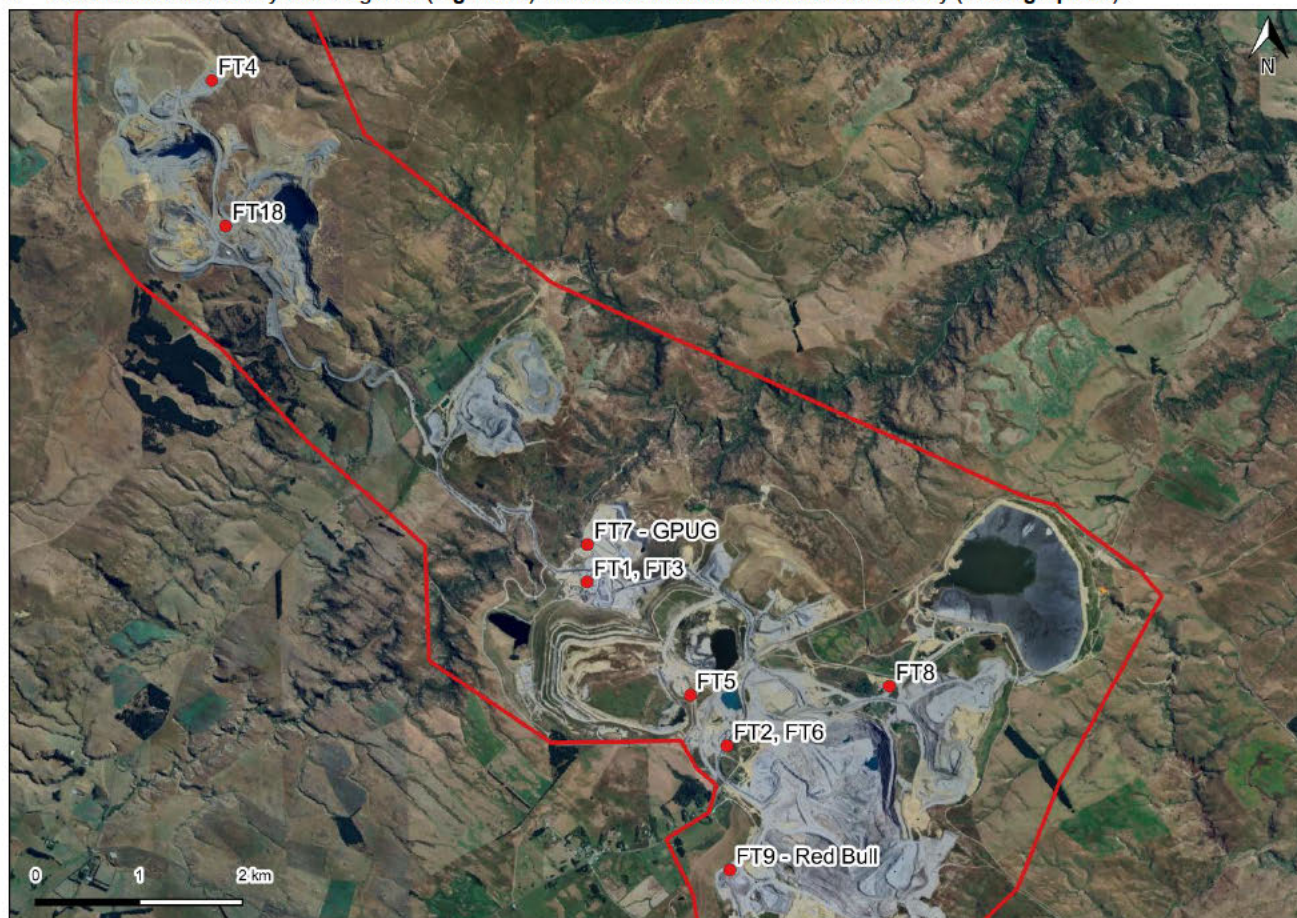
Figure 12. Fuel farms as of February 2026 (image source: Google Earth).

- Tanks are double-lined but generally do not have an external bund. Minor staining is typically visible around the bowsers from spills during refuelling (**Photograph 19**).

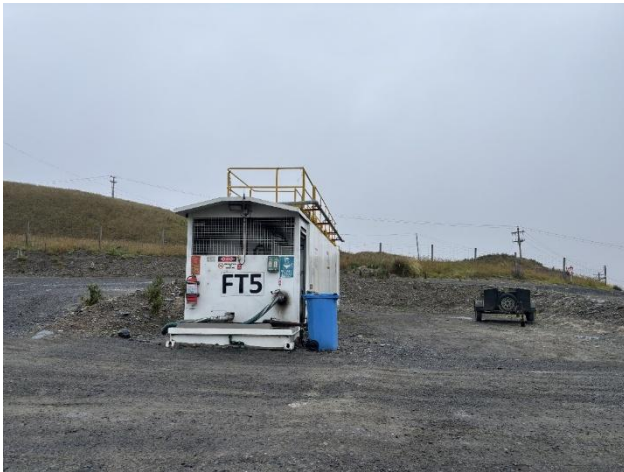
Photograph 18. Typical fuel farm set up at Vehicle Workshop

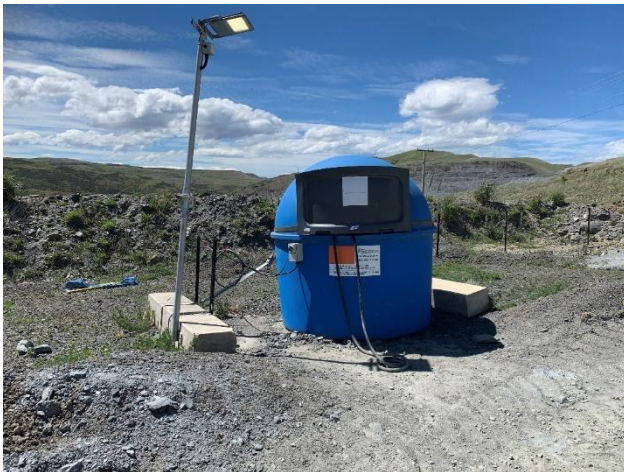
- Some fuel farms also have AdBlue and other fuel additives available for filling, such as at Golden Point Underground Fuel Farm (**Photograph 20**).
- An example of a typical former fuel farm is that which was observed during the site visit at Coronation Crib (**Figure 9**; noting this is now back in use) where only the gravel tank pad, electrical wiring and protective tyres remain. There was no evidence of residual staining at this former fuel farm (**Photograph 21**). Minor building waste, such as residual pipes, was also present at the former Coronation Crib.

Photograph 20. AdBlue filling station, Golden Point Underground

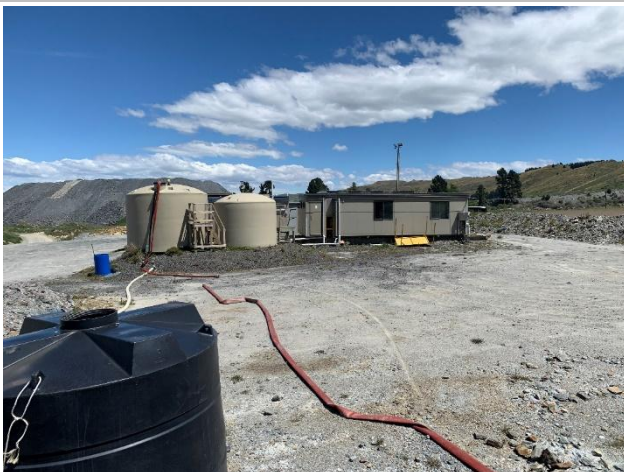
- Crib facilities typically comprise a small lunchroom and toilet facilities, either with a local septic system or a holding tank that is pumped out regularly by contractors (**Photograph 22**).

Photograph 22. Typical Crib set up at Deep Dell.

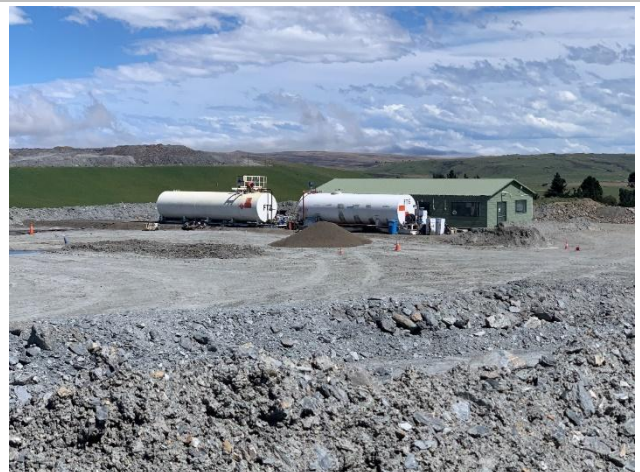
- The most modern facility is at Finger 19 (**Figure 11**). It has two tanks and a modern Crib facility (**Photograph 23**).

Photograph 23. Finger 19 fuel farm and crib

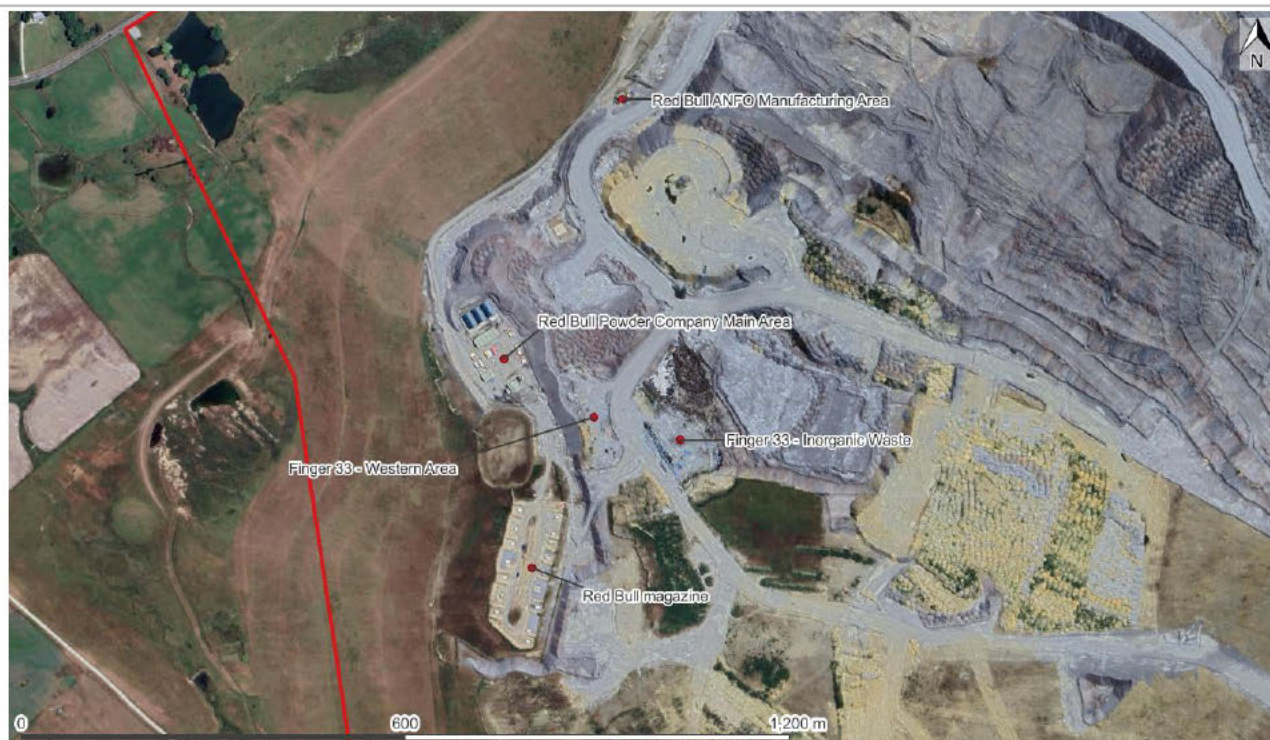
Figure 13. Finger 33 and Red Bull facilities (image source: Google Earth)

- Finger 33 was previously used for waste storage area for the underground operations. Material stored included vent (duct) bags, tyres, core and proof drilling samples, steel rock anchors/bolts and mesh. It was observed during the site visit that some of the materials had been buried under the western portion of the platform. This has now been largely remediated, with removal of waste and disposal to a licensed landfill ongoing. Updated photos provided by OGNZL as of March 2026 are provided as **Photographs 27 and 28**.

- The majority of the wastes stored in the fingers is inert and therefore a low contamination risk, but it was noted that waste grease drums are located at Finger 33 and are not banded or covered and localised hydrocarbon staining was observed.

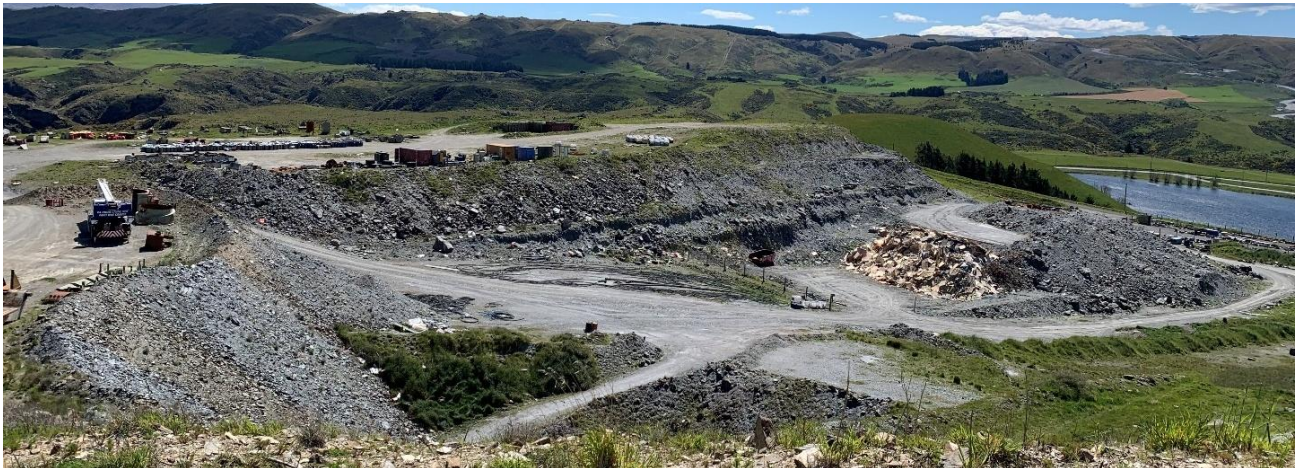
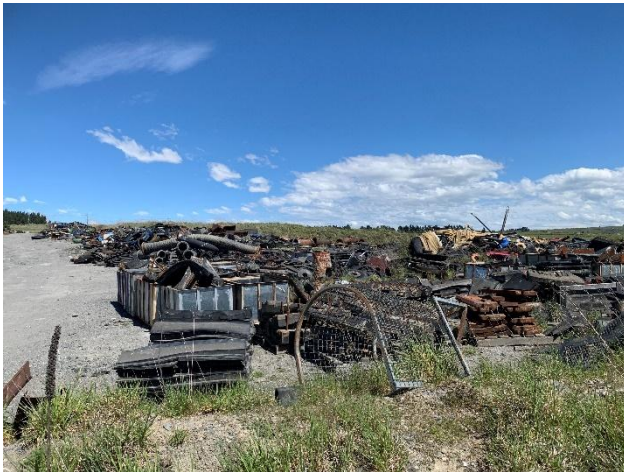
- General wastes are stored in these areas, including spent drums, IBCs, wire, plant/equipment, etc (**Photograph 26**). Many of the drums and IBCs at Finger 13 were noted to be full of used Granular Activated Carbon (“GAC”) from the processing plant; it was expected that this would be re-processed through the plant. Some of the IBCs contained liquid, assumed to be water mixed with the original contents of the IBC. WWLA understands that as of March 2026, remediation of Finger 13 is underway.

Photograph 24. General overview of Finger 13 and Burnables

Photograph 25. Reusables at Finger 13

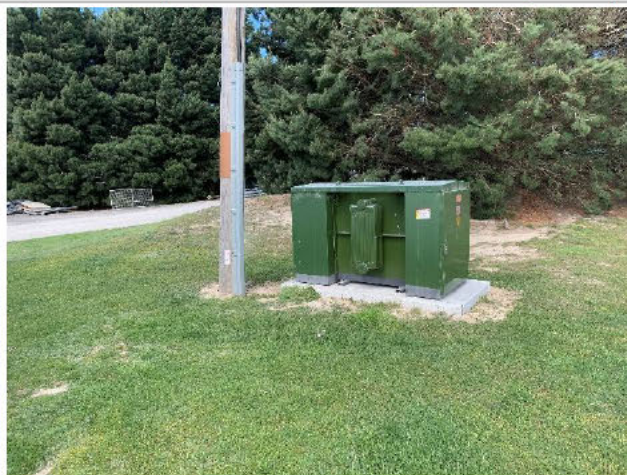
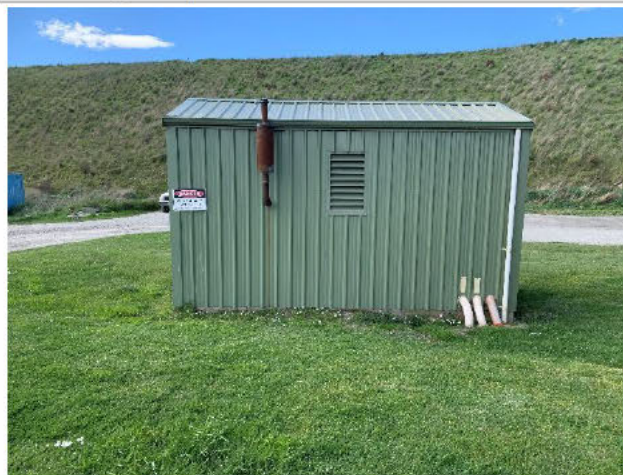
- A transformer and backup diesel generator are located adjacent to the main office/administration area (Photographs 29 and 30). These are typical of several such features around the wider mine site. They are generally modern and in good condition with no staining evident, although the diesel shed was locked and its interior could not be inspected.
- Golden point substation is located south of the main office building. It is bunded and drains to a holding tank. Overflow was being directed to ground at the time of the inspection and is presumably only used during maintenance activities (Photograph 31 and 32).

Photograph 29. Transformer next to office, typical of those on site

Photograph 30. Backup generator building next to main office

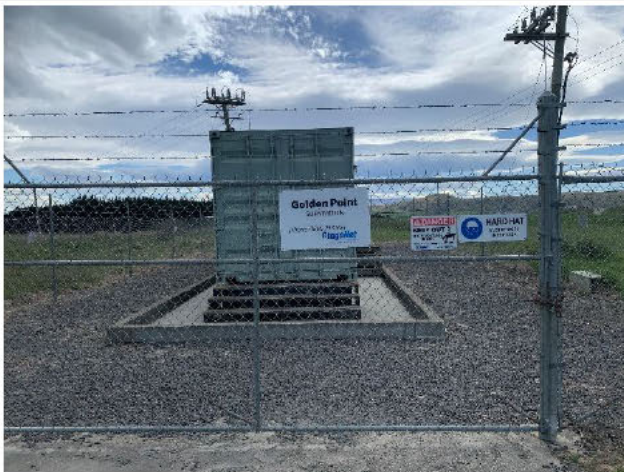
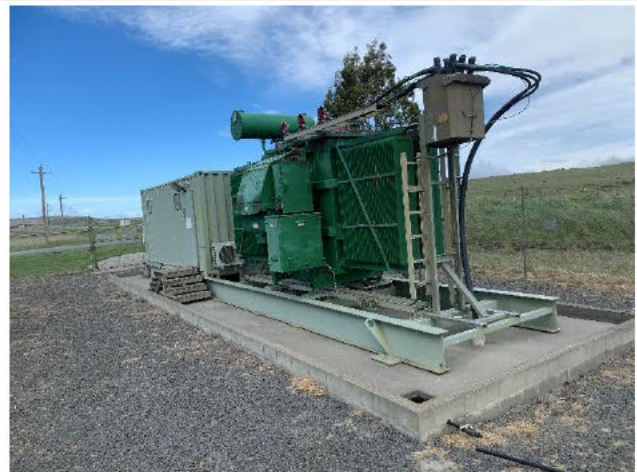
Photograph 30. Golden Point Substation

Photograph 32. Golden Point Substation

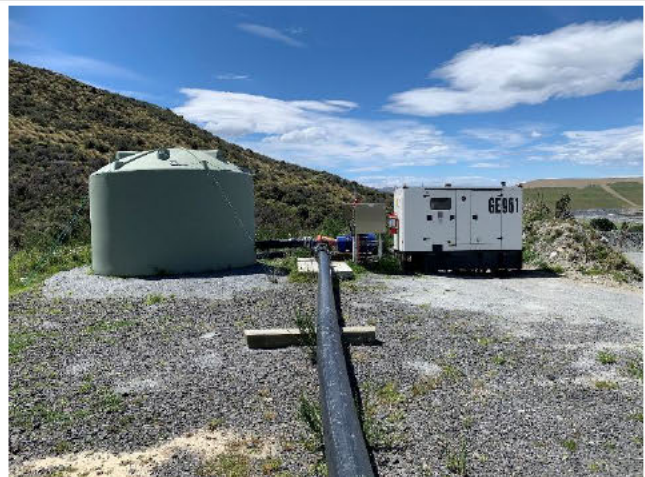
- A diesel generator which runs an electric pump (**Photograph 33**). Refuelling is undertaken using a mobile tank fitted on a ute.
- A large water holding tank and associated valving and pipework.

Photograph 33. Typical pumping station set up

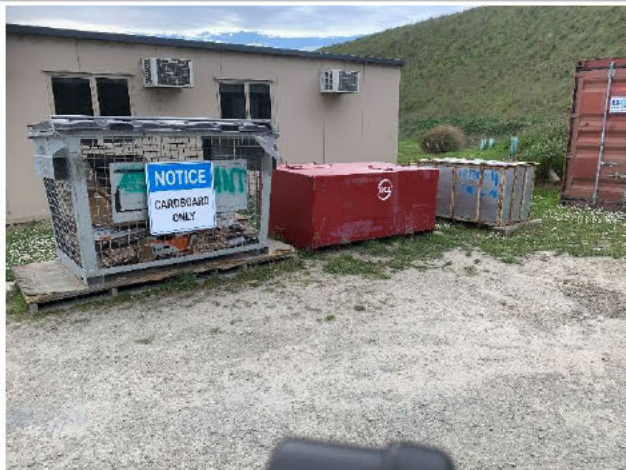
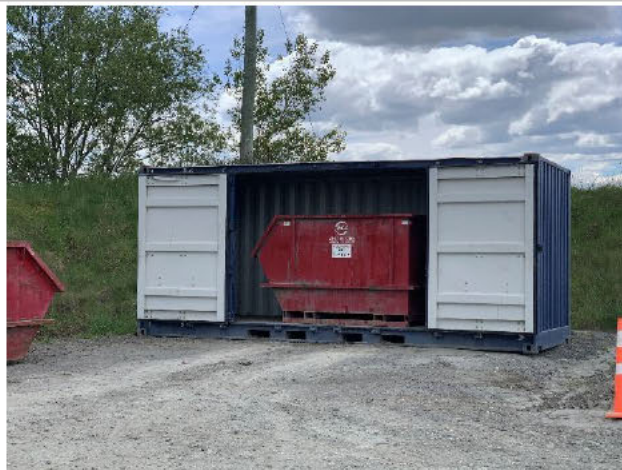
A variety of waste collection facilities are located throughout the mine. These all appeared to be tidy and well managed at the time of the inspection. Facilities used for collection of liquid and hazardous wastes were observed to be covered. Whitestone Contracting Limited provide skips, bins etc. and collect the wastes for disposal offsite.

Photograph 34. Example of waste collection at the main office

Photograph 35. Example of covered hazardous waste collection area

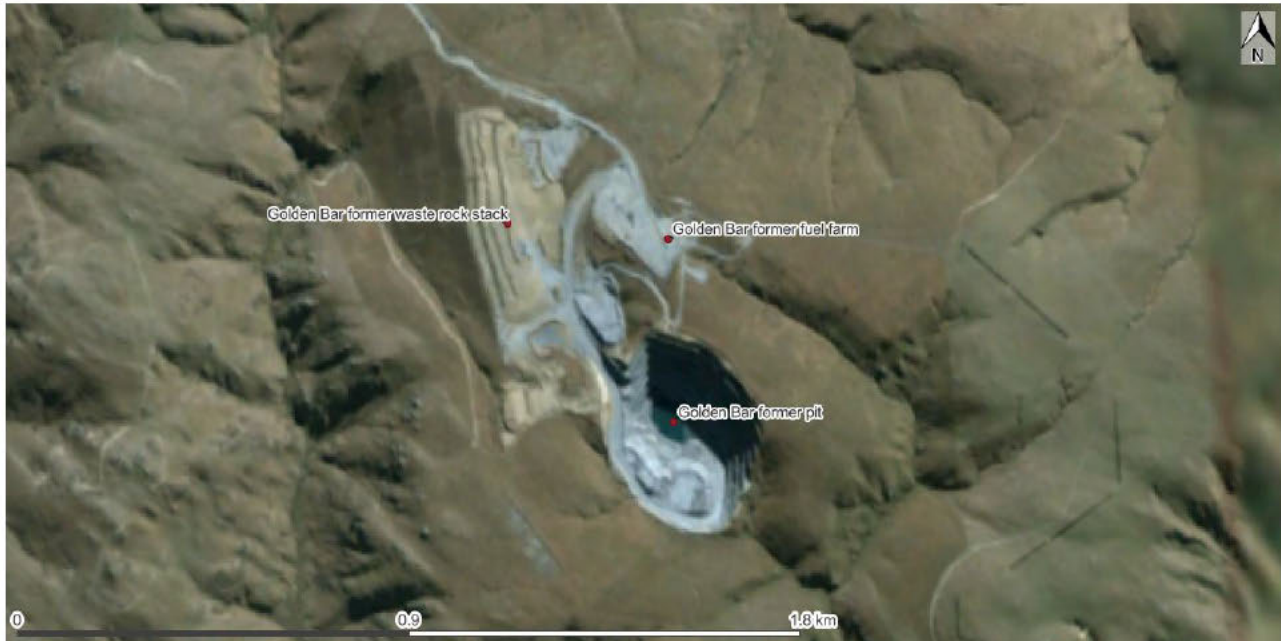
Figure 15. Golden Bar former mining area (historical features shown as per 2007 Google Earth Imagery)

Golden Bar mine is located approximately 5 km south of the Frasers complex at the main Macraes Mine as illustrated on **Figure 2**. This area was mined in the early 2000s with a small open pit, associated waste rock stack and a fuel farm.

- The current surface expression of the mine comprises a lake within the former open pit and a graded and grassed waste rock stack as shown on **Figure 15**.
- Key site features at the time of mining are indicated by the 2007 aerial image (described further in the aerial review in **Section 3.1**) are shown below.

In addition to the historical fuel farms shown below, another historical fuel farm was visible in aerial imagery at the former Golden Bar open pit to the south of the main Macraes complex. Refer to **Figure 15**.

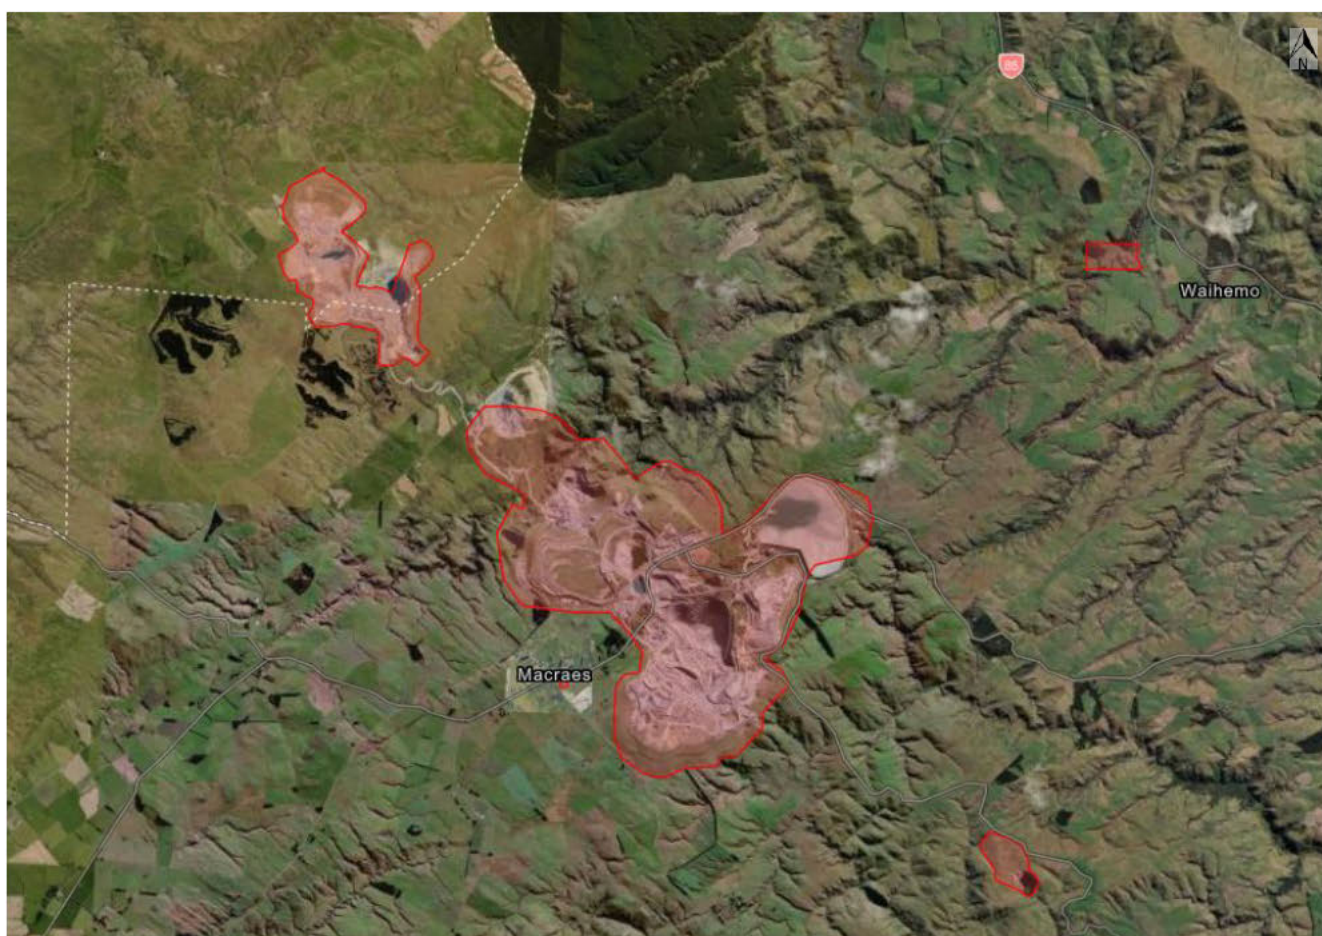
Figure 17. Extract from ORC HAIL register.

Otago Regional Council's (ORC's) Selected Land Use Sites (or SLUS) Register<sup>5</sup> was searched in March 2026 to obtain an understanding of its classification and knowledge of the site and surrounds. ORC lists the three portions of the Macraes Operation on its register, being the Coronation Section, the central portion (Fraser's, the processing area), and the Golden Bar pit to the south (refer Figure in **Appendix A2**), as shown in Figure 17.

All three areas are tagged as HAIL Activity E7: Mining Activities, with all being "verified" HAIL activities but none having any records of investigations being carried out.

The smaller areas to the west and east (distal) of the mine are identified as Macraes Flat Landfill and Cooks Transport Depot Fuel Storage (west) and potential timber treatment at Shag Valley Station timber mill (east). The Cooks Transport site has been remediated. Neither of these are known to be connected to mine activities or have any impact on the MP4 Project.

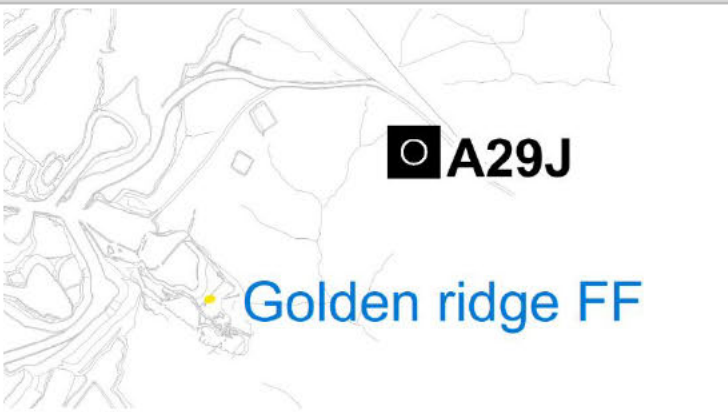
| Name | Refer location in yellow<br>Note: Survey locations are black squares, current fuel locations in orange and green and permit boundary as blue line |
|---|---|
| Golden Ridge | |

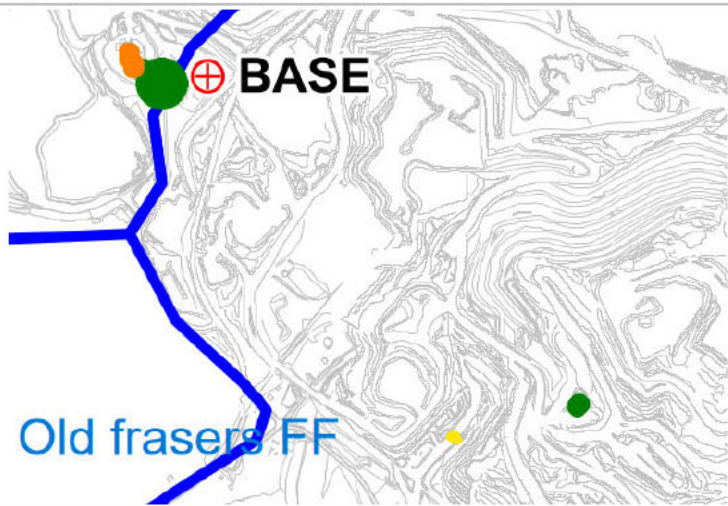
| Name | Refer location in yellow<br>Note: Survey locations are black squares, current fuel locations in orange and green and permit boundary as blue line |
|---|---|
| Old Frasers | |

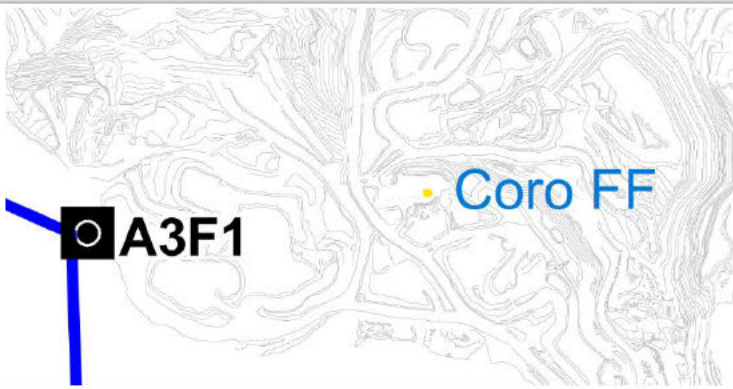
| Name | Refer location in yellow<br>Note: Survey locations are black squares, current fuel locations in orange and green and permit boundary as blue line |
|---|---|
| Coronation | |

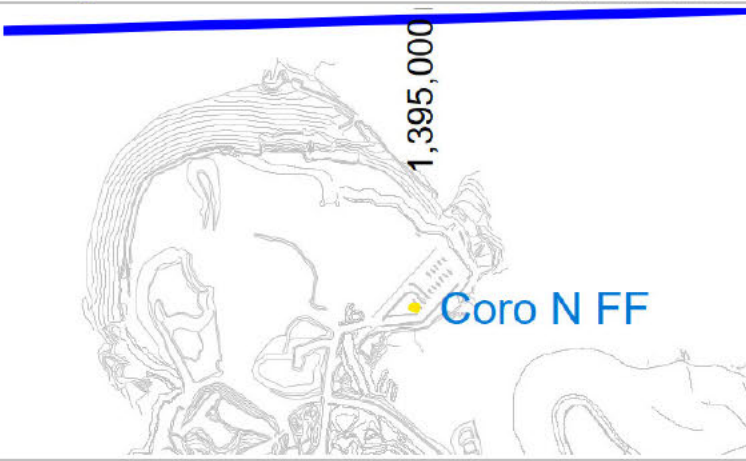
| Name | Refer location in yellow<br>Note: Survey locations are black squares, current fuel locations in orange and green and permit boundary as blue line |
|---|---|
| Coronation North | |
