# **Macraes Operation**

## **Preliminary Site Investigation (Ground Contamination)**

OCEANA GOLD (NEW ZEALAND) LTD

WWLA1659 | Rev. 0

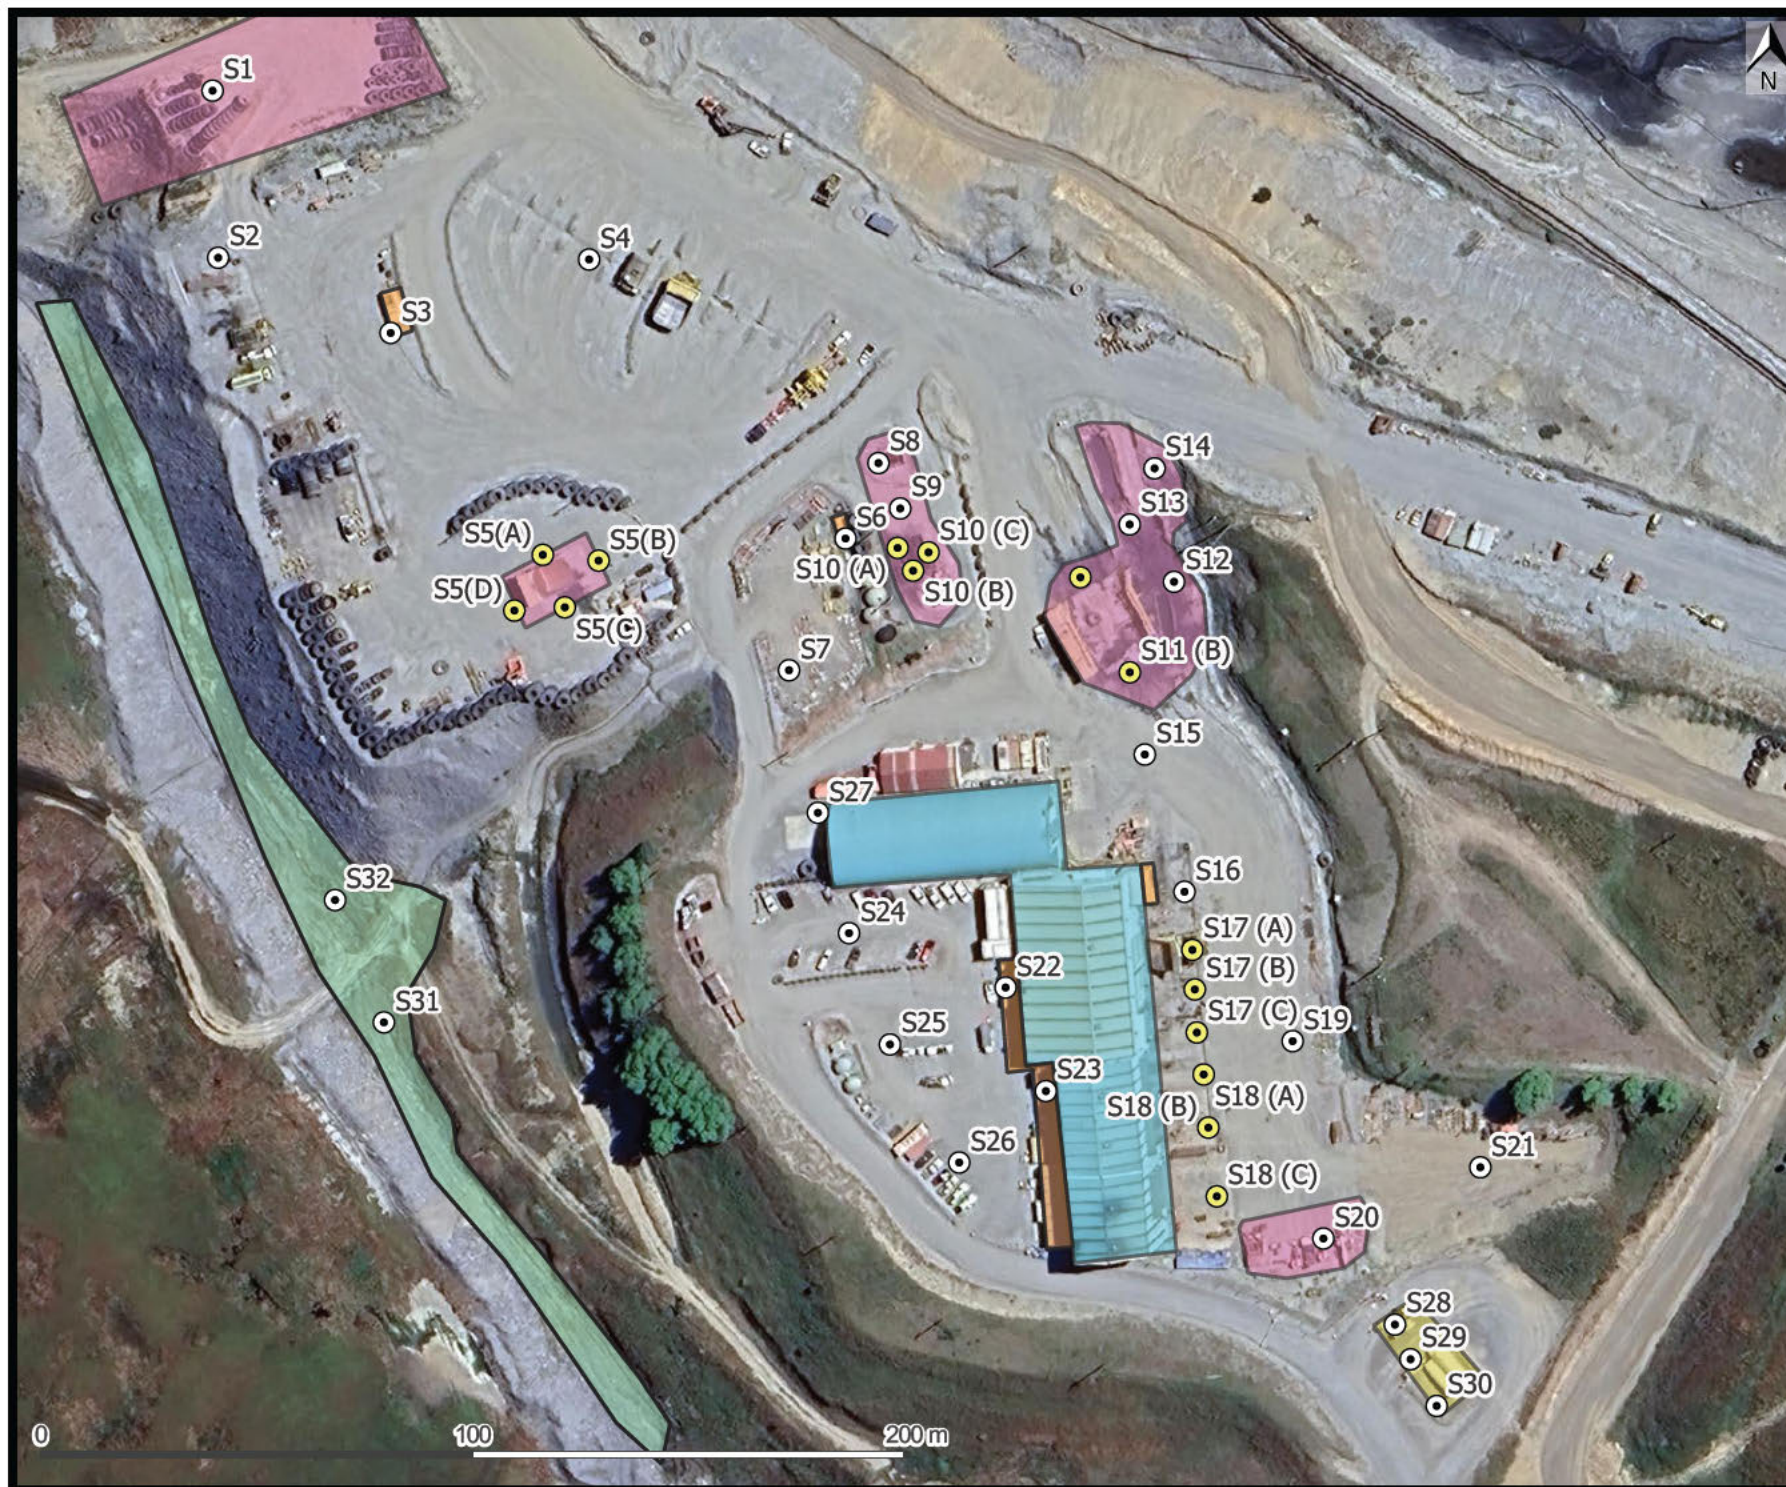
Map Title:  
**Sampling Locations**

| Operational activity | Proposed investigation (contaminants, areas, strategy) |
|---|---|
| Mining Workshop<br>(partially complete) | <ul style="list-style-type: none"> <li>Both discrete and composite sampling recommended for the Mining Workshop as it is proposed to be relocated. Nature of sampling relates to the site features observed (e.g. discrete sampling at discharge points, composite may be appropriate at apron edges).</li> <li>Testing for metals, hydrocarbons. Solvents adjacent to solvent storage and use.</li> <li>Also testing of sumps at wash bays and discharge drains etc that receive workshop runoff.</li> </ul> |
