Geotechnical Appraisal Report

Land Exchange Belmont Quarry
Development Project

Job Reference: BGL000252 v1.0

Report prepared for: Winstone Aggregates

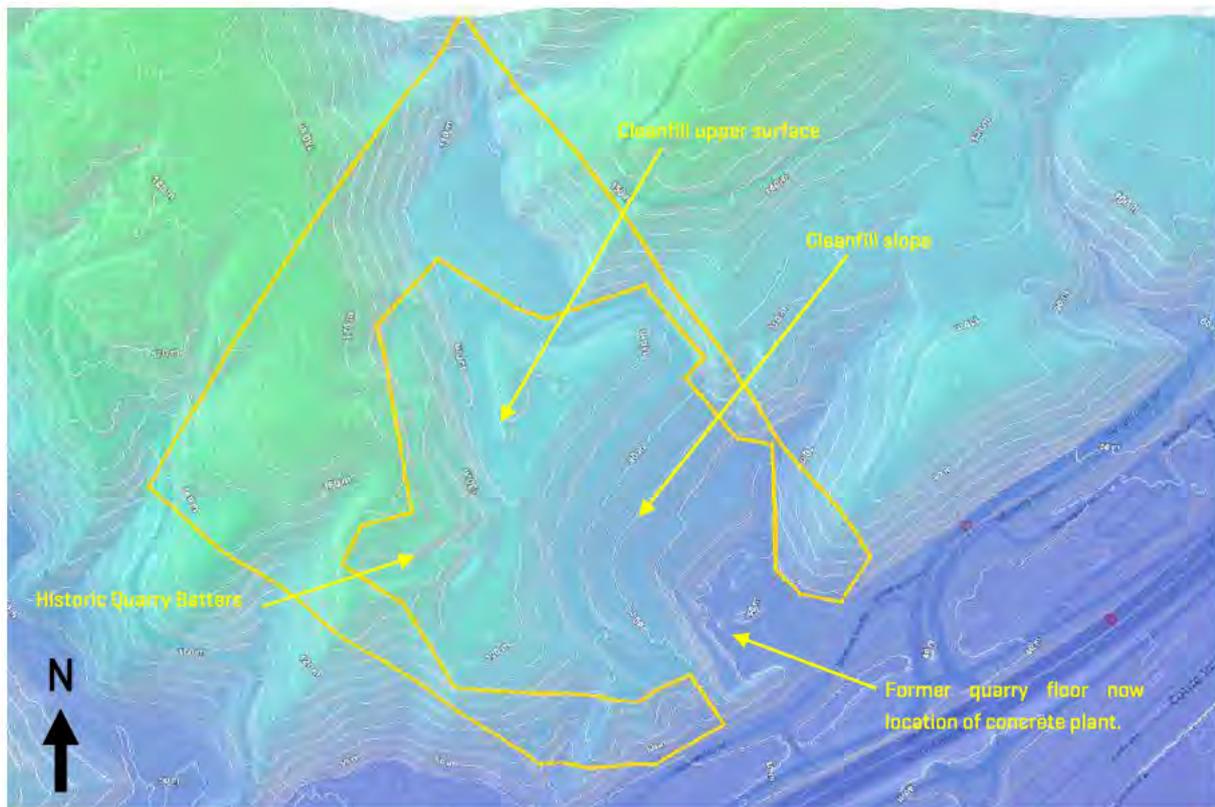
Figure 4-1: Lidar data for Dry Creek Site and exchange boundary shown indicatively [source: Winstone Aggregates Propeller Site].

The cleanfill has been developed within a northwest to southeast orientated gully with adjacent ridges extending to an elevation of approximately RL 180 m. The cleanfill extends across the gully mouth terminating against the western and eastern slopes. The base of the cleanfill slope, is at approximately RL 50 m, with the crest of the existing cleanfill at approximately RL 120 m [Figure 4-1].

The remnant quarry batters range from 7 m high to approximately 20 m high with a batter angle of 65 to 75 degrees. Remnant benches and ramps range from 6 m to 10 m wide. The former quarry topography is clearly evident in recent lidar survey of the site [Figure 4-1].

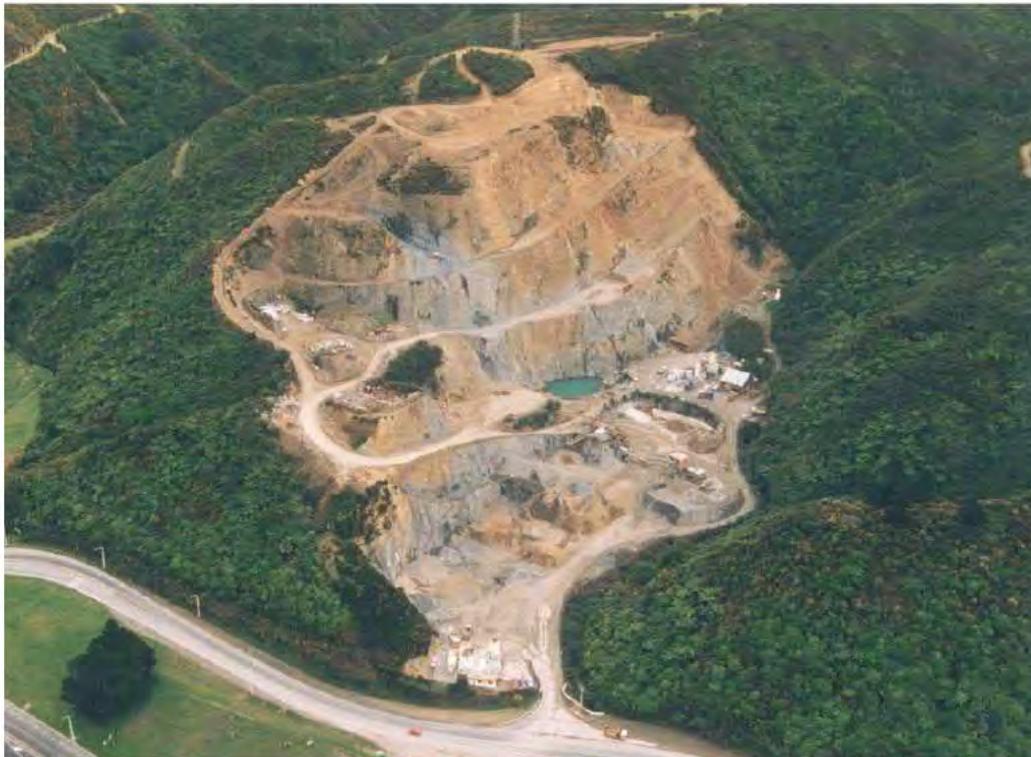
Figure 4-3: 1992 oblique photograph [image supplied].

A quarry that potentially dates to the early 1940's previously occupied the site [Figure 4-2]. Based on an oblique photograph from 1992 [Figure 4-3], the quarry extraction process over this 50 to 60 year period excavated into the western slopes of the gully forming a series of benches and batters. The quarry exposed unweathered rock in the lower slopes and weathered rock in the upper slopes.

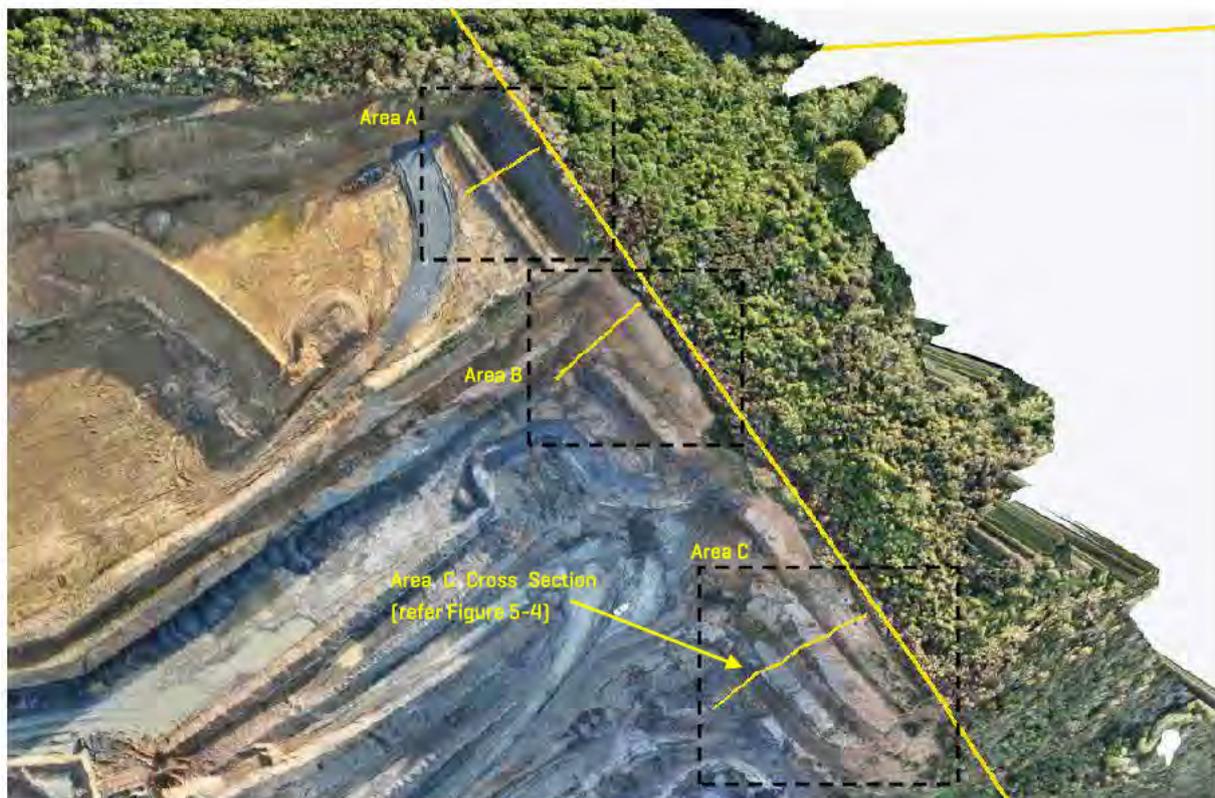
Figure 5-3: Belmont East wall abutting the Firth Block.

There are three key areas adjacent to the boundary where cut batters have been developed, as set out in Figure 5-3.

The key defects in the face are west to east striking bedding, which dips very steeply towards both the north and south. Bedding is defined by thin seams of dark grey argillite.

A localised area of slope failure has occurred at the far southern end of the cut batters in this area. This appears to have occurred in an area of deeper weathering of the greywacke, but also where the batters were rotated around to become more northwest-southeast trending as a tie-in to the ground surface. This change in geometry has allowed failure to occur on steep bedding, orientated oblique to the slope with breakout through the highly weathered rock mass. The instability extends through the upper two batters, with debris spilling onto the benches below. It is not clear whether this instability extends into the proposed land exchange area.

Based on our observations in this area, we consider that a 6 m zone measured from the crest of the slope back into the proposed land exchange area presents a higher risk of instability than would normally be accepted for a final cut batter adjacent to a property boundary. The basis for this zone is a hypothetical bench batter geometry of 10 m high batter slopes at 45° separated by a 5 m wide bench, which could be expected to perform acceptably in the materials observed.

While instability could be expected to develop slowly in this area due to residual strengths on defects in the weathered zone, if this zone is included in the land exchange, it would be prudent to exclude people from this area. This could be achieved by erecting fencing positioned a minimum of 6 m from the crest of the quarry batters in this area.
