# SH 67 Granity Ngakawau LCSIA

Bathurst Resources Limited

August 2026

**SH67 Granity Ngakawau (1395) LCSIA**

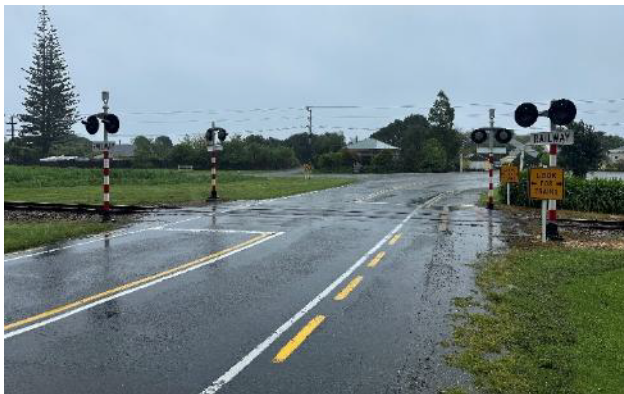
Figure 3-3: Southern approach to the level crossing from Torea Street

The level crossing is controlled by duplicated FLBs provided on both approaches. Both the primary and secondary FLBs face the approaching the north and south lanes of SH67 as seen in Figure 3-3 and Figure 3-4. FLBs are visible from both approaches only after navigating the first of the reverse curves in each direction. This means the advanced warning signs act as the primary indicator to a motorist that a level crossing lies ahead on the road.

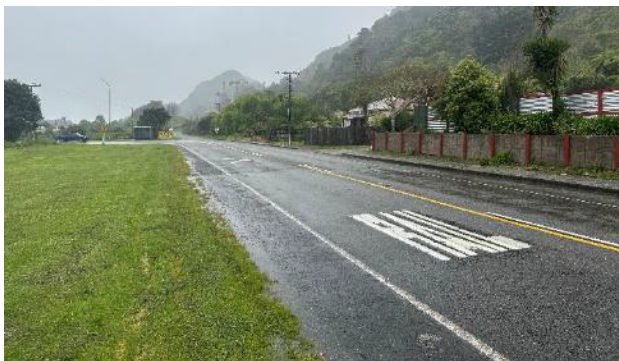
Figure 3-19: Rail X markings from southern approach

Figure 3-19 and Figure 3-20 show the 'Rail X' road markings from the southern and northern approaches to the level crossing.

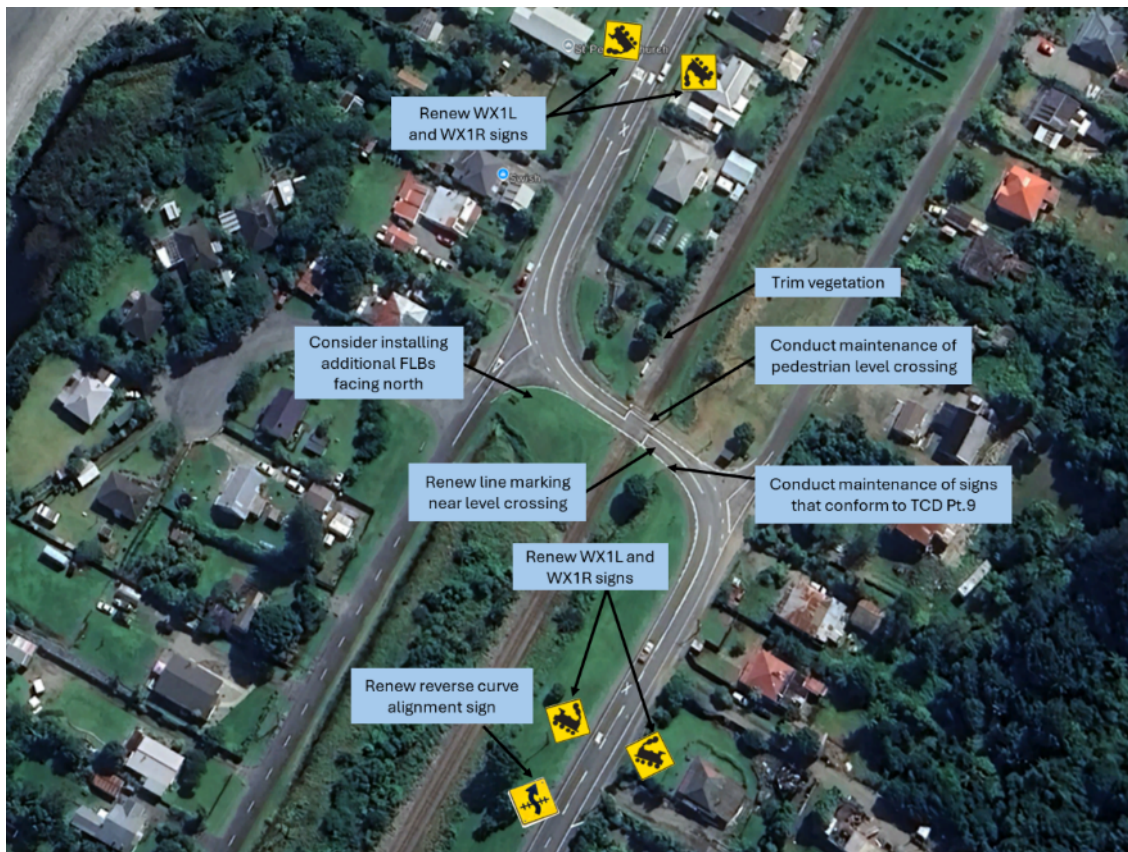
Figure 3-27: Recommendations for the SH67 Granity Ngakawau road level crossing

| Safety Recommendation | Necessity |
|---|---|
| Although not directly a level crossing issue, the reverse curves in the road only exist because of the level crossing. A couple of crashes have occurred with vehicles leaving the road, therefore there needs to be a review of what else can be done (despite the presence of side roads) to increase the visibility of the curves | |

The recommendations to improve safety at the road level crossing are outlined in Table 3-2. Figure 3-27 shows how these changes would look in an aerial view. The column on the right states the level of necessity of the recommendation from the following list:

| Safety Recommendation | Necessity |
|---|---|
| <b>9. Improve delineation of the curves on the level crossing approaches</b> | |
