Memo

Date: 19 March 2026

Subject: **Tekapo B Power Station tailrace weir and chute – condition assessment and review of bathymetric survey data**

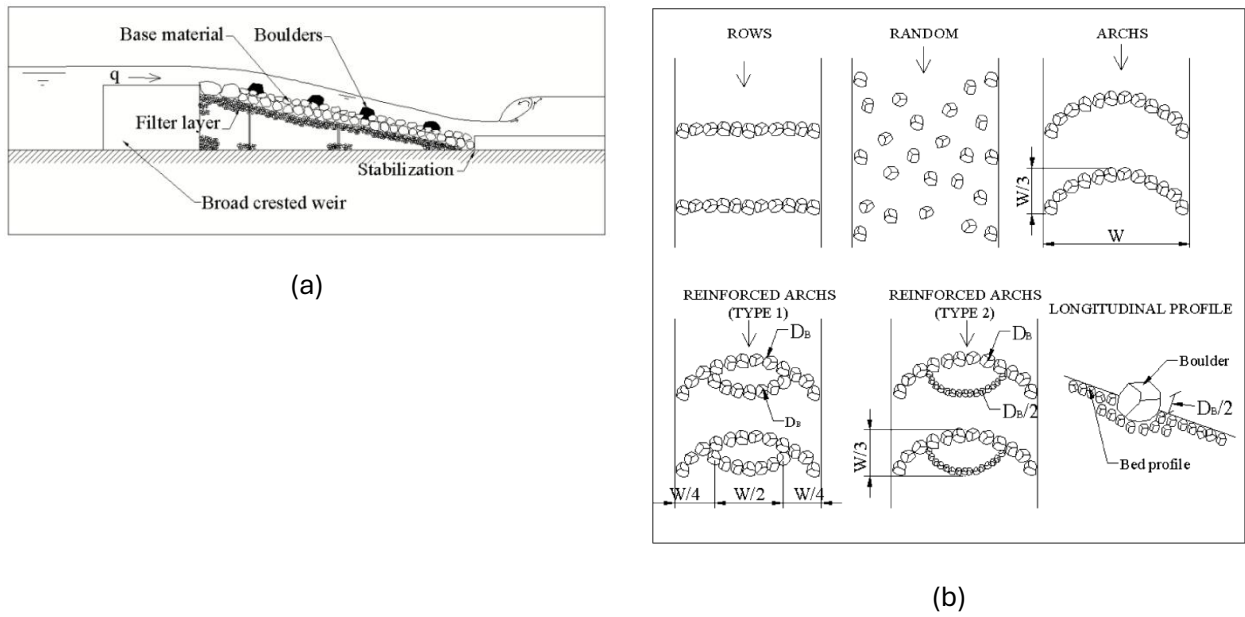
Figure 3: Experimental setup for investigation of block ramp failures: (a) schematic drawing of block ramp model and (b) alternative boulder reinforcement arrangements

Pagliara and Chiavaccini (2007) carried out further experimental investigations of the morphological evolution of block ramp failures for ramps with different bed slopes (1 in 4, 1 in 8 and 1 in 12) and reinforcement configurations. Figure 3(a) shows a schematic drawing of the experimental setup while Figure 3(b) shows the different reinforcement configurations using larger boulders than the base material used to form the ramps. The model block ramp setup was stabilised at the toe to prevent the formation of a scour hole in the channel bed which would undermine the toe and cause an unravelling failure of the ramp to develop.

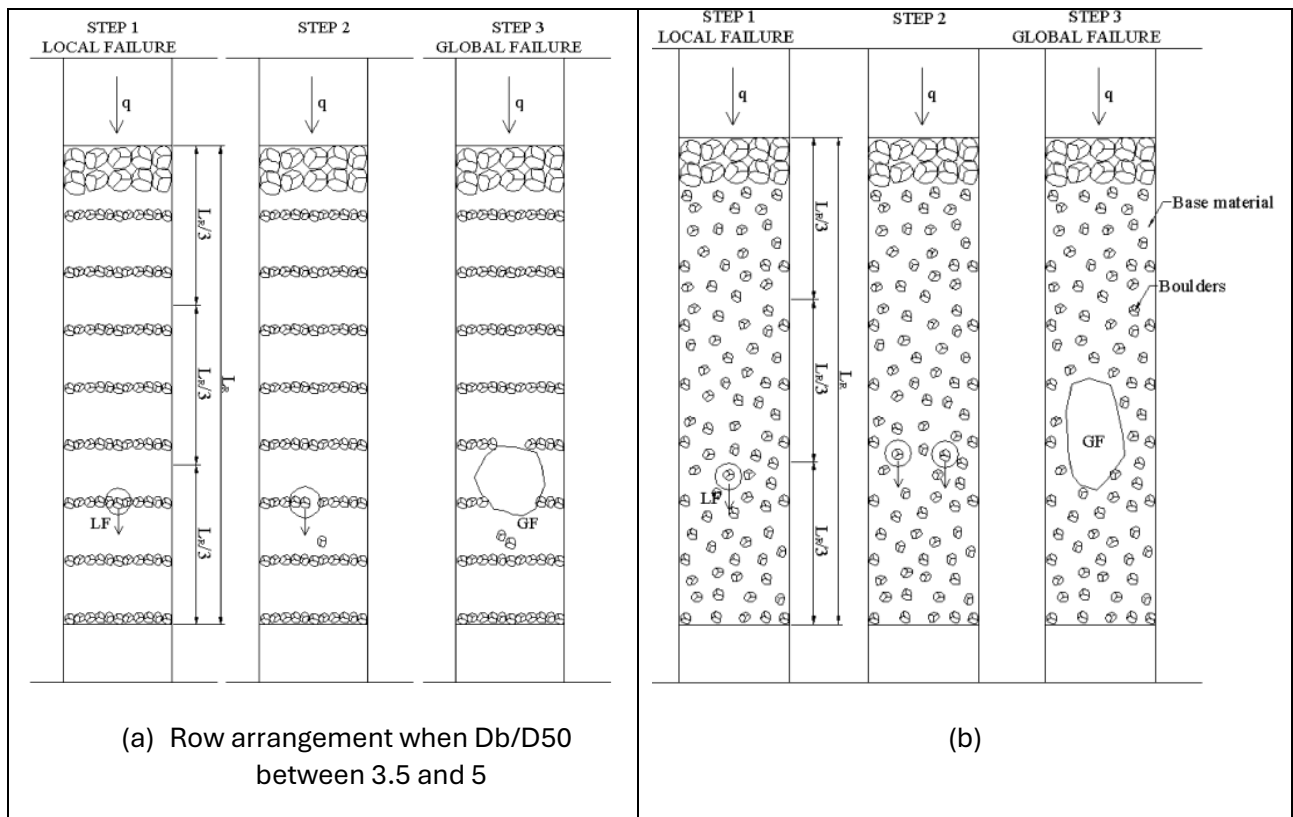
Figure 4: Failure mechanisms for (a) boulder row and (b) random boulder placement configurations in rock ramps

- In the model block ramps, local failures of the large reinforcing boulder rows occurred (see Figure 4(a)) whereas such failures cannot occur with the concrete sills on the Tekapo B tailrace weir and rock chute structure.

- In the model block ramps, the local failures of the large reinforcing boulder rows lead to a global failure of the base material between the rows (see Figure 4(a)). If the reinforcing boulder size was small enough, the global failure in the model block ramps was observed to extend longitudinally across several rows of reinforcement boulders.

- On the Tekapo B tailrace weir and rock chute structure, a local failure only of the riprap paving layer between the concrete sills could develop if the threshold flow for riprap stability was exceeded. If the excessive discharge occurred for a long duration, the local failure could develop into a bigger scour hole as in the global failure pattern for a random boulder reinforcement arrangement for the model block ramps (see Figure 4(b)). However, any global failure would be confined by the concrete sills.

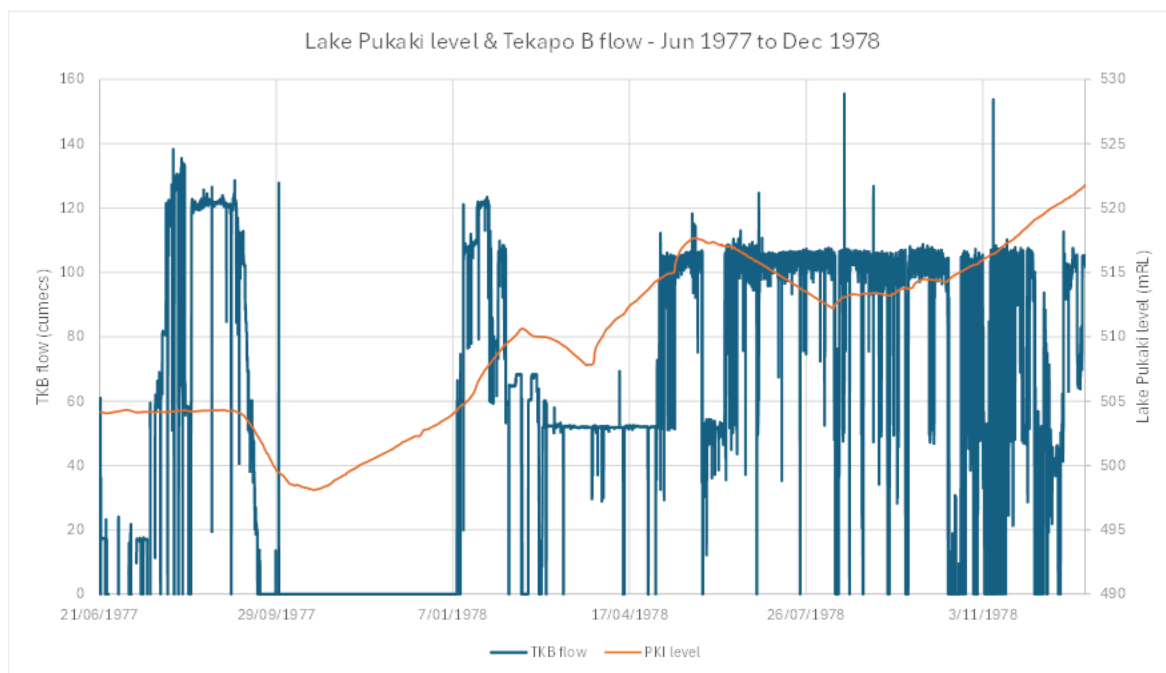
Figure 5: Tekapo B Power Station outflow and Lake Pukaki level from June 1977 to Dec 1978

After the two scour hole repairs were completed, the temporary tailrace weir and rock chute structure continued to function as an energy dissipation structure from January to November 1978 until the level of Lake Pukaki exceeded RL 518 m and fully drowned the structure (see Figure 5). Over this 11-month period, the tailrace weir and rock chute structure showed no further evidence of any local or global failures of the riprap lining between bays. The operation instructions for the structure (MWD, undated-b) required flow over the control weir and down the rock chute to be observed at least three times daily when operating for any “*erosion, unusual turbulence, unsymmetrical flow, bypassing of the formed channel, or any other abnormal condition*”. The operation of the structure while its was functioning as an energy dissipation facility was therefore rigorously observed.

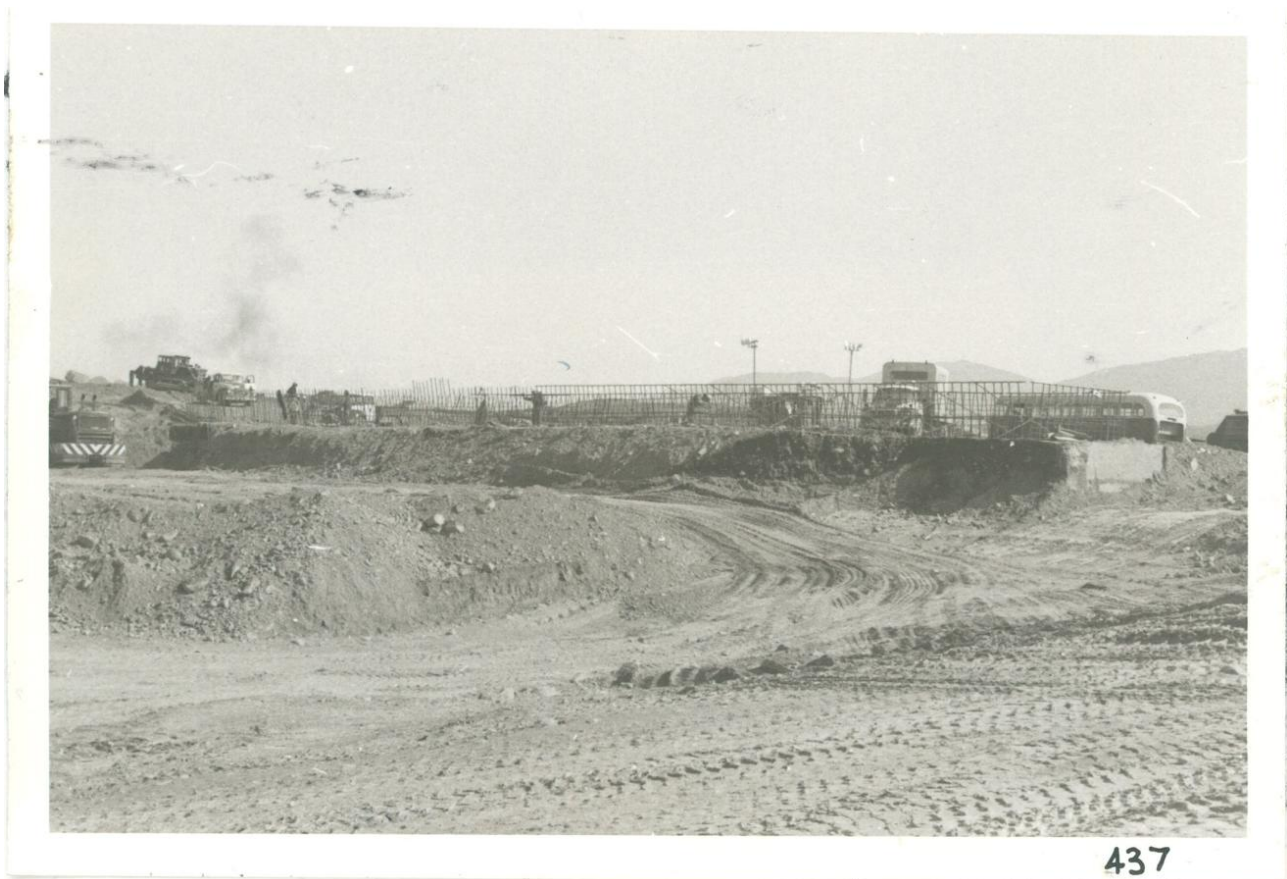
Figure 10: Weir construction – bars spaced at 1’0” centres with no vehicle passage

The steel reinforcement bars acting as dowels (1¼” dia. bars at 1’0” centres for the control weir and 3’0” centres for the sills) between the two stages of concrete provide structural continuity across the joint (refer Figure and Figure). In the absence of this continuity (e.g. a complete loss of dowel strength and bond between the two stages of concrete), the second lift would be expected to behave as an independent “rigid body” subject to hydraulic actions from flow and boulder impact in the longitudinal direction (e.g., riprap displacement under flow).

A vehicle passage left in the middle of the channel of the sills (not the control weir), was later filled with second-stage concrete that would provide the action of a shear key, but only in the transverse direction. The shear strength of the joint in the longitudinal direction would be provided by the combination of steel dowels, joint roughness, and bond between the first and second stages of concrete placement.

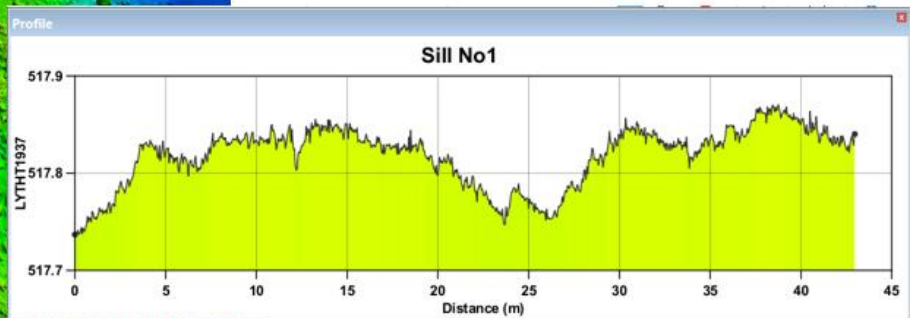
- From MBES Survey = 517.75 – 517.86
- From As Built Plan = 517.85

Note: Sill is not completely flat – see profile

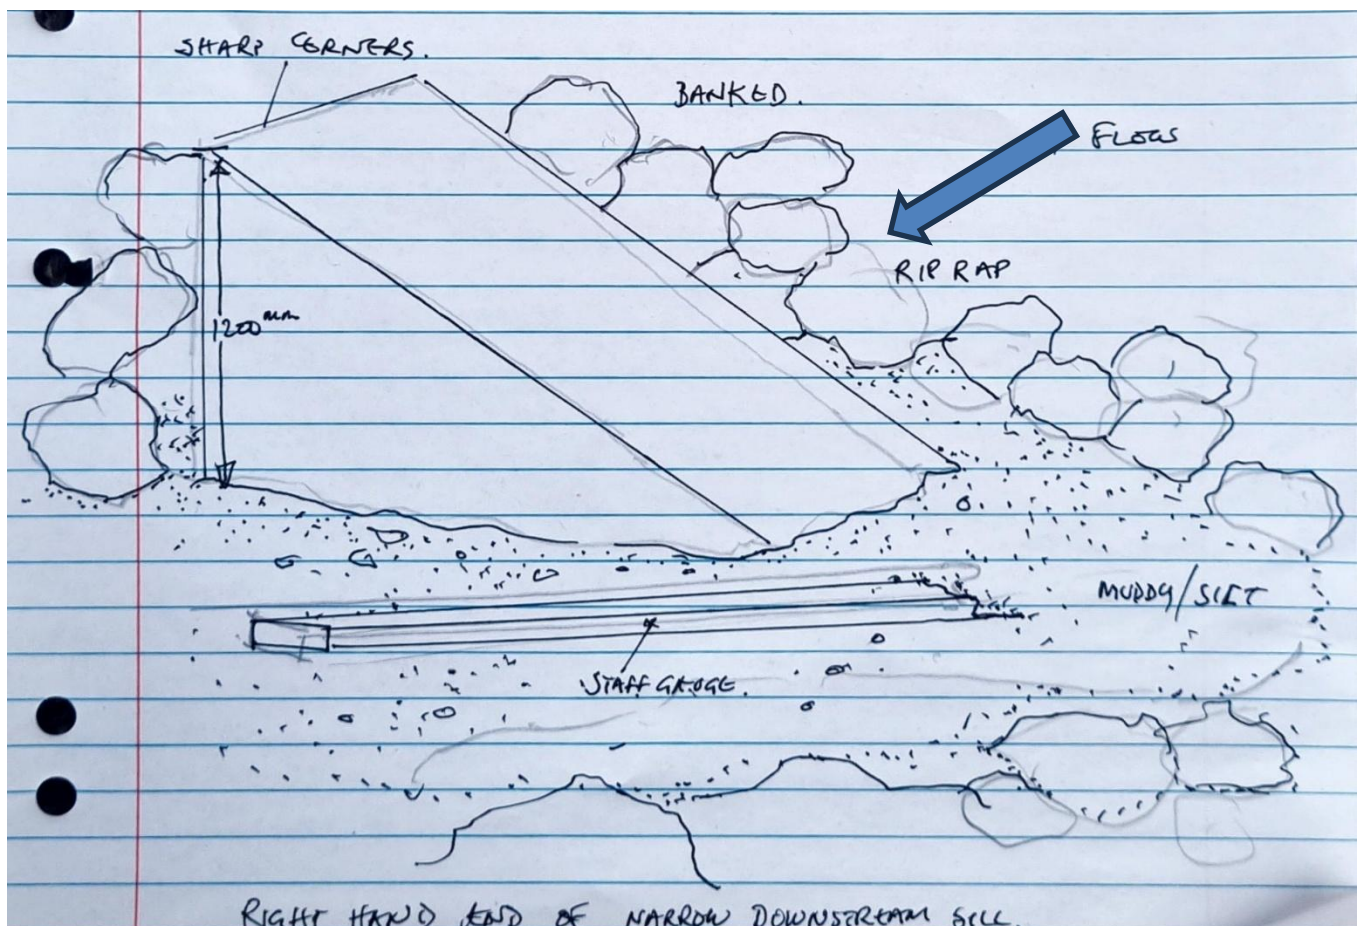
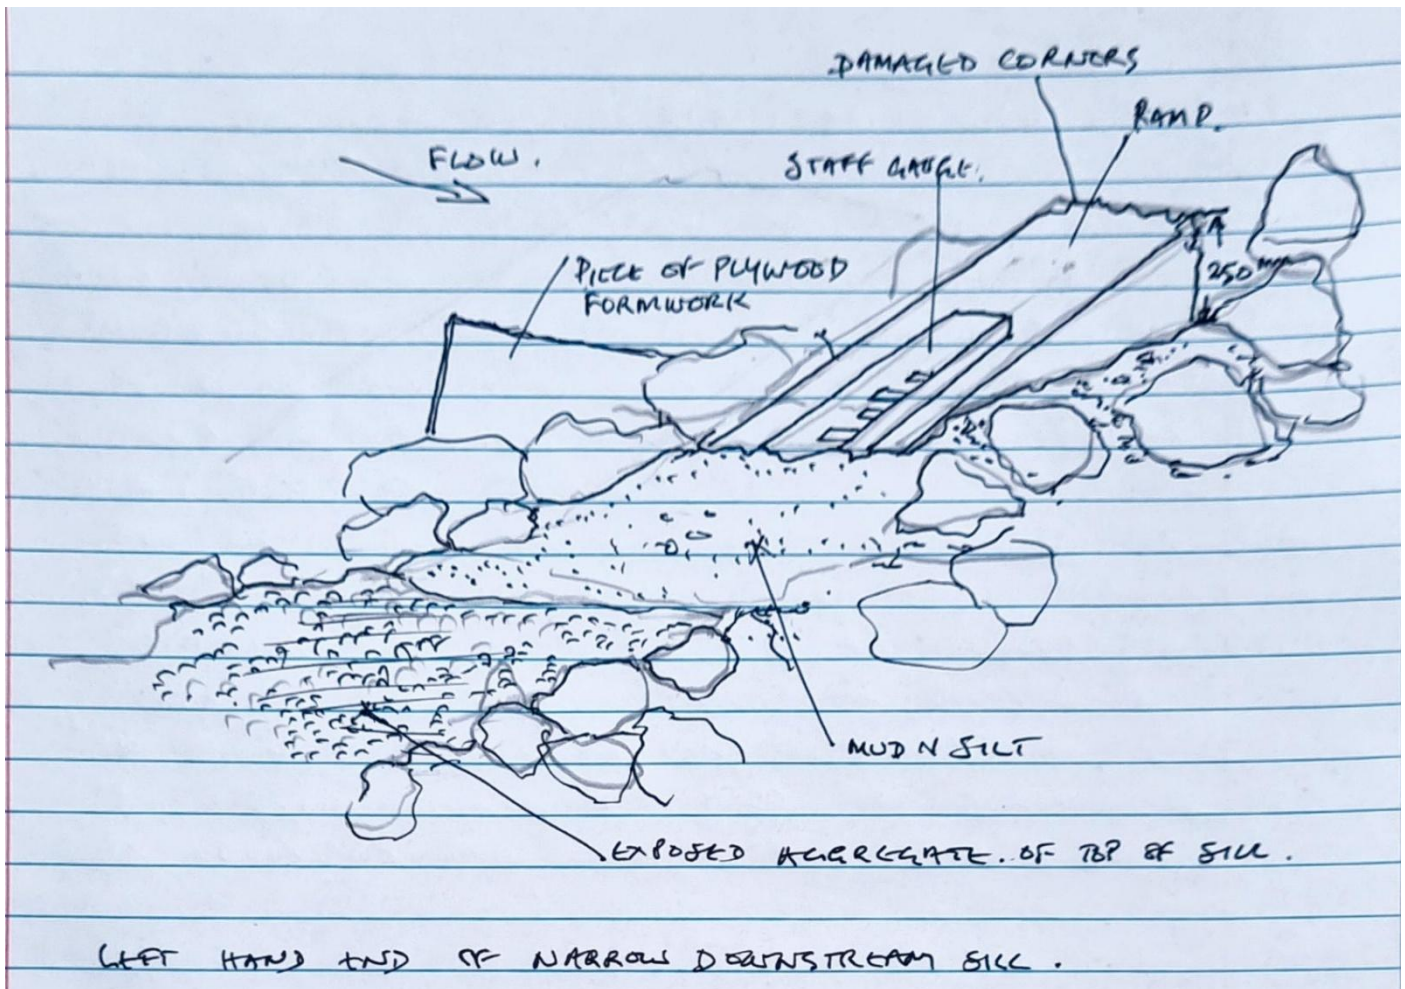
On the right, the top of the ramp is 800 millimetres above ground and the corners are sharp and unbroken.

An inclined wooden staff gauge is attached to the 45° angle. The bottom of the ramp and staff gauge are buried in mud and riprap.
