## Technical Advice – Water Engineering - by Mark Groves

Date	30.03.2026
To	Trinity White, Environmental Manager – South Island Renewables, Genesis Energy
From	WSP New Zealand Limited
Project advice provided for	Fast-track Application for Lake Pukaki Hydro Storage and Dam Resilience Works
Documents referred to	WSP, 2025 “ <i>Tekapo B Weir Assessment Summary Memo</i> ” WSP, 2026 “ <i>Tekapo B Weir Assessment Memo Addendum</i> ”
Qualifications and experience	ONC, HNC Civil Engineering. Chartered Engineer (CPEngNZ). 28 years of experience.
Code of Conduct	As an expert witness I have read, and I am familiar with, the Code of Conduct for expert witnesses contained in the Environment Court Practice Note 2023. This memorandum has been prepared in compliance with that Code. In particular, unless I state otherwise, this response is within my area of expertise and I have not omitted to consider material facts known to me that might alter or detract from the opinions I express.

**To:** Andrew Balme  
**From:** Jeremy Robertson  
**Office:** Taupō  
**Date:** 19 December 2025  
**File/Ref:** 2-38161.00  
**Subject:** Tekapo B Weir Assessment - Summary of Findings

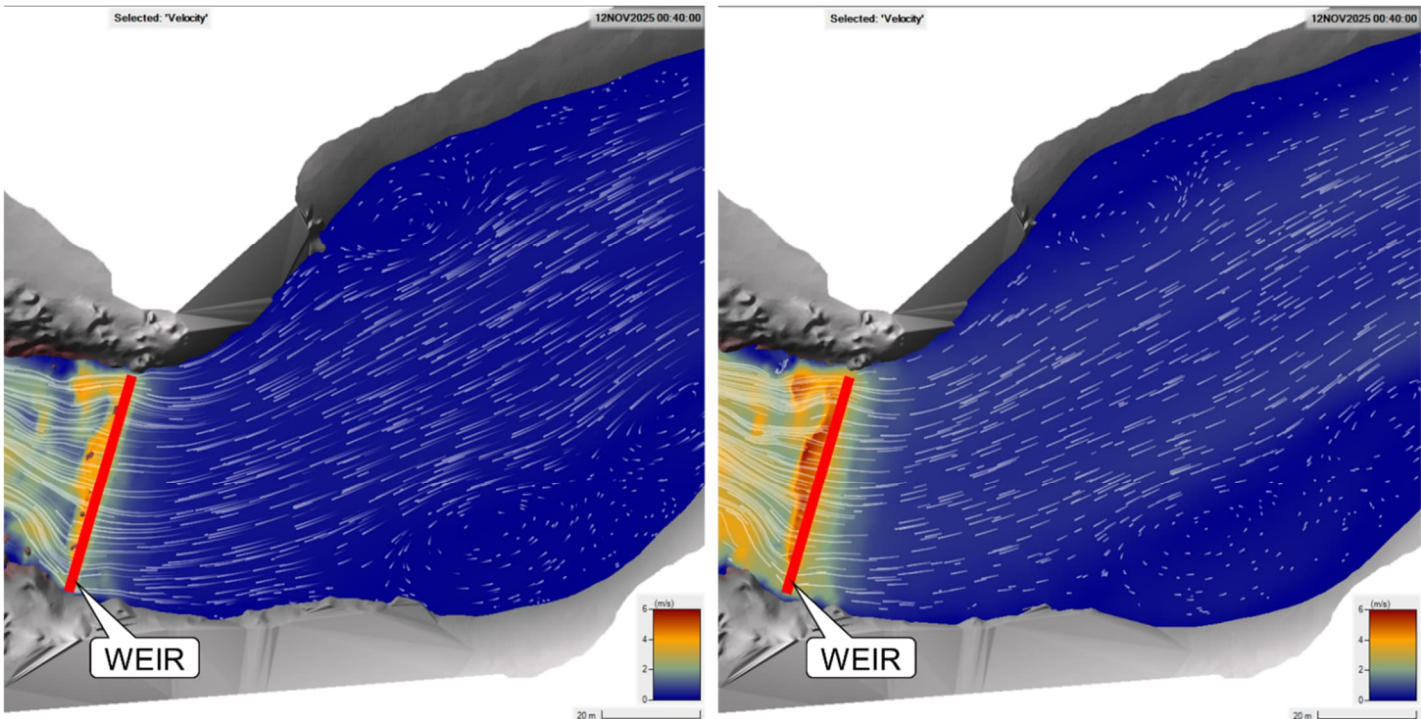
Figure 3-2 Predicted flow extents, velocities and particle tracing at 40 m<sup>3</sup>/s (left) and 112.5 m<sup>3</sup>/s (right)

Figure 3-2 shows the predicted flow extent, velocities and particle tracing under two design flows considered. The design flows through the tailrace are predicted to be contained within the tailrace banks, albeit based on assumed bank levels on the immediate upstream. Eddies are likely to form on both banks of the tailrace just upstream of the constricted section towards the weir, although the flow velocities are <0.3 m/s. Flow velocities upstream of the weir are below 0.6 m/s – as a reference, Austroads riprap sizing guide does not specify a class of rock protection for floodway flow velocities of less than 2 m/s (Austroads, 2023).

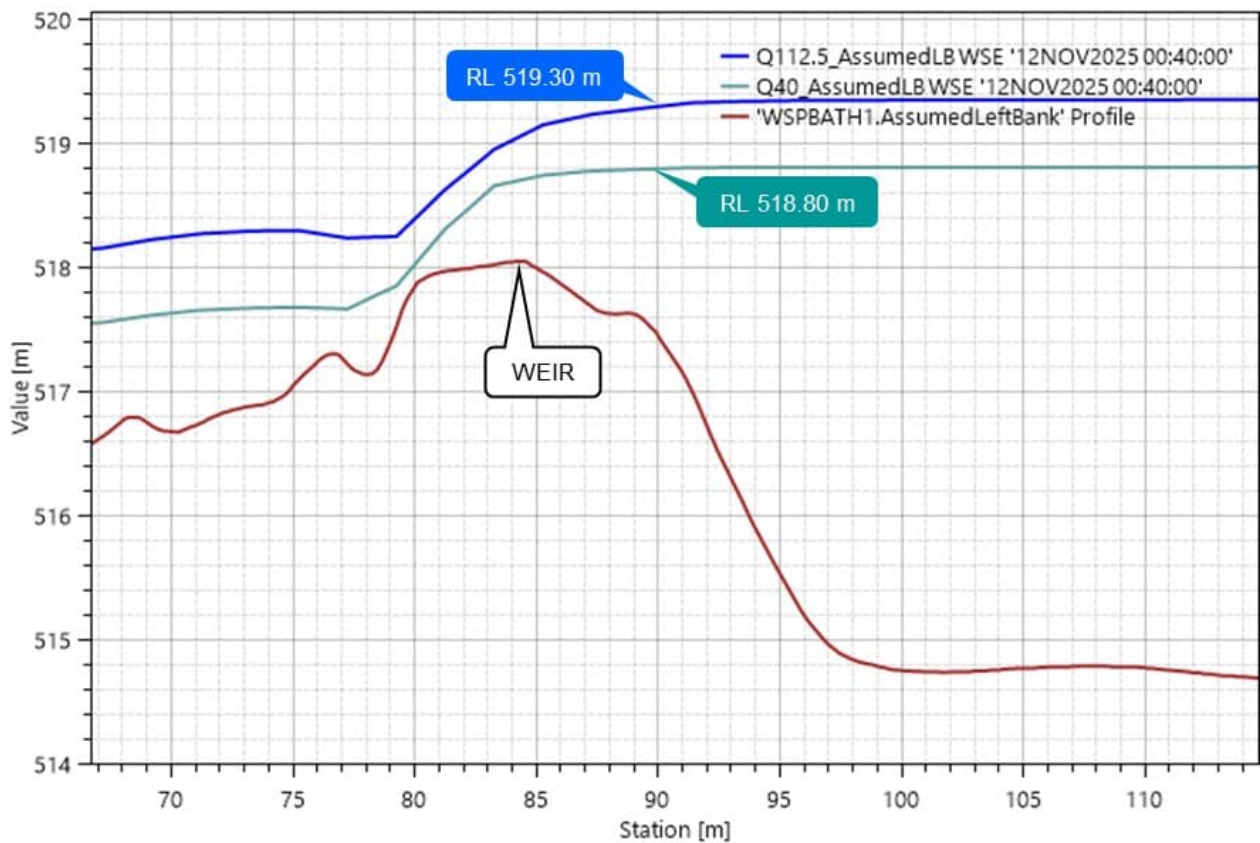
Figure 3-3 Predicted water surface elevations along the tailrace centreline

Figure 3-3 shows the resulting water surface elevations based on the maximum and minimum design flows. The predicted water surface elevations at the weir are RL 518.80 m and RL 519.30 m at 40 m<sup>3</sup>/s and 112.5 m<sup>3</sup>/s, respectively. Although differences between the weir equation and model results are 40-150 mm, all estimated water surface elevation at the weir is above the operational minimum of RL 518.00 m.

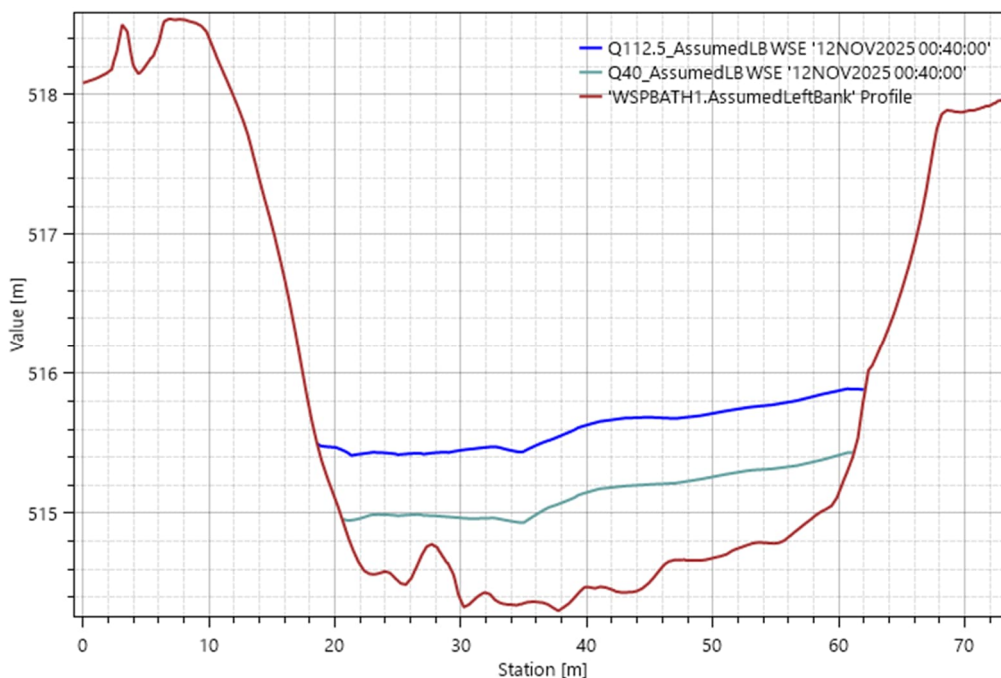
Figure 3-6 Predicted water surface elevation 60 m downstream of the weir at 40 m<sup>3</sup>/s (bottom) and 112.5 m<sup>3</sup>/s (top)

Figure 3-6 shows the water surface elevation at the chute at 60 m downstream of the weir, as predicted in the HEC-RAS 2D model. Model results show that the top of right bank is 1 m above the water surface elevation at a design flow of 112.5 m<sup>3</sup>/s. Despite the uncertainties of using HEC-RAS 2D for this application, 1 m of freeboard from the chute flow surface to the top bank improves confidence that the chute is unlikely to overtop at the maximum design flow.
