8 June 2026

Ben Murray  
Corporate Affairs and HSE Manager  
Graymont New Zealand Limited  
214 Collingwood Street  
**HAMILTON 3204**

## **OPARURE QUARRY SOUTH-WESTERN PIT – CONTAMINATED LAND PRELIMINARY SITE INVESTIGATION**

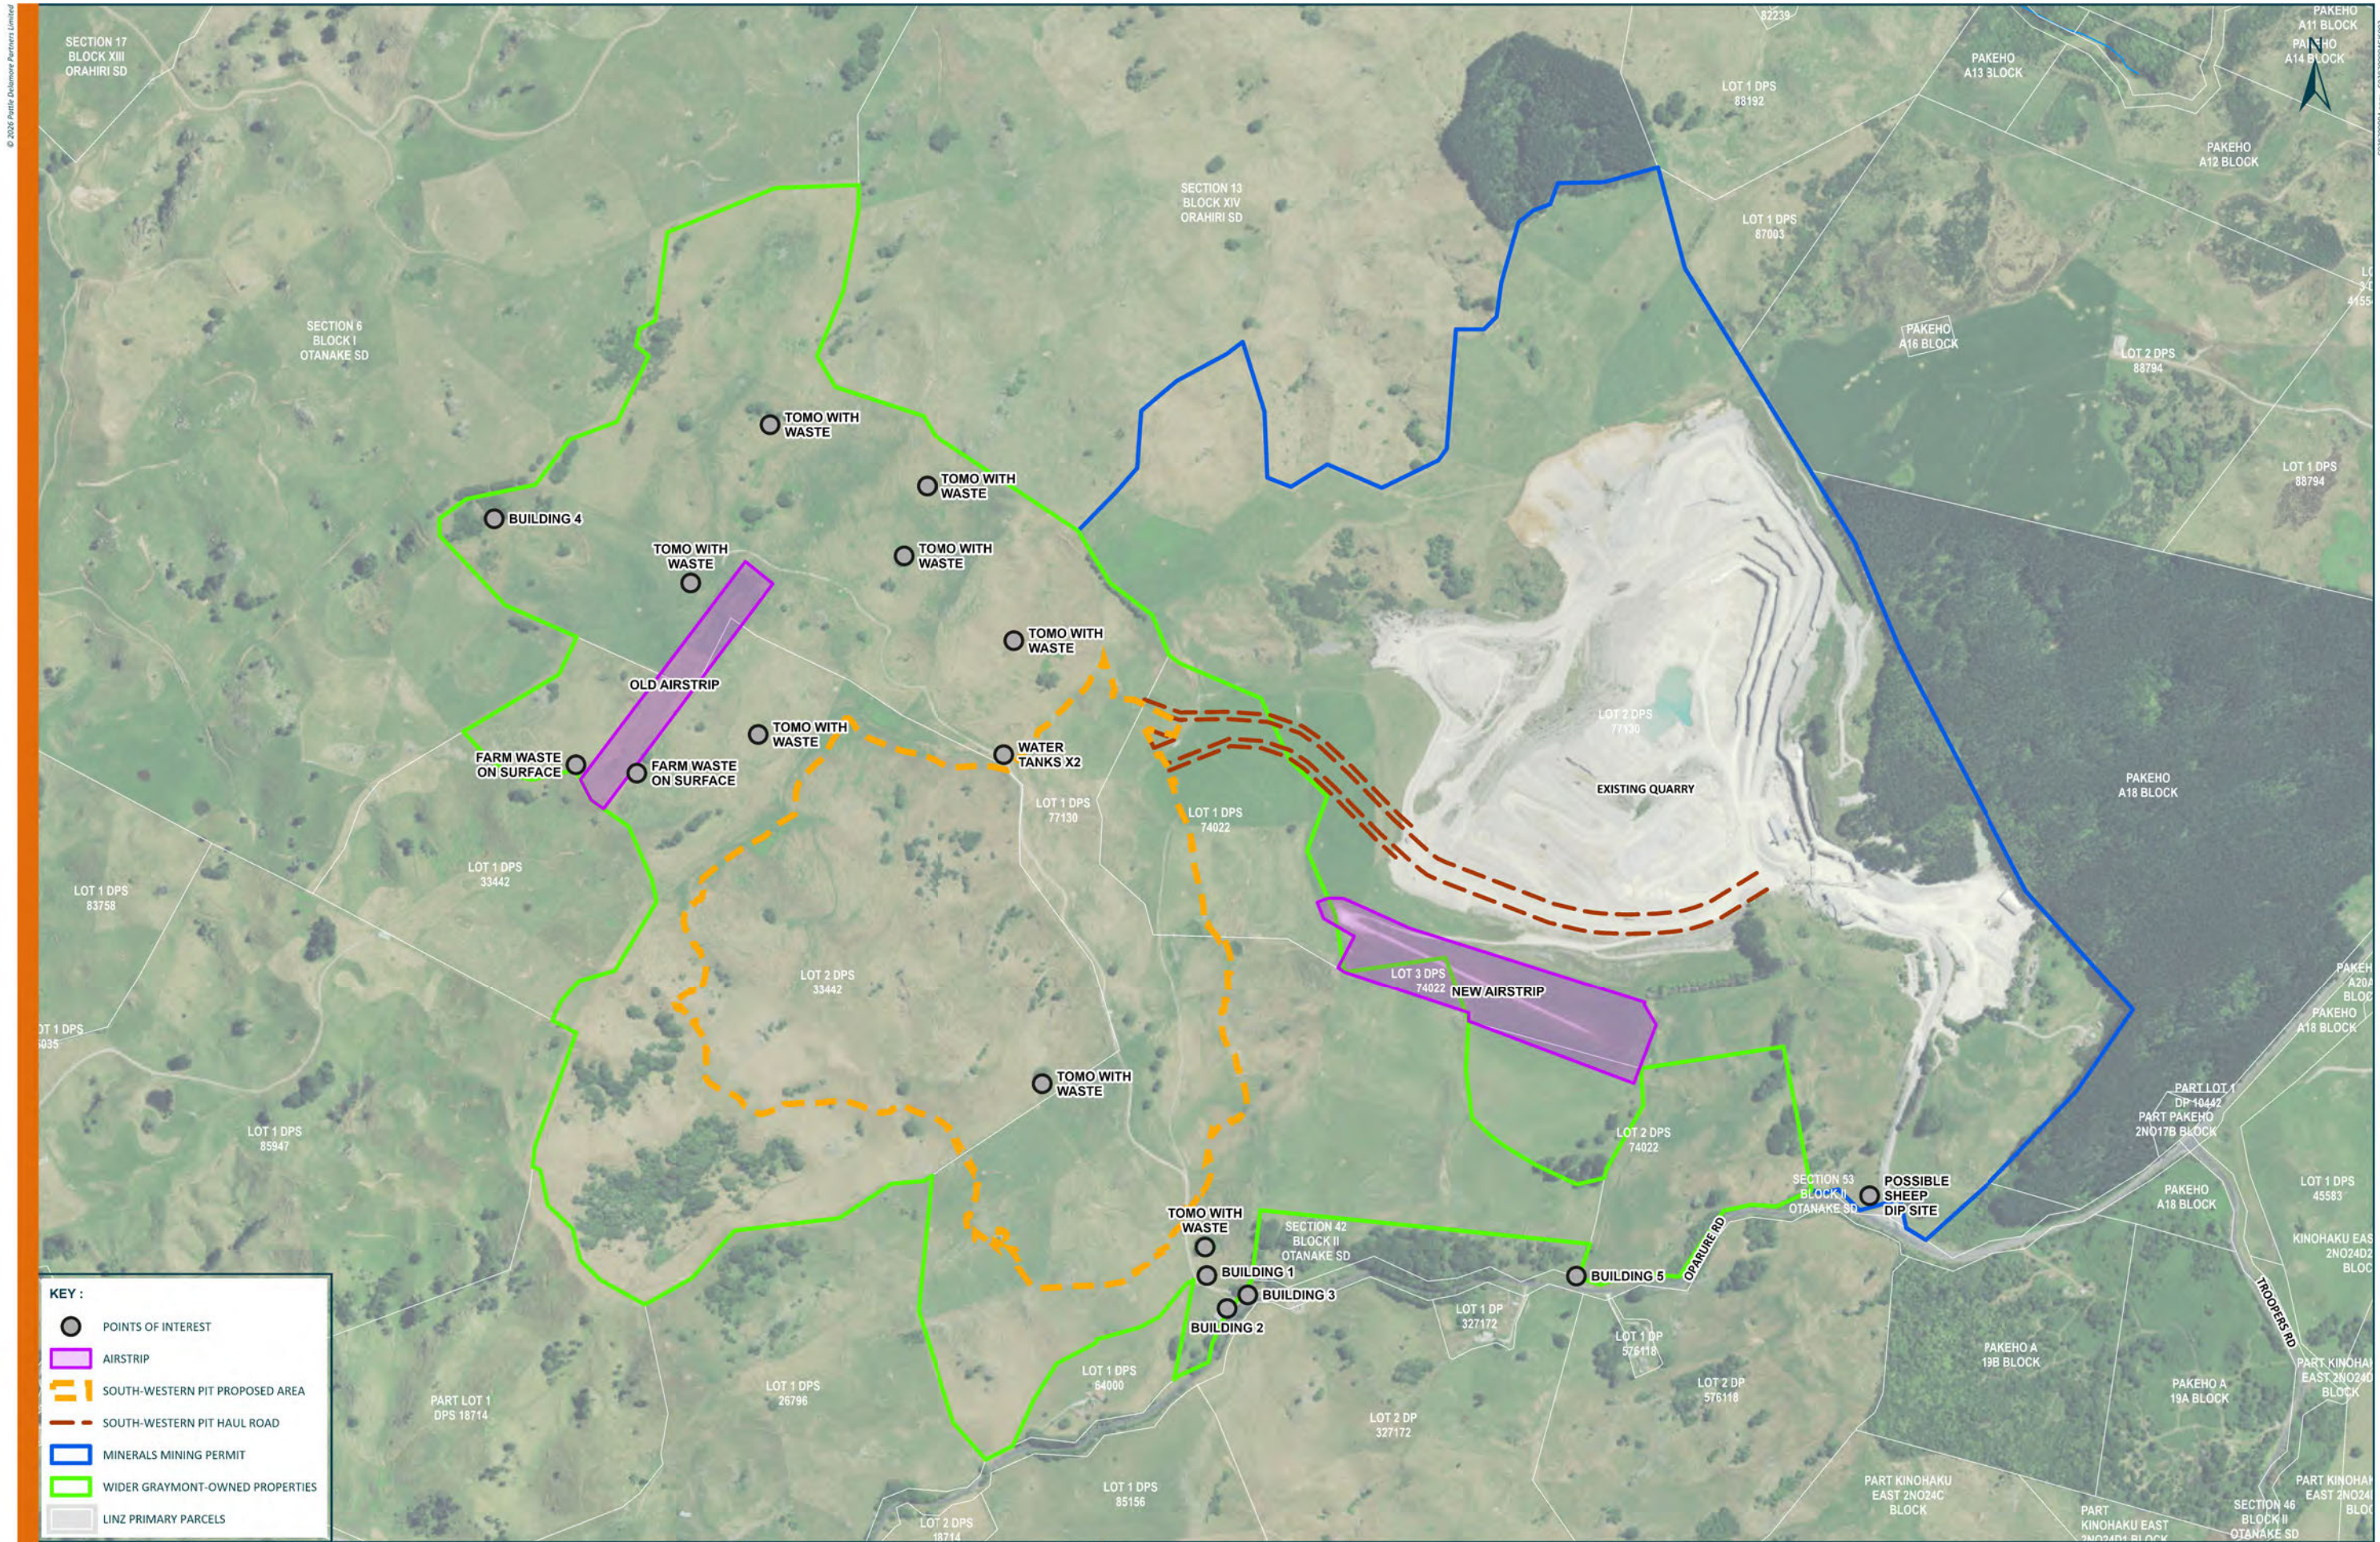
FIGURE 2: LOCATION OF POTENTIAL GROUND CONTAMINATION ACTIVITIES

The information gathered during this PSI regarding the current and/or historical land use activities at the site relating to potential ground contamination are summarised in the following sub-sections. Refer to Figure 2 in Appendix A for a plan showing the location of these identified land use activities.

This PSI has not identified any HAIL land use activities, or 'pieces of land' within the proposed quarry area (identified with a brown outline in Figure 2, Appendix A). All identified potential sources of contamination / HAIL activities are located within the site, however located outside of the proposed quarry area. PDP understands that land use in the areas of the site outside of the proposed quarry area will continue as farm related activities, and no activities covered by the NES-CS are contemplated to be undertaken at the identified HAIL (or potential HAIL) locations.

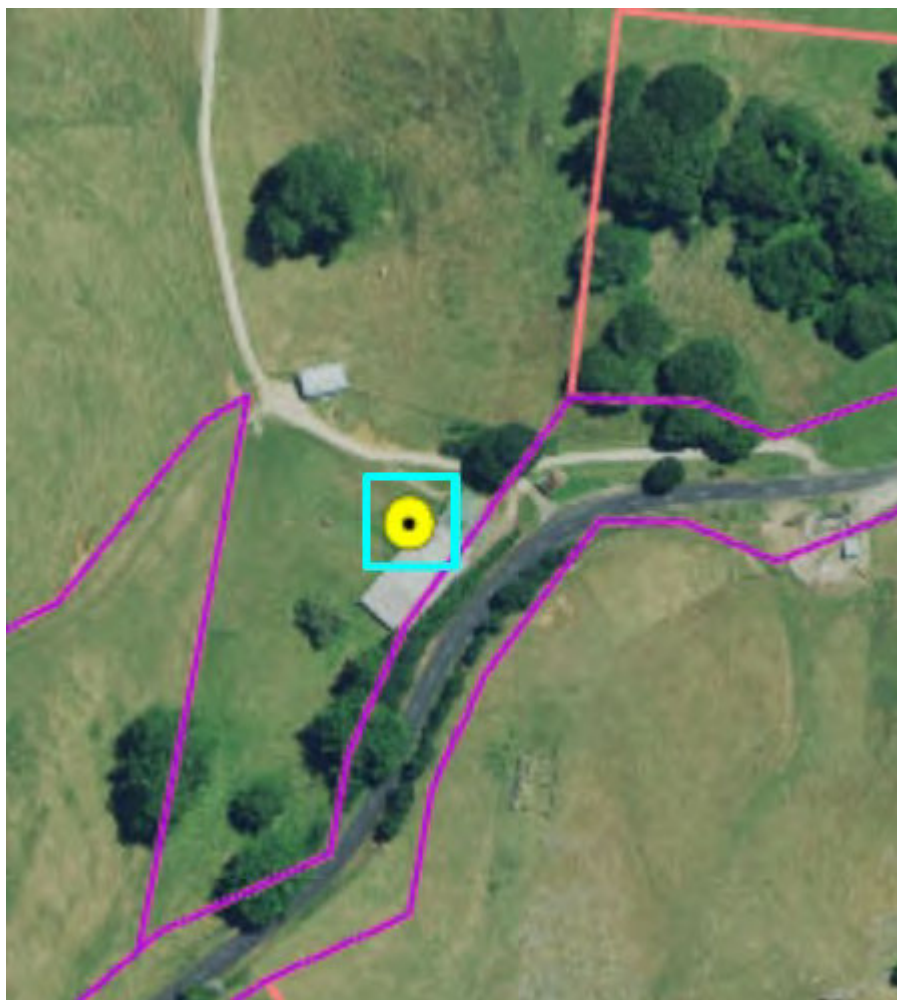
**This property :** I can confirm that this site **does** appear on the Land Use Information Register, as indicated by the yellow dot on the map below.

At or about the yellow dot above appears on the Land Use Information Register as **LUI12777** with a classification of 'Unverified HAIL' due to past land use for HAIL activity 'A8. Livestock dip or spray race operations' associated with this pastoral farm . This site is included on the register for land use information only; we do not hold soil investigation reports regarding the presence or otherwise of hazardous substances in the soil.

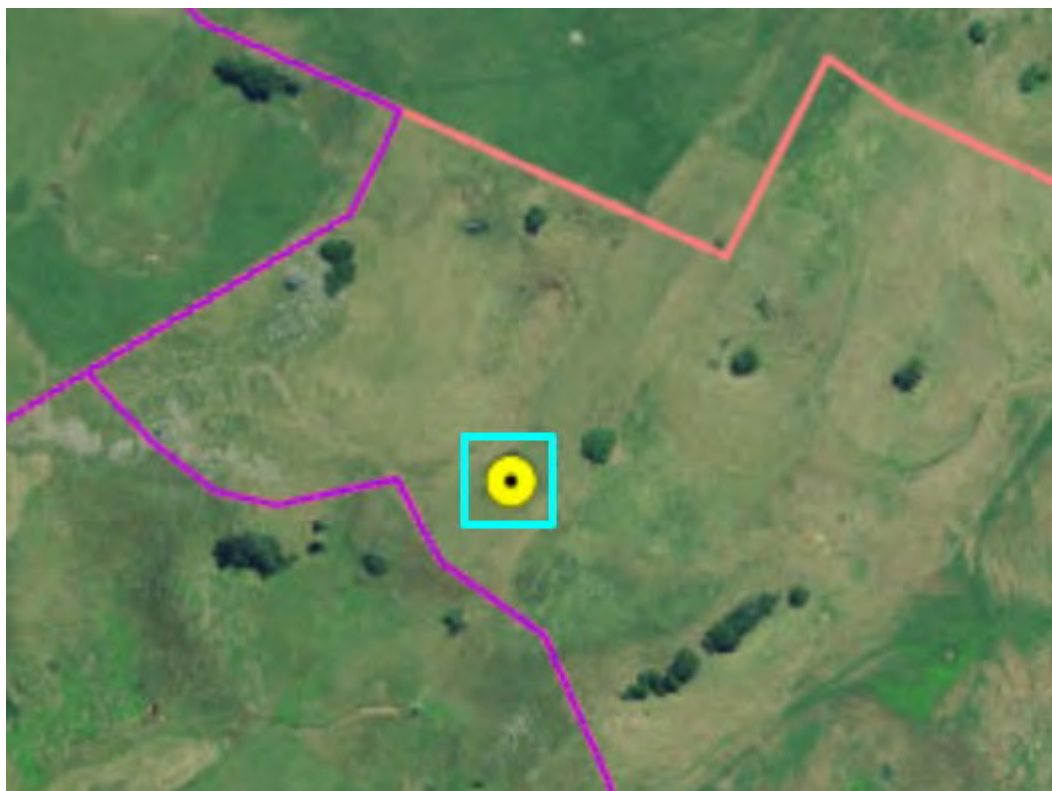
At or about the yellow dot above appears on the Land Use Information Register as **LUI06628** with a classification of 'Unverified HAIL' due to past land use for HAIL activity 'A6. Fertiliser bulk storage' associated with this pastoral farm. This site is included on the register for land use information only; we do not hold soil investigation reports regarding the presence or otherwise of hazardous substances in the soil.
