# Geotechnical Assessment A Drive Borrow Pit, Stockton Mine

Bathurst Resources Limited

✦ March 2026

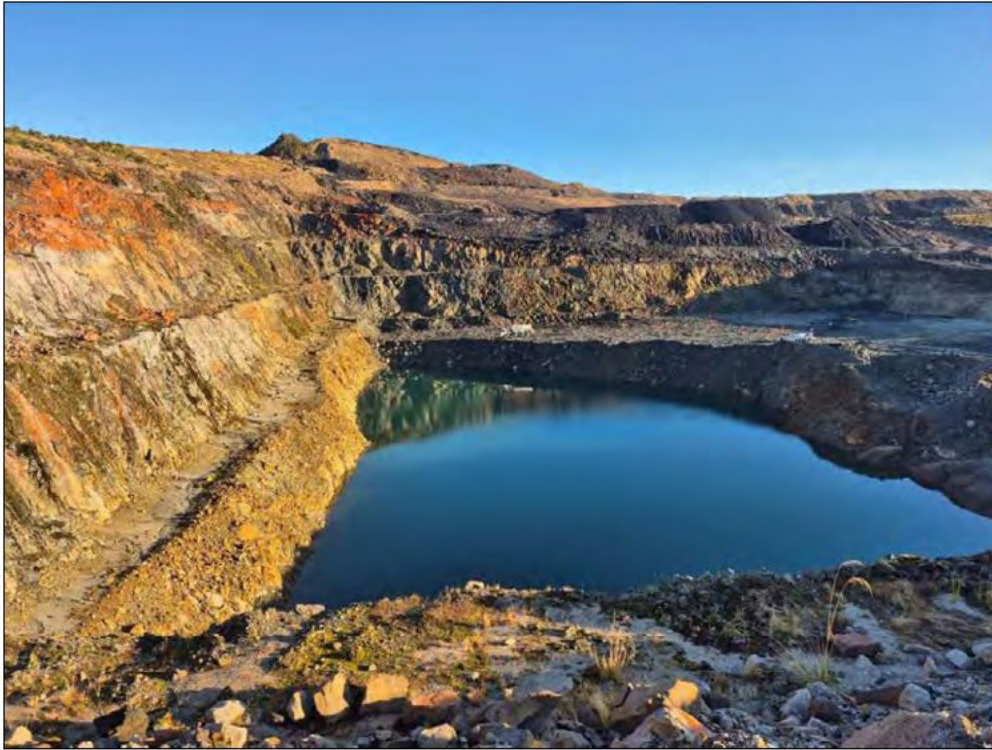
Figure B1: General site photograph looking west across the existing A-Drive borrow pit.

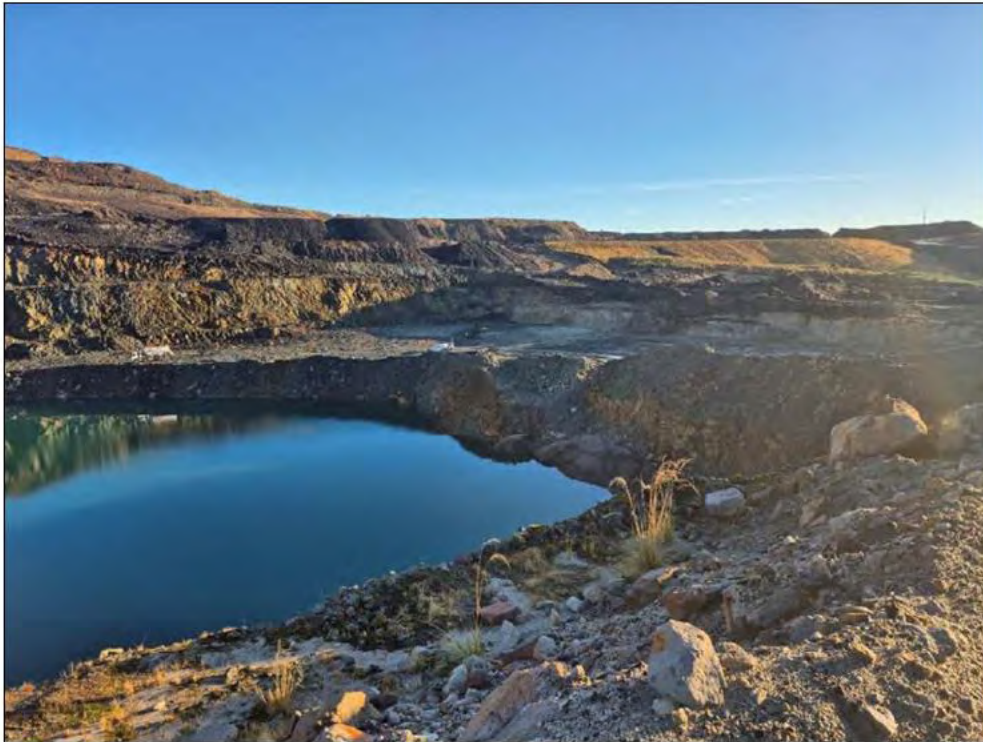
Figure B2: General site photograph looking northwest across A-Drive borrow pit.

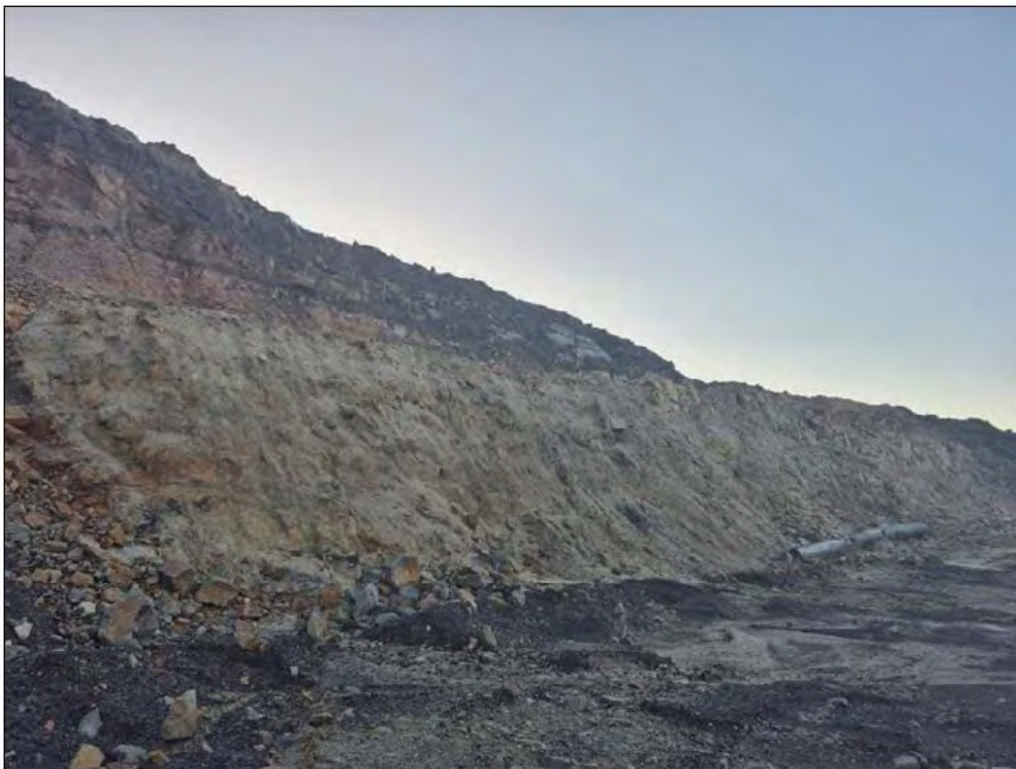
Figure B6: Photograph of the northern highwall of the A-Drive borrow pit. Note: Surficial layer (approximately 1.0 m thick) of completely weathered to extremely weathered granite on highwall batter face.

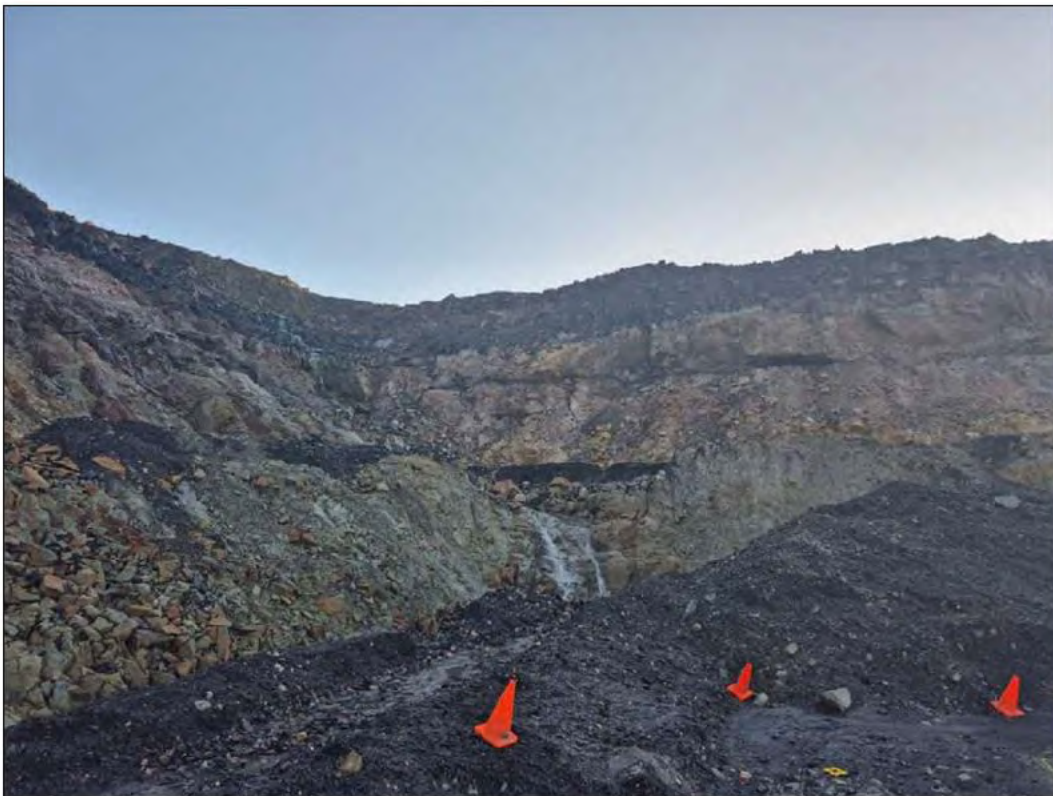
Figure B8: Surface water runoff entering the A-Drive borrow pit at the intersection of the western and northern pit walls
