# **Appendix K   Preliminary   Site Investigation**

**Hinuera Solar Farm**

**Harmony Energy NZ #6 Limited**

# Preliminary Site Investigation

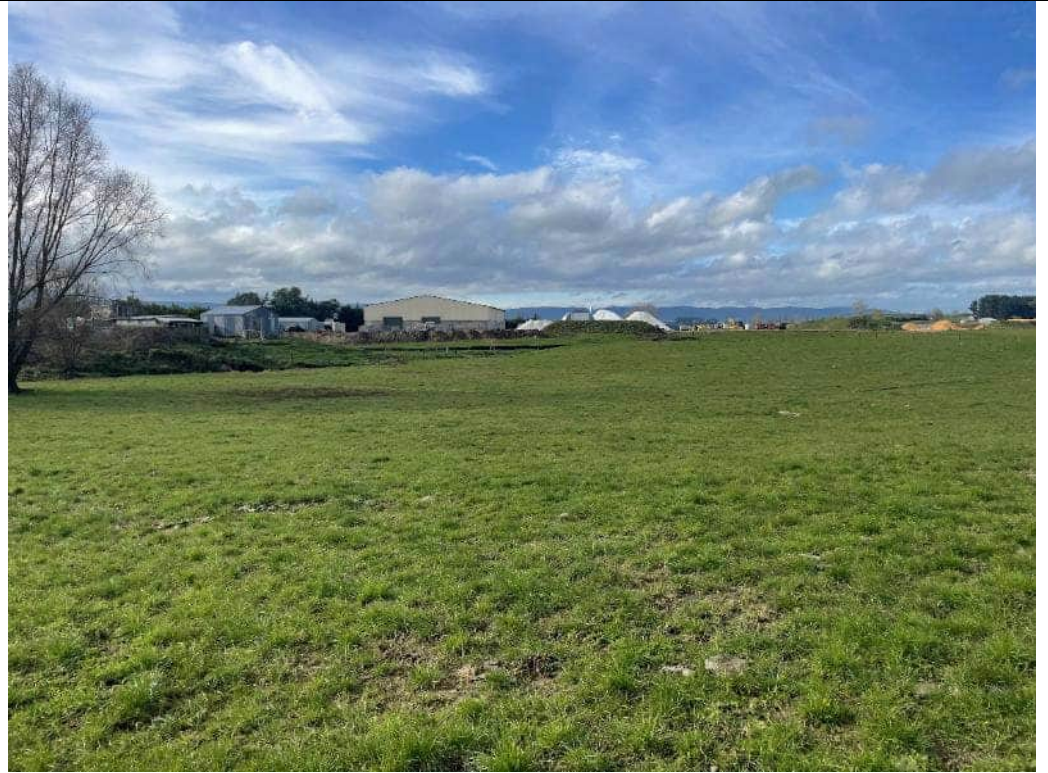
**Photo No.**  
2

**Description:**  
General view of  
paddocks on western  
boundary.

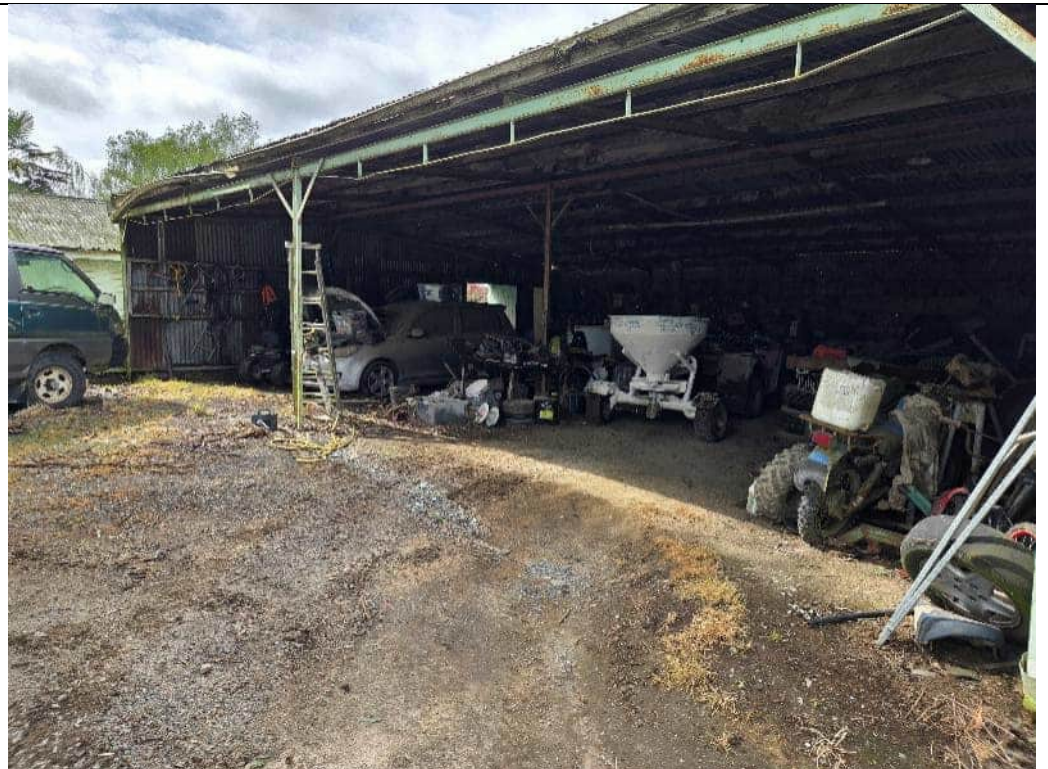
**Description:**  
General view of storage  
shed near residential  
dwelling in along  
eastern boundary of the  
Site.
