Geotechnical assessment report for

Proposed Maitahi Village Subdivision
Kaka Valley, Nelson

Prepared by
Tonkin & Taylor Ltd

Date
February 2025

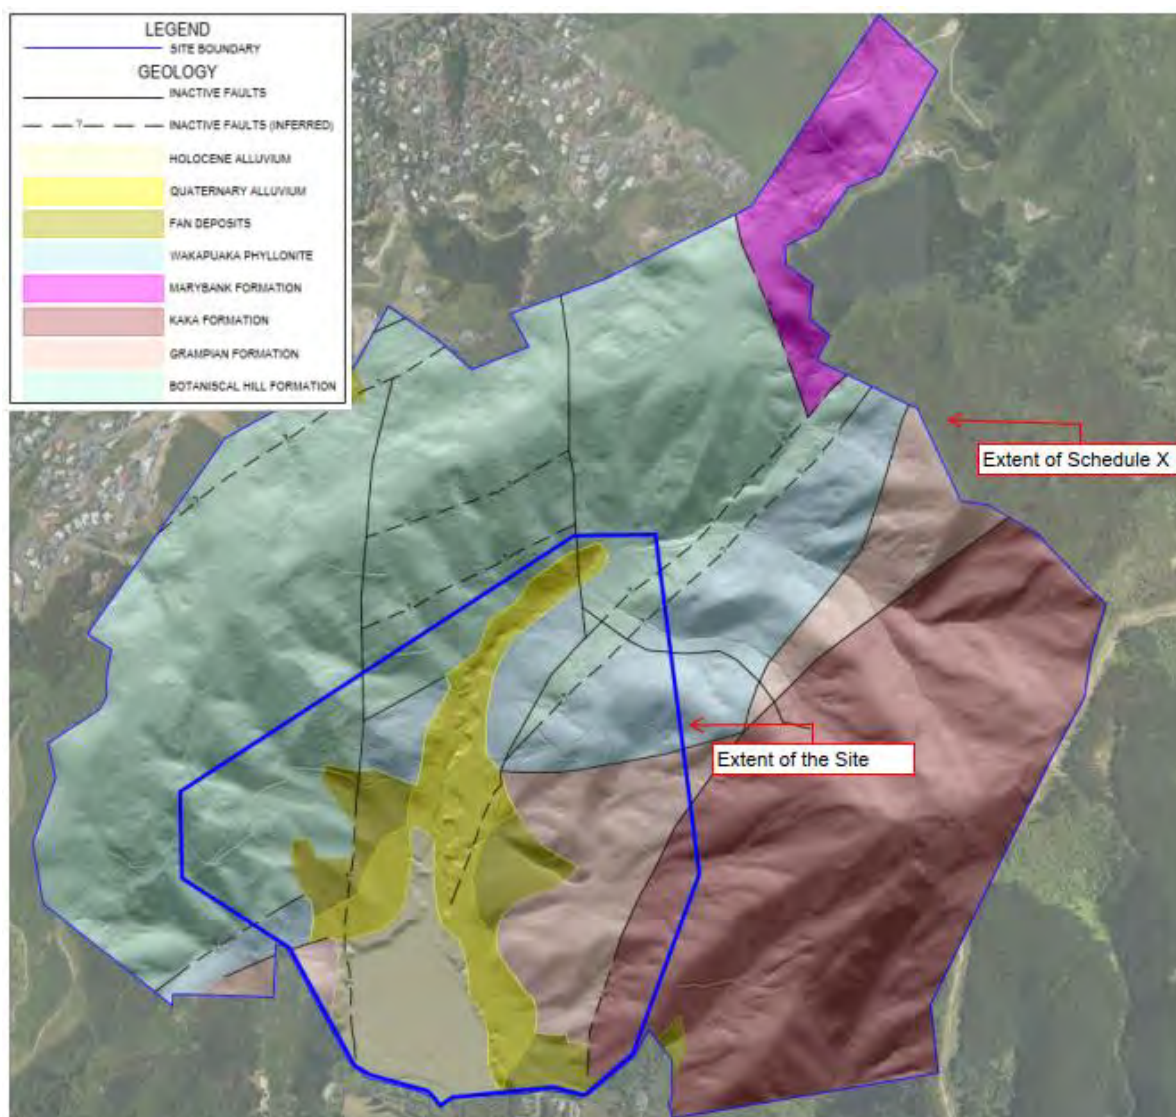
Figure 4.1: Geology of the Site (sourced from Johnston, M.R. 1981²)

The New Zealand Geological survey, Dun Mountain 1:50,000 scale geology map¹ shows five basement rock types **Botanical Hill Formation, Wakapuaka Phyllonite, Grampian Formation and Kākā Formation** predominate within the Site, Figure 4.1. Apart from the Wakapuaka Phyllonite, these basement rocks are principally strong to very strong breccia, tuff and tuffaceous sandstone. Kākā Formation is noticeably stronger than other rocks. The Wakapuaka Phyllonite varies from a strong to weak rock and has led to more subdued topography and more evidence of ancient slope instability than other mapped basement rocks.

We have also reviewed the more recent 2021 'Revised Geological Map of the Nelson-Richmond Urban Area'². This map does not show the individual unit formations of the Drumduan and Brook Street Terranes but shows a similar distribution for the bedrock geology and younger alluvium and fan deposits that is shown in Figure 4.1 above.

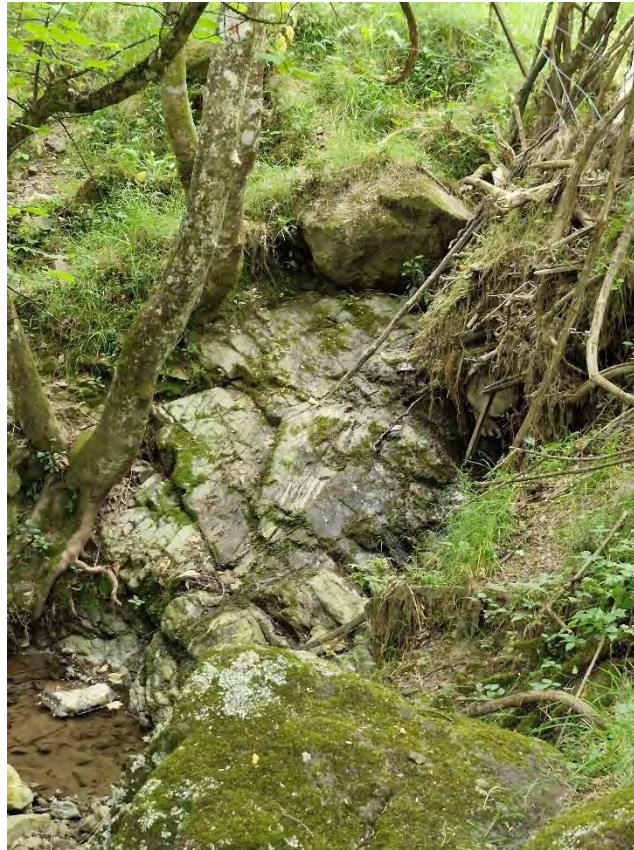
Observation of a Farm Track cut batter on the western side of Kākā Hill exposed a volcanoclastic breccia in the cut. A 1987 journal paper by Johnston, Raine and Watters ⁴, describes the Wakapuaka Phyllonite in this area as comprising red schistose rock. This description is similar to the descriptions we have provided in test pits TP23-22 and TP24-22. Rock exposure in the Kākā Stream exposes Botanical Hill Formation siltstone dipping steeply towards the south-east (*Photograph 4.1*). Based on

our site observations the Wakapuaka Phylonite/ Botanical Hill Formation contact passes between the track cut and the stream bed in Gully 14.

Photograph 4.1: Botanical Hill Formation siltstone in the stream downslope of the western slopes of Kākā Hill, in Gully 14.

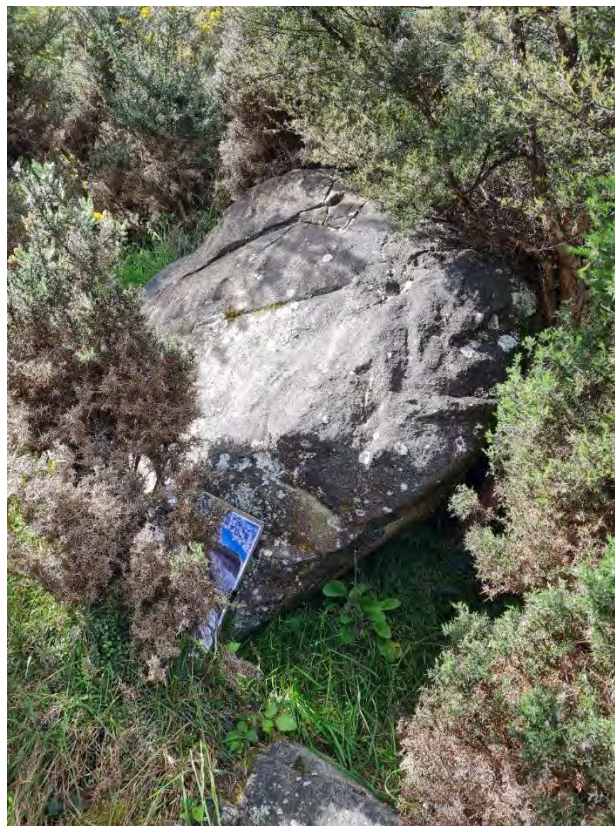
Boulders varied in size from 0.4 m (mean diameter) up to 1.2 m (intermediate axis) (*Photograph 4.2*) and are estimated range of mass approximately 200 kg and 2,600 kg per boulder. Boulders coalesced along the Farm Track at the northern side of the Debris Fan within Gully 14 appear to have been side cast as part of track development.

Photograph 4.2: Example of a large boulder on the slope

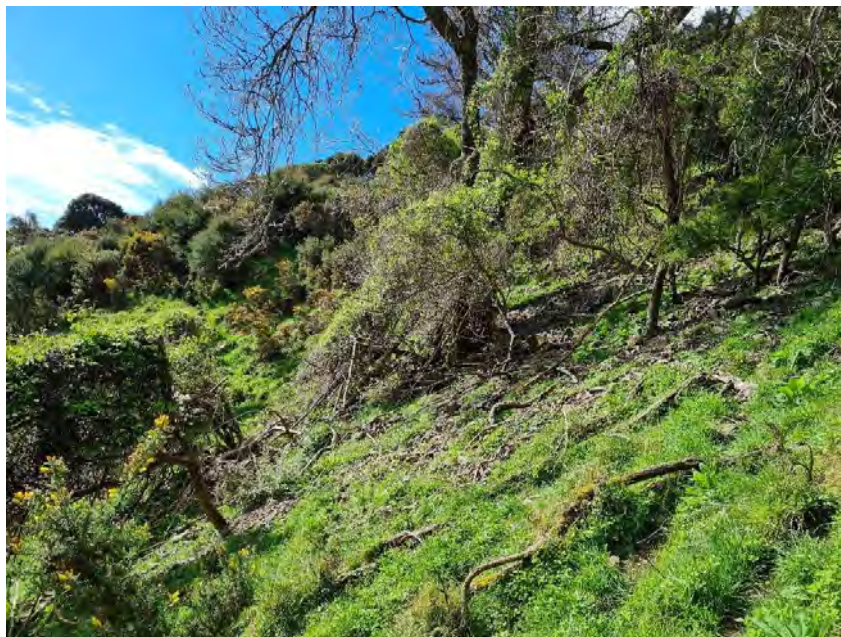
Upslope of the scarp area and below the Kākā Hill ridge the slope surface was covered in cobble sized scree deposits (*Photograph 4.4*).

Photograph 4.4: Scree slope below the Kākā Hill ridge

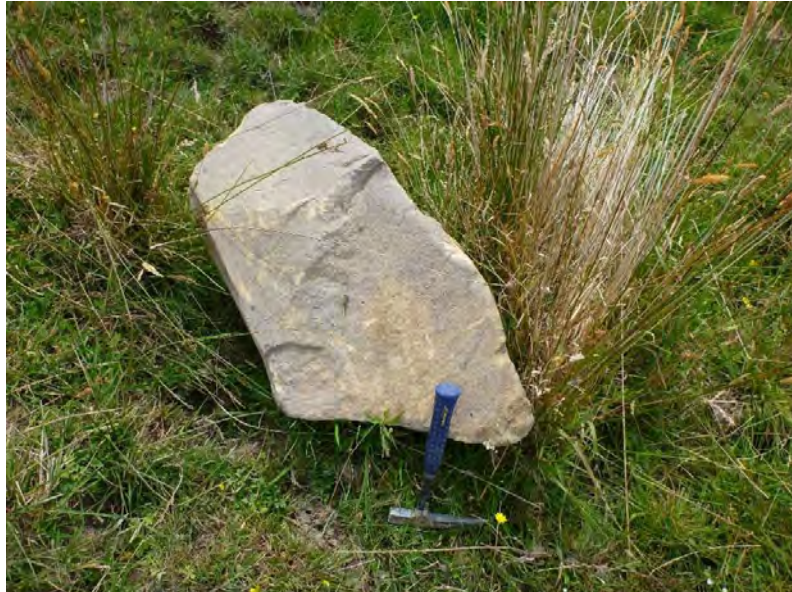
Cobbles and boulders that varied in size from 0.3 m up to 0.6 m wide along the intermediate axis (*Photograph 4.5*) and boulder mass is estimated to vary between approximately 50 kg and 450 kg. Boulders are present in two primary locations on the western slope, these are:

- Along the outlet channels downslope of mouth of Gullies 5 and 6 on the downslope side of the Farm Track (T+T Figure 1012397.1000-GT-F03). The source of these boulders appears to be either landslide or flood debris derived from the two gullies which culminate in this general location. As the boulders are primarily located downslope of the track it is also possible that some of these boulders may be the result of side cast fill generated as part of track development.

Photograph 4.5: Example of one of the larger boulders in the runout zone of Gullies 5 and 6

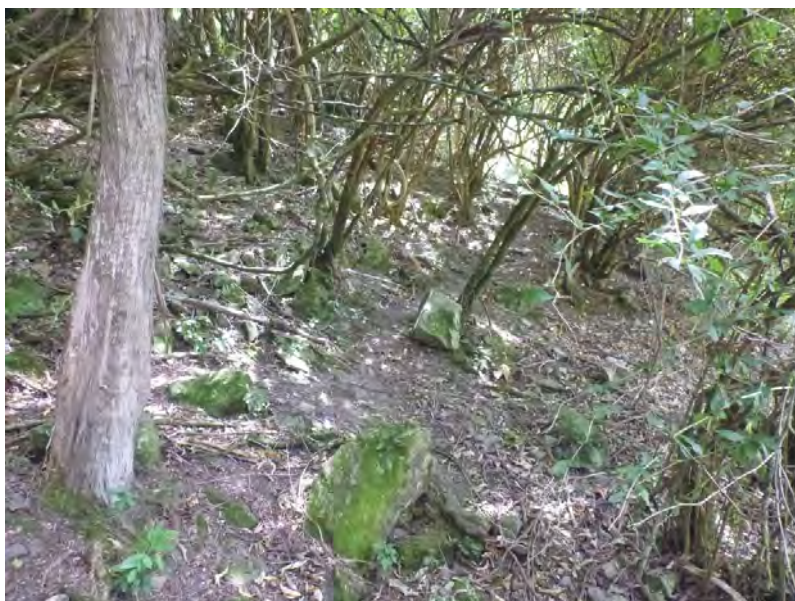
- A boulder garden concentration of the true left of Gully 5 and directly upslope of the track (*Photograph 4.6* below).

Photograph 4.6: Boulder Garden on true right of Gully 5

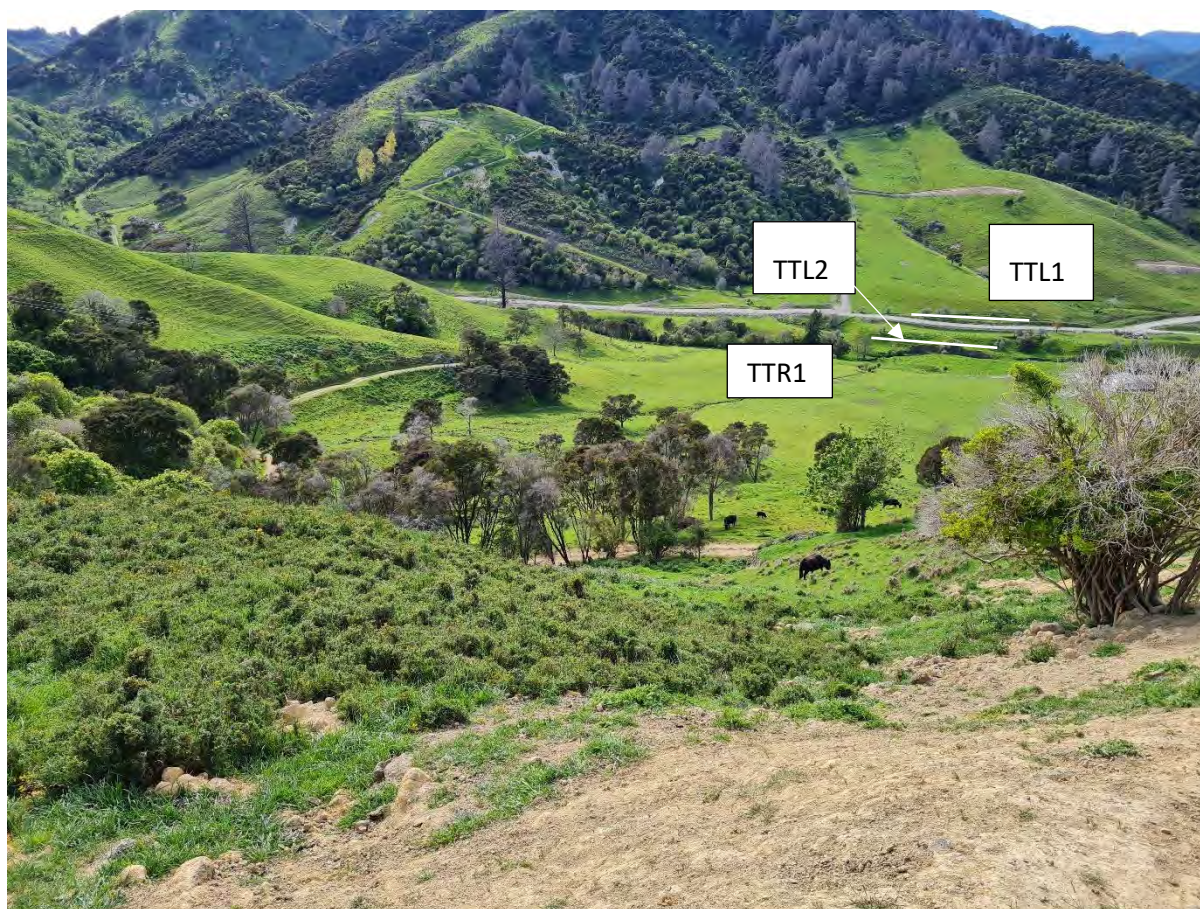
The broad valley floor has been formed by downcutting Alluvial terraces, that are now preserved in Areas 3 and 5 to the east and west of both sides of the valley floor (*Photograph 4.7*) and periodic infilling by flood derived sediment from the Maitai/Maitahi River and Kākā Stream over the last 1,000 to 20,000 years. The terraces occur at two elevations and are thought to have been formed by aggradation processes within the last 150,000 years when the climate was significantly different to that which exists today.

Photograph 4.7: View West to East Example of remnant stream terraces near the toe of the Debris Fan (Area 3) and below the Western Slopes in Area 5.

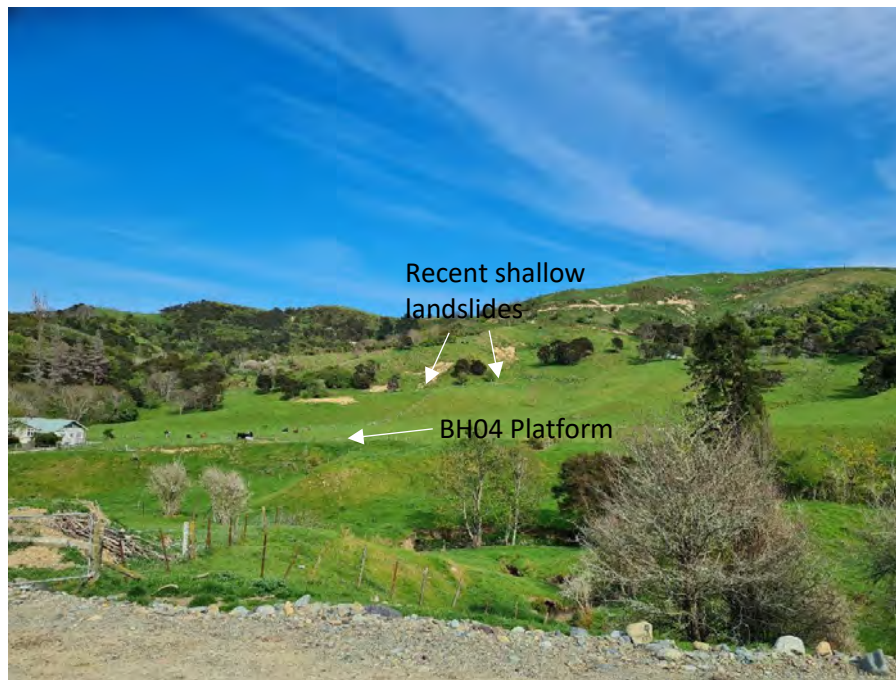
This area contains a flat lying to gently inclined (to the south and east) alluvial terrace where the farm dwelling is located (*Photograph 4.8*) The terrace surface merges into fan surfaces and gently rounded spurs to the West These slopes are largely free of any evidence of slope instability except near the southern end of the areas where a very thin (0.1 m) deposit of silt has been deposited from rainfall erosion of debris from three shallow landslides originating in Area 6 during the August 2022 rainfall event. Minor subdued hummocky ground in this area and locally in the floor of each of the gullies that extend into Area 5 from the west indicate past (pre-historic) episodes of soil deposition likely due to erosion during major rainfall events.

Photograph 4.8: View of Area 5 and 6.

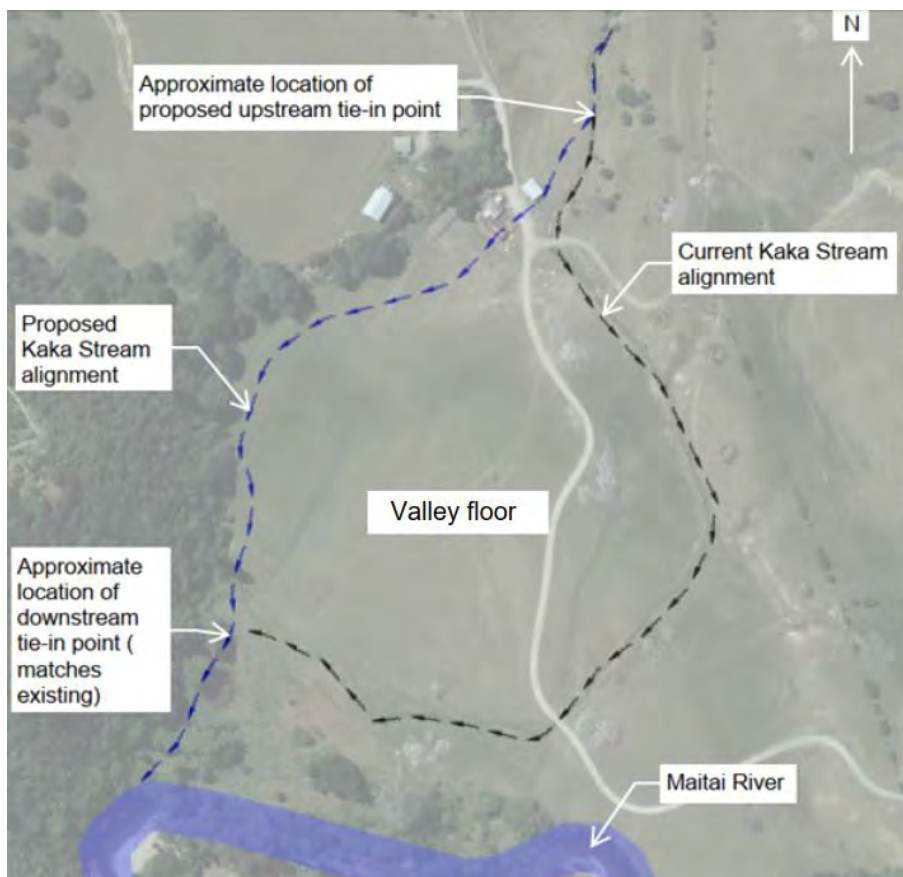
Figure 6.1: Existing and proposed Kākā Stream alignment

It is proposed to realign the lower reach of Kākā Stream to follow a new naturized corridor generally on the western side of the lower reach. To reduce the frequency of the stream drying up, and ensure it remains saturated for as much time as practicable, the proposed stream alignment will be cut down below current ground level to intercept groundwater and follow the base of the hill around to the south, finally discharging into the Maitai/Maitahi River at a location similar to where the existing stream confluence. The existing and proposed stream alignments are shown on *Figure 6.1* below.

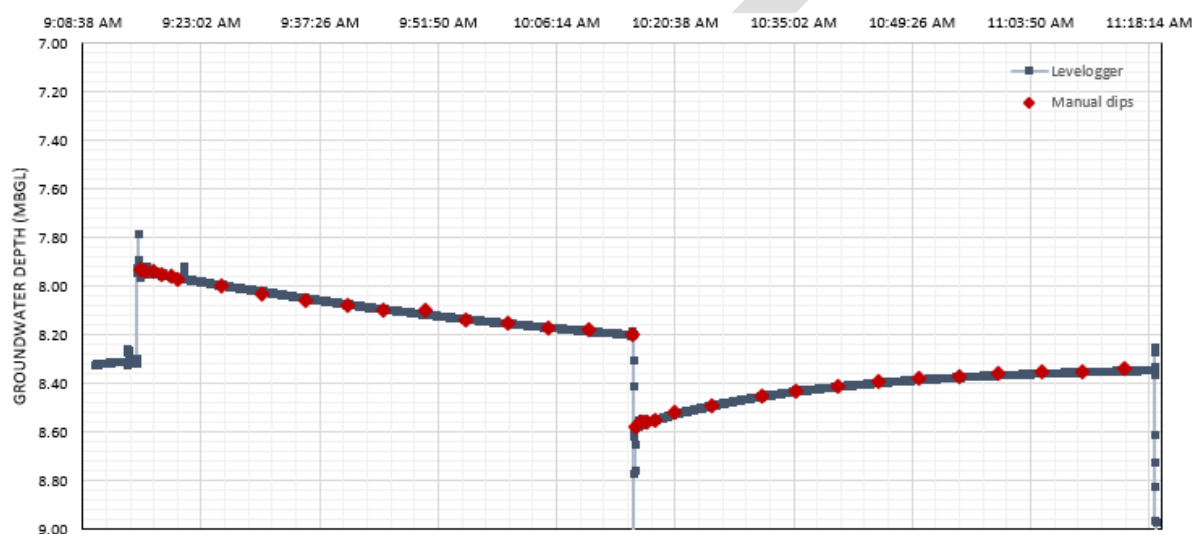
Figure 1.1: BH01-0723 groundwater levels recorded during the falling and rising head tests.

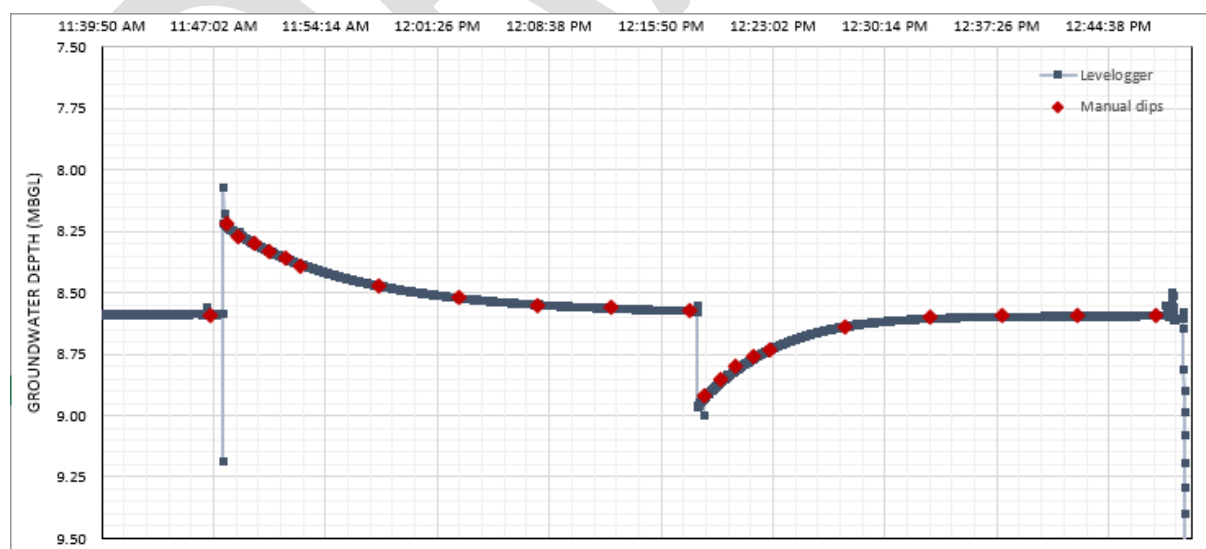
Figure 1.2: BH02-0723 groundwater levels recorded during the falling and rising head tests.

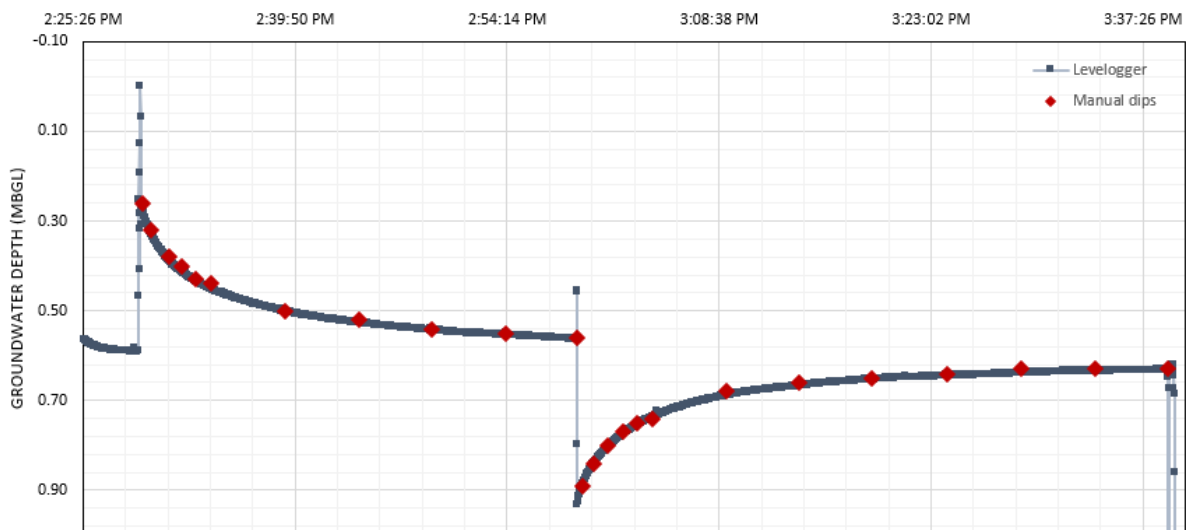
Figure 1.3: BH06-0723 groundwater levels recorded during the falling and rising head tests.

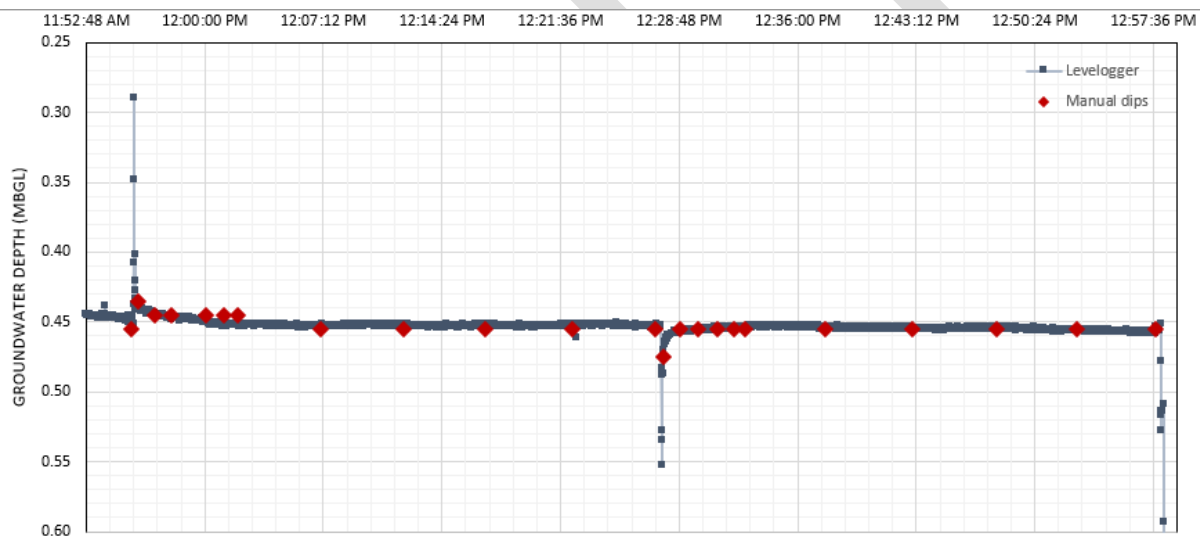
Figure 1.4: BH06 Deep groundwater levels recorded during the falling and rising head tests.

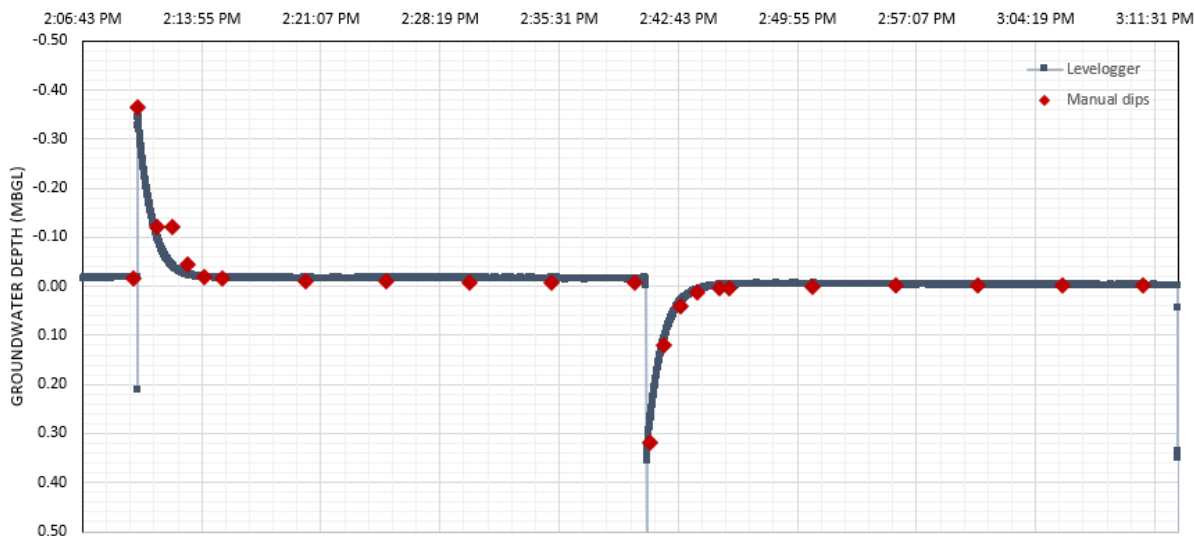
Figure 1.5: BH06 Shallow groundwater levels recorded during the falling and rising head tests.
