**Project Number 16998.000.002**

**Cannon Point Stage 4 - Geotechnical  
Investigation for Resource Consent**

10 Cannon Point Road, Craigs Flat, Upper  
Hutt, Wellington 5018

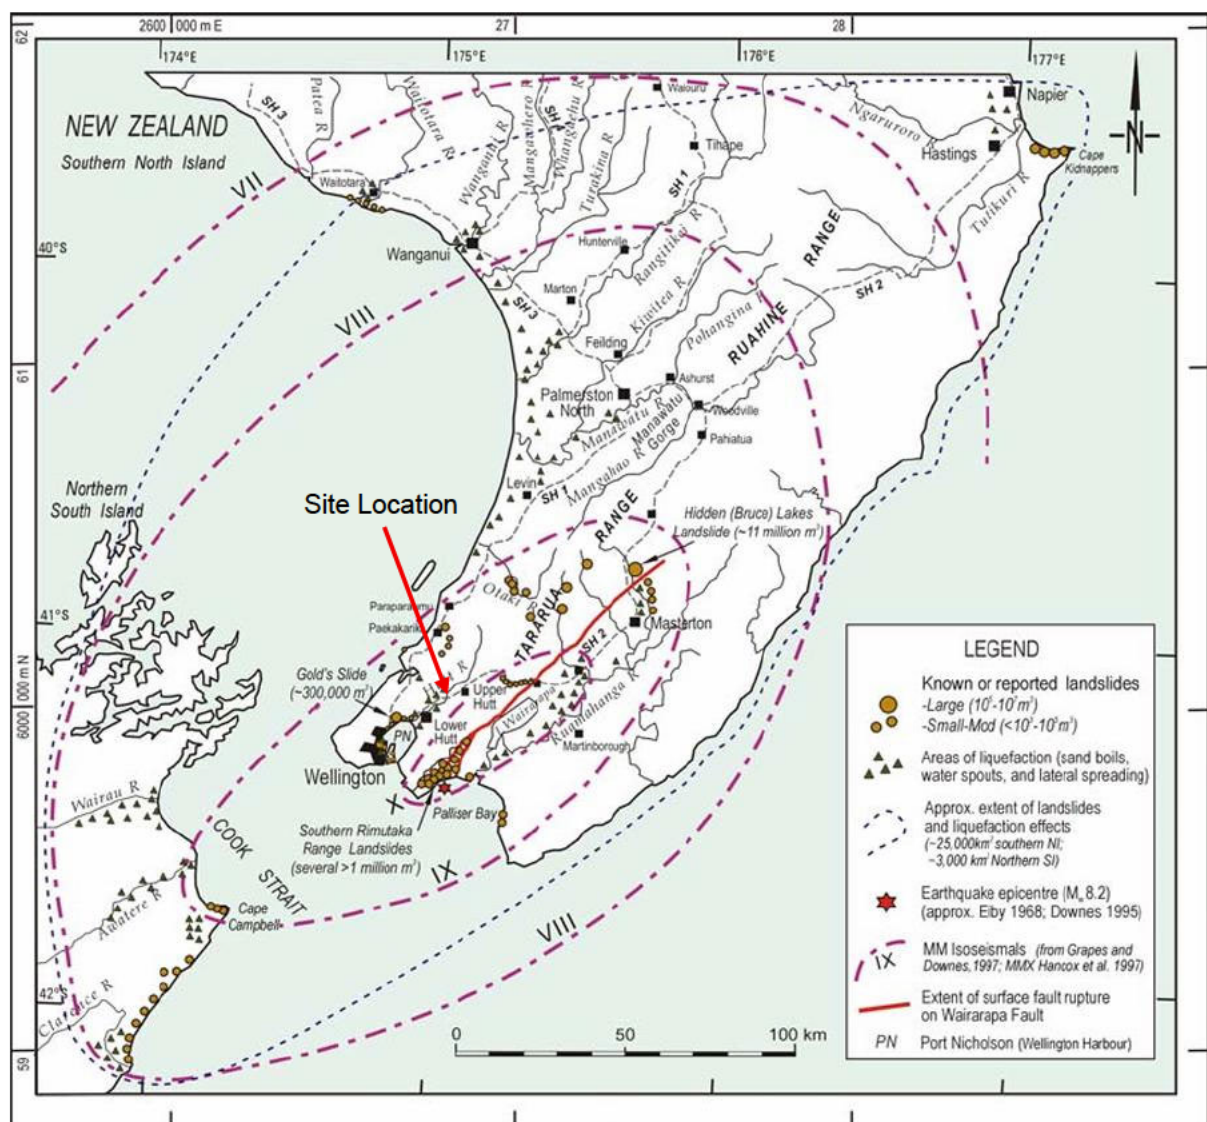
**Figure 5: Distribution of Reported Landslides Following the 1855 Wairarapa Earthquake (Hancox, 2005)**

The morphology of the hill slopes and general fracturing and weakness present in the geology of the western valley wall of the fault-angle basin has largely been caused by the Wellington Fault. When considering all of the factors outlined above, it is the Wairarapa Earthquake that is most likely candidate to have caused the proposed landslide in our opinion.

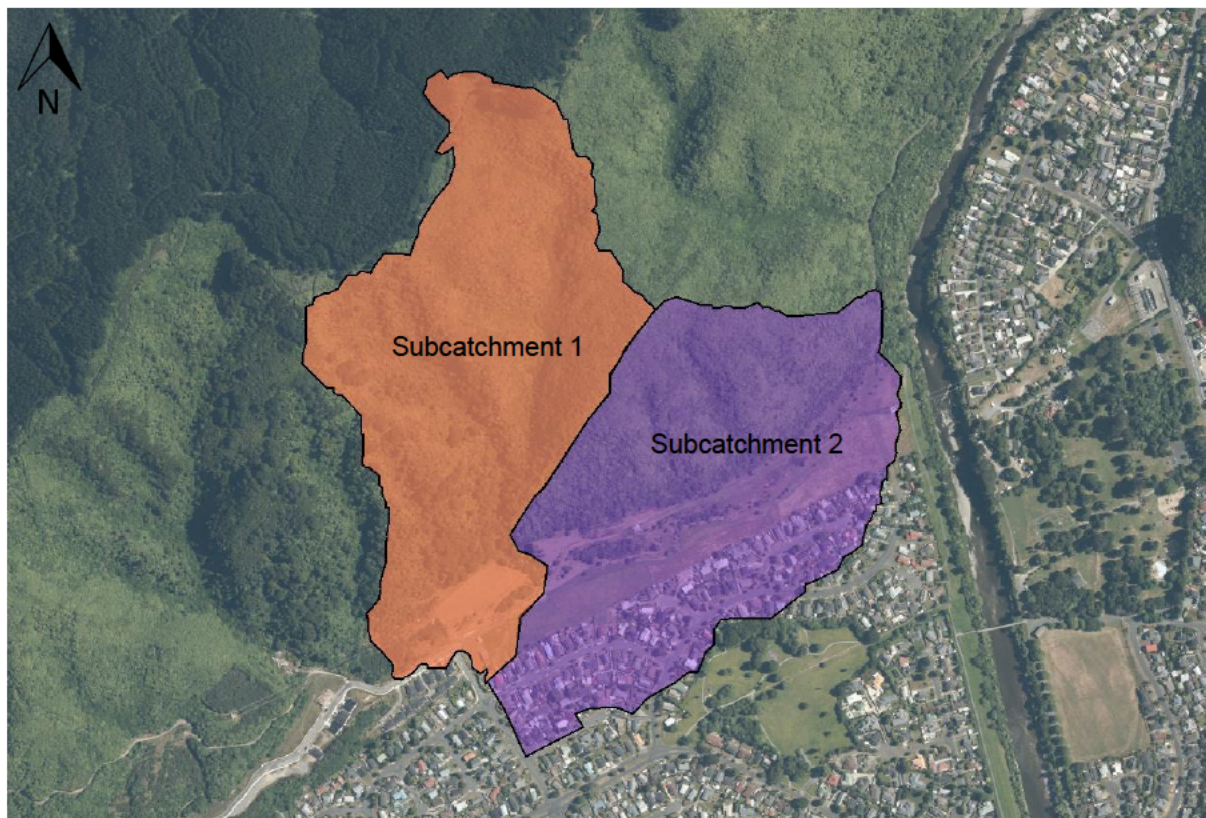
**Figure 6: Catchment Areas Located Above Stage 4**

The site is largely contained within the limits of two primary catchment areas (Figure 5). Subcatchment 1 has the largest surface area and is the only perennial stream on the site; meanwhile, Subcatchment 2 contains four minor southeast facing gullies which are ephemeral (only flowing some of the time, and usually briefly).

Based on field evidence, we were unable to determine whether there was a discrete event or whether a series of events had previously occurred, but investigations near the apex of the gully revealed approximately 1.3 m of medium dense gravels which were brown in colour when compared to the bluish-grey gravels seen below.

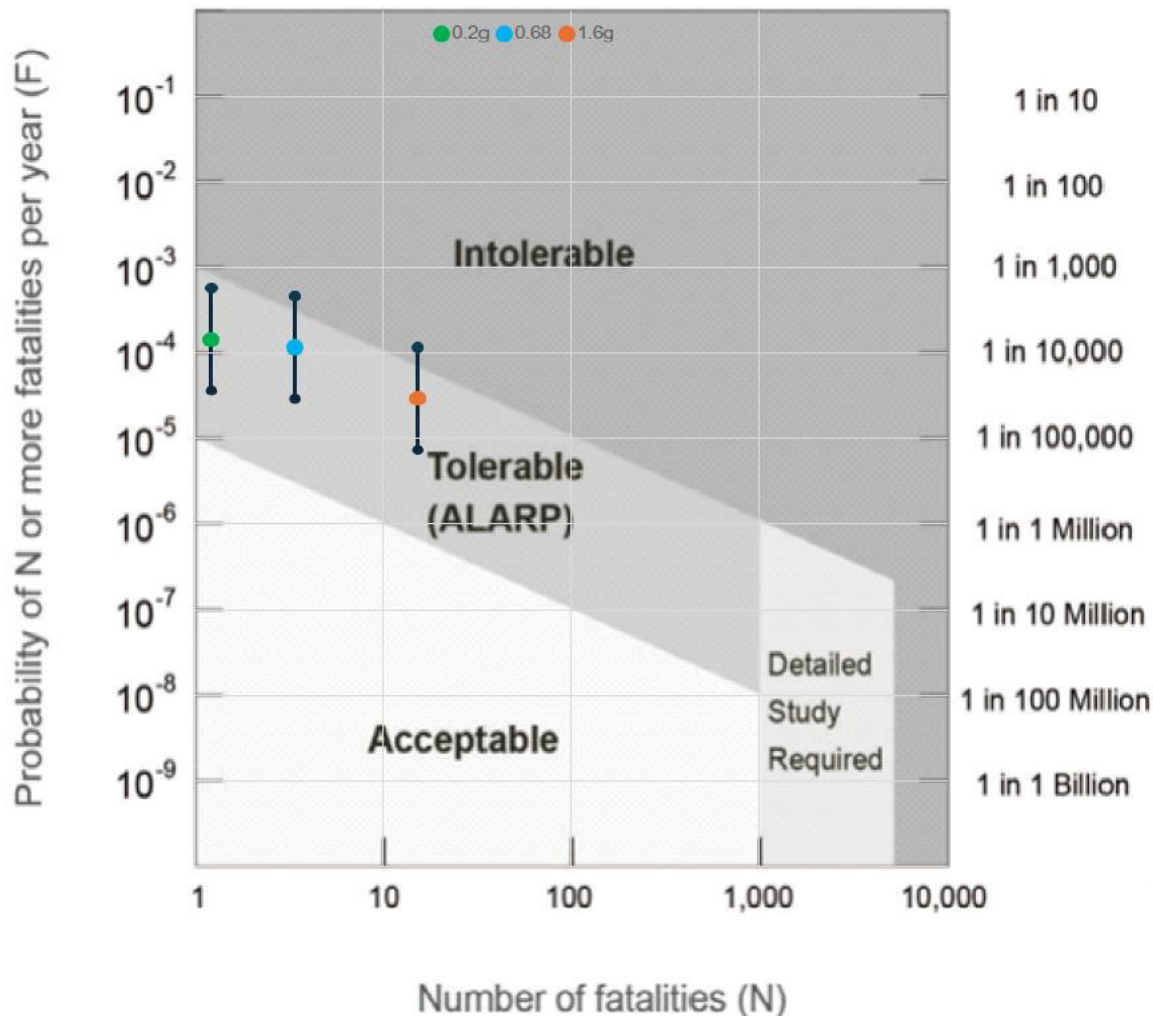
**Figure 11: F/N Curve for Proposed Lots Below the Slopes Above the Site Stage 4. (Societal tolerability framework from de Vilder et al., (2022))**

6. For lots where partial inundation is likely, a lower inundation depth was assumed, as demonstrated by the inundation height towards the edges of the lobe of the historical landslide. A probability of death of 0.3 was assumed.
7. Average occupancy rates have been assigned to properties depending on the intended number of bedrooms per property, with 2.5 occupancy for three-bed houses, and 3.5 for four-bed houses, in line with 2023 Census data. The total exposed population was then calculated by multiplying the number of partially and completely inundated lots by these occupancy rates.
8. This process was repeated for the three seismic scenarios, resulting in the F/N pairs displayed in Figure 11. Levels of societal risk have been calculated using event probability trees which are displayed in Appendix 9.

Using the system developed by Paul and Miner (2025) and outlined in AGS/NZGS (in prep) an uncertainty index ( $I_e$ ) of 17 has been assessed. For a landslide of moderate complexity, this implies an error range between the upper and lower probability of loss of life of 1.2 orders of magnitude, or +/- 0.6 orders of magnitude from the best estimate. This calculated uncertainty is reflected in the error bars in Figure 11.
