# Belmont Quarry Development – Part F

Substantive Application  
Appendix F.1.B.12 – Land Exchange Application  
- Geotechnical Report  
Winstone Aggregates

# Geotechnical Appraisal Report

Land Exchange Belmont Quarry  
Development Project  
Wellington

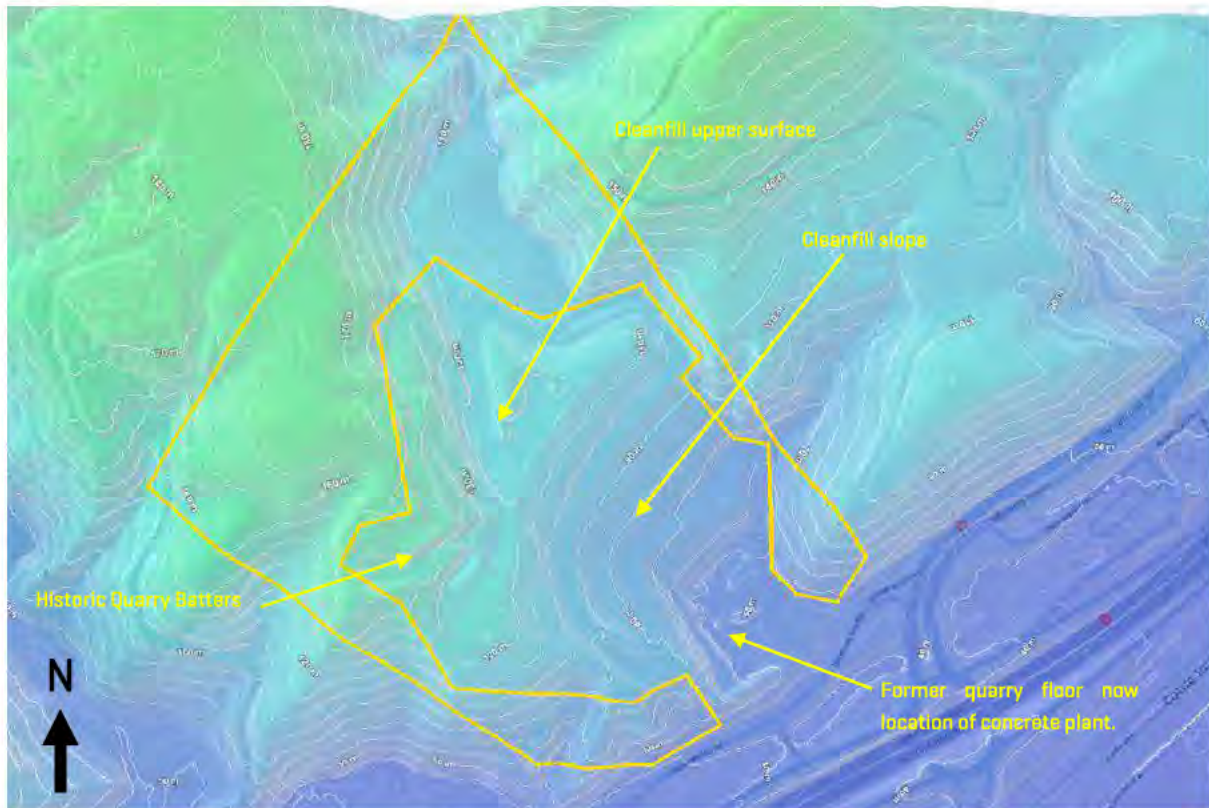
Figure 4-1: Lidar data for Dry Creek Site<sup>3</sup> and exchange boundary shown indicatively [source: Winstone Aggregates Propeller Site].

The cleanfill has been developed within a northwest to southeast orientated gully with adjacent ridges extending to an elevation of approximately RL 180 m. The cleanfill extends across the gully mouth terminating against the western and eastern slopes. The base of the cleanfill slope, is at approximately RL 50 m, with the crest of the existing cleanfill at approximately RL 120 m [Figure 4-1].

The remnant quarry batters range from 7 m high to approximately 20 m high with a batter angle of 65 to 75 degrees. Remnant benches and ramps range from 6 m to 10 m wide. The former quarry topography is clearly evident in recent lidar survey of the site [Figure 4-1].

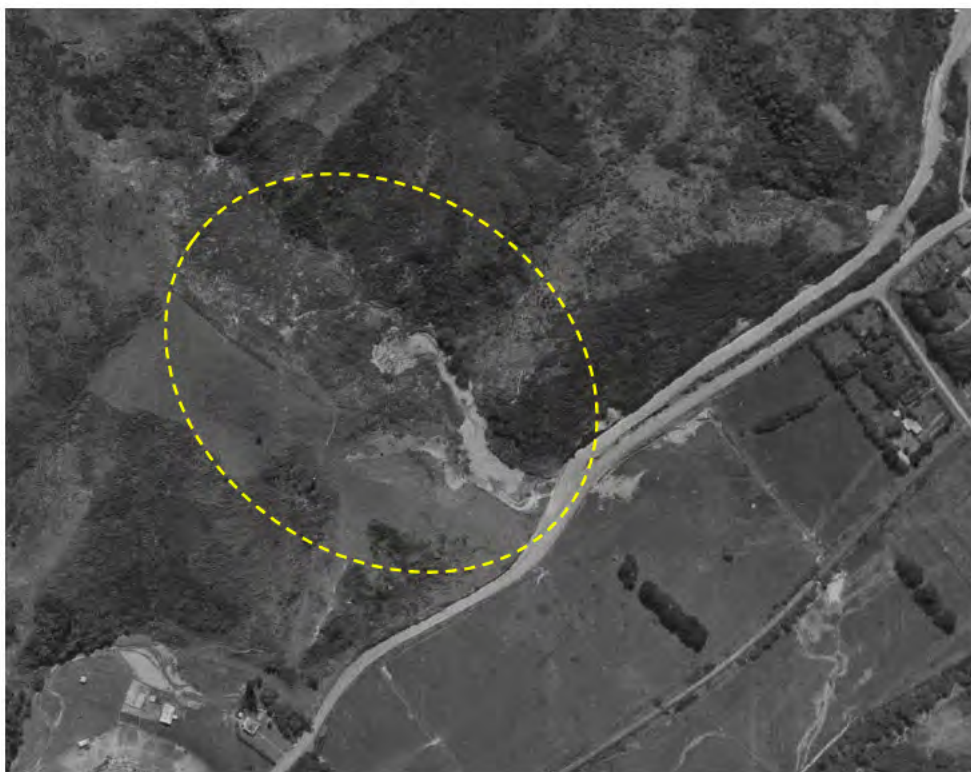
Figure 4-2: 1941 aerial image of site [retrieved from retrolens on 26 March 2021].

A quarry that potentially dates to the early 1940's previously occupied the site [Figure 4-2]. Based on an oblique photograph from 1992 [Figure 4-3], the quarry extraction process over this 50 to 60 year period excavated into the western slopes of the gully forming a series of benches and batters. The quarry exposed unweathered rock in the lower slopes and weathered rock in the upper slopes.

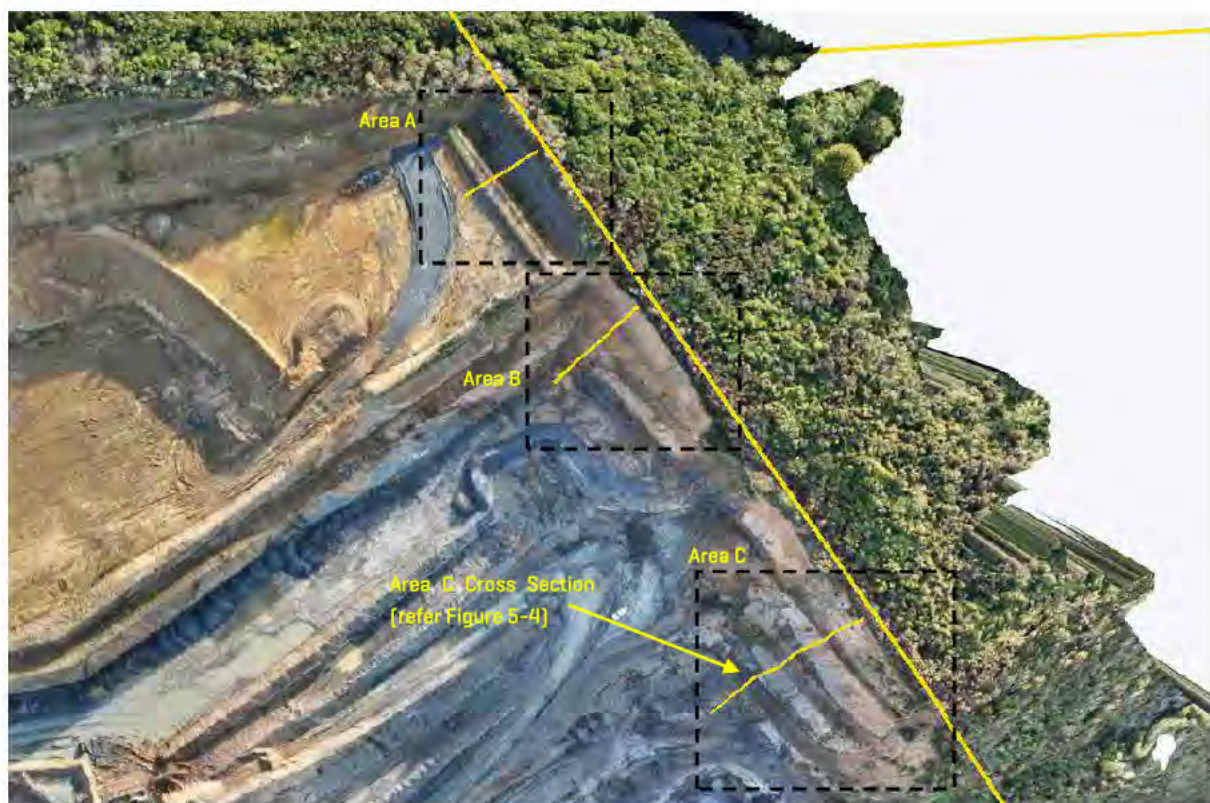
**Figure 5-3: Belmont East wall abutting the Firth Block.**

There are three key areas adjacent to the boundary where cut batters have been developed, as set out in Figure 5-3.

A localised area of slope failure has occurred at the far southern end of the cut batters in this area. This appears to have occurred in an area of deeper weathering of the greywacke, but also where the batters were rotated around to become more northwest-southeast trending as a tie-in to the ground surface. This change in geometry has allowed failure to occur on steep bedding, orientated oblique to the slope with breakout through the highly weathered rock mass. The instability extends through the upper two batters, with debris spilling onto the benches below. It is not clear whether this instability extends into the proposed land exchange area.

Based on our observations in this area, we consider that a 6 m zone measured from the crest of the slope back into the proposed land exchange area presents a higher risk of instability than would normally be accepted for a final cut batter adjacent to a property boundary. The basis for this zone is a hypothetical bench batter geometry of 10 m high batter slopes at 45° separated by a 5 m wide bench, which could be expected to perform acceptably in the materials observed.

While instability could be expected to develop slowly in this area due to residual strengths on defects in the weathered zone, if this zone is included in the land exchange, it would be prudent to exclude people from this area. This could be achieved by erecting fencing positioned a minimum of 6 m from the crest of the quarry batters in this area.

We note that the long term stability of the Firth Block land exchange parcel is reliant on the final design of the adjacent Belmont Quarry slopes. We recommend geotechnical verification of the final design for the quarry walls.

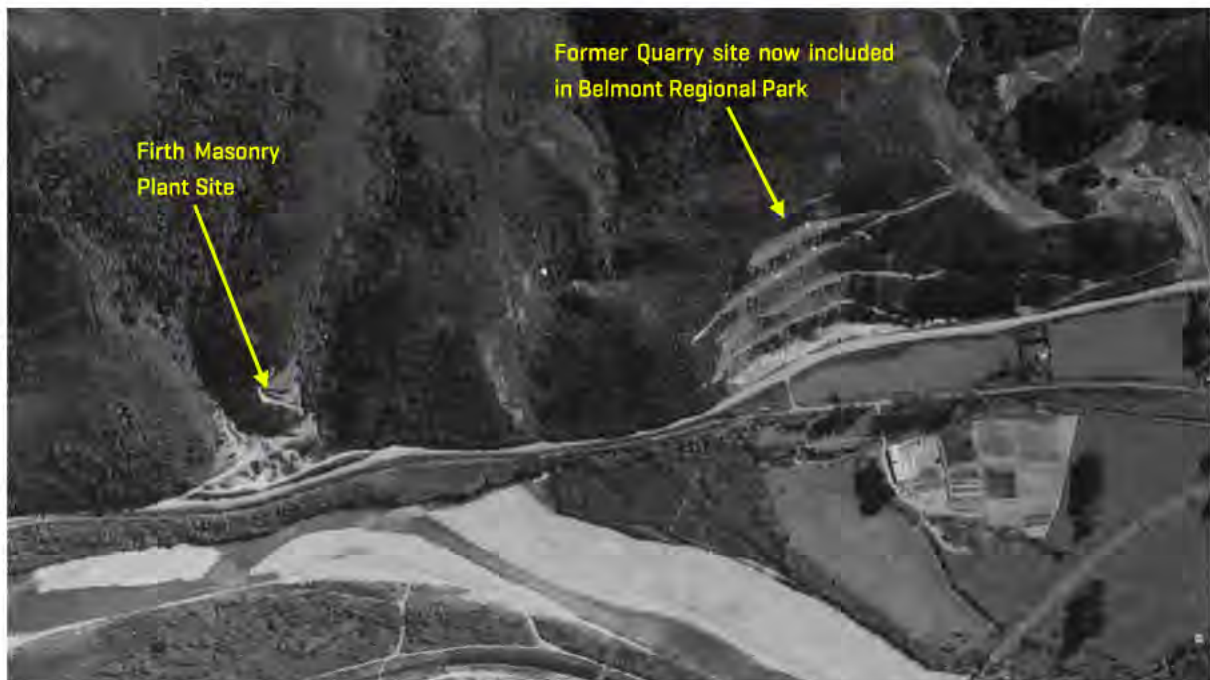
**Figure 5-6: 1957 aerial photograph illustrating historic quarry faces incorporated in Belmont Regional Park.**

We note that the conservation estate in this area already incorporates an old quarry site on Hebden Crescent, located between the Firth Block and Dry Creek Sites, which was later incorporated into Belmont Regional Park. Excavation at that site appears to have been undertaken in the 1950's and 1960's [Figure 5-6], with the site closed and beginning to revegetate in the 1974 aerial photographs. The remanent quarry batters at the Firth site are consistent with size and scale of those remnant batters that already exist within the Regional Park.
