Remarkables Ski Area Expansion Project Natural Hazards Assessment

Prepared for:
NZSki Limited

29 April 2026

Remarkables Ski Area Expansion Project - Natural Hazards Assessment

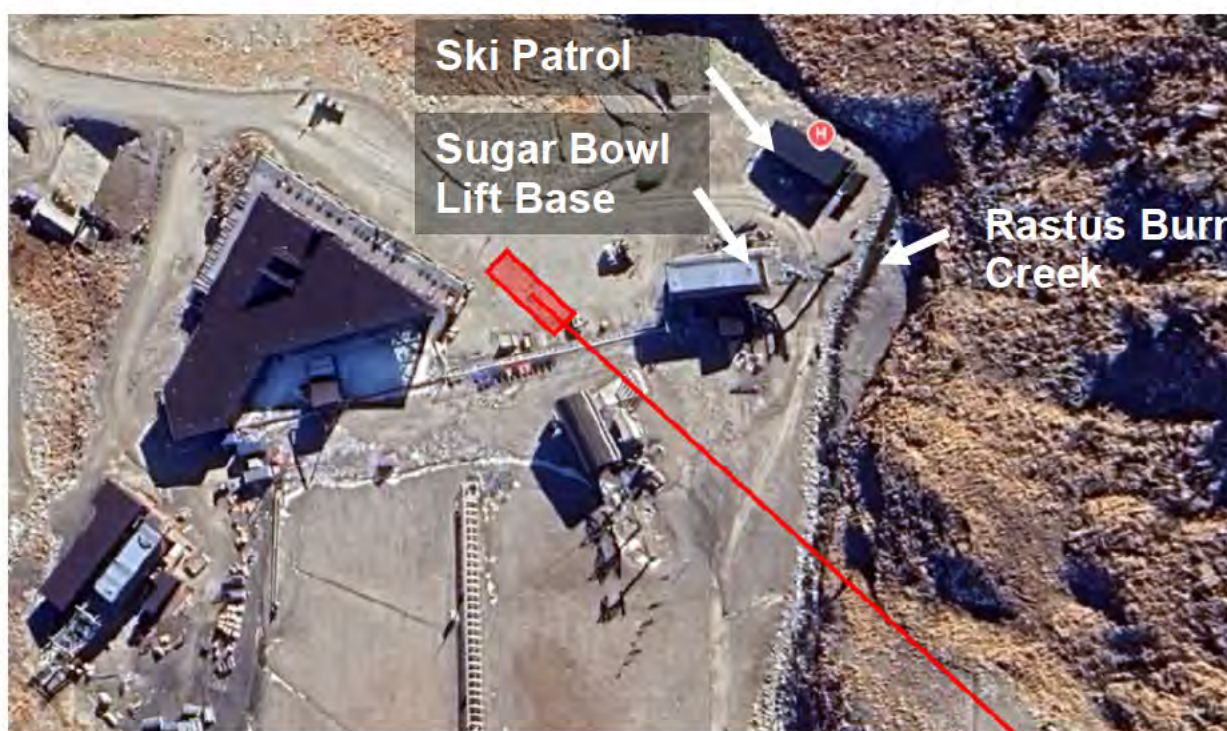
Figure 2. Nominal Location of Gondola Base Drive Station (red) and the Rastus Burn Creek.

The proposed gondola bottom drive station and the Base Building are adjacent to the vehicle arrival and Drop Zone area. This location is immediately west of the Rastus Burn Creek and the nominal location is shown in the figure below.

arrival and Drop Zone area and Buildings. This channel is visible in Figure 2 above as a snaking white line (because the channel is partially snow filled). In addition, if a super-design event does occur water flow will spread out onto the vehicle arrival and Drop Zone area and a degree of attenuation will occur, it is expected that should this occur much of the flow will dissipate over the vehicle arrival and Drop Zone area bank.

The measures undertaken to mitigate the risk of flooding at the Gondola Base Station and the Base Building include the previous engineered stream training for the Rastus Burn Creek described above. Secondary mitigation measures include localised surface flow redirection on the lower learners slope to redirect sheet flow into the Rastus Burn Creek rather than allowing this to flow directly into the vehicle

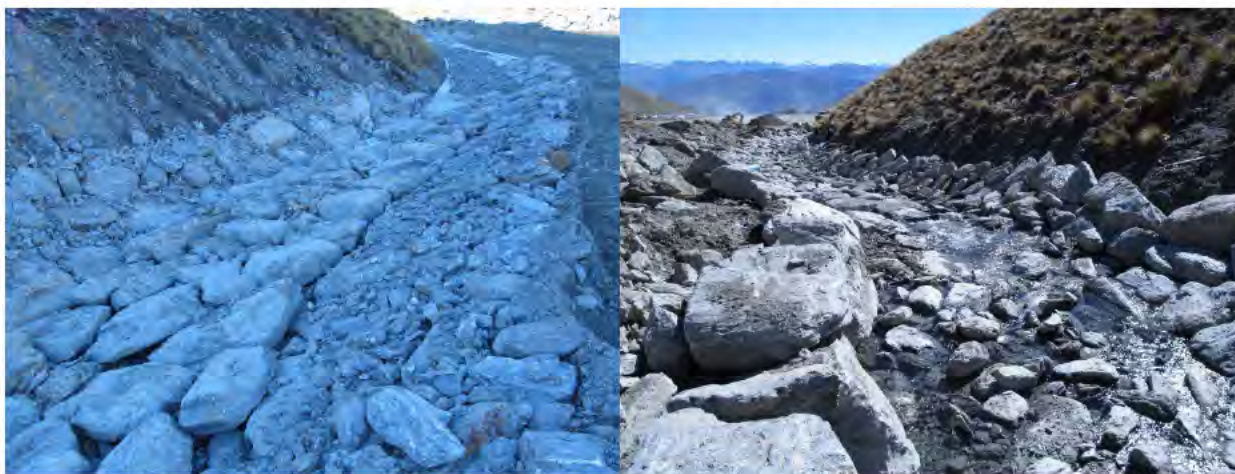
Figure 3. Rastus Burn Creek Stream Training and Armouring

The channel of the Rastus Burn Creek (adjacent to the learners' ski area), has been relocated from its original location and the channel cross section designed for calculated flows and lined with armouring rock with a designed minimum size. The creek bed was designed to convey a 1/100 ARI (Average Recurrence Interval) with a 600mm freeboard. The creek bed through the learners' slope and past the

Sugar Bowl Lift Base Station and the Ski Patrol Building has been armoured to protect against erosion. A photograph of the armouring during construction of the stream training is shown below.

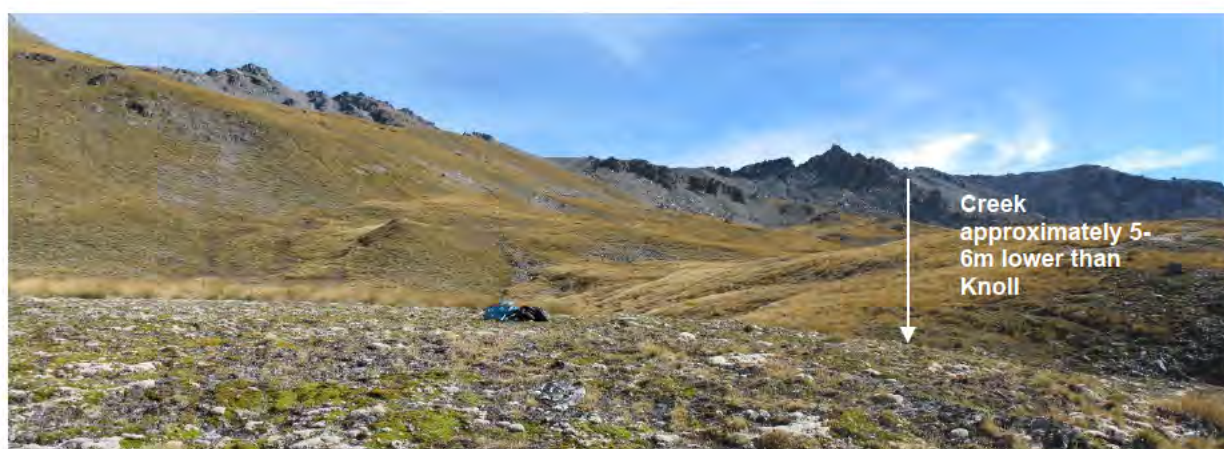
The gondola towers and mid stations are located away from watercourses and any potential flood risks. The proposed Gondola Return Station would be located adjacent to an unnamed creek on a rock knoll and there is approximately 5m height between the location of the top station and the adjacent creek bed. Consequently, the station location is not anticipated to experience flooding.

Figure 4. The Return Station Location and showing height distance to adjacent creek on the right

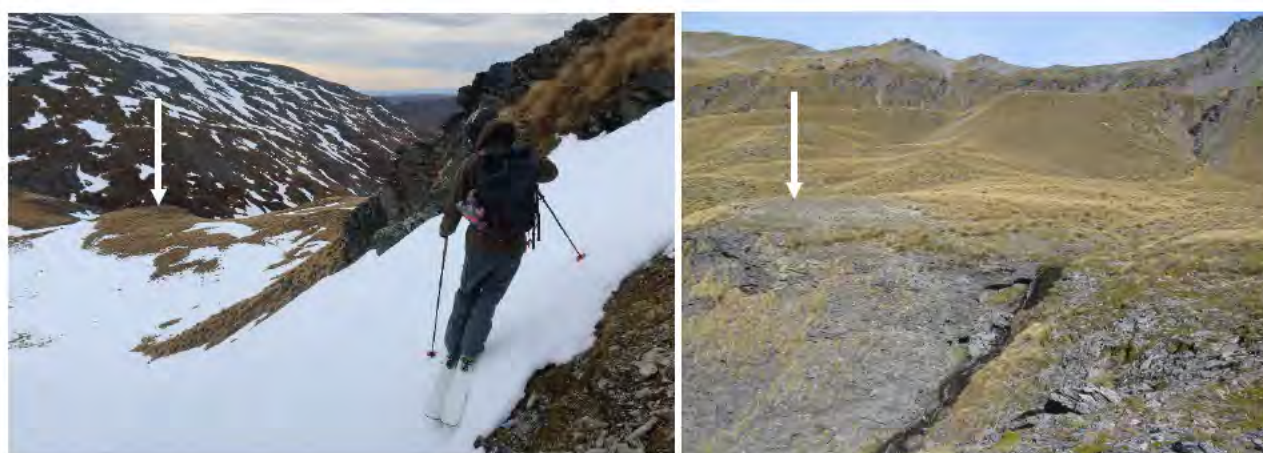
Figure 5. Location of the Gondola Return Station showing the freeboard to the adjacent creek. Return station location arrowed

The likelihood of flooding of the Doolans Gondola Station is assessed to be at Rare (because of the freeboard between the platform and the creek) and the consequence is assessed as Moderate. Thus, the risk of flooding to these facilities is low as identified in the matrix below. The presence of the

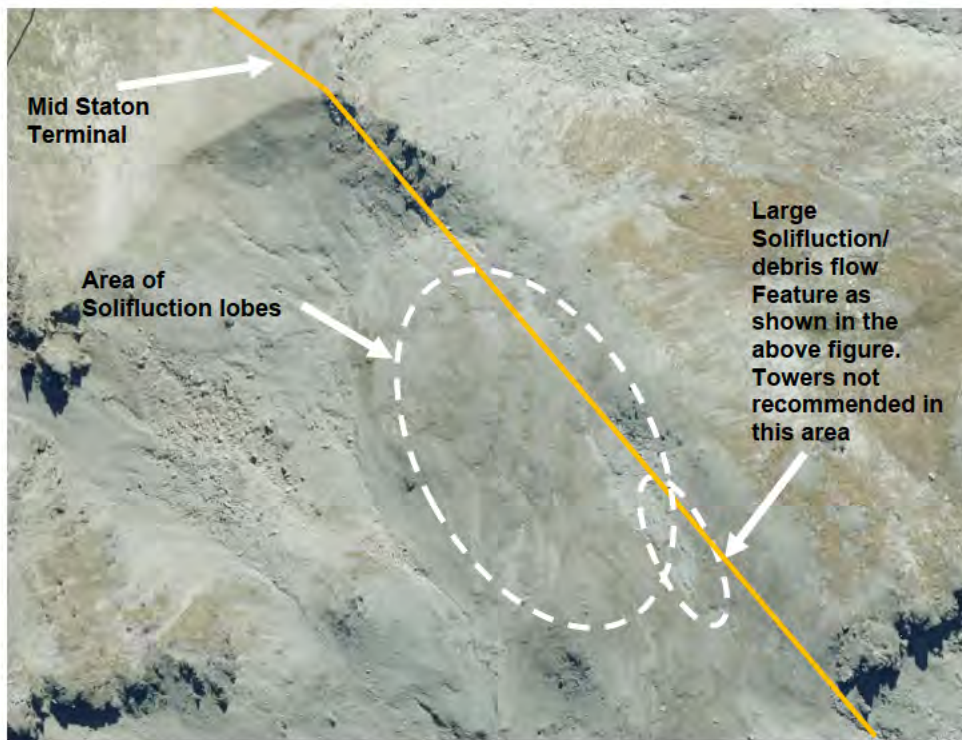
There is a significant solifluction lobe southeast of Helicopter Ridge which is sufficiently deep to be considered a minor debris flow. The flow speed of this feature has been a slow creeping movement, but the quantity of material involved is greater than typical solifluction lobes.

Figure 7. Debris flow & solifluction features in Upper Doolans Creek Right Branch

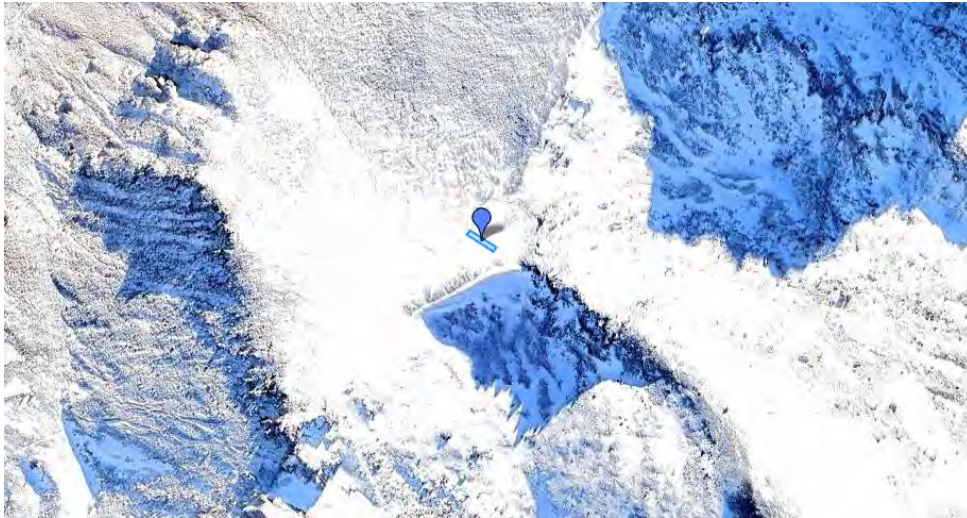
Figure 22. Site used for wind speed calculation of the gondola mid station

The windswept nature of the site is visible in the figure below. It is conceivable that the wind speed has been a contributing factor to surface erosion at the site.

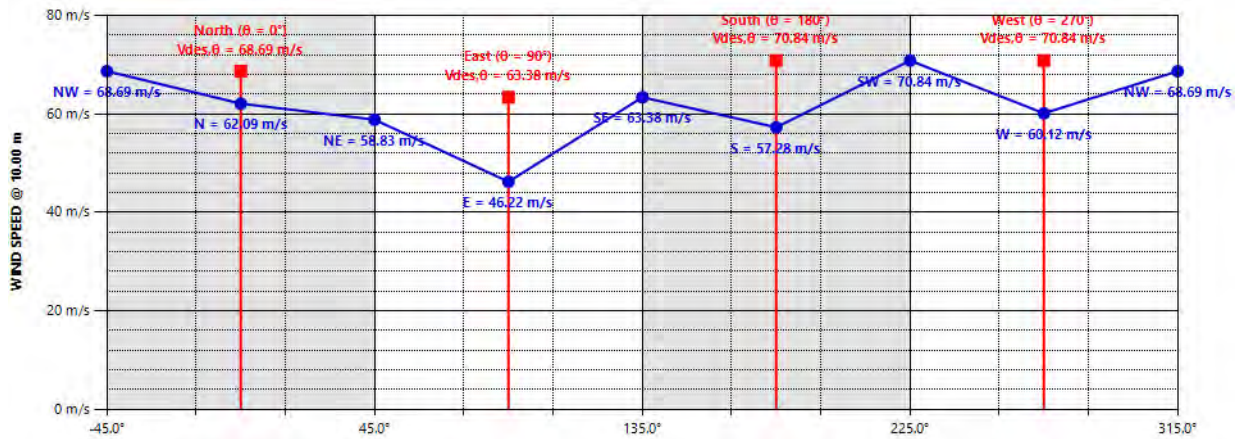
The maximum wind speed calculated for a 1/500-year event for the Doolans return terminal using NZS 1170.2 with the dimensions above, is approximately 71m/s or 255 km/h and is from the west. This wind speed is typical for this type of installation in the area and less than experienced in exposed locations. Chair lift top stations are typically exposed to wind speeds of up to approximately 300 km/h. The wind speed calculations for the Doolans return terminal site are shown in the figure below.

Figure 25. 70.84 m/s wind speed at 10m height for 500-year ARI at Doolans Creek Right Branch Gondola Return Terminal using the 1170.2 methodology

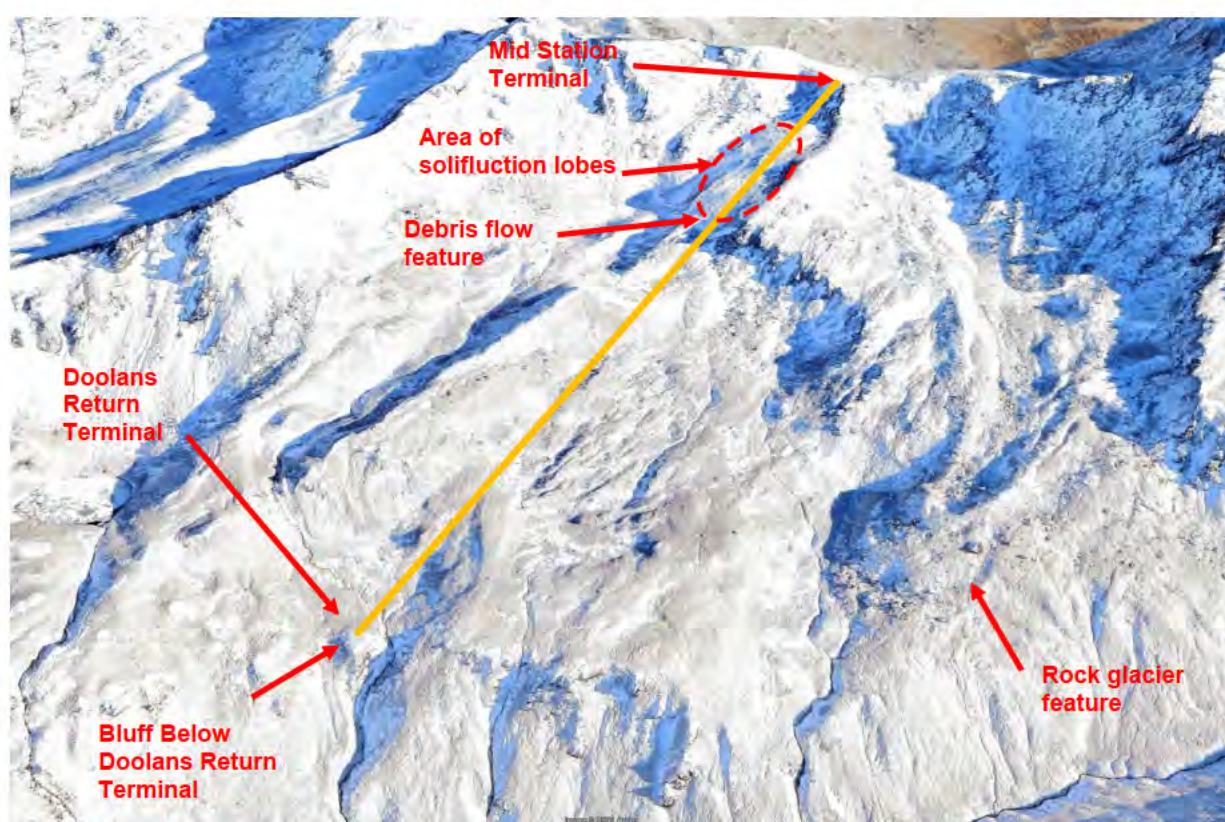
We note there is a large rock glacier feature within the Upper Doolans Creek Right Branch. This is an ancient feature and is no longer moving as there is no longer permanent ice in the area. The last glaciation in the area was the Ōtira Glaciation, which was at a peak approximately 16–18,000 years ago, and ended approximately 10,000 years ago.

Figure 30. Large rock glacier feature (arrowed) and the approximate gondola alignment and features in Upper Doolans Creek Right Branch

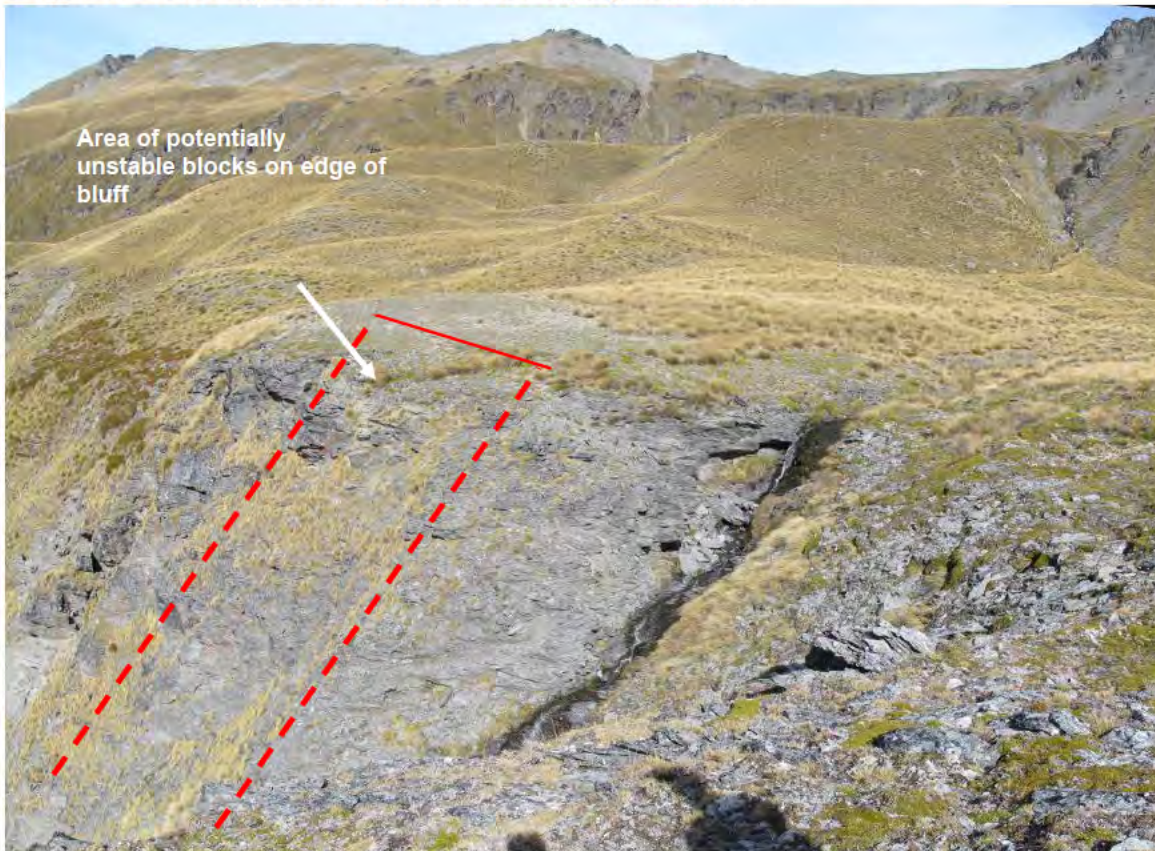
The Doolans Return Terminal is located above, and near, an existing bluff. In this location the foliation of the schist is favourable and approximately horizontal and thus there is a low risk of sliding along the schist planes. No signs of settlement or land movement were detected in the area but there remains a potential risk of localised block toppling failure or failure along joints at the upper part of the feature which may compromise the station foundations. A preliminary assessment indicates that it is prudent to found the base station approximately 15m from the bluff shoulder as this places the station beyond unstable joint sets which are potentially unstable. Visual inspection of the site did not detect evidence of significant joint sets which could pose a risk of block toppling. As part of detailed design further

Figure 31. Bluff and nominal location of Doolans Terminal structure

investigation is recommended to confirm this. Should investigation identify joint sets be located which may compromise the founding of the Gondola Return Station this risk can be mitigated by drilled ground anchors to secure any such blocks to the underlying rock mass.

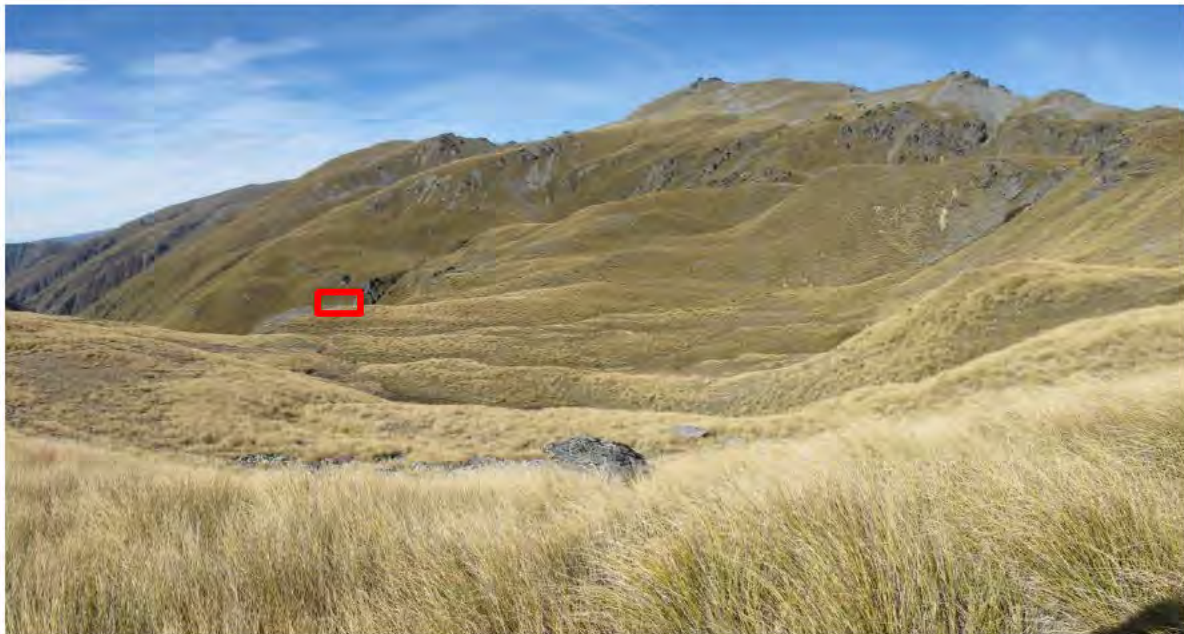
Figure 32. Nominal Doolans terminal location viewed looking east

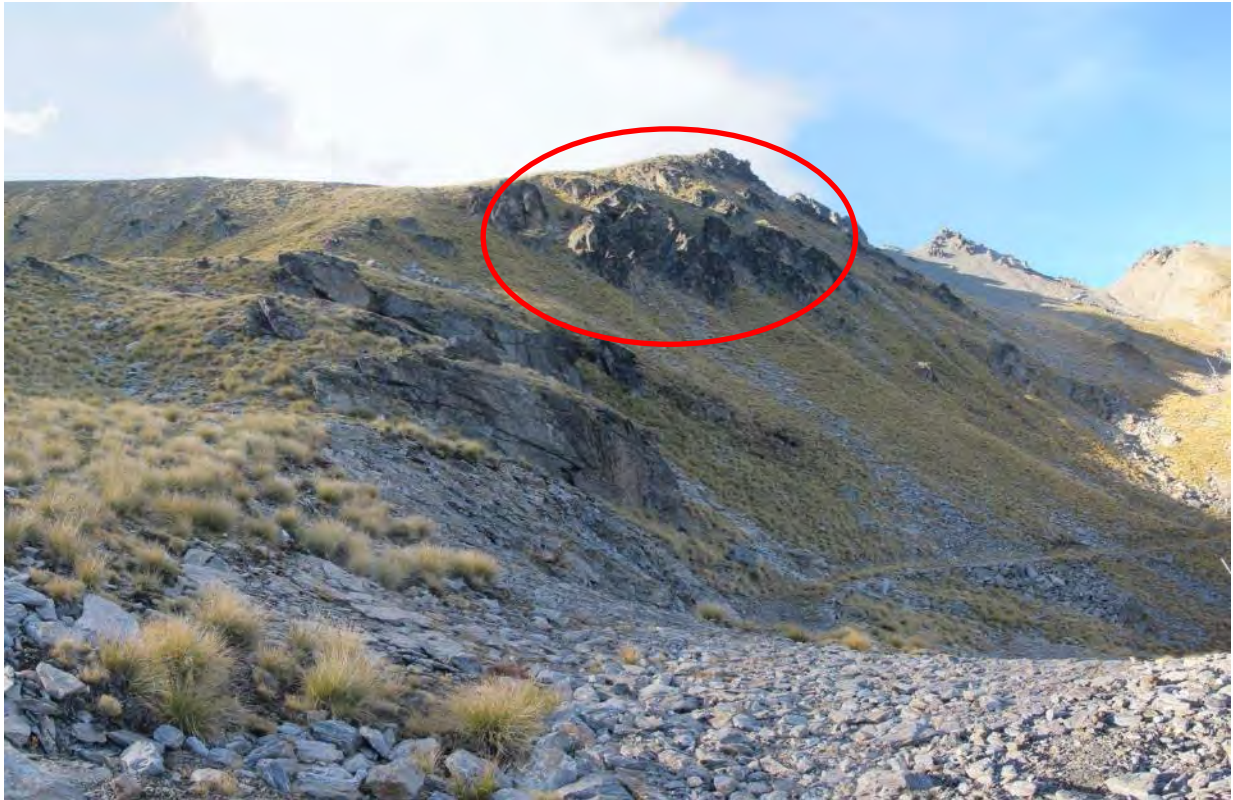
Figure 33. Gallipoli Chutes

On the north-western (the existing Remarkables Rastus Burn Ski Area) side of Helicopter Ridge, the gondola line passes over bluffs known as the Gallipoli Chutes. This area is shown in the figure below.

Within the chutes there are a number of perched rocks which are at risk of becoming unstable, particularly in an earthquake. These features are shown in the figures below.

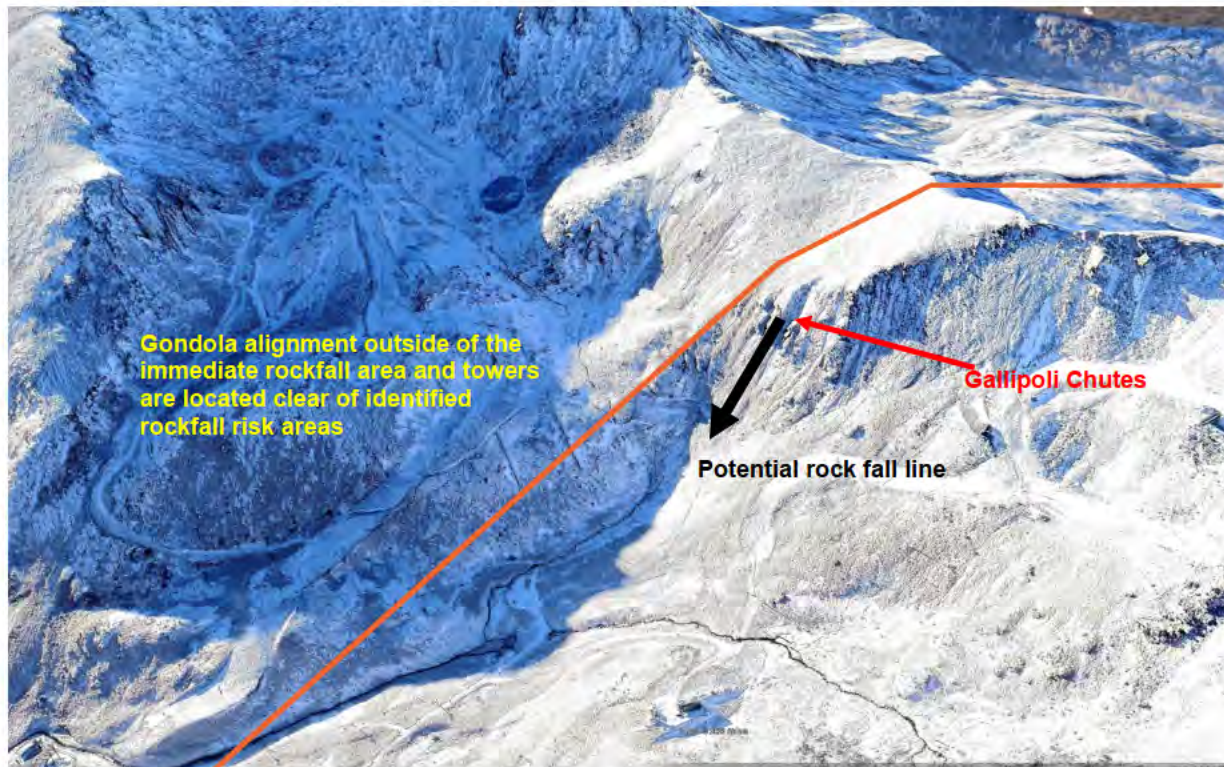
The risk of damage to gondola infrastructure from rocks falling from Gallipoli Chutes is low because the lift towers will not be located in an area identified as being threatened by rockfall. This is demonstrated in the figure below.

Figure 35. Gondola alignment vs potential rockfall line from Gallipoli Chutes

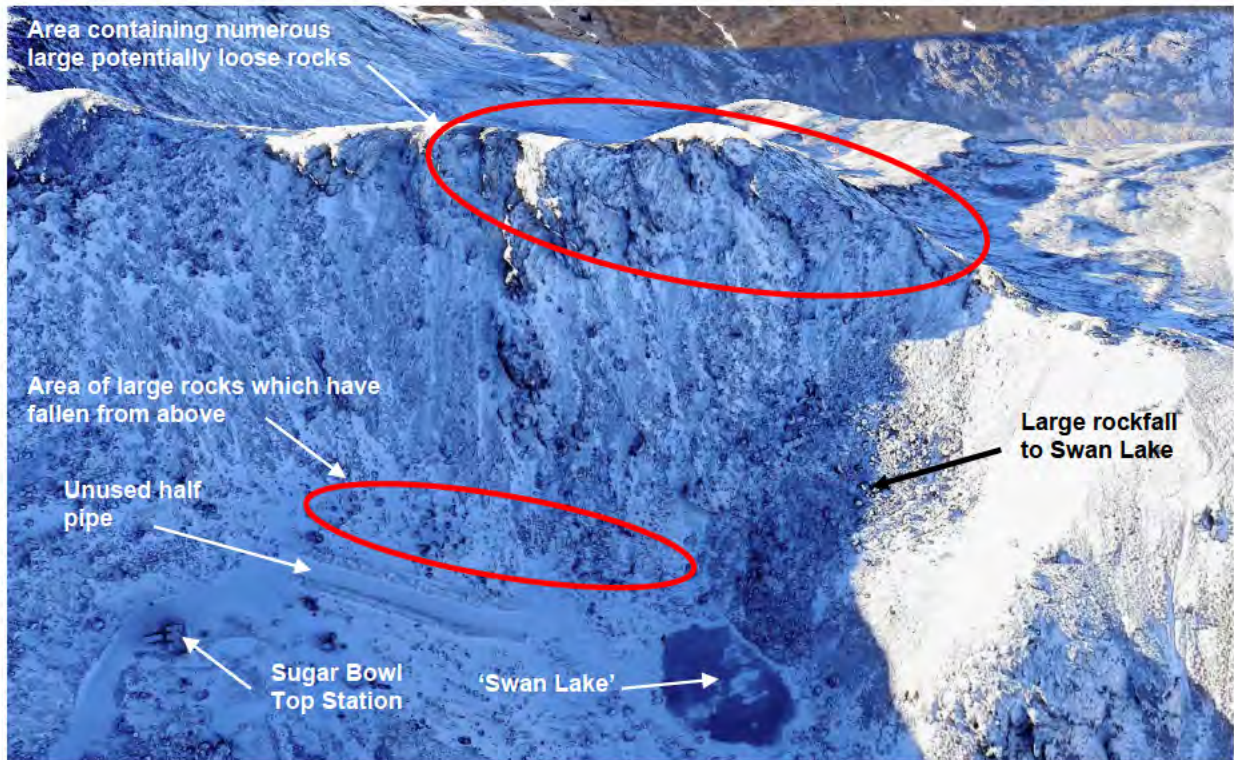
An access route is proposed to be constructed between the top of Sugar Bowl lift and Helicopter Ridge. This alignment traverses below a steep rocky ridgeline. This rocky ridgeline contains numerous large and potentially unstable, rocks. The apron below this area contains numerous large rocks which have fallen from the bluffs above. Immediately above 'Swan Lake' is a very large rockfall feature where a significant part of the ridgeline has collapsed and fallen to Swan Lake Below. These features are indicated in the figures below.

Figure 38. Ridge features between Sugar Bowl and Helicopter Ridge

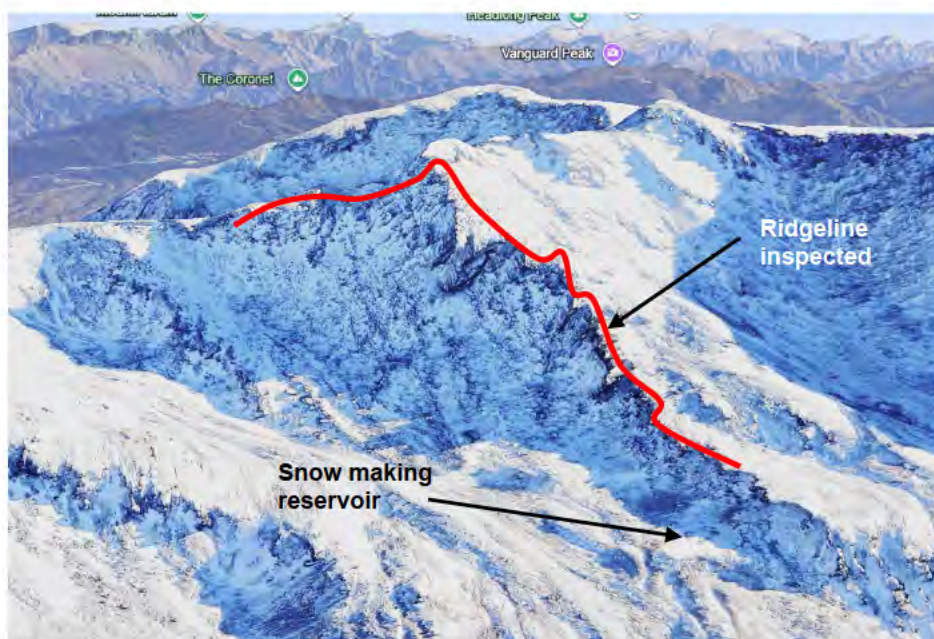
There is a rocky ridge extending southeast toward the proposed snow making reservoir. This ridge contains a number of rocky tors and has been inspected to identify rockfall risk. This ridge line is indicated in the view below.

Figure 43. Ridgeline above snow making reservoir

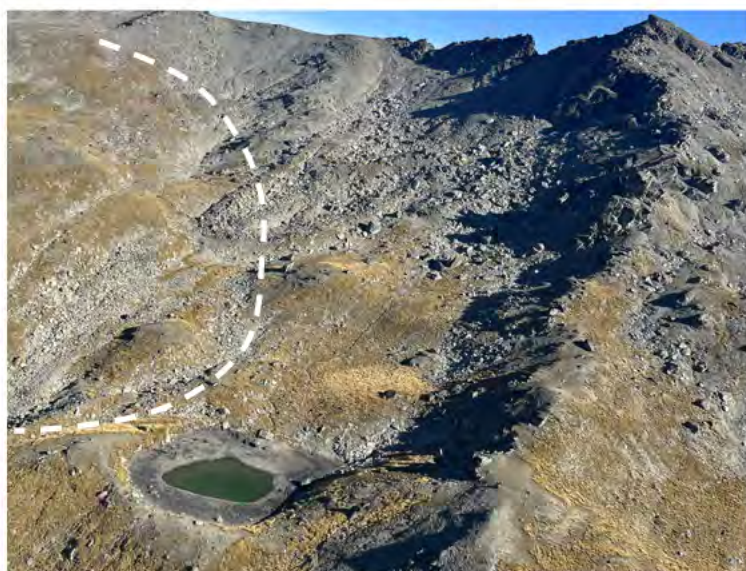
Figure 44. Ridgeline above Snow Making Reservoir, nominal route of trail and access marked in white

Rock mass stability along this ridge is controlled by block sliding along the dip of the schistosity. There are numerous large blocks which have detached from the rock along the ridge and slid/toppled to the scree slopes below. Most blocks which are potentially unstable appear to have previously detached

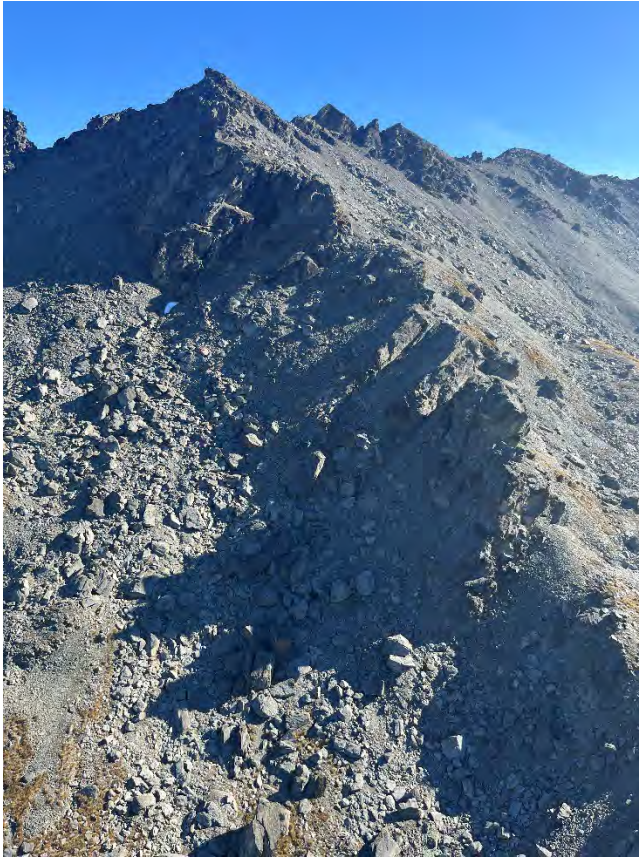
from the ridge and there are few significant remaining blocks. This is shown on the figure above and below.

Figure 45. Ridge line and schistosity dipping to bottom left

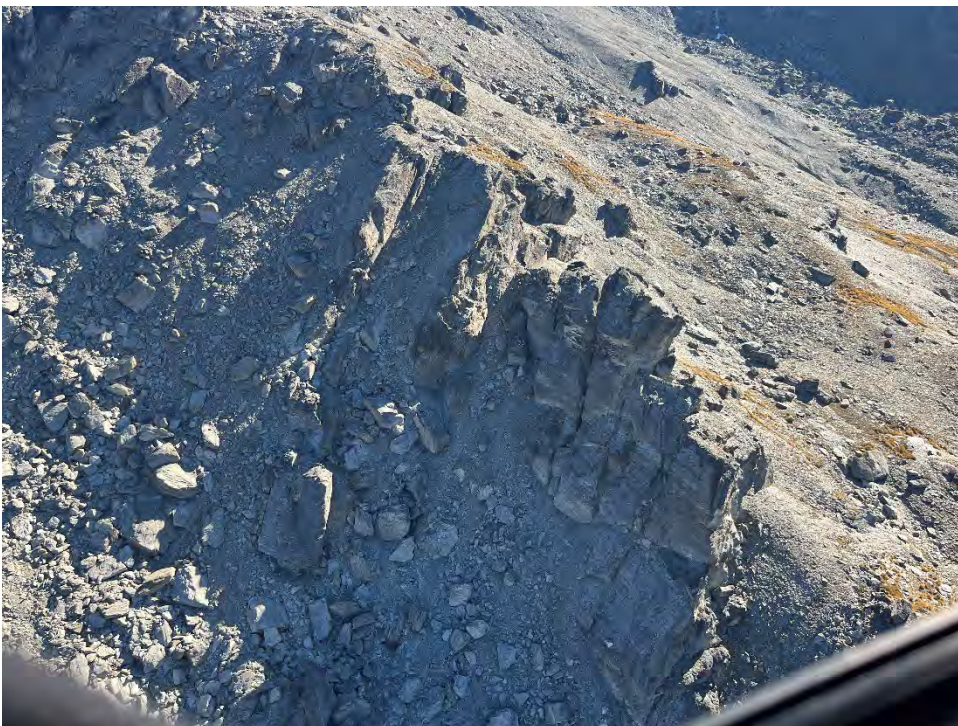
On the bottom section of the ridge there are a number of tors above talus slopes. There are few perched blocks in this area, and larger blocks are embedded within the scree. The tors and scree blocks are shown in the figure below.

Figure 47. Tor section of ridge above snow making reservoir

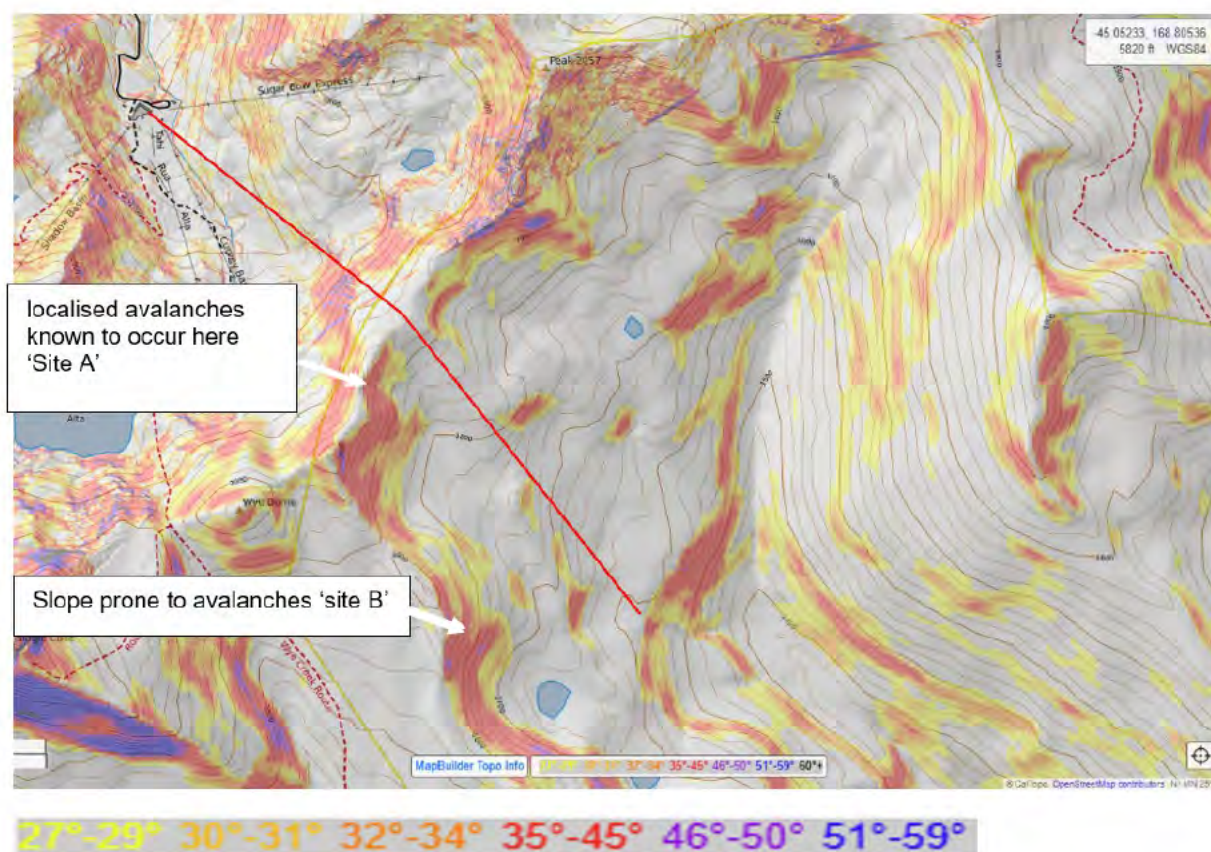
Along the gondola alignment within Upper Doolans Creek Right Branch, below the headwall to Helicopter Ridge, the slope averages approximately 13 degrees (a change in level of 300m over 1,300m) and consequently there is a reduced occurrence of natural avalanches occurring. A map of the slope gradient is shown below which indicates that the slope is less than 27 degrees and consequently naturally occurring or human triggered snow avalanches are rare in this area.

The slope to immediate south-east of Helicopter Ridge is sufficiently steep that localised natural or human triggered avalanches do occur on this slope. This is also a known risk and will be managed as part of the Remarkables Ski Patrol's active avalanche management programme. In this area the gondola rope will span over the slope and there is little risk to either the towers or other infrastructure. This is shown in the figure below.

Figure 50. Slope angle map showing gondola alignment in Upper Doolans Creek Right Branch showing a slope of less than 27 degrees

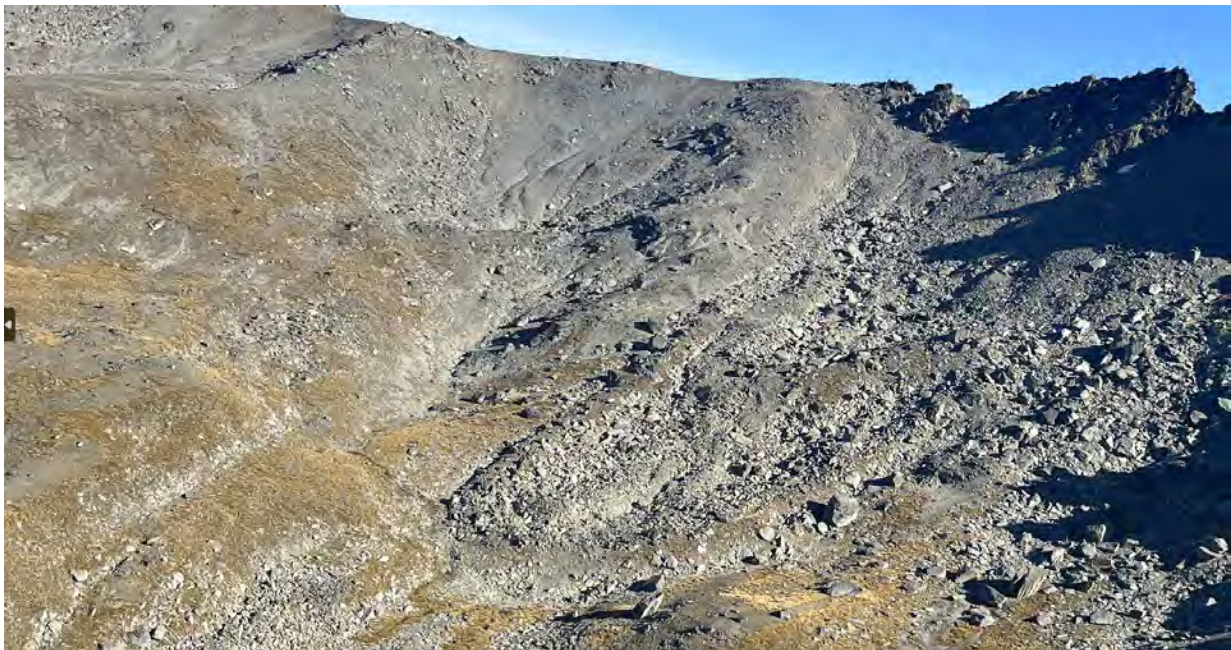
Within the Upper Doolans Creek Right Branch the area of development is in relatively benign terrain. There are some significant and spectacular ancient 'Rock Glacier' features, but these are no longer active. The rock glacier and the upper basin is shown in the figure below.

Figure 53. Ancient and inactive rock glacier feature in the Upper Doolans Creek Right Branch, with some solifluction lobes on the left of the image

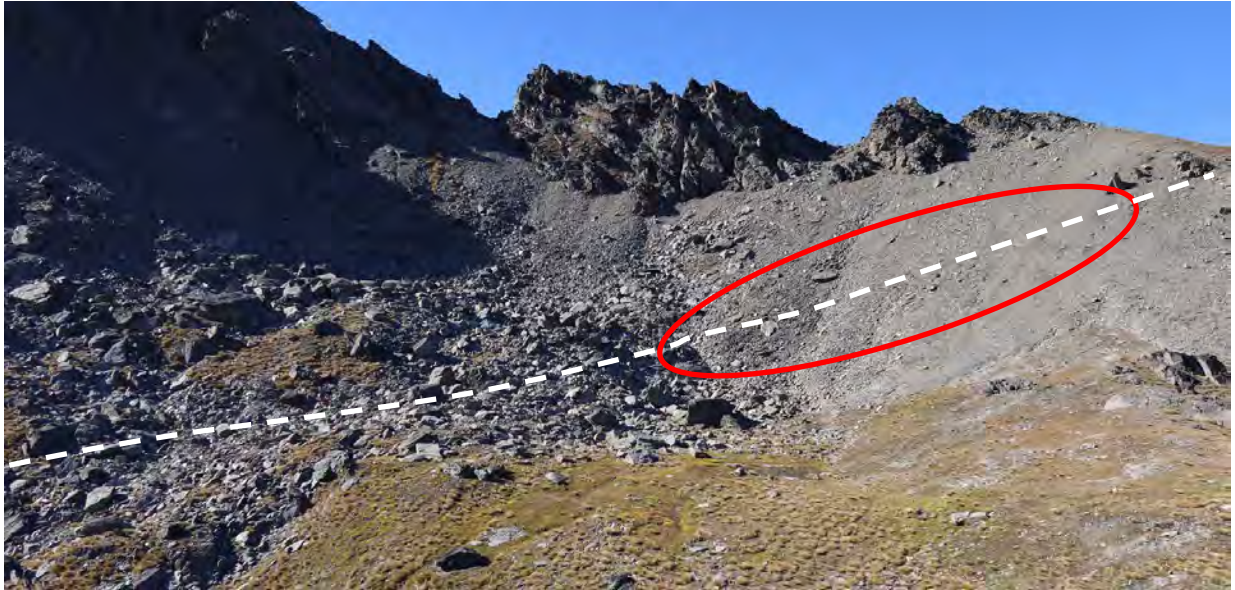
The proposed access route between the top of Sugar Bowl and Helicopter Ridge traverses steep scree terrain. We anticipate that over parts of this route the formation will be difficult to support to current accepted standards. This area is considered to be at the area of greatest potential for localised slope instability. Cutting the access formation into the slope likely to cause areas of upslope instability. Down slope the scree is sufficiently steep that retaining of the formation on the downhill side is also difficult to achieve with a practical and economic solution. This area is shown below.

Figure 54. Nominal route of proposed temporary construction access immediately north of Helicopter Route shown in white. Area of very steep scree indicated in red

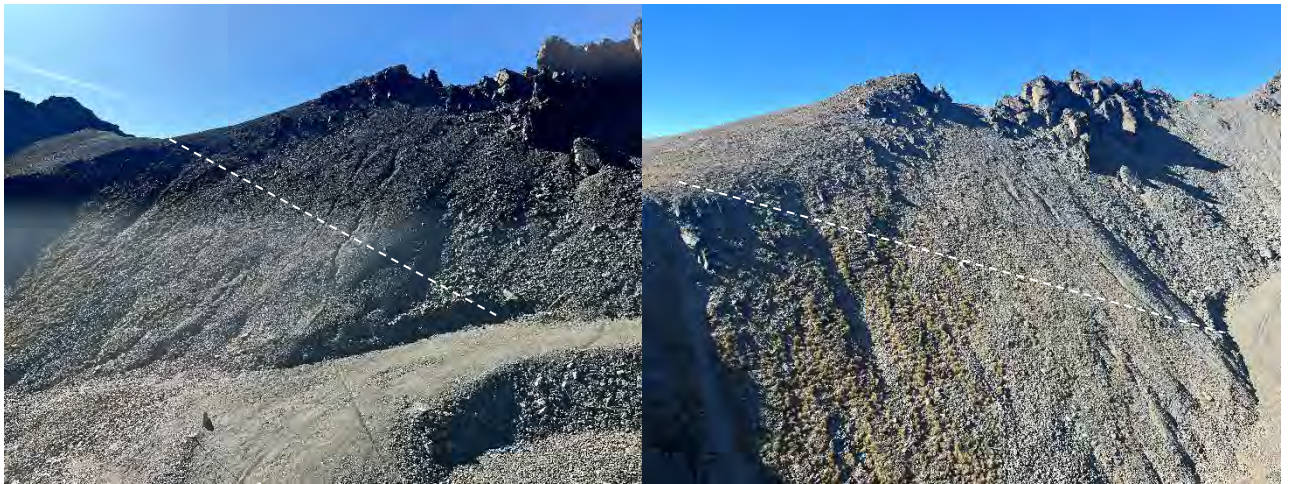
It is proposed to provide a service corridor and potential trail route between Helicopter Ridge and Curvey Basin. This route traverses a scree slope above the existing Curvey Basin trails. This is shown in the figures below.

Figure 55. Nominal permanent access and service route between Helicopter Ridge and Curvey Basin

The gradient and existg slope on the route between Helicopter Ridge and Curvey Basin is consistent with other accesses constructed at the Remarkables as part of recent developments which have remained stable.
