Haldon Solar Project Integrated Transport Assessment

Prepared for: Lodestone Energy Limited

Prepared by: Stantec NZ

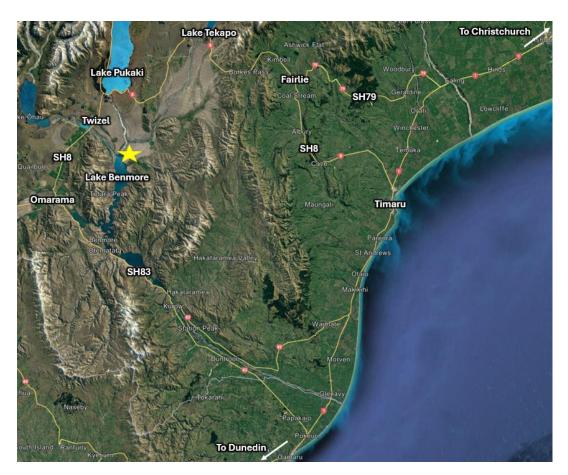
The proposed solar farm site (the Site) is part of Haldon Station, which is located approximately 14km southeast of Twizel (as a "crow fly distance"), adjacent to Lake Benmore. Figure 2-1 shows the location of the Site in the context of the wider area.

Figure 2-1: Site Location (Yellow Star) in Wide Area Context (Aerial Image Source: Google Earth)

Figure 2-1 shows the Site's location relative to the State Highway (SH) network. SH8 runs from SH1 in Washdyke (north of Timaru), through Fairlie, Lake Tekapo, and Twizel in the Mackenzie District, and further south through Omarama and into Central Otago. SH79 runs from SH1 at Rangitata through Geraldine to SH8 at Fairlie. SH83 runs up the Waitaki Valley, from SH1 at Pukeuri to SH8 at Omarama.

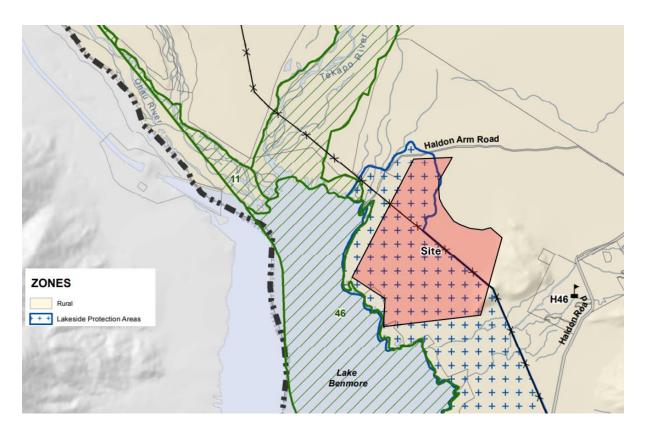
The Site is zoned Rural in the District Plan as shown in Figure 2-2.

Figure 2-2: Site Zoning (Source: Mackenzie District Council)

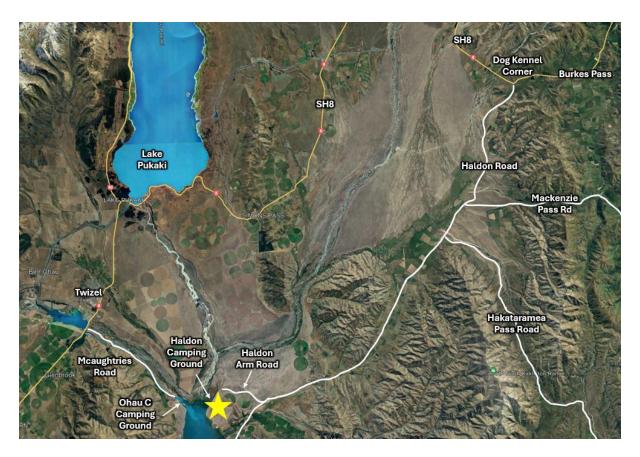
The location of the Site in relation to the local road network is shown in Figure 3-1. The Site is located approximately 40km south-west of Dog Kennel Corner on SH8, which is between Lake Tekapo and Burkes Pass. Vehicle access to the Site is via Haldon Road and Haldon Arm Road.

Figure 3-1: Site Location (Yellow Star) in Local Road Network (Aerial Image Source: Google Earth)

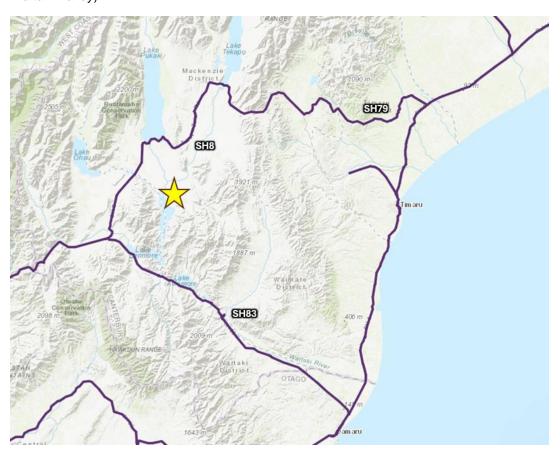
The below shows State Highway high productivity motor vehicle (HPMV) routes. These are routes that have been approved to carry 'Full HPMVs', which are trucks able to operate above the current 45/46T weight limit under permit. According to NZTA, this map can be used to plan routes and apply for a higher mass HPMV permit. The section of SH8 between Pleasant Valley and Fairlie is not included, however there are routes from the north (SH79 via Geraldine) and the south (SH83 via Waitaki Valley).

Figure 3-2: State Highway HPMV Routes

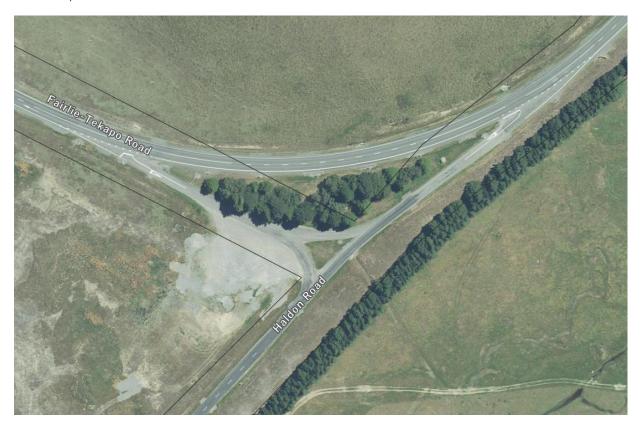
Haldon Road meets SH8 at 'Dog Kennel Corner'. Haldon Road splits and meets SH8 at each end of the curve, as shown below.

Figure 4-1: SH8 Dog Kennel Corner Boundaries

The SH8 curve has an 85km/h advisory speed. Vehicle speeds for design purposes in the order of 100km/h can be expected on such a curve. NZTA requirements for sight distances at intersections to observe potentially conflicting vehicles reference Austroads. That specifies a safe intersection sight distance (SISD) for a 100km/h design speed of approximately 250m, and for the advisory 85km/h speed approximately 200m.

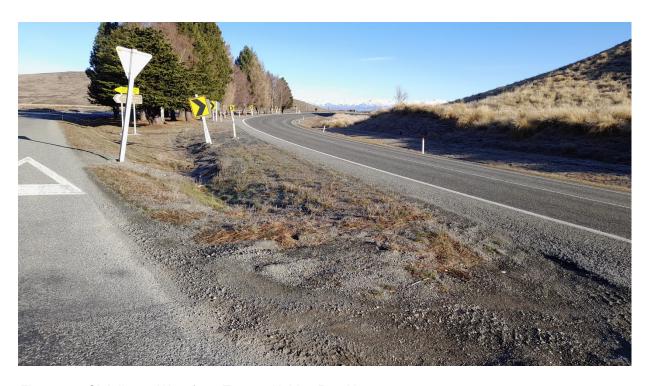
Figure 4-2: Sightline to West from Eastern Haldon Road Leg

The alignments of the two Haldon Road approaches to SH8 mean that drivers must look behind to see vehicles approaching from the curve. Drivers exiting towards the east are required to cross the

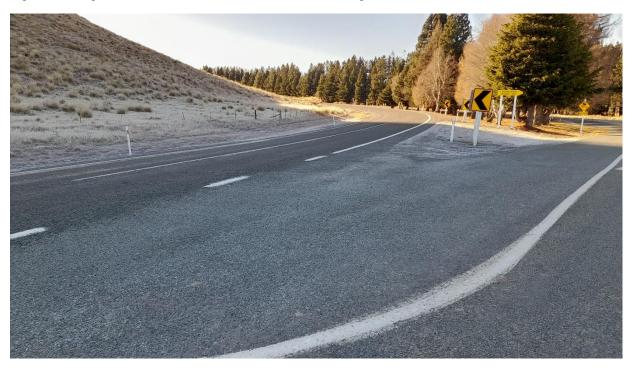
Figure 4-3: Sightline to East from Western Haldon Road Leg

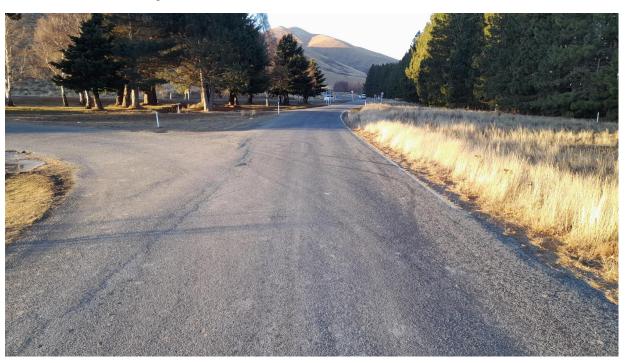
The two Haldon Road legs meet at a form of Y-intersection, with the western leg curving around into the main Haldon Road alignment, as shown below. The intersection is uncontrolled.

Figure 4-4: Intersection of Haldon Road Legs

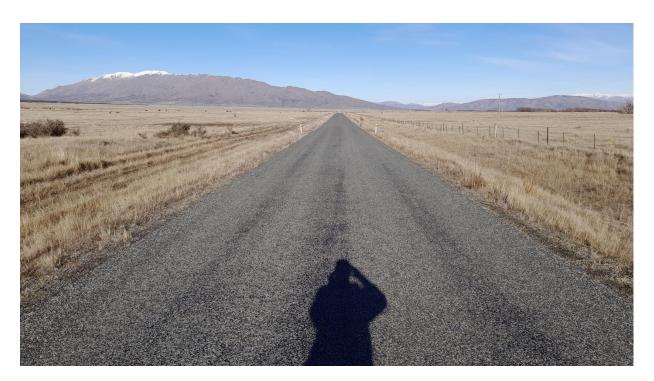
The road is generally flat and straight, with good forward visibility along most of the route. A typical view is shown in the following photograph.

Figure 4-5: Typical Sealed Section of Haldon Road

Carriageway widths vary, with much of the sealed section having widths in the 5.8m-6m range which is marginal for two-way heavy vehicle movement passing without using some of the unsealed shoulder, but acceptable for low volume usage where good visibility forward is available. Some localised sections of seal are narrower than this. Generally, the road does not have edge break, with only minor edge break noted in a limited number of locations.

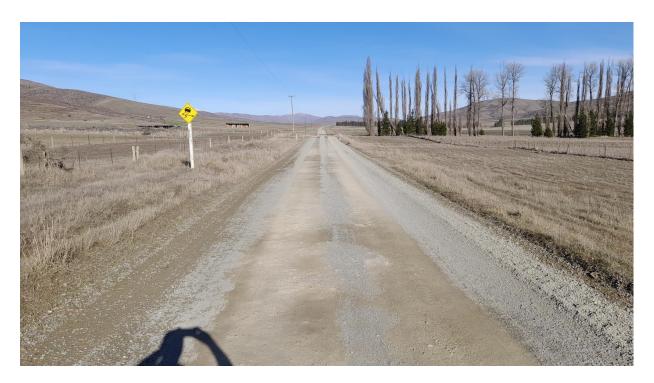
The unsealed section of road is also generally flat and straight, with good forward visibility along most of the route. A typical view is shown in the following photograph.

Figure 4-6: Typical Unsealed Section of Haldon Road

The initial gravel road sections (approximately 10km) are generally wide at approximately 6.5m.

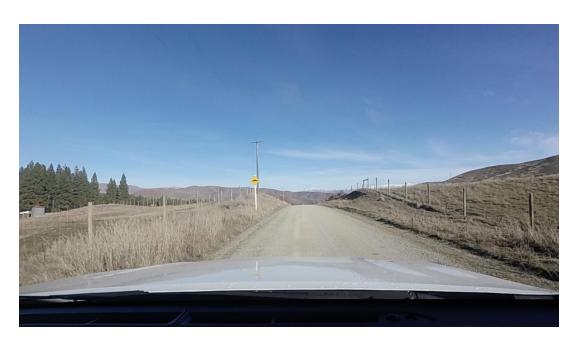
A series of curves from approximate chainage 28.400 to 29.100. As shown below there is a
permanent 'Hump' warning sign in advance of a crest curve with limited visibility within this
section of road.

Figure 4-7: Permanent Hump Warning Sign

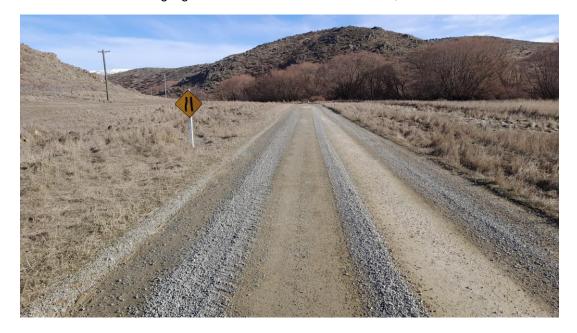
• A series of curves from approximate chainage 33.500 to 34.400. There is a permanent Road Narrows warning sign in advance of this section of road, as shown below.

Figure 4-8: Approach to Narrower / Winding Section of Haldon Road (Chainage Approx. 33.500)

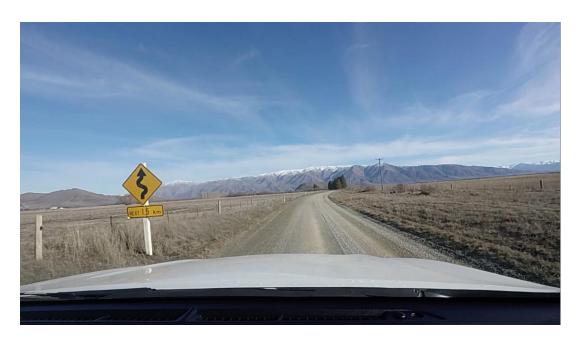
A series of curves over the last 1.5km of Haldon Road before the Haldon Arm Road intersection. There is a permanent Reverse Curve warning sign in advance of this section of road, as shown below.

Figure 4-9: Warning Sign for Section of Haldon Road in Advance of Haldon Arm Road

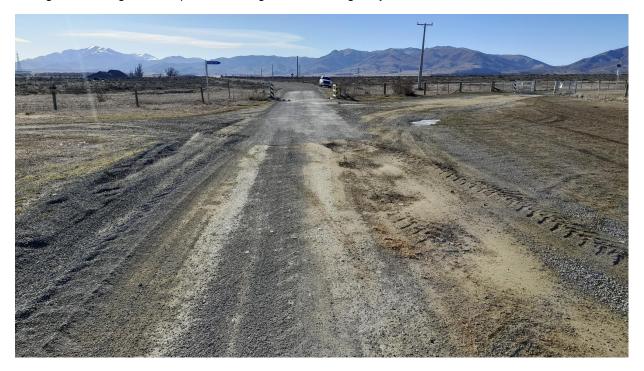
Sections of the road and particularly the unsealed sections were noted to be in poor condition. There are locations with potholes (for example the below near the Hakataramea Pass Road intersection), corrugations and gravel heaped at the edge of the carriageway.

Figure 4-10: Poor Road Condition at Hakataramea Pass Road Intersection

The pre-construction condition survey would highlight any existing road sections in poor condition so that this is not attributed to construction traffic. It is recommended that areas in poor condition (such as the area described in Section 4.3.2) be improved with a suitable running course ahead of construction to support safety of vehicle movements.

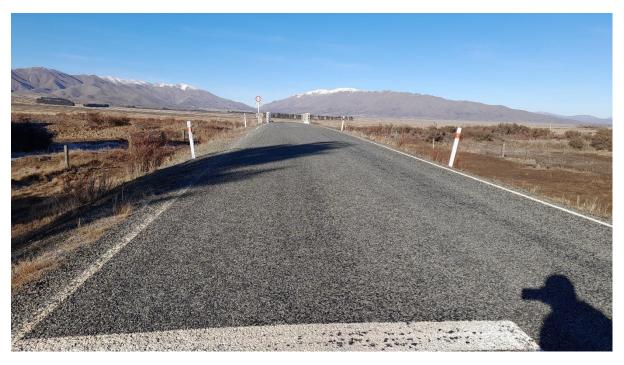
There are five one lane bridges on Haldon Road across Bullocky Creek, Red Hut Creek, Mackenzie Stream, Snowy River and Station Creek. Generally, the level of forward visibility at the one lane bridges is good although it varies. The Red Hut Creek bridge, shown below, is located at the top of a crest, limiting forward visibility. The one lane bridges have typical warning and priority signage and markings. The direction of priority (northbound or southbound) varies across the bridges.

Figure 4-11: Red Hut Creek Bridge, Northern Approach

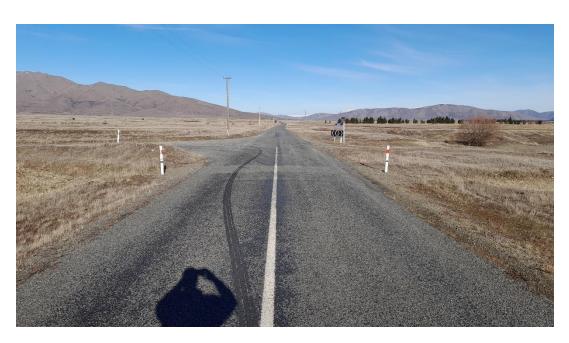
Mackenzie Pass Road and Hakataramea Road meet Haldon Road at basic uncontrolled T-intersections, as shown in the two figures below. Good driver sightlines are available at the intersections.

Figure 4-12: Haldon Road / Mackenzie Pass Road Intersection

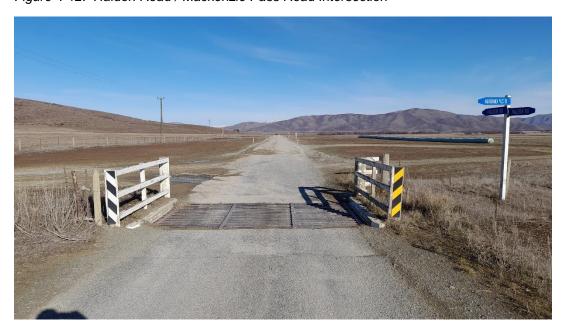
Figure 4-13: Haldon Road / Hakataramea Pass Road Intersection

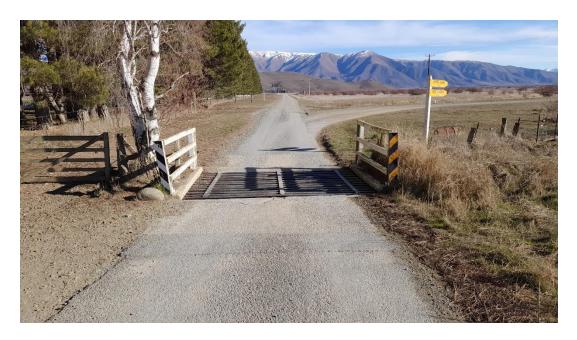
Haldon Arm Road meets Haldon Road at a form of Y-intersection, where Haldon Arm Road curves into the Haldon Road northern approach, as shown below. Good visibility is available between the three legs of the intersection.

Figure 4-14: Haldon Road / Haldon Arm Road Intersection

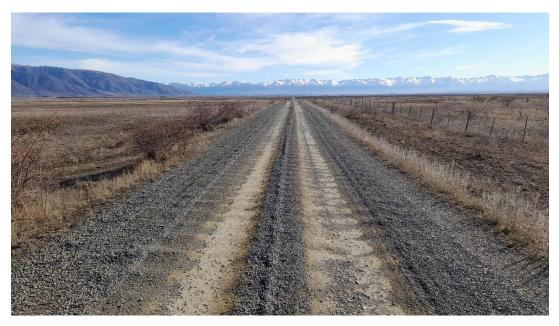
The road generally has a 5.5m wide, unsealed carriageway, as shown in the photograph below. It has a mostly straight and flat alignment. Grass shoulders next to the road are mostly flat and driveable. Sections of the carriageway are in a rough condition with corrugations and there is one cattle stop towards the eastern end of the road.

Figure 4-15: View Along Haldon Arm Road

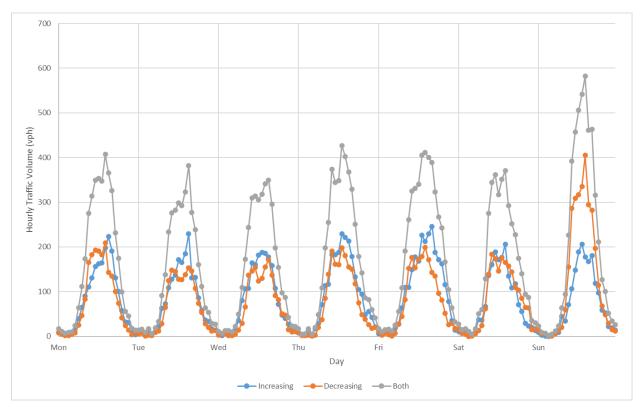
Figure 5-1 shows hourly traffic volumes by direction for a week in March 2024 ('Increasing' is travel towards Lake Tekapo and 'Decreasing' is travel towards Burkes Pass). Typically, two-way traffic volumes peak through the middle of the day at approximately 400 vehicles per hour, with higher traffic volumes recorded on the Sunday.

Figure 5-1: Hourly Traffic Volumes on SH8 for March 2024

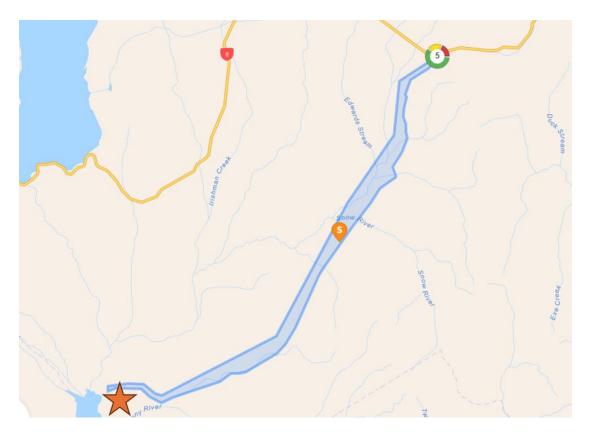
The NZTA Crash Analysis System (CAS) has been used to review crash records in the vicinity of the Site. The search area illustrated in Figure 6-1 below, included the SH8 / Haldon Road intersection and the Dog Kennel Corner curve, as well as the full lengths of Haldon Road and Haldon Arm Road. Crashes from the most recent 10-year period of 2014 to 2023 were reviewed.

Figure 6-1: Crash Location Map (NZTA CAS)

A total of six crashes were reported within the search area, with five of them being at Dog Kennel Corner and one along Haldon Road.

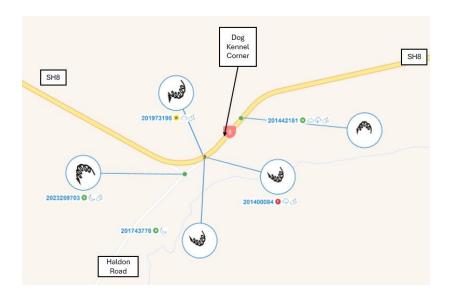
Figure 6-2 shows the collision diagram for the Dog Kennel Corner crashes. Four of the crashes occurred on SH8 and one non-injury crash occurred at the intersection of the two Haldon Road legs. All five crashes were single-vehicle loss of control crashes. One of the SH8 crashes was a fatal crash, one was a minor-injury crash and the other two were non-injury crashes. Wet or icy conditions, vehicle speed and distraction were factors listed for the crashes. No crashes involving vehicles turning into or out of Haldon Road at SH8 have been reported.

Figure 6-2: Collision Diagram at SH8 and Haldon Road Intersection (NZTA CAS)

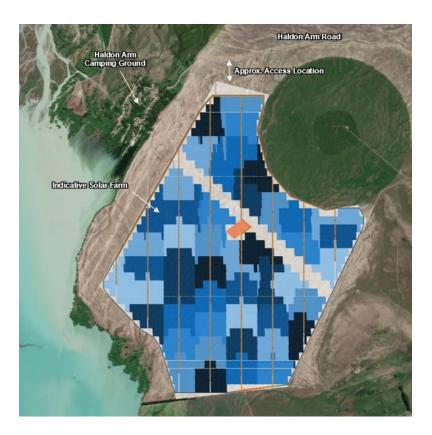
The solar farm will also include, inverters, transformers and associated switchgear, as well as ancillary buildings, access roads, undergrounding cables, deer fencing, rabbit fencing and other infrastructure. Figure 7-1 shows a schematic of the proposed solar farm layout.

Figure 7-1: General Extent and Layout of the Haldon Solar Project

The Site will be accessed via a single vehicle access point off Haldon Arm Road, located approximately as labelled in Figure 7-1.

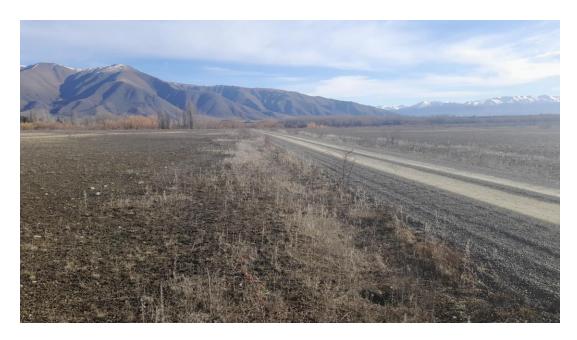
The photographs below are from this location, which is approximately 200m east of the 45km/h advisory speed curve. Clear visibility of at least 200m will be available in both directions.

Figure 7-2: Sightline to Left at Haldon Arm Road Access Location

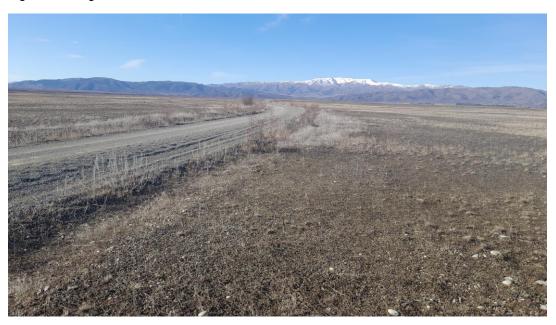
Figure 7-3: Sightline to Right at Haldon Arm Road Access Location

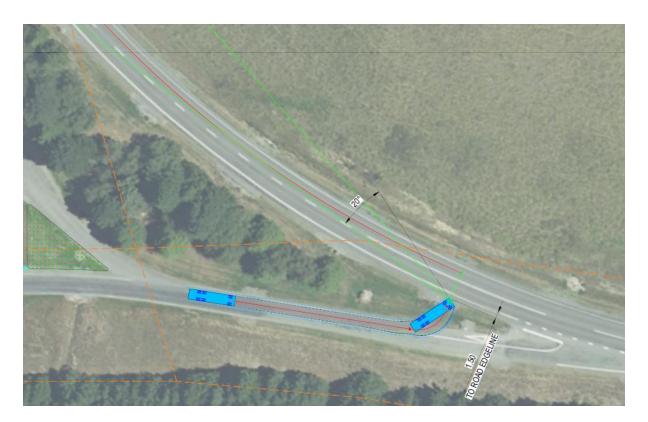
Minor changes to the intersection to provide an improved observation angle for drivers on Haldon Road have been investigated. The below figure indicates the necessary path of a large rigid truck to allow the driver to see traffic approaching from the left at no more than a 20-degree angle behind perpendicular.

Figure 9-1: Large Rigid Vehicle Path for Improved Observation Angle

Widening to accommodate this path appears feasible in terms of constructability. Ideally the realignment of the approach would not impact the existing delineation signage around the outside of the SH8 curve. It may be necessary for vehicles to meet SH8 east of where the truck above is indicated to avoid the existing signage, and this may require widening on the southern side of Haldon Road, which also appears feasible.

It is recommended that works are carried out to improve the driver observation angle if imported material and / or equipment delivery is to be to and from SH8 to the east of Dog Kennel Corner. The above concept has been discussed with NZTA's safety engineer who agrees with squaring up the approach for driver visibility and that this appears feasible. Details to be worked through would include the Haldon Road approach alignment, line marking on Haldon Road to encourage drivers to approach the intersection to maximise their visibility to the left and any changes to delineation around the curve on SH8 (both line marking and signage).

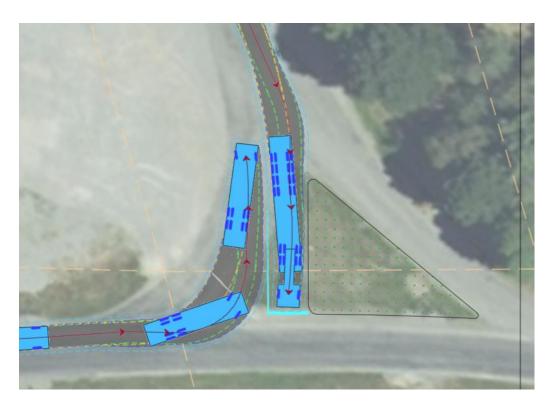
The extent of minor widening of the intersection necessary to allow for two-way vehicle movement, square up the western approach and formalise priority at the intersection has been investigated. The figure below indicates widening to allow a large heavy vehicle (such as a truck and trailer) to turn left in while a single-unit truck waits to turn right out, and vice versa. This appears to be readily achievable and is recommended along with associated line marking and signage as mitigation for potential construction traffic effects. These actions will also benefit the safety of the intersection longer term. The Mackenzie District Council Manager – Roading has advised in initial consultation that this appears feasible, with no major concerns raised.

Figure 9-2: Indicative Mitigation Works at Intersection of Haldon Road Legs
