**BEFORE AN EXPERT PANEL  
SOUTHERN SEAWALL RENEWAL PROJECT**

In the matter of an application by Wellington International Airport Limited for approvals for the Southern Seawall Renewal Project

**STATEMENT OF EVIDENCE OF JENNIFER HELEN HART AND AMY LOUISE SHEPPARD (COASTAL PROCESSES, ENGINEERING AND DESIGN) ON BEHALF OF WELLINGTON INTERNATIONAL AIRPORT LIMITED**

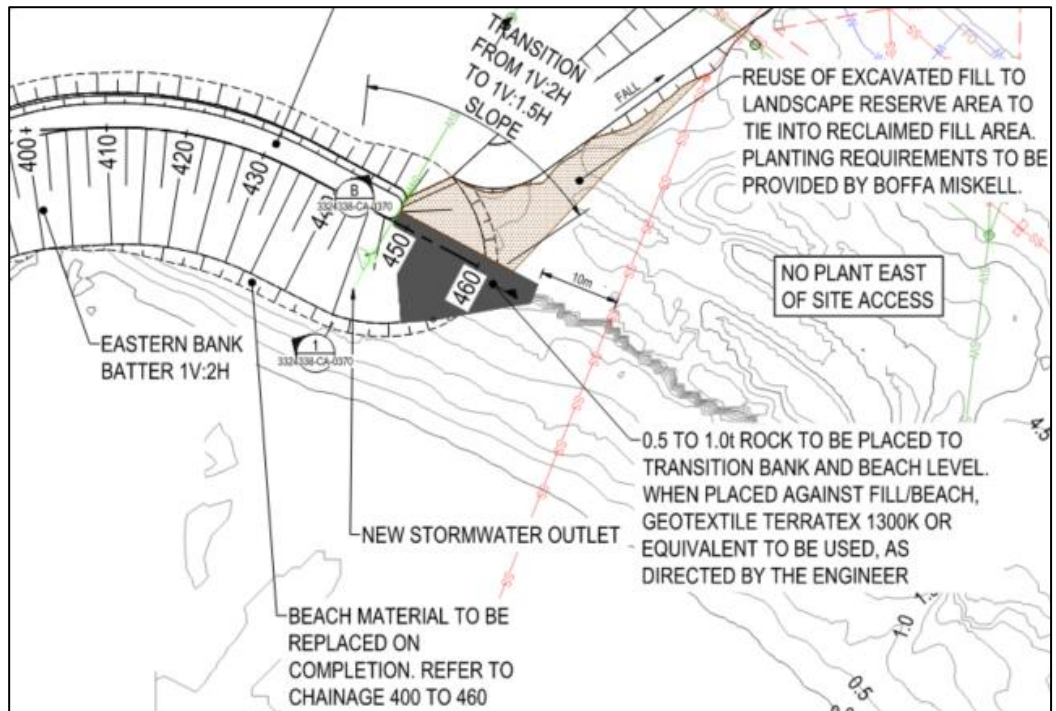
18. The Eastern Bank Remediation design also incorporates a tapered rock section on the upper beach at the eastern end of the revetment (refer to **Figure 1** for this detail). This tapered rock section is placed over geotextile.

19. The tapered rock section bridges between the revetment armour rock and the bank to the east, providing a smoother transition in the revetment footprint (i.e. avoiding a 90-degree intersection with the existing bank) and easing the change in slope from the milder revetment slope to the subvertical bank face. This minimises end effect erosion by providing an extended rock slope to help dissipate wave energy and reducing any theoretical reflection of waves from a 90-degree face laterally along the beach (although noting that waves approach and reflect perpendicular to the shoreline at this location). This design addresses GWRC's main concern.

Figure 1: Eastern end of Eastern Bank Remediation

- (a) the alignment of the Eastern Bank Remediation, which follows the existing shoreline, smoothing the transition between the Southern Seawall and the shoreline further east (refer to **Figure 1**);

- (b) the tapered rock section at the eastern end, which bridges between the of the Eastern Bank Remediation and the bank further to the east to minimise end effect erosion (refer to **Figure 1**); and

- (a) the tapered rock section bridging between the armour rock of the Eastern Bank Remediation and the bank to the east to minimise end effect erosion;
- (b) wrapping the armour rock landward to protect the end of the Eastern Bank Remediation; and
- (c) founding the Eastern Bank Remediation in the greywacke bedrock underlying Moa Point Beach to prevent undermining of the structure.

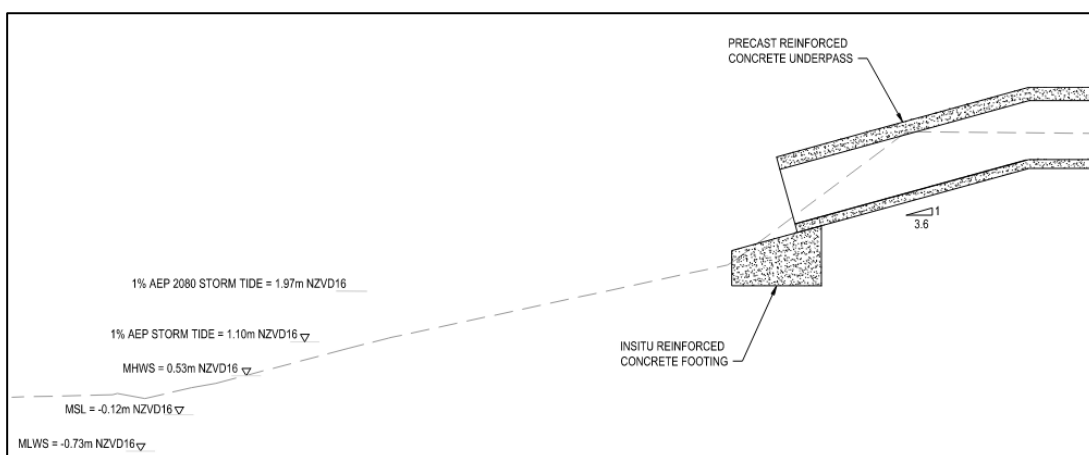
33. The seaward end of the underpass is supported on a reinforced concrete footing, founded in the greywacke bedrock underlying the gravel beach. This will provide a resilient foundation for the culvert if the surficial beach gravels are eroded in the future.

34. A concept sketch of the seaward end of the proposed Kororā underpass, with present day and future water levels and present day beach levels, is shown in **Figure 2**.

Figure 2: Section through Kororā underpass showing present day tide and storm-tide levels, 2080 storm-tide level and existing ground surface (dashed line)
