**OCEANA GOLD (NEW ZEALAND) LIMITED
WAIHI OPERATION, NEW ZEALAND
STORAGE 3 - TAILING STORAGE FACILITY - RL155
DAM BREACH AND POTENTIAL IMPACT
CLASSIFICATION ASSESSMENT**

OGNZL Reference No.: WAI-983-080-REP-GT-0013_Rev1

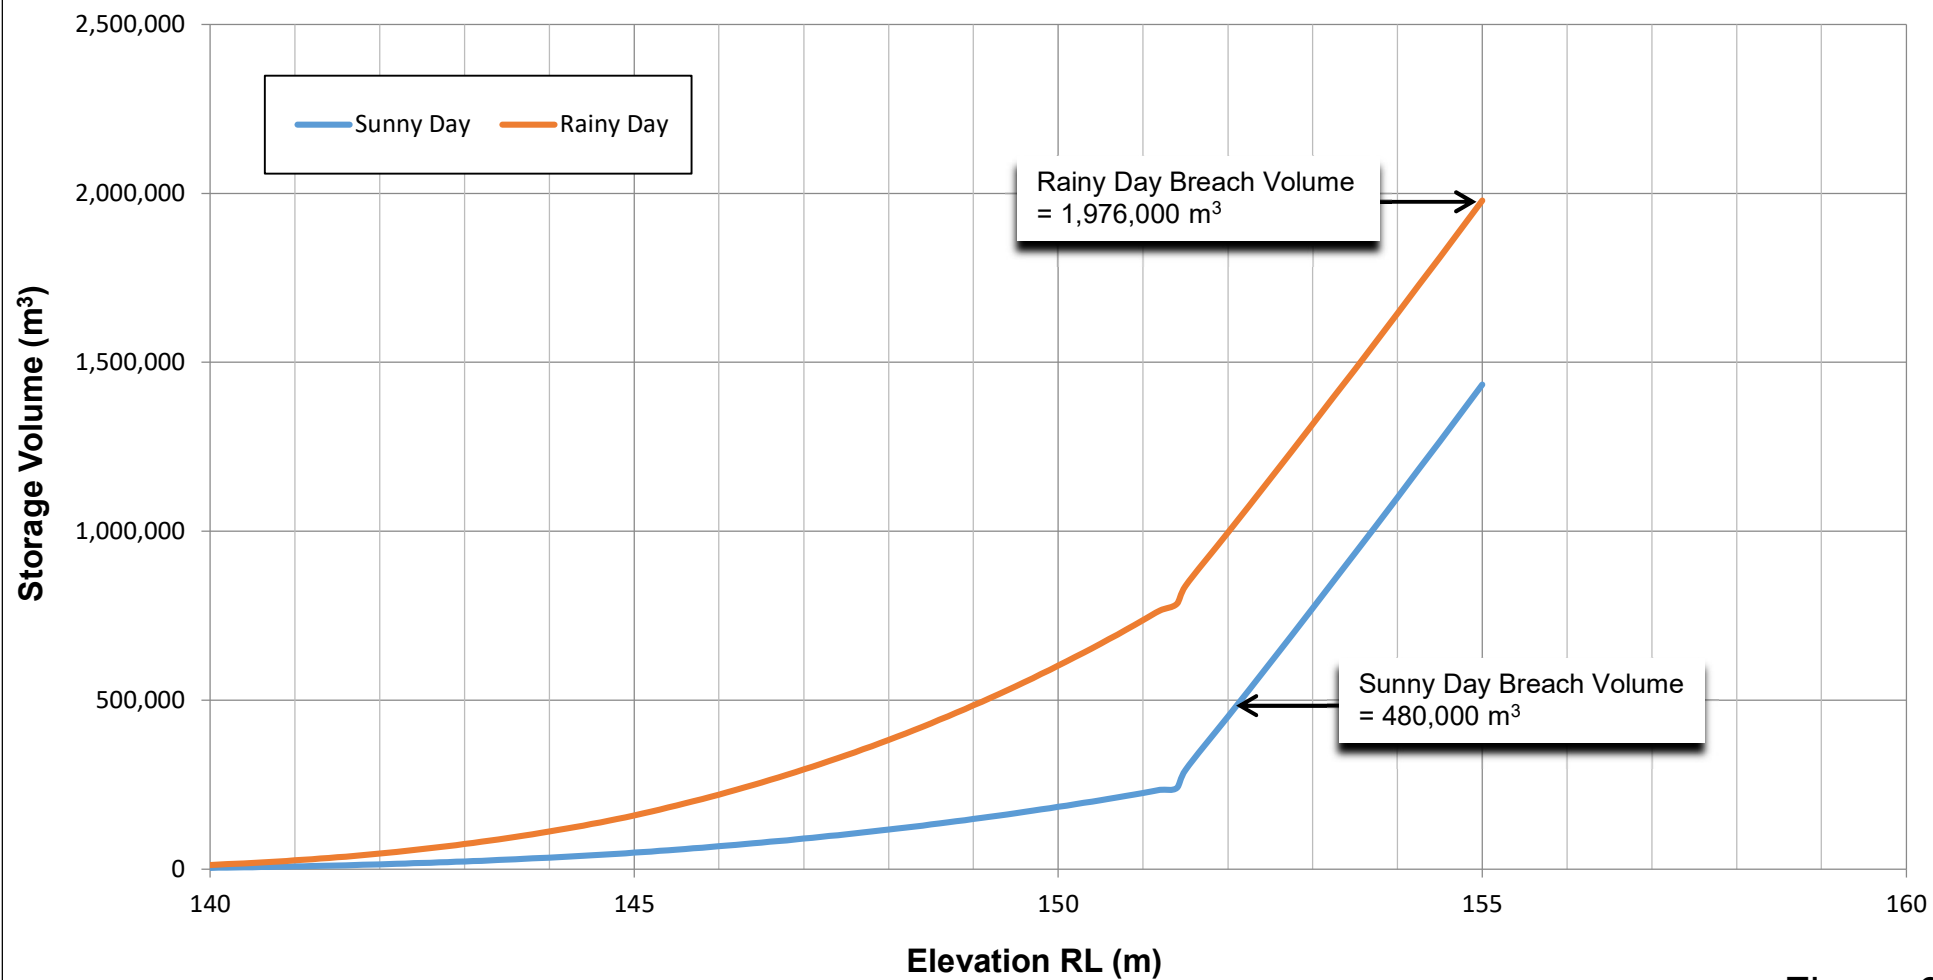
| Figure 3 | Elevation - Storage Curves |

The Sunny Day breach scenario is assumed to be a collapse type failure caused by instability associated with weak embankment foundations under strong earthquake shaking. Breach parameters were determined by using the regression models in Section 10.5.1 and are summarised in Table 2. The volume of released material in Process I was estimated to be the total volume of supernatant water (i.e., 0.24 Mm³) and an equal volume of eroded tailings (i.e., 0.24 Mm³). The breach bottom elevation on the upstream face of the embankment for TDBA Process I, was taken to be the same as the Process II breach geometry shown in Figure B1. An elevation-storage relationship was derived to represent the volume change from the breach bottom elevation to the normal operation decant level. It is shown in Figure 3. The dam breach outflow hydrographs were derived by using HEC-RAS.

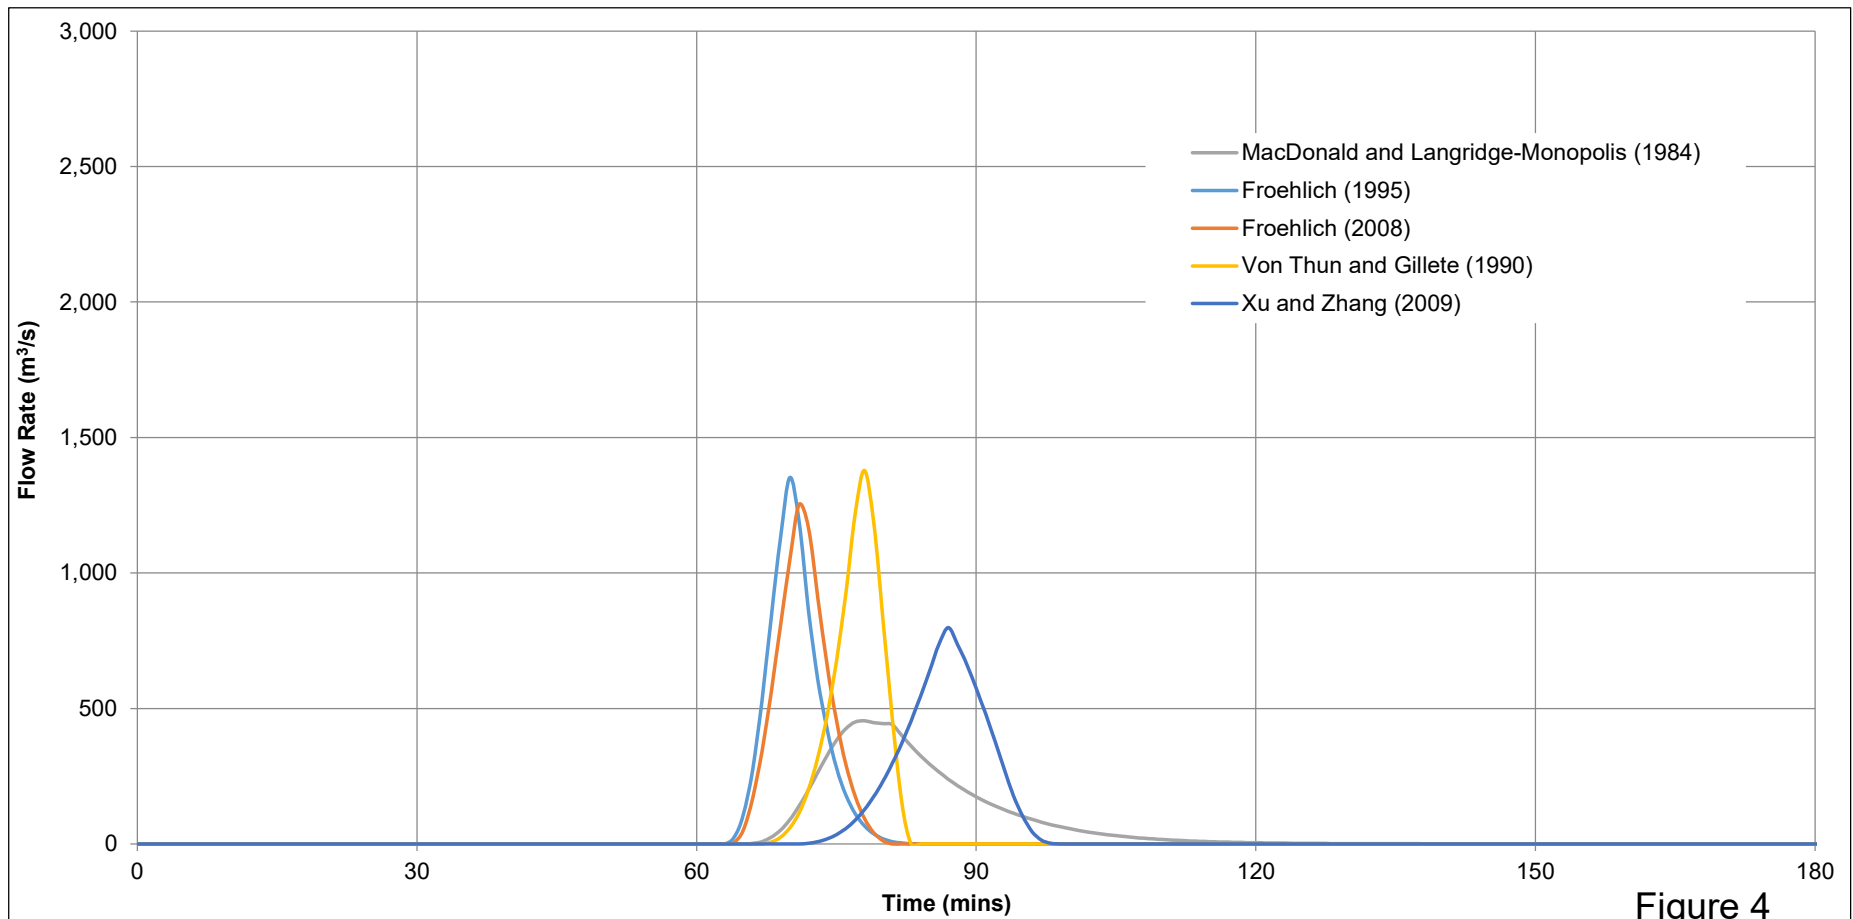
| Figure 4 | Breach Outflow Hydrographs for Sunny Day Breach Scenario |

A suite of breach outflow hydrographs for the Sunny Day and Rainy Day breach scenarios are shown in Figures 4 and 5, respectively. The maximum breach outflows are associated with the model of Von Thun and Gillete (Ref. 16) for both of the Sunny Day and Rainy Day conditions. The maximum associated outflow hydrographs have been used in the runout analysis to assess the extent of inundation.
