# Taharoa Ironsands Ltd

*Attention: Expert Panel for the Central and Southern Block Mining Project*

1. The Panel's Request for Further Information (RFI) 1, as set out in Appendix A to Minute 24 dated 20 August 2026, raises the issue of potential dewatering / seepage from the Mitiwai Stream as a result of Taharoa Ironsands Limited's (TIL) mining operations.

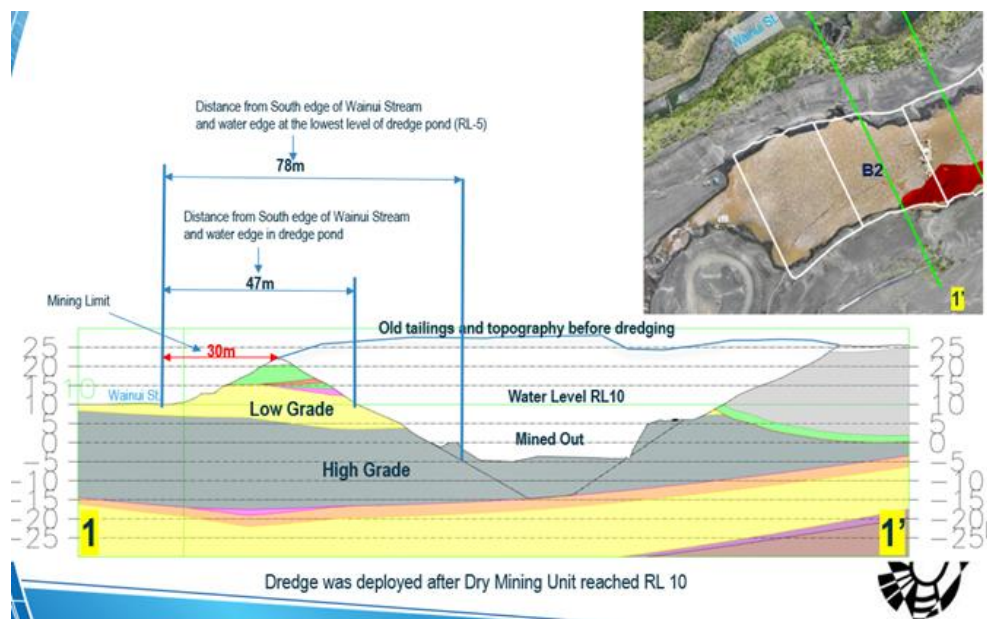
### 2. Typical cross section in the Dredge Pond by the Wainui in 9<sup>th</sup> of January 2024

12. I personally have not observed, nor am I aware of, any seepage into the mine pits originating from either the Wainui or Mitiwai Stream.
13. In addition to this ongoing monitoring, it is important to understand that the edge of Pit 1 is set back at least 30m from the boundary of the Mitiwai Stream. The actual mining and dredging activities take place at an even greater distance from the Mitiwai boundary. However, as the pits are engineered and designed with a 35° slope from the edge of the pit, this provides an additional safeguard to ensure that no water seeps from the Mitiwai Stream during these works. Cross-sections of the dredge ponds adjacent to both the Wainui and Mitiwai Streams are also included in **Appendix B**.

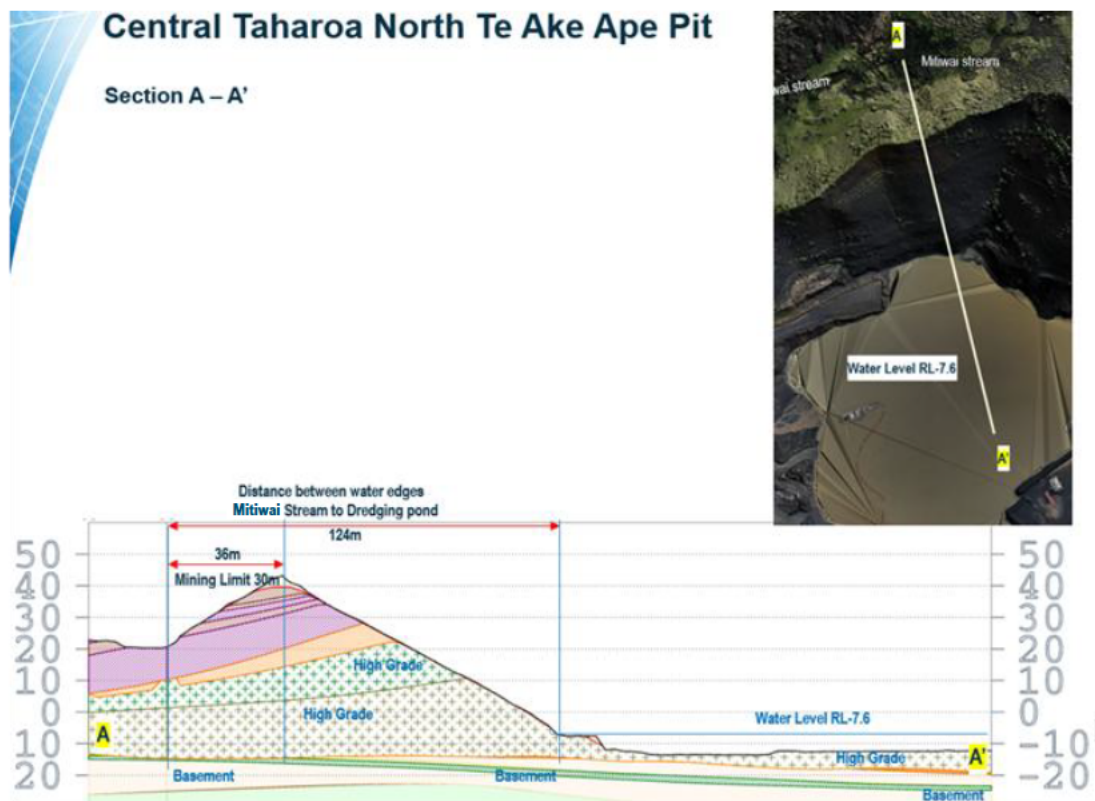
### 3. Typical cross section in the Dredge Pond by the Mitiwai in 24<sup>th</sup> of August 2026
