# Southern Link Inland Port

## Geotechnical Desktop Study and Appraisal

Prepared for:  
Southern Link Property Limited

Prepared by:  
Stantec New Zealand

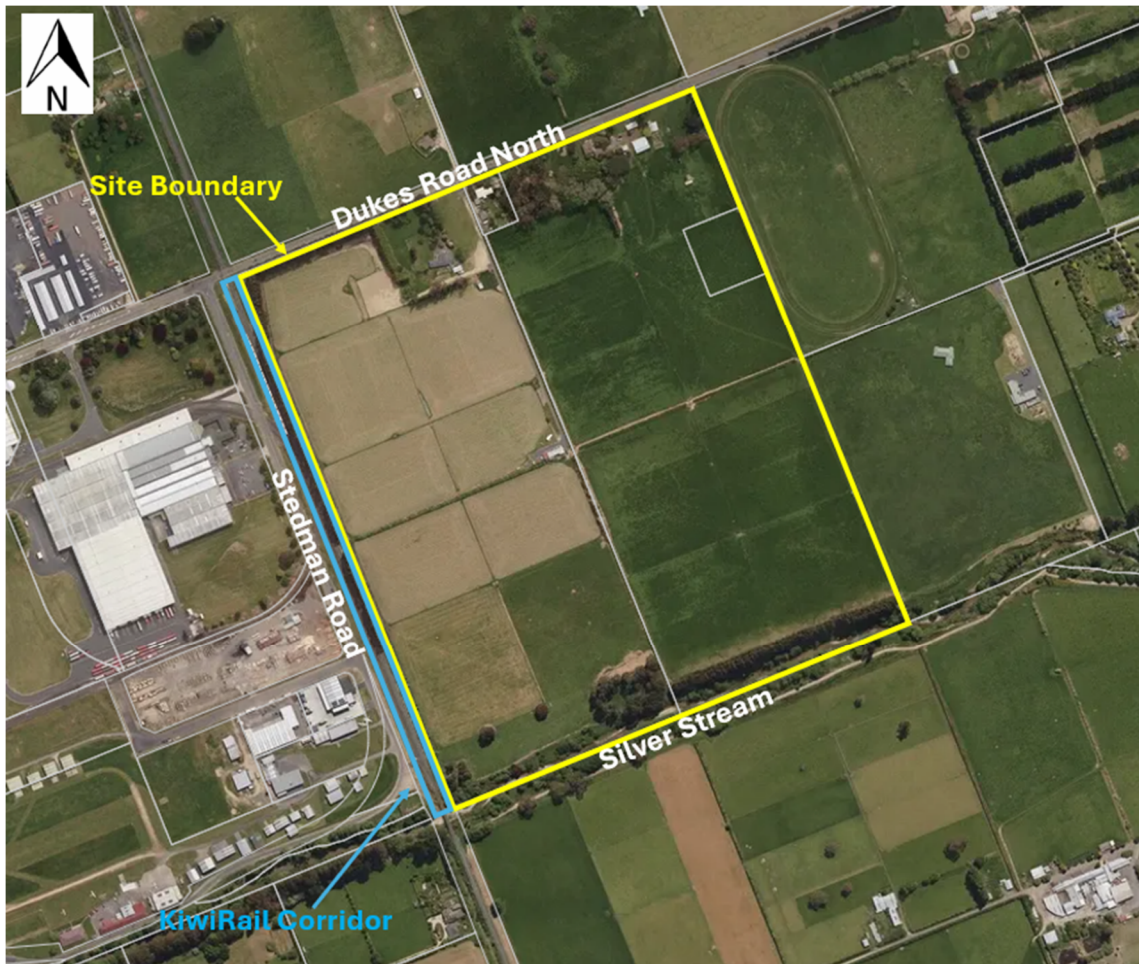
SLPL seeks to establish an Inland Port / Logistics Hub on an approximately 40-hectare site on the Taieri Plains near Mosgiel to enable freight transfer between trains and trucks. The SLIP Site is located at 270 – 292 Dukes Road North, as outlined in yellow. Ancillary activities will also occur within the KiwiRail corridor marked blue in Figure 1, however those ancillary activities are not being applied for as part of this application, and are not discussed further in this report. This SLIP will deliver critical infrastructure to support regional economic growth, improve freight logistics, and enhance resilience to environmental risks.

Figure 1. Site overview

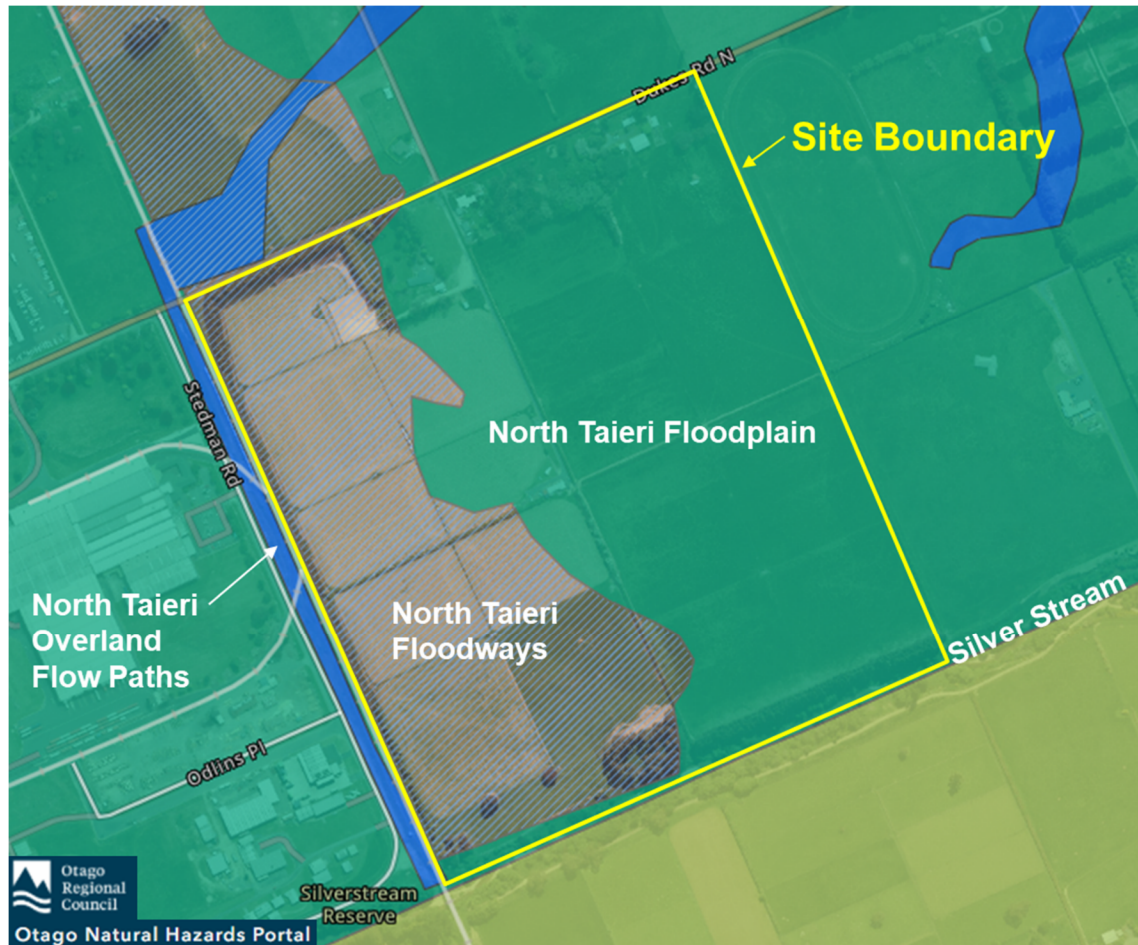
Otago Regional Council (ORC) developed flood-hazard maps which divide the geographical areas based on flood hazard characteristics. The North Taieri area is further subdivided into areas that are critical for the conveyance or storage of floodwater ('North Taieri overland flow paths' and 'North Taieri floodways'), and the residual floodplain ('North Taieri floodplain'), each of which have been mapped in proximity to the Site (see Figure 4).

As shown in Figure 4, the southwestern boundary of the Site is adjacent to an overland flow path along the Taieri Gorge Railway embankment, with much of the southwestern portion of the Site falling within the North Taieri flood ways area. The rest of the site falls within the North Taieri floodplain area, where runoff is slower and of shorter duration compared to the flood ways.

Figure 4. Flood hazard characteristics of the Site area, from Otago Regional Council's Natural Hazards Portal and based on ORC (2015)

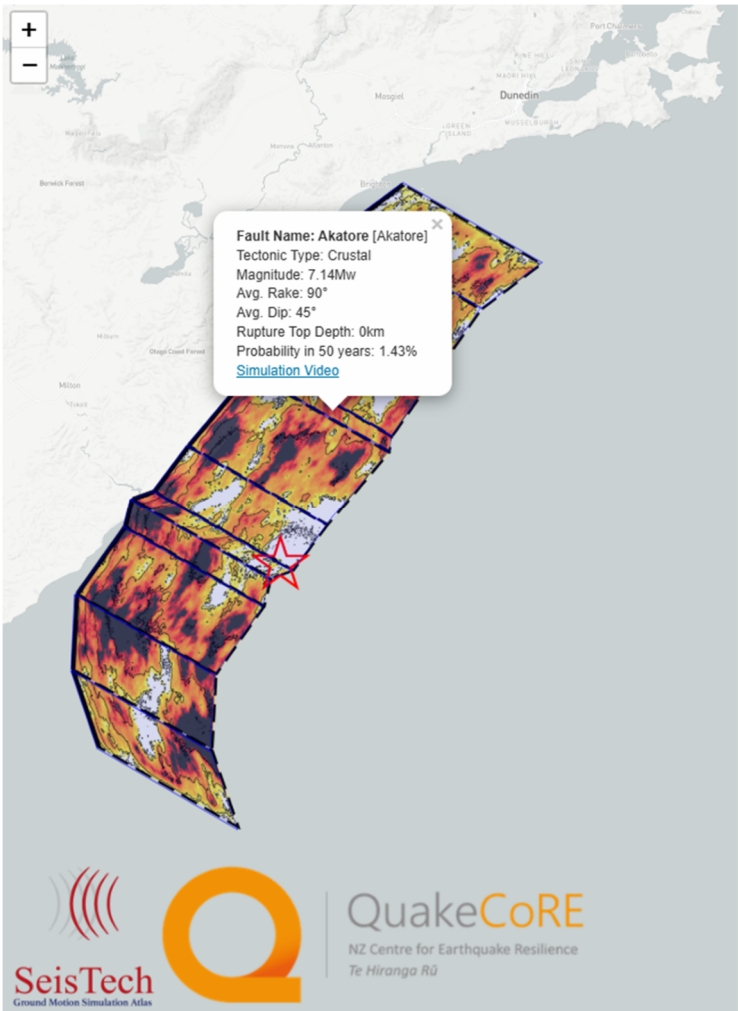
Figure 6. Characterisation of the Akatore Fault (QuakeCoRE)

Figure 5 shows nearby active faults mapped in the GNS New Zealand Active Fault Database (NZAFD). The nearest faults include the North Taieri Fault and Titri Fault, both reaching within approximately 5 km of the Site. The Akatore Fault is the best-known and has generated at least two large earthquakes with surface rupturing (likely magnitude 7) within the past 3,800 years (Barrell, Cox, Glassey, & Lyttle, 2014). According to QuakeCoRE, a research institute funded by the New Zealand Tertiary Education Commission, the seismic hazard corresponding to the Akatore Fault is expected to comprise a  $M_w$  7.14 earthquake with a probability of occurrence of 1.43% in 50 years, as shown in Figure 6.

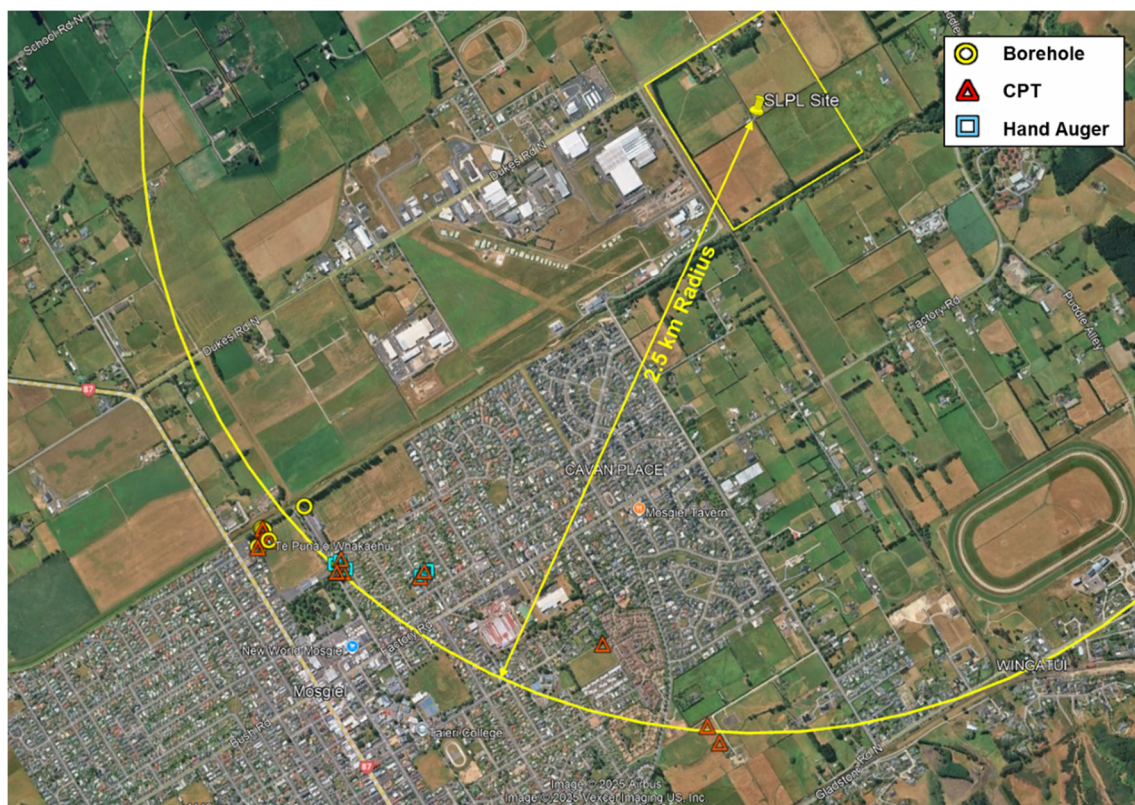
Stantec searched the New Zealand Geotechnical Database (NZGD) for past investigations with data relevant to the Site assessment. The nearest investigations, including several Boreholes (BH), Cone Penetration Tests (CPT) and Hand Augers (HA), were located approximately 2.2 to 2.7 km away in the town of Mosgiel, as shown in Figure 9. BH logs, HA logs and CPT reports from representative NZGD investigations have been included in Appendix B.

*Figure 9. NZGD investigation locations*

Although the CPT profiles are from Domain B locations (see Figure 9 and Figure 11), LPI results from the parametric analyses suggest a Low risk of liquefaction when the expected Site (Domain A) groundwater level (5.0 m bgl) is considered. The analyses further indicate that liquefaction-induced settlements less than 4 cm are expected for PGA up to 0.26 g.

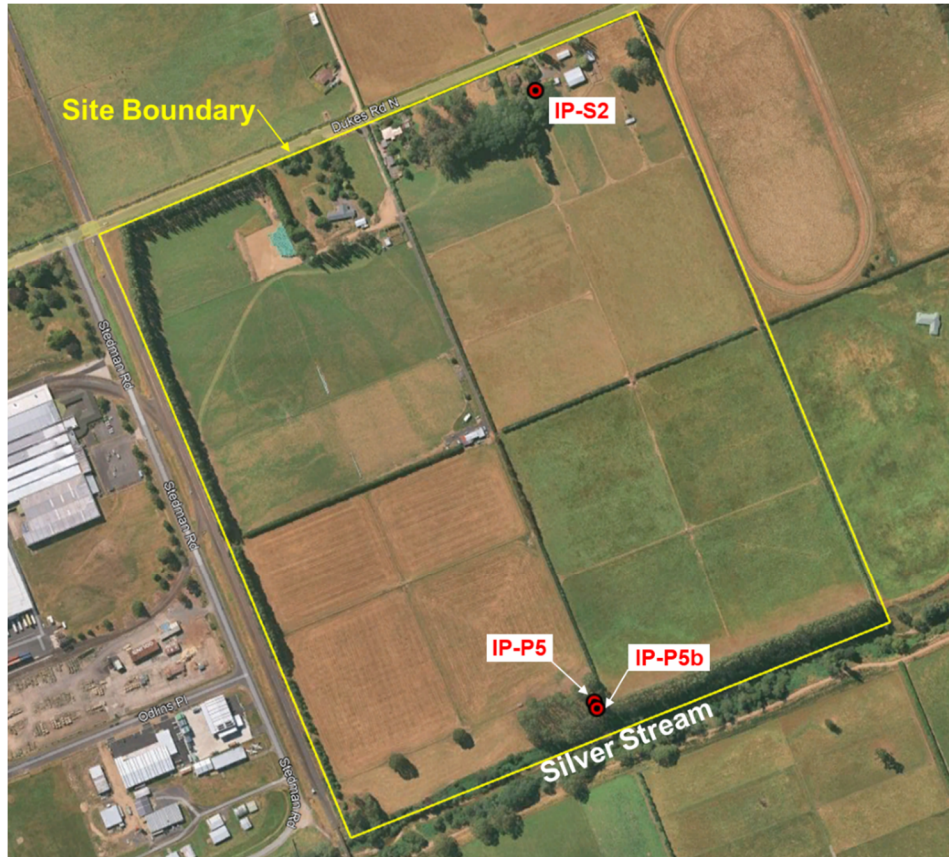
Data loggers have recently been installed in on-site bores, and groundwater level monitoring is ongoing at the time of writing. Preliminary standpipe piezometer readings were taken at the time of instrumentation installation at the three well locations shown in Figure 10.

*Figure 10. Site groundwater monitoring locations*

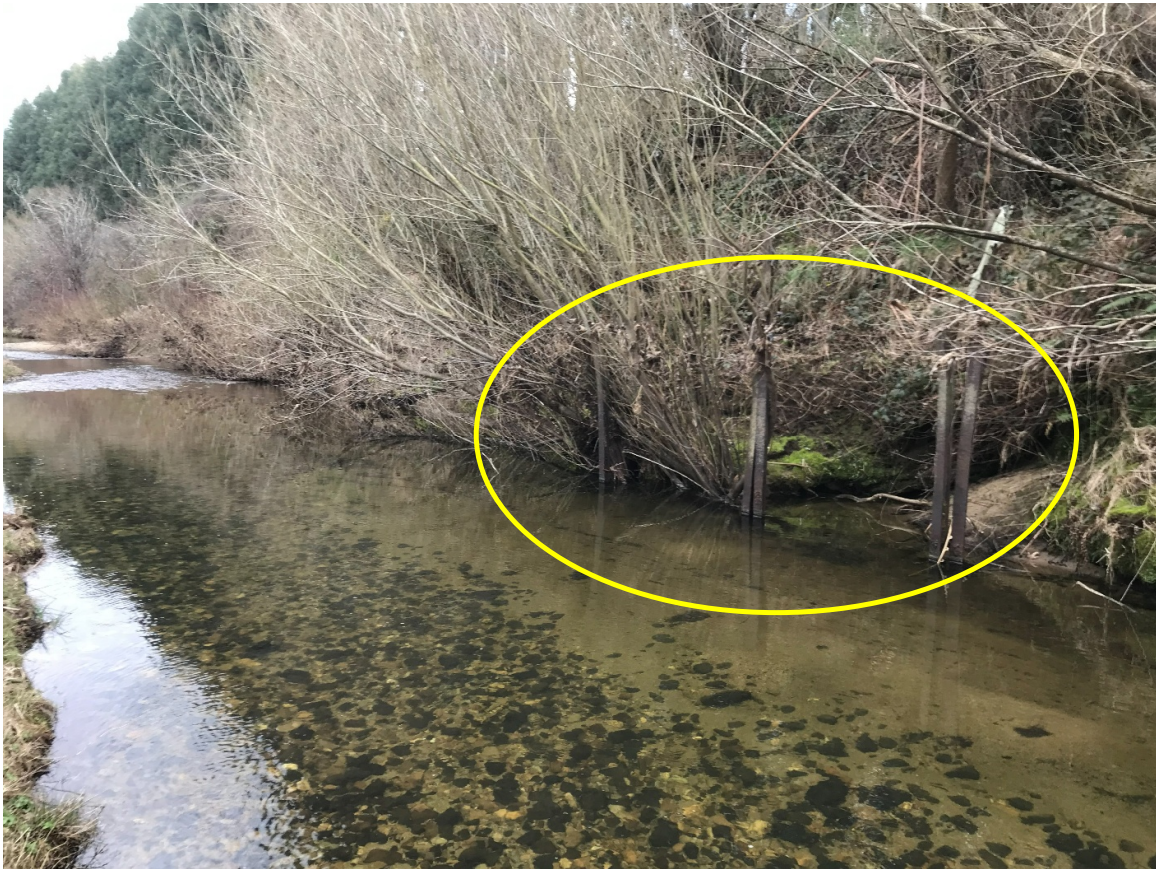
A site visit was undertaken by **e3 Scientific** (e3) as part of a Site freshwater ecological assessment focusing on Silver Stream. During their site visit, e3 observed railway iron installed at the base of the stream banks that appears to have been placed as a form of slope protection, though the original intent is unknown. Figure 14 presents a photograph from the e3 site visit showing the iron inserted vertically into the ground at the base of the slope.

*Figure 14. Railway iron (highlighted by a yellow circle) placed along the Silver Stream bank (photograph provided by e3 Scientific)*

According to e3, the iron rails appeared to have been placed along most of the stream length along the Site boundary, presumably at a similar spacing as shown in the photo above. The timing of installation is unknown since they are not visible in historical aerial imagery. Nonetheless, their presence suggests that bank erosion has been a concern in the past. Whether the measures have been effective at stabilising the bank remains unknown at this stage, though they will be further assessed during and after the upcoming site walkover and geotechnical investigations, as described below.

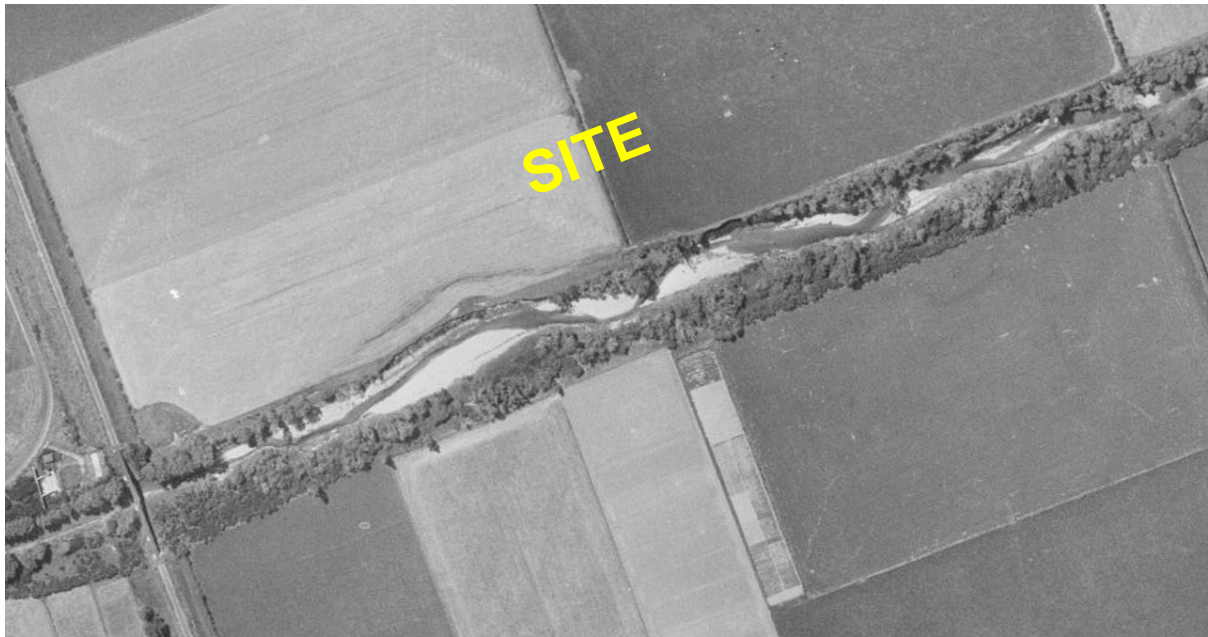
*Figure A7. 1970 aerial imagery of Silver Stream (Retrolens)*

A relatively unobstructed view from 1970 shows less vegetation and considerable progression of erosional and/or slope instability features in areas where the flow channel passed along the toe of the northern stream bank at that time. In particular, the western (downstream) potential instability area shown in Figure 3 appears to have experienced notable subsidence sometime between 1963 and 1970. The subsided area is still evident in the topography from the recent LiDAR data discussed above in Section 2.3. The eastern (upstream) potential instability area is also labelled in Figure 3 is first observed in aerial imagery from 1985, with little evidence of continued progression between then and the present day.

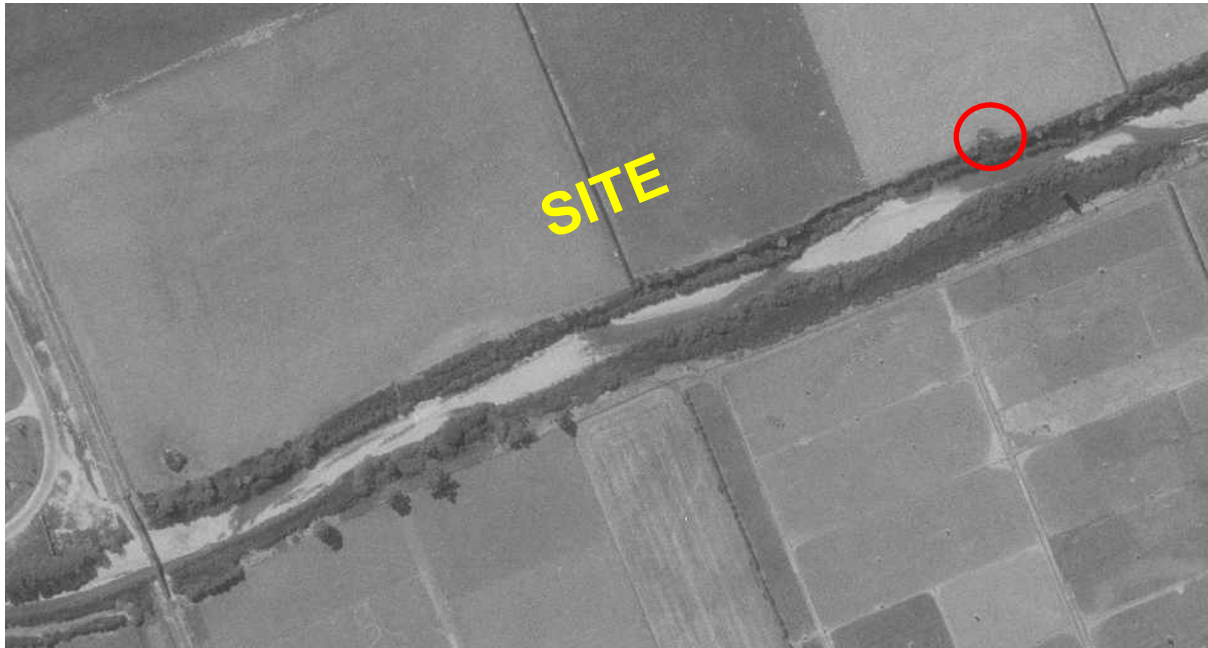
*Figure A9. 1985 aerial imagery of Silver Stream (Retrolens), showing first noted occurrence of potential slope instability area (circled in red) near southeastern corner of Site*
