# Mount Fred South – Geotechnical Assessment Report Pre-Feasibility Study

BT Mining Limited

✦ September 2025

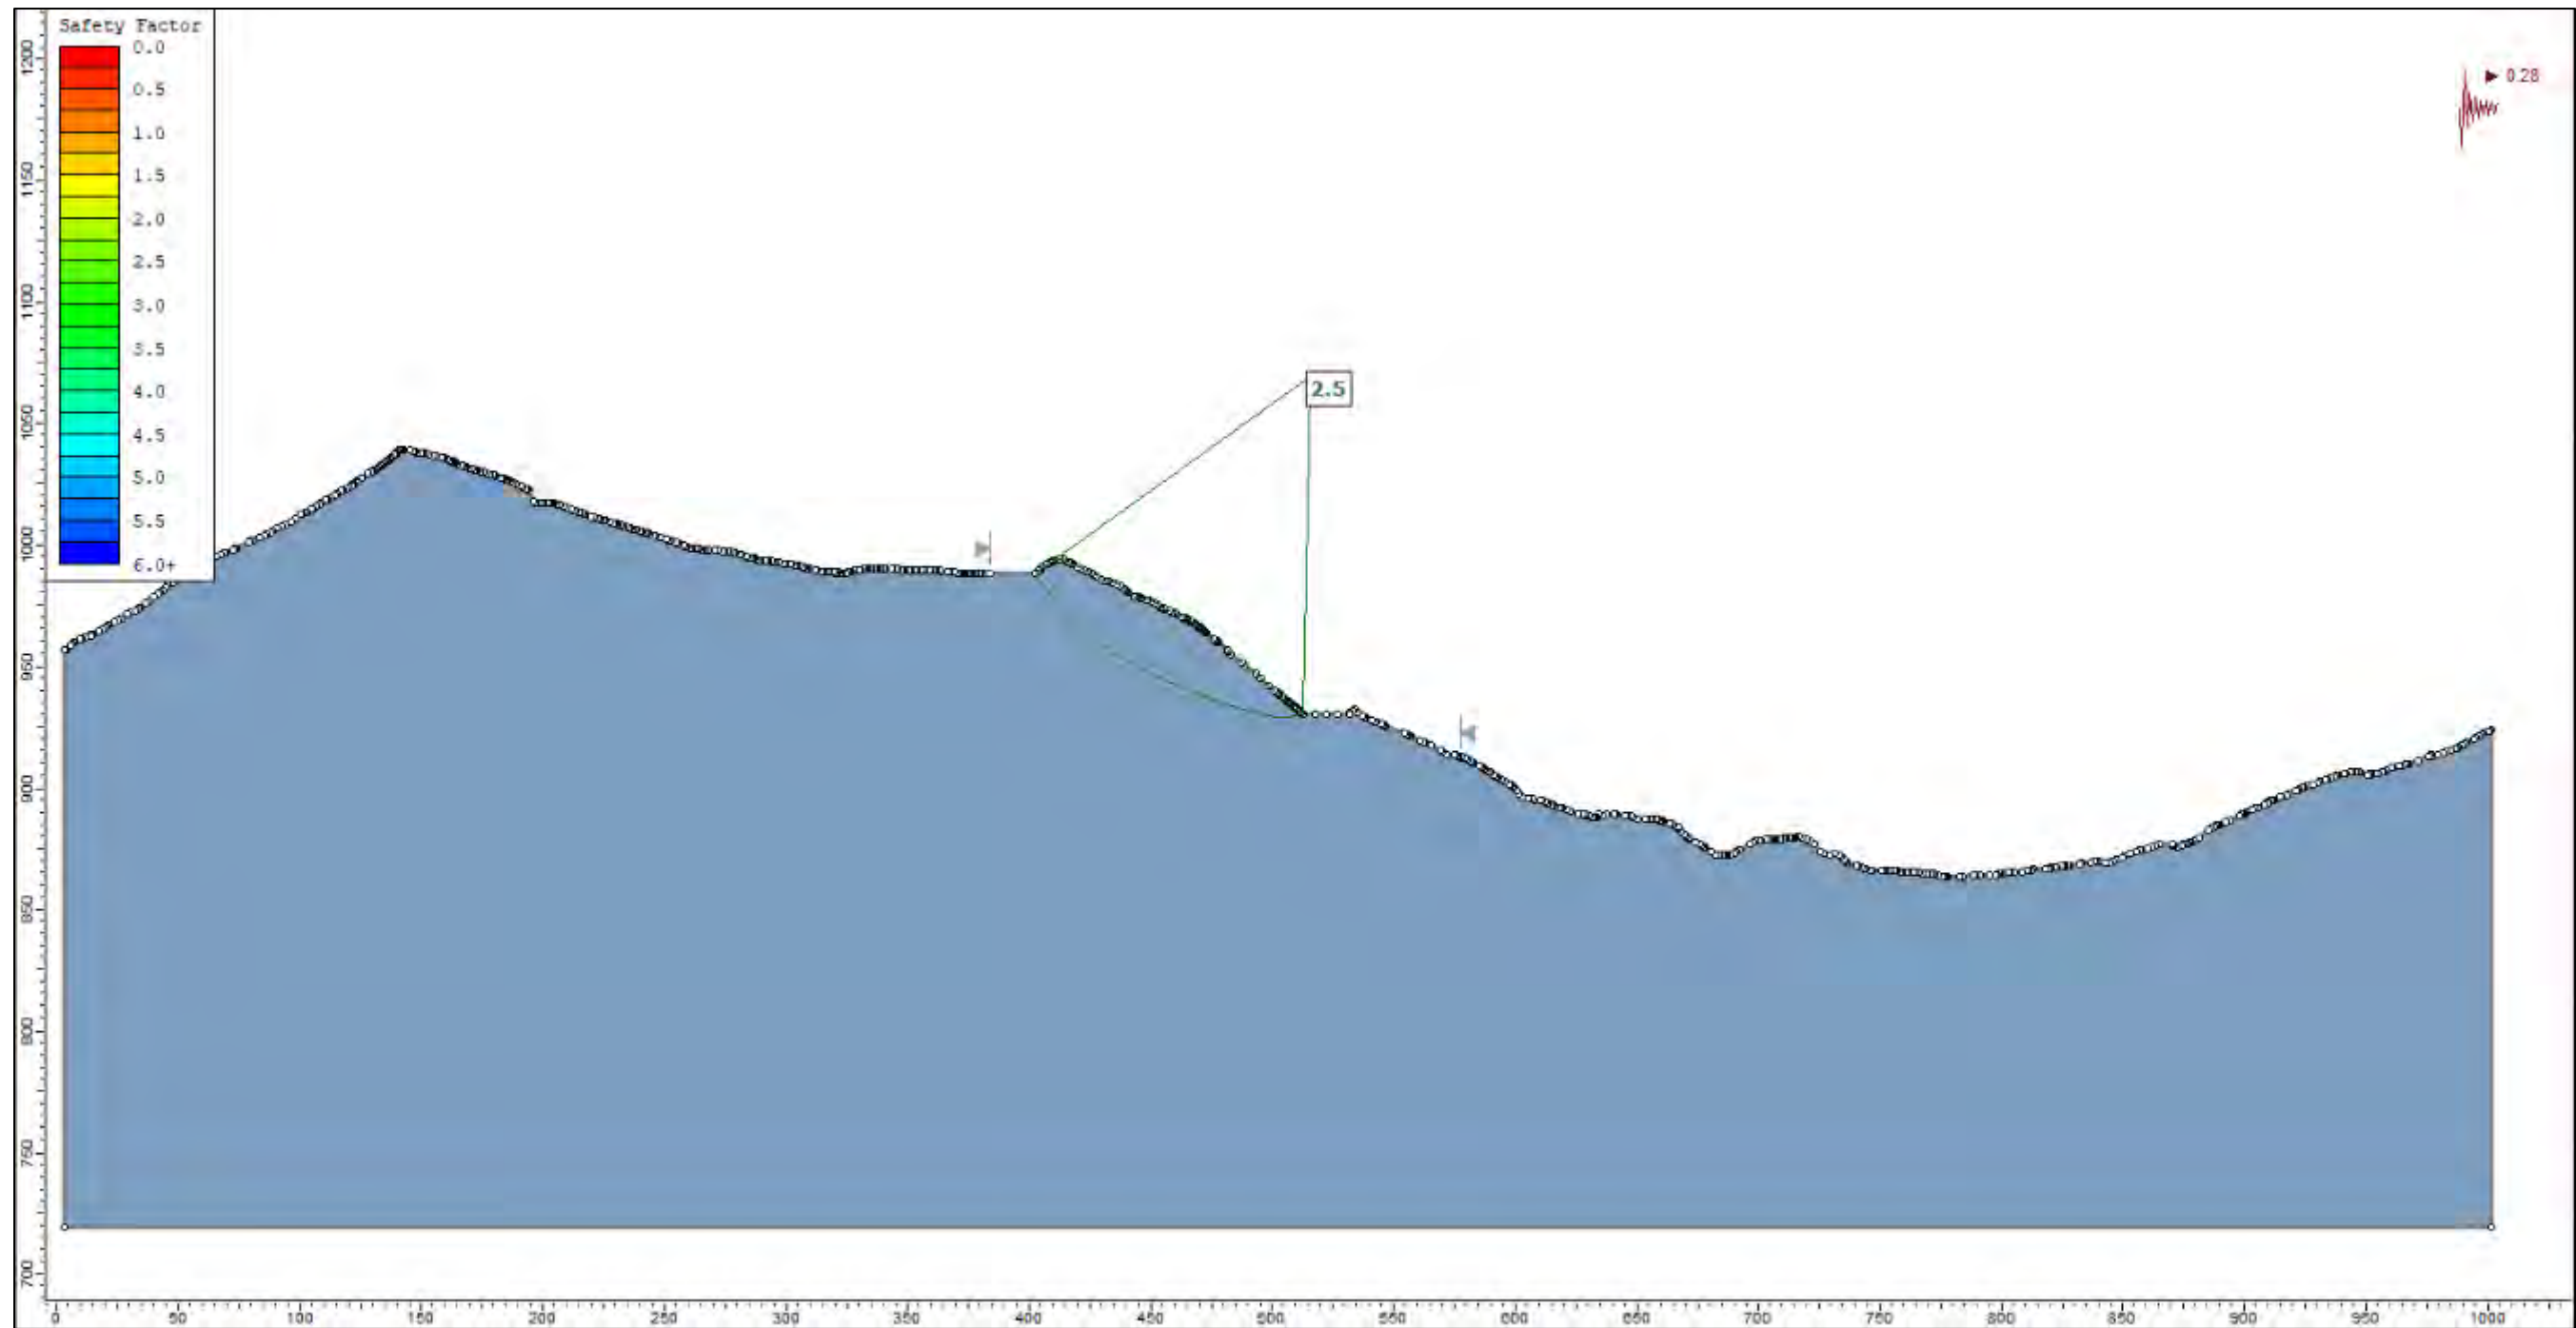
Figure: B158 - Haul Road Cut - Section 108 – Static Conditions.

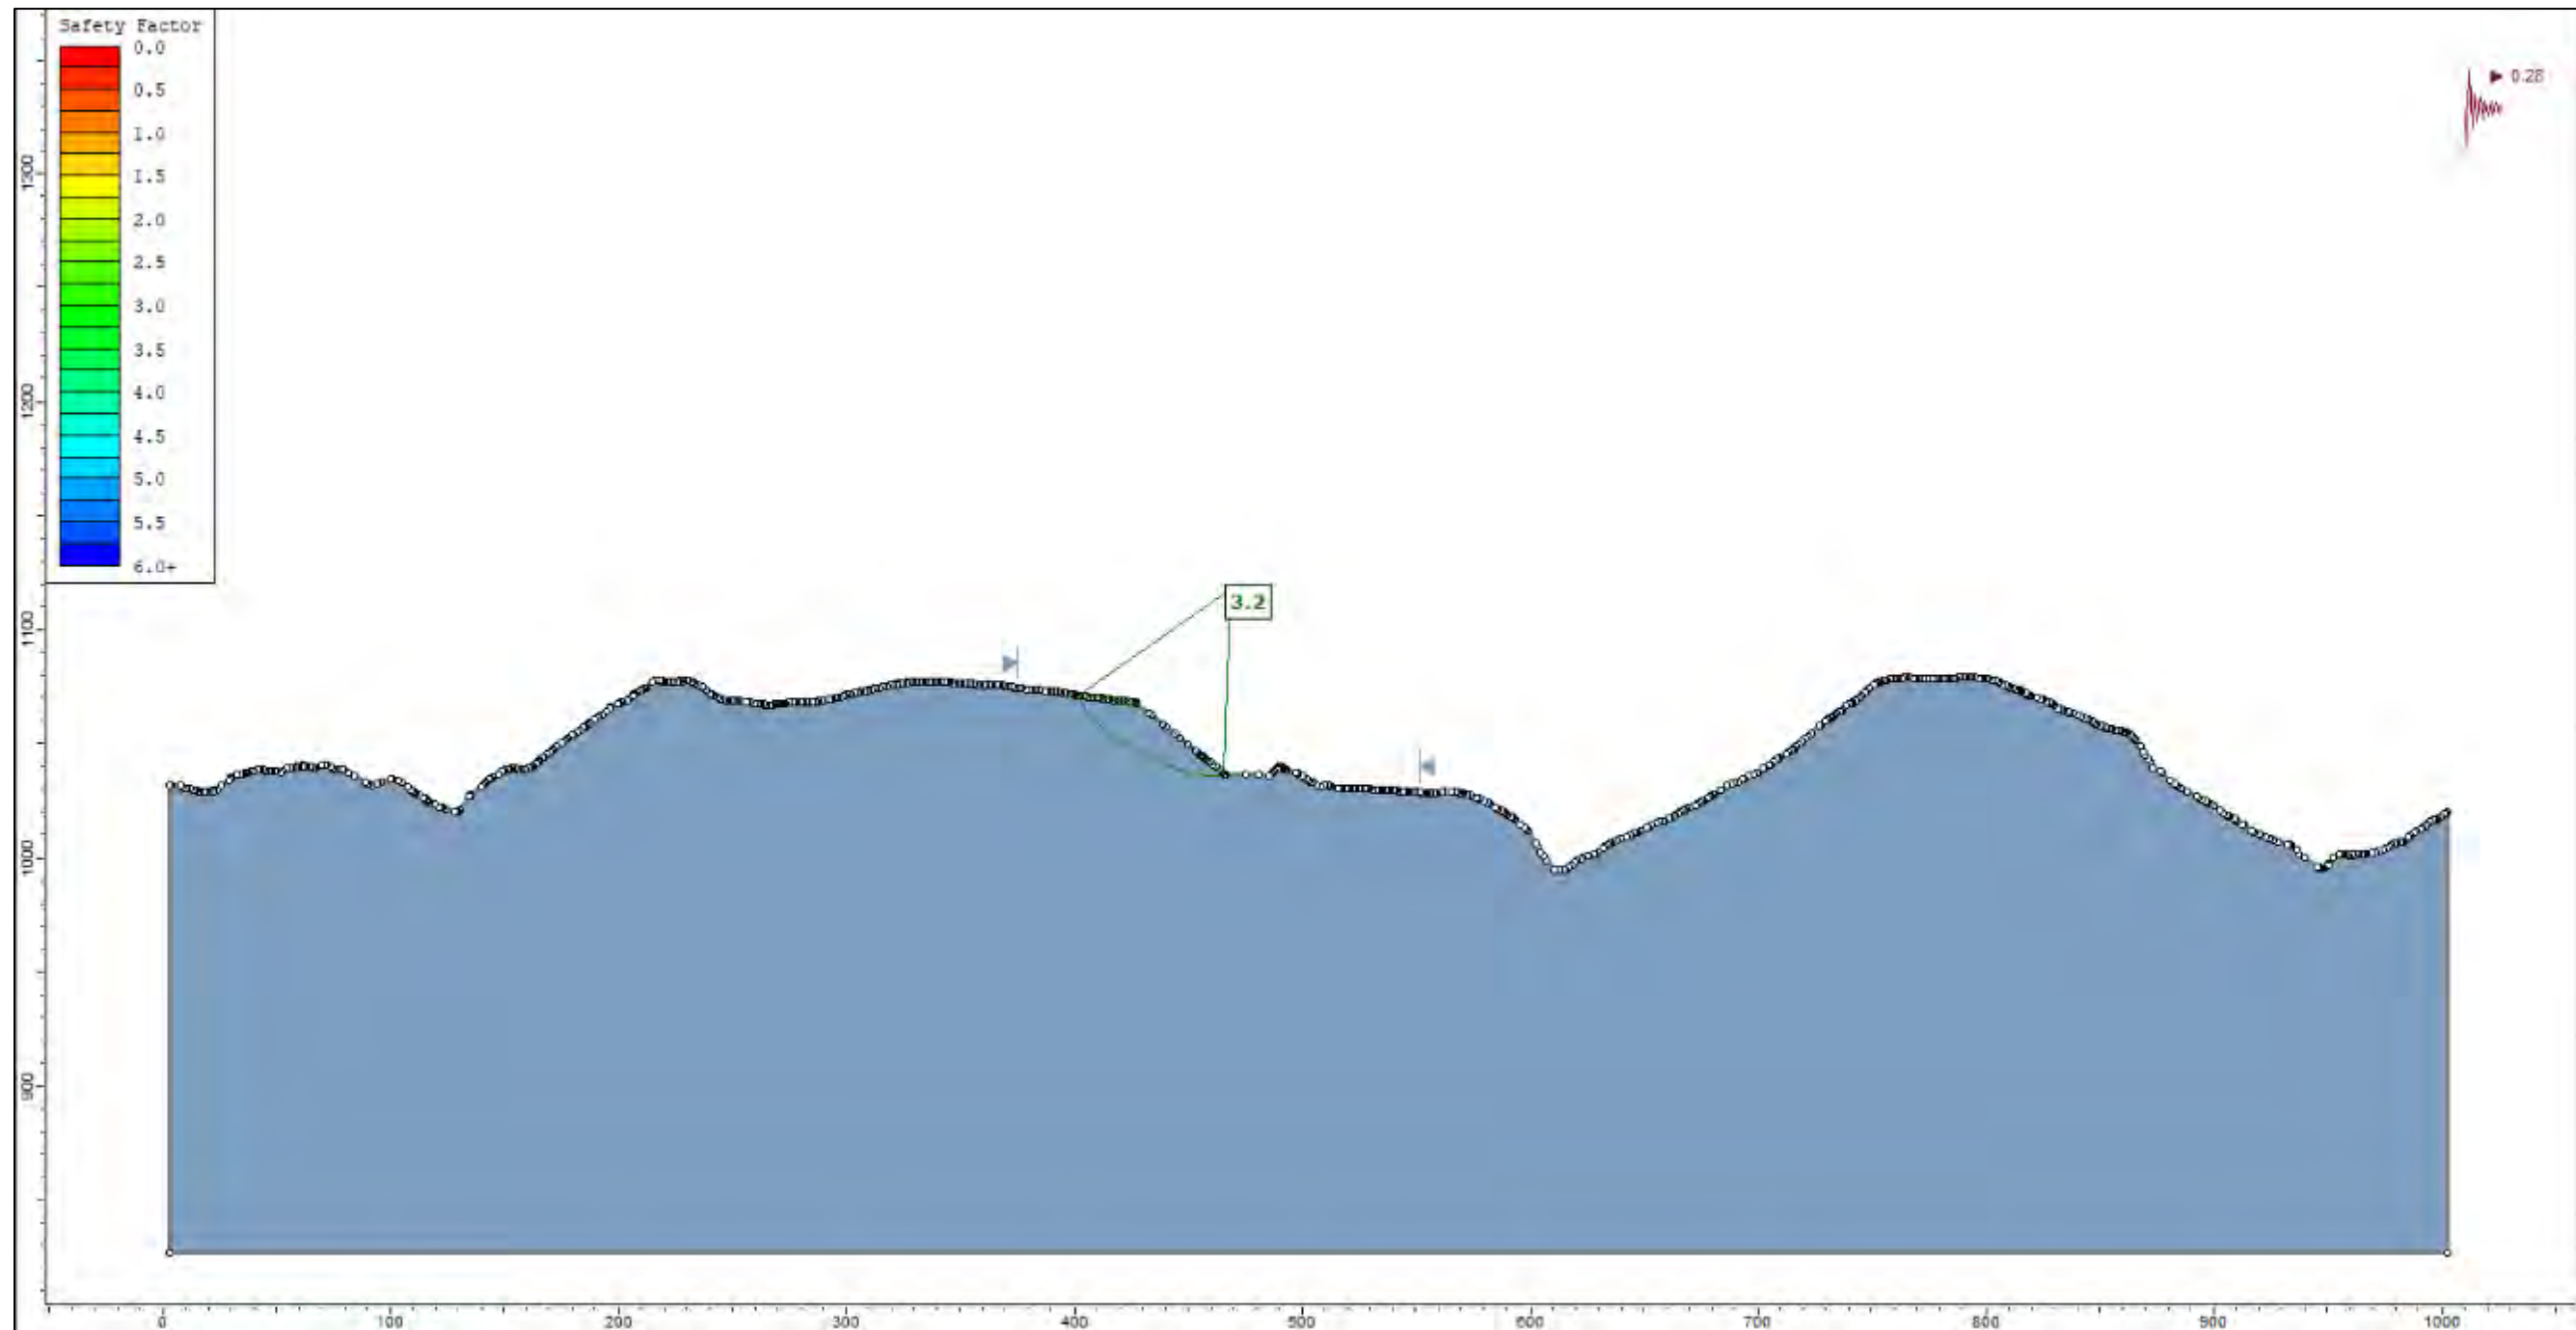
Figure: B168 - Haul Road Cut - Section 110 – Static Conditions.
