# **WAITAHA HYDROELECTRIC SCHEME:** **GEOLOGICAL FEASIBILITY REPORT**

Prepared for:  
ElectroNet Services Ltd

Date: October 2013

Prepared by:  
**Dr Mark Yetton, Geotech Consulting Ltd**

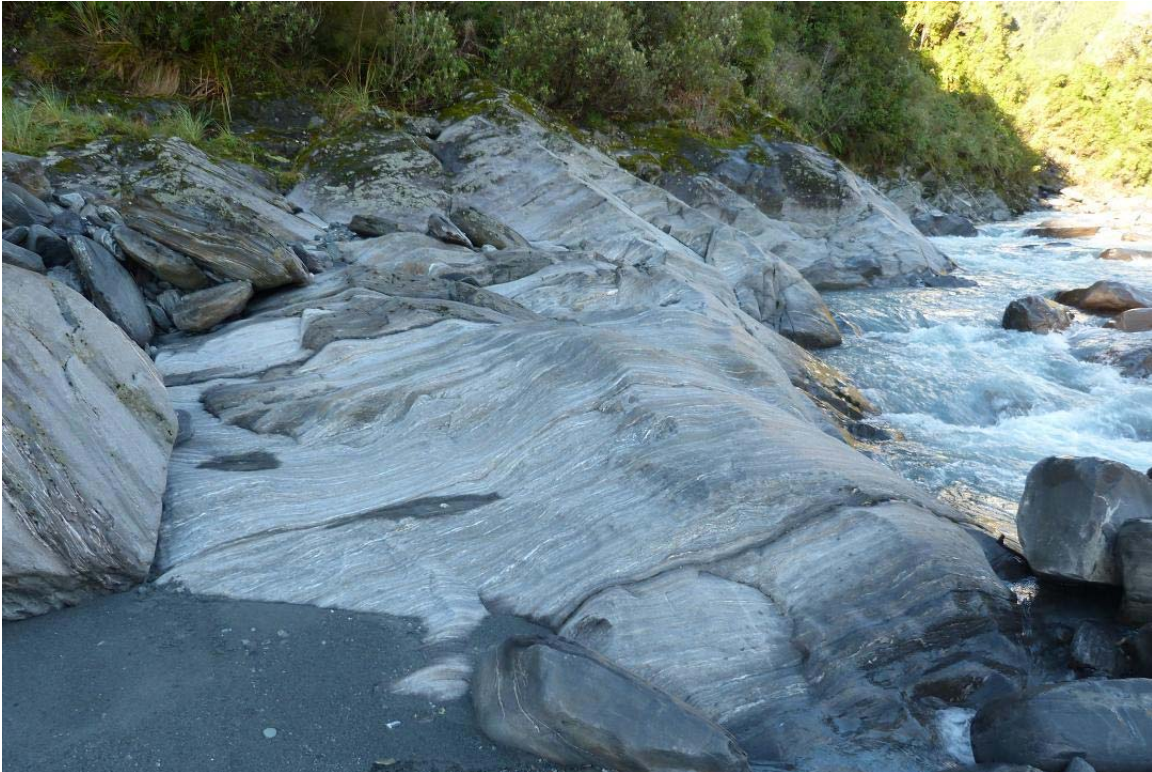
**Photograph 1:** Strong regularly foliated schist bedrock exposed in the true right bank of the Waitaha River 200m upstream of the proposed location of the powerhouse.

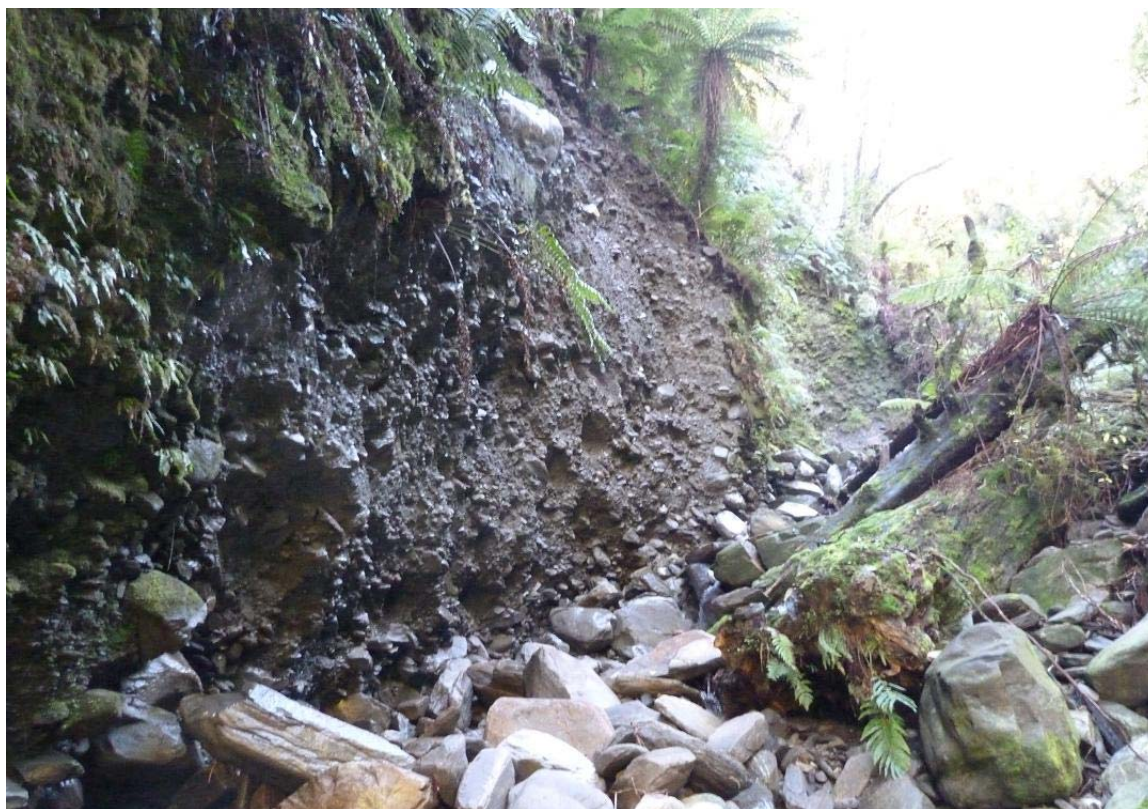
**Photograph 2:** Post glacial aggradation [pga] gravels exposed in Alpha Creek approximately 100m downstream of the proposed powerhouse.

Because of the high fines content, angularity and age of the post glacial aggradation gravels [the age has allowed some cementing over the elapsed time] the pga material is relatively cohesive and strong and will frequently stand vertically for tens of metres for long periods. When failure does eventually occur [for example due to earthquake or rainfall triggers] cliffs in pga gravels most often fail as falls and topples of exfoliation slabs [layer between 1 and 5m thick] that have developed sub-parallel to the cliff face.

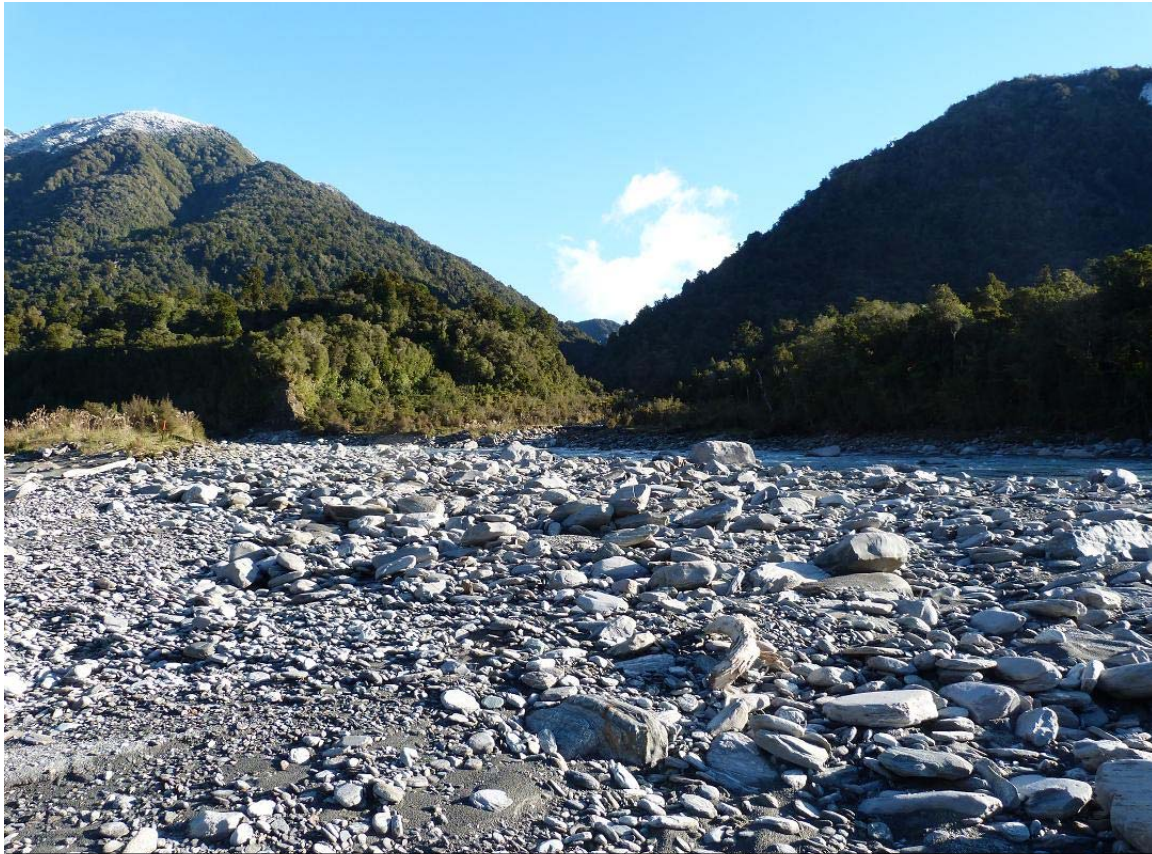
**Photograph 3:** Young alluvial gravels in the true right bed of the Waitaha River near the confluence with Douglas Creek.

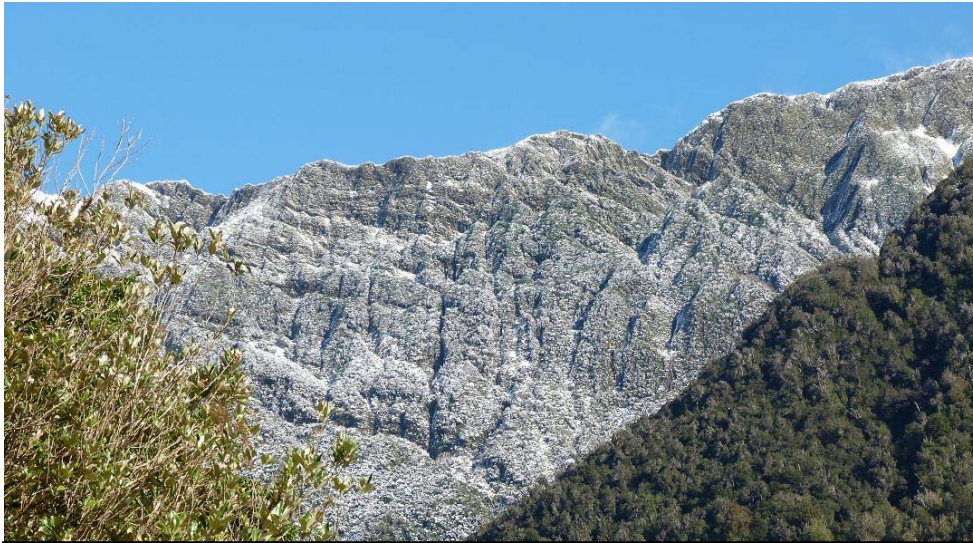
**Photograph 4:** View looking southwest along bedrock foliation strike. The recent snow is picking out the bedrock defect patterns where the steep foliation dips at 75-85 degrees in the middle and left of photo, but reduces to closer to 60 degrees at the right. There is a joint set creating a sub-horizontal trace on the snowy face and dipping towards the southwest which is the northwest-southeast striking joint set showing up in the joint survey data.

From an engineering geological perspective joints include partings parallel to the schist foliation. The foliation orientation [strike and dip] is shown in Figure 1 at all the bedrock exposures that have been located in the fieldwork to date. The foliation is notably consistent with a strike of approximately 060 degrees [northeast to southwest] and dips that are more variable but typically around 60-85 degrees to the southeast. Given the presence of significant faults the consistency in foliation strike is a positive sign implying that the bedrock may not be extensively disturbed. Variation in foliation dip is quite common in the general area as a result of broad scale folding and can be observed in some areas over scales of hundreds of metres [photograph 4].

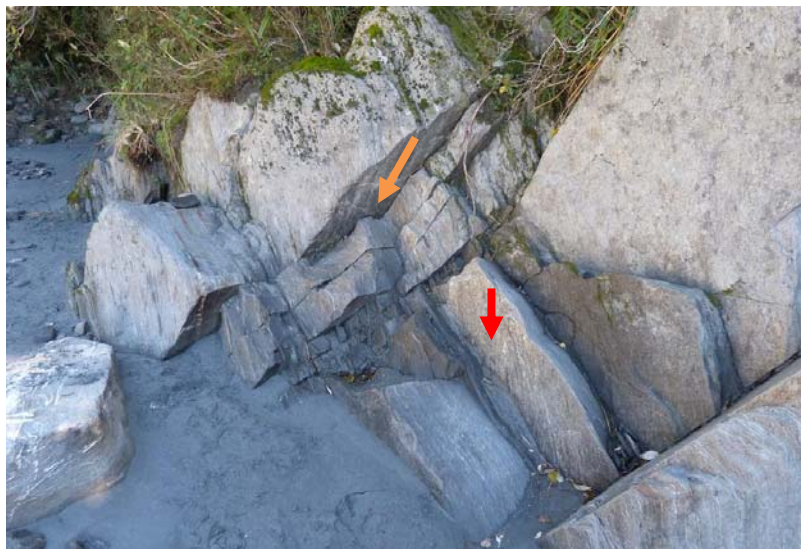
**Photograph 5:** The most common joint orientation at all the sites [orange arrow], in this case showing up at Whirling Water, where the dips average 50 degrees to the southwest [strike 152 degrees]. The foliation is at approximate right angles to this joint set and is dipping at 80 degrees southeast [red arrow].

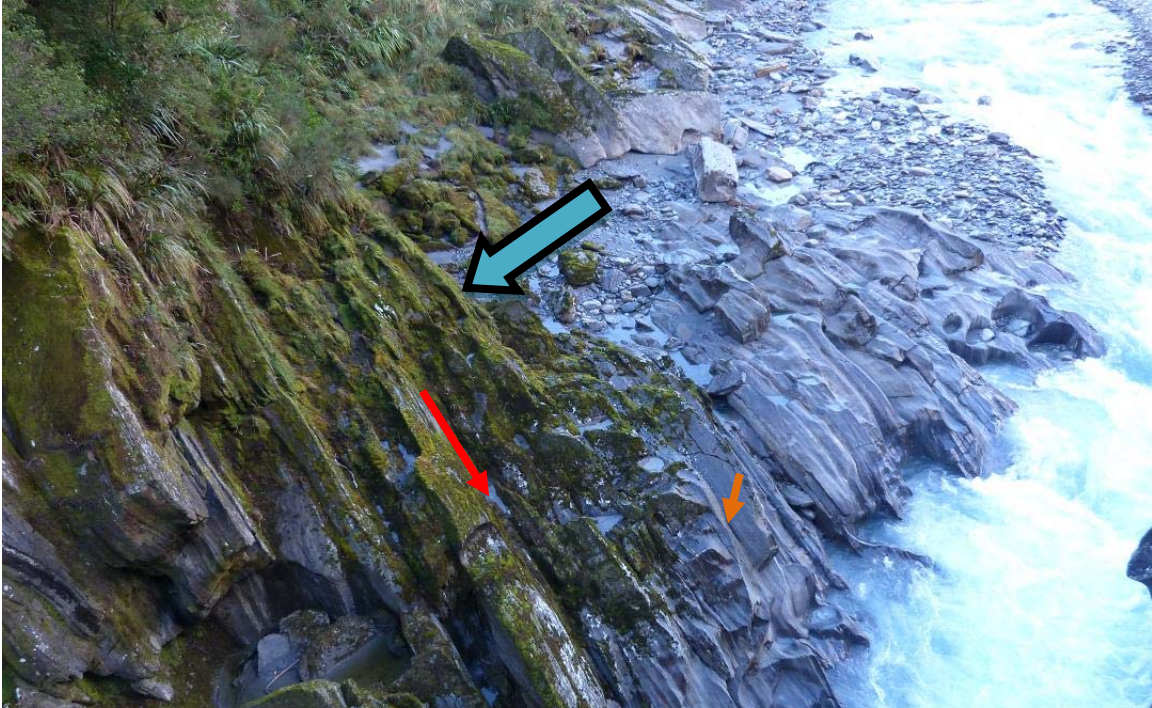
**Photograph 7:** The bedrock bench on which the intake will be located [river cleaned rock at right of photograph] with the tunnel entry in the direction of the green arrow and at right angles to the bedrock foliation shown by the red arrow. Dominant joint set dip at this location is shown by the orange arrow.

Once again the dominant joint set is oriented with dips to the west and northwest [Photograph 6 and Figure 2] but based on this exposure the initial tunnel orientation is well placed to avoid running exactly parallel to the dominant joint set. The initial tunnel direction here is also perfectly placed [i.e. perpendicular] with respect to the foliation orientation, and the foliation will be the main control on tunnel stability [Photograph 7].

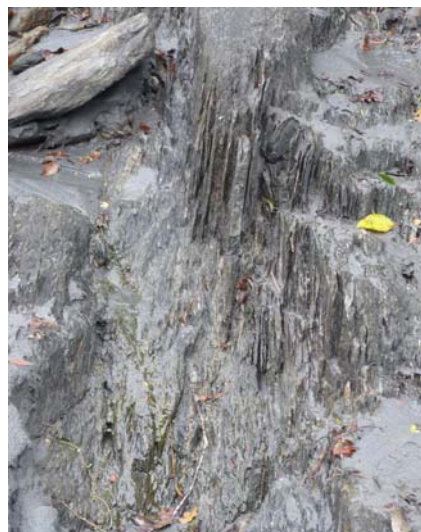
**Photograph 8:** Small fault parallel to foliation on true left bank 30m upstream from

There is a fault that is parallel to foliation and located immediately upstream of the intake site which has been responsible for uplifting the bedrock into the path of the river in the Morgan Gorge area [Figure 1]. Minor shears associated with the fault can be found on the true left bank close to the start of the gorge [Photograph 8]. Fortunately the fault appears to have little influence on the quality of the rock at the proposed intake.

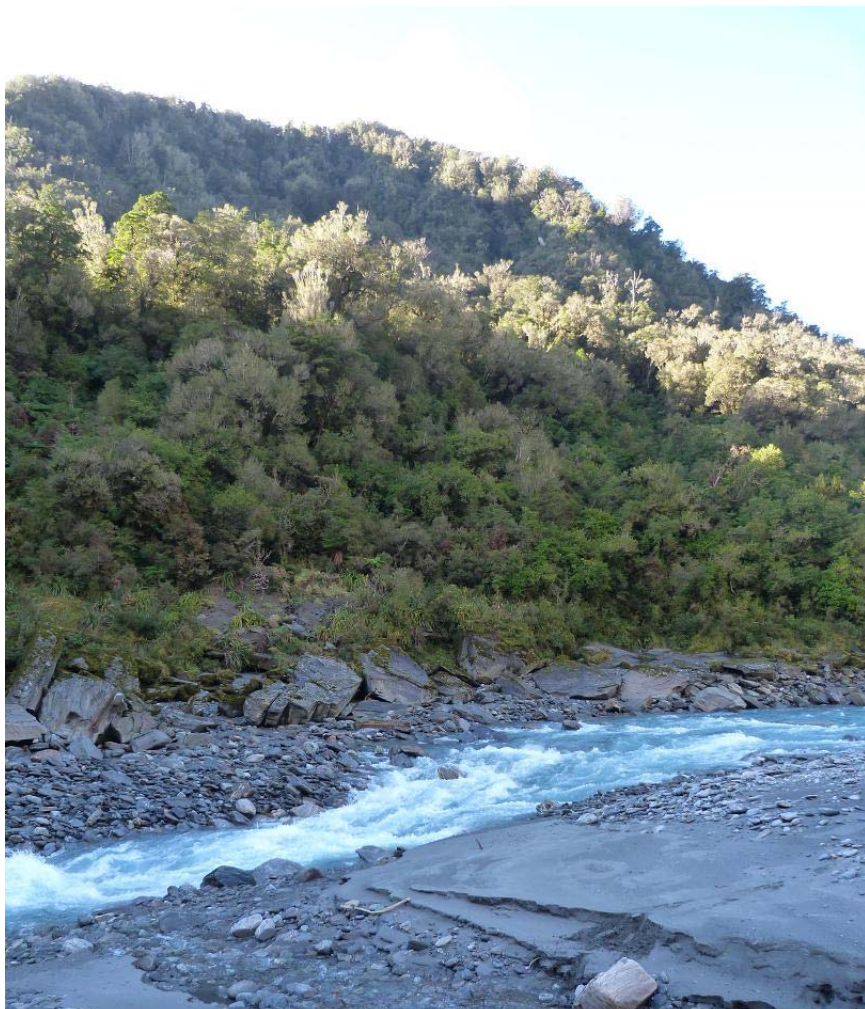
**Photograph 9:** Angular boulder talus from rockfall into the modern river channel level on the true right of the Waitaha River 20m upstream of the intake. An arcuate scarp and 'basin' marking the approximate extent of the failure can be seen picked out by the shadow.

There has been a rockfall near the intake site in the past that has dumped large angular boulder talus down into the start of the gorge. Rockfalls such as this may have been earthquake triggered and could occur again during strong earthquake shaking. The intake will need to take into consideration the possibility of future rockfall impact by ensuring robust design.

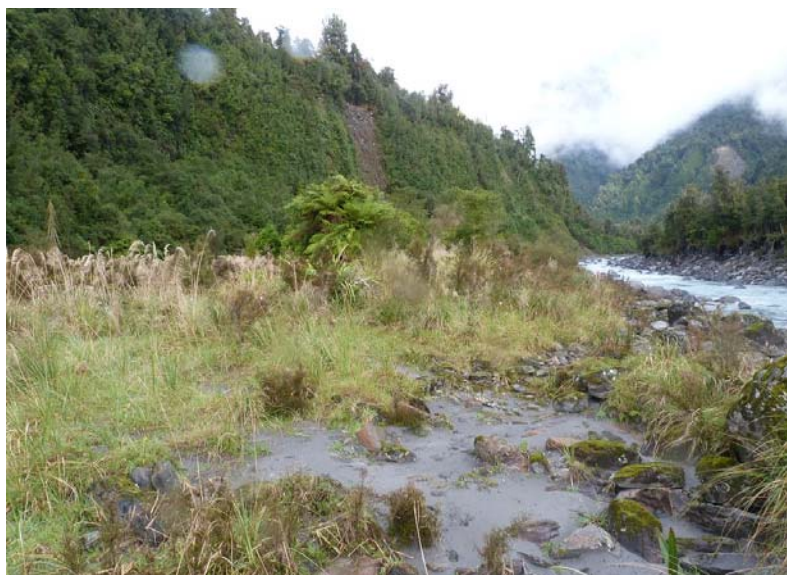
**Photograph 10:** The proposed powerhouse site near river level with the 60-70m high terrace edge in the background.

The powerhouse will be built on a relatively low and young alluvial gravel surface with no significant old vegetation implying regular past flooding [Photograph 10]. Extensive flood protection works will be required for the powerhouse area.

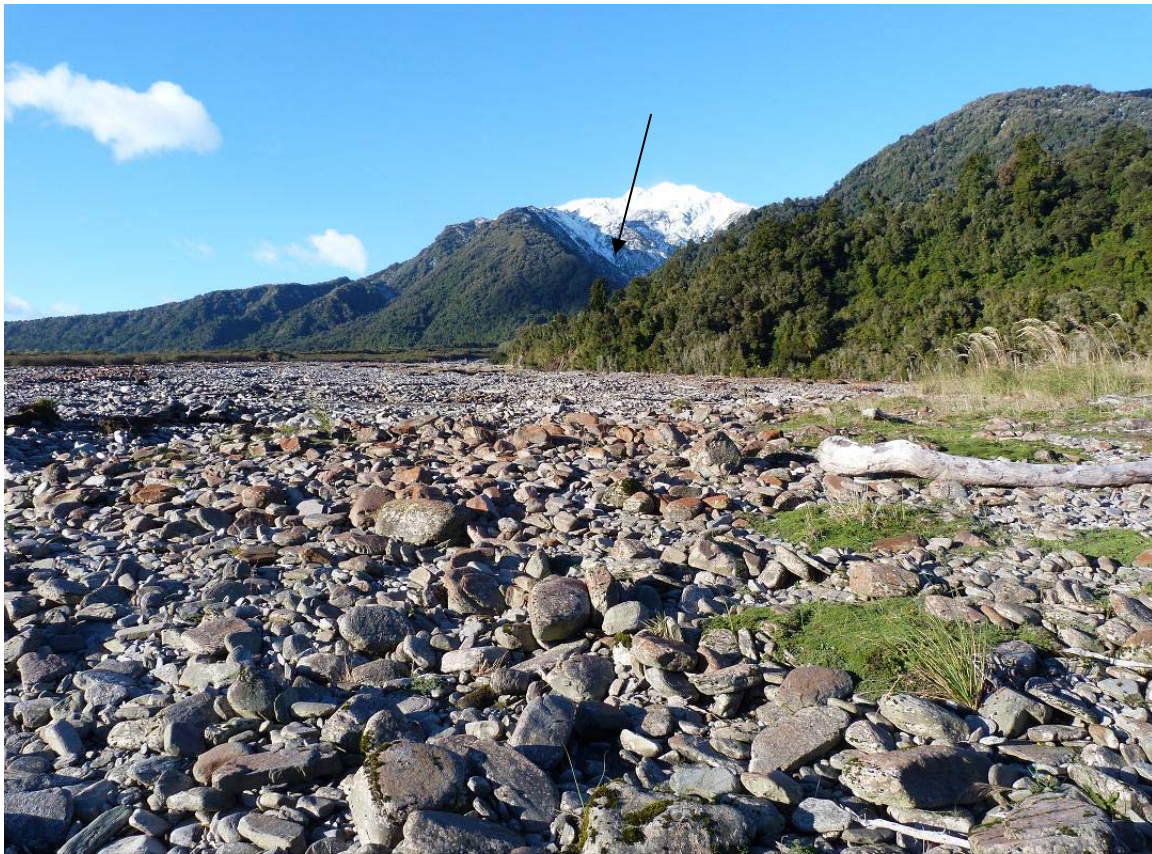
**Photograph 12:** The bottom end of McGregor Creek near the junction with the Waitaha River. The 1903 Robinson slip occurred in the area arrowed. The creek channel in this lower fan continues to shift about in response to the massive sediment load released 110 years ago.

The existing gravel road would require some minor widening and metalling and probably new culverts at two creek crossings in the approach to McGregor Creek. McGregor Creek has a very wide and unstable creek bed fan that has formed since a major rainfall triggered landslide [‘Robinson Slip’, Figure 1] occurred in 1903 in the upper catchment near the Alpine Fault [Yetton, 2000]. Accounts from the time indicate the slip occurred after a sustained period of heavy rain and extreme local flooding. The debris flow associated with the landslide completely buried a large area of mature forest with the coarse debris. Finer sediment ‘flowed’ north along Waitaha Valley road where horses reportedly got stuck in the ‘quick sand’. The fan continued to grow for many years after 1903 before downcutting in the middle catchment, re-exposing the buried forest, and triggering further aggradation and avulsion of the lower creek catchment. This process has continued in the lower creek catchment to the present day.

During floods the creek channel in the lower fan continues to shift about [avulse]. Temporary access via fords can easily be provided, subject to periodic reconstruction of flood damaged sections of the road, but permanent access will require a relatively long bridge [50m?] with extensive protection and river training works for both abutments. This is another area where tunnel spoil could be usefully disposed of as part of the river protection works.

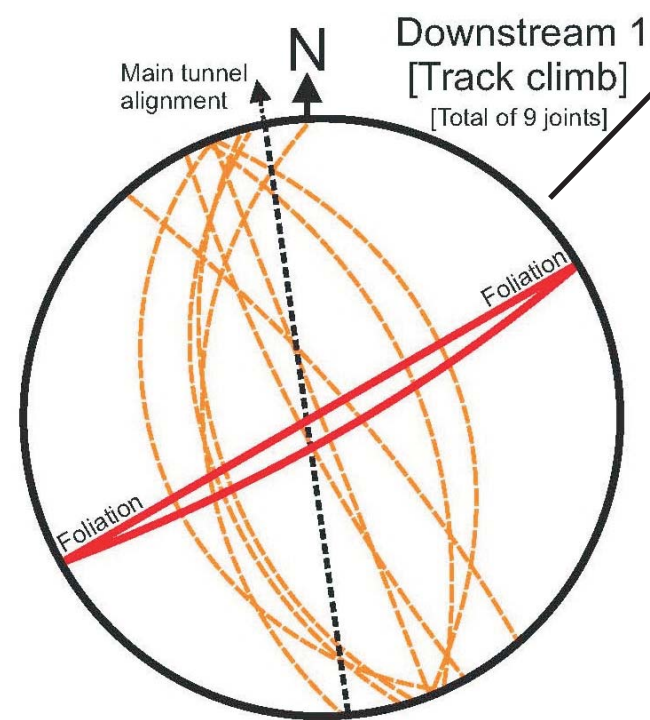
All joint plots lower hemisphere stereographic projections on Wulff nets. Refer key on Figure 1/1930 for features on map insert

Figure 2 – Joint data

The joints at Whirling Water fall into three groups averaging 015/78NE [11 out 45], 126/64SW [8/45], and the most common set at 152/50SW [26/45]. We show stereographic projections for each of the various joint surveys in Figure 2 and discuss the results with respect to tunnel orientation in Section 8. The average joint spacing at Whirling Water is 650mm.

Other joint surveys were undertaken at the proposed intake at upper Morgan Gorge and at two outcrops at the other end of gorge near the proposed powerhouse and tunnel exit [Figure 2]. A total of 17 joints were recorded at the intake that fell into two sets at 050/48NW and 072/40W with joint spacings averaging approximately 1.5m. The two locations at the downstream end had far fewer joints exposed for measurement. The joints in these areas generally had a SE-NW strike [160 degrees approx. average] with dips around 30-60 degrees in both directions [NE and SW]. The joint spacings were closer to 1m on average.
