TO: OGNZL MP4 Team  
Oceana Gold New Zealand Limited (OGNZL)

## MP4 COAL CREEK AND CAMP CREEK DAMS - SCHEDULE 9 FISH PASSAGE ASSESSMENT

To enable MP4 to be developed and operate as proposed, water will be stored in two previously consented<sup>1</sup> reservoirs that have yet to be constructed. The two reservoirs will be created by constructing a dam on each of Coal Creek and Camp Creek. The actual and potential effects of the construction and operation of the two dams were described and considered during the consenting process. However, the existing consents have not expressly considered the Freshwater Fisheries Regulations 1983, therefore it has been proposed to include these additional permissions within the wider MP4 Fast-Track application. No components of the initial dam design, construction or discharge regime have been changed since consents were issued, therefore no additional consideration of the effects of the dams, with the exception of how they will impact fish passage, are necessary.

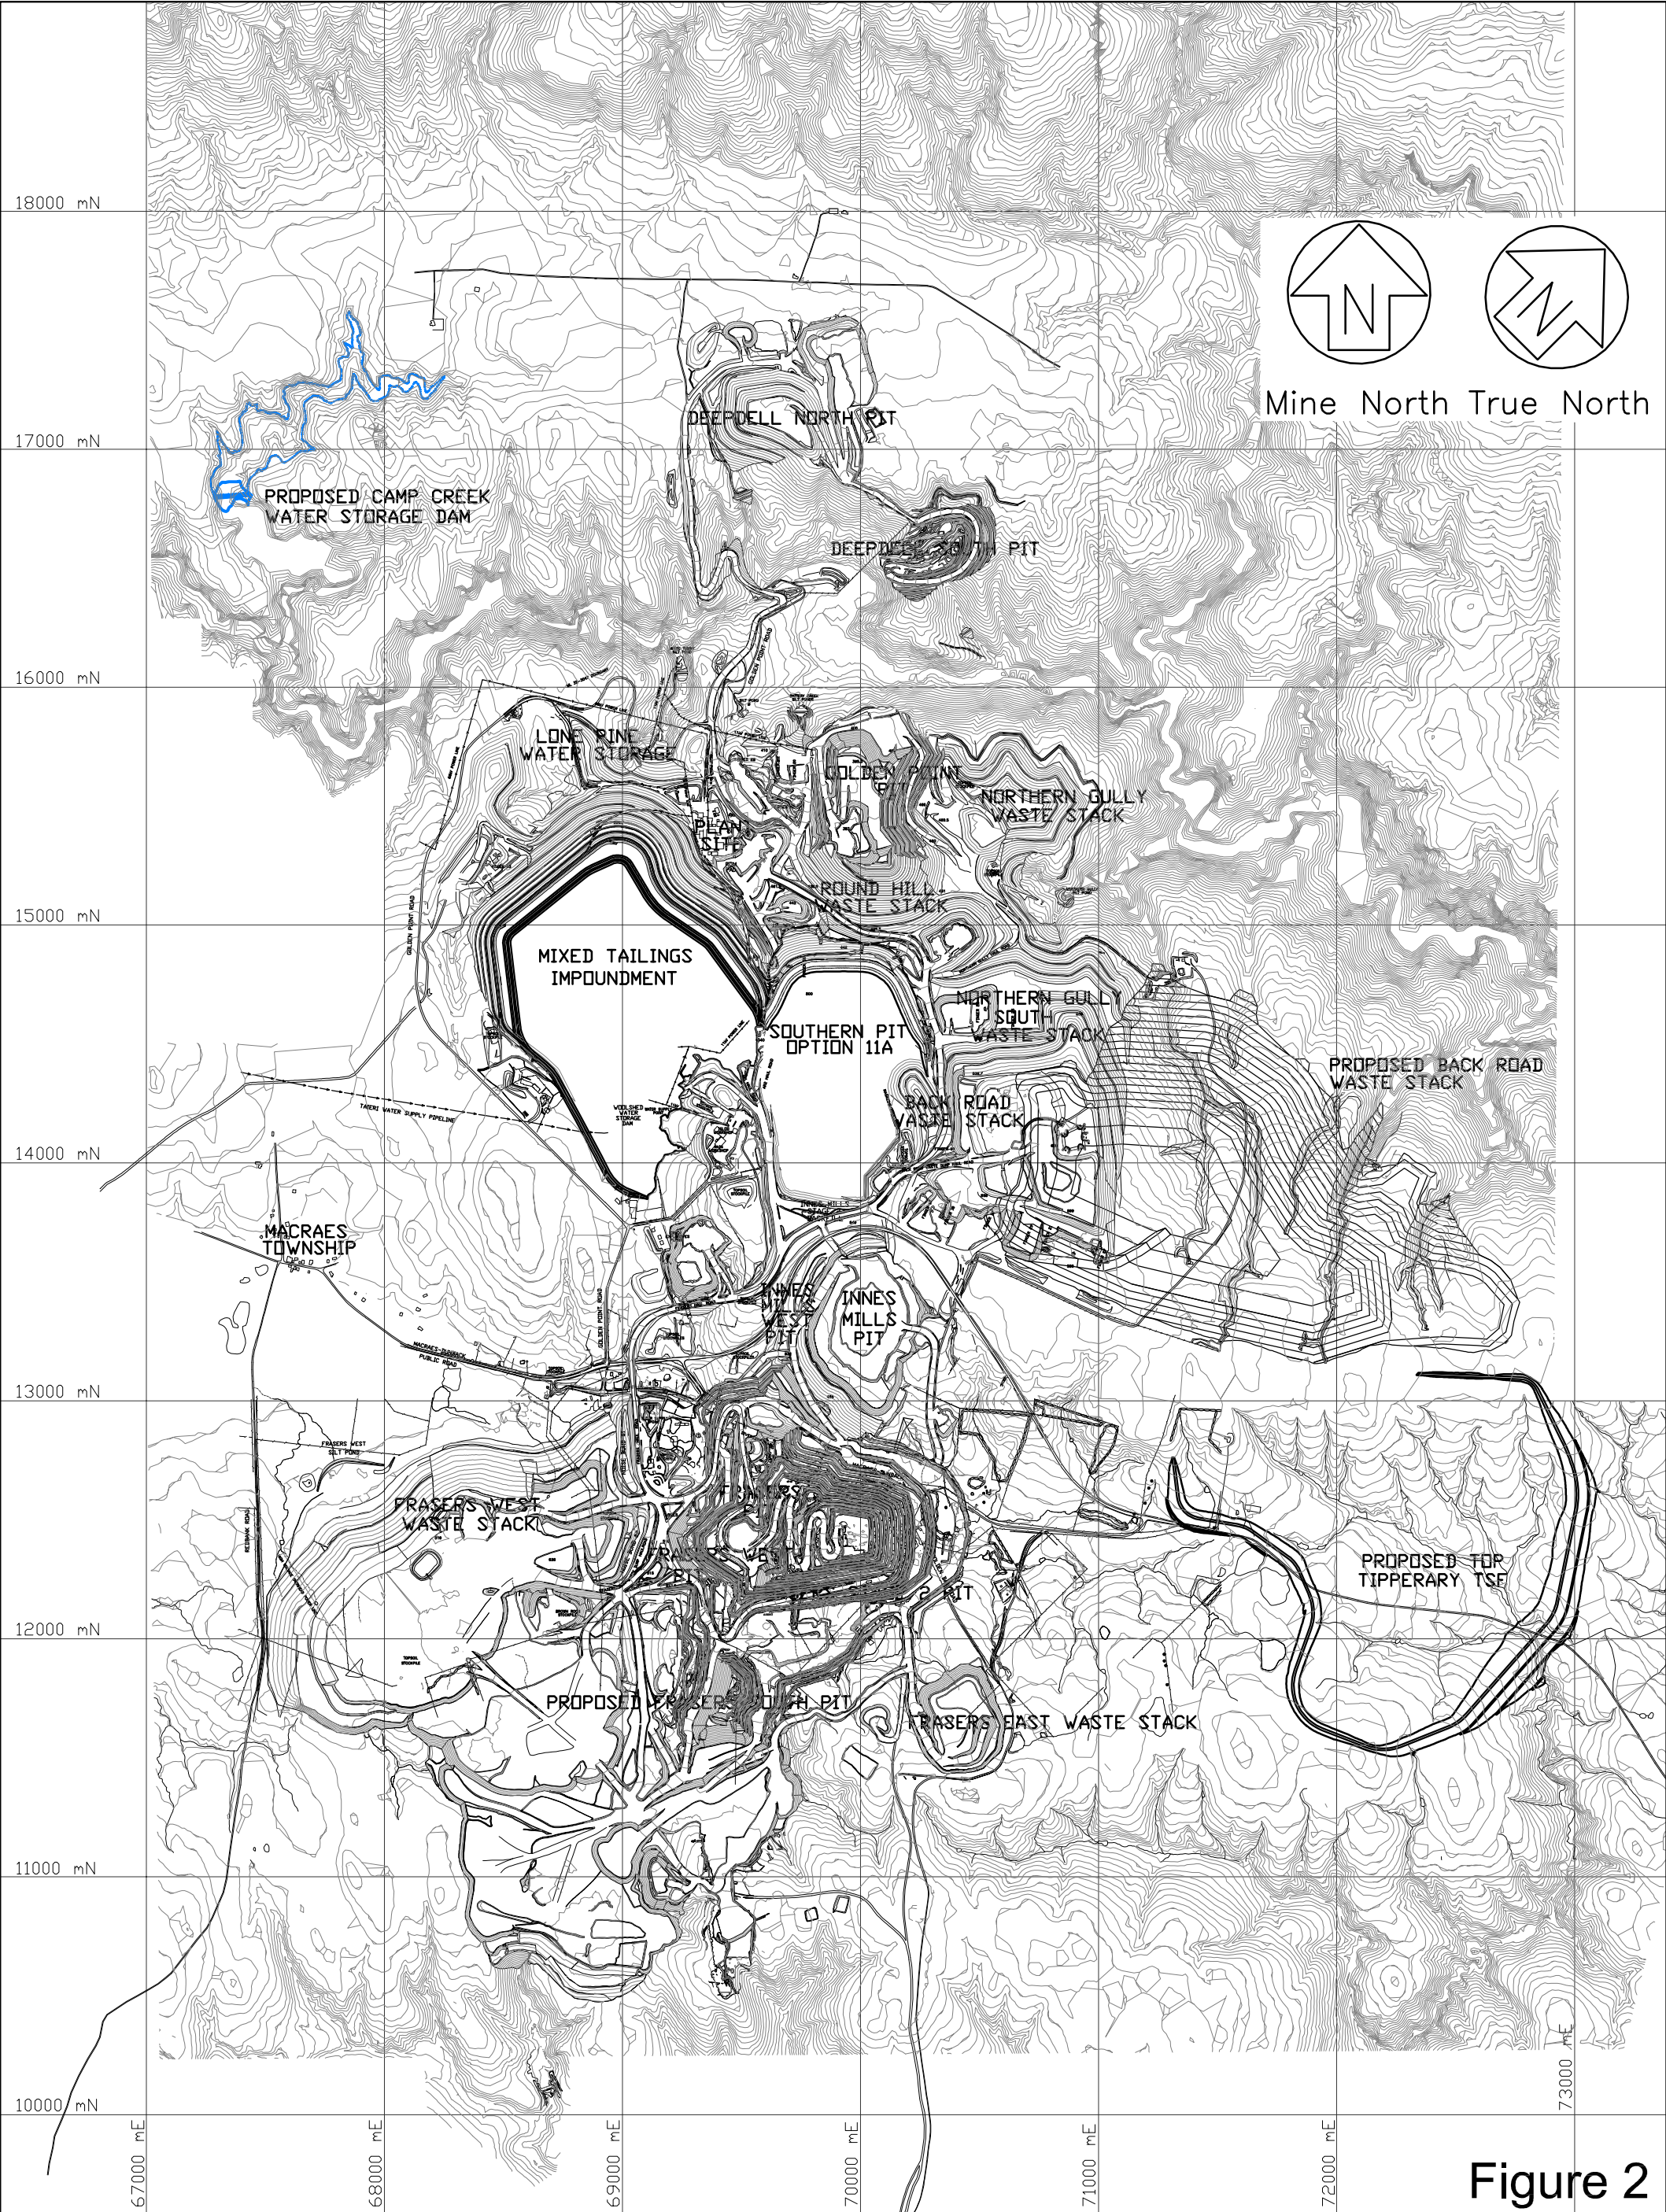
Figure 2

**OCEANA GOLD (NZ) LTD, MACRAES GOLD PROJECT**  
**Camp Creek Water Storage Dam**  
*Site Plan*

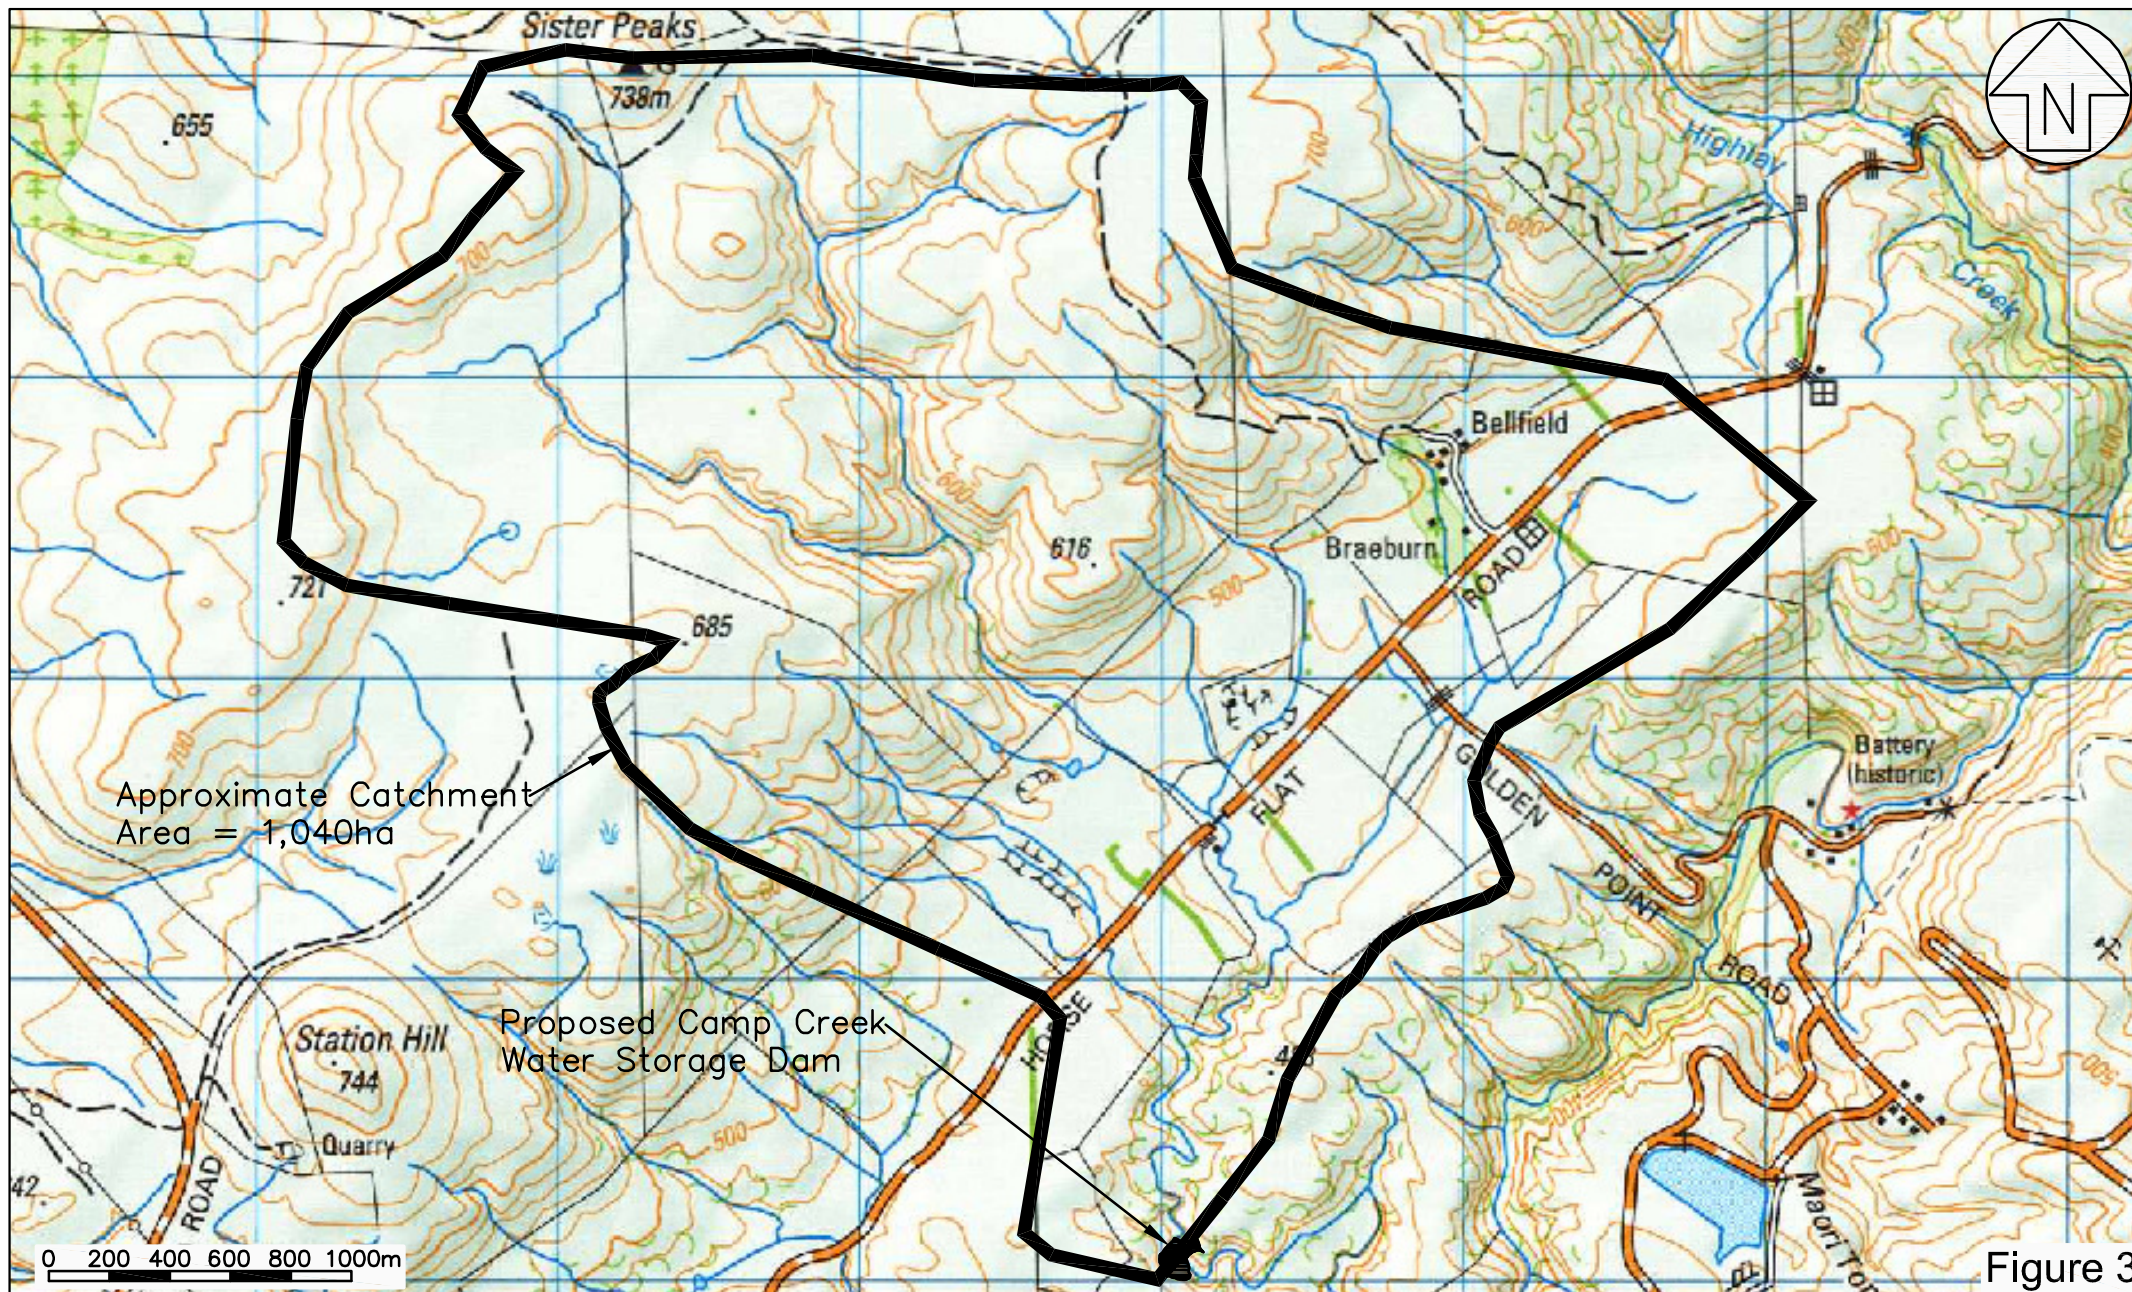
Drawing No. 6914-Fig 3  
Date: 8 Mar 2011  
Drawn: BL  
Scale: 1:25000 (@A4)  
Filename: 6914-Fig 3.dwg

**OCEANA GOLD (NZ) LTD, MACRAES GOLD PROJECT**  
**Camp Creek Water Storage Dam**  
*Catchment Area Plan*

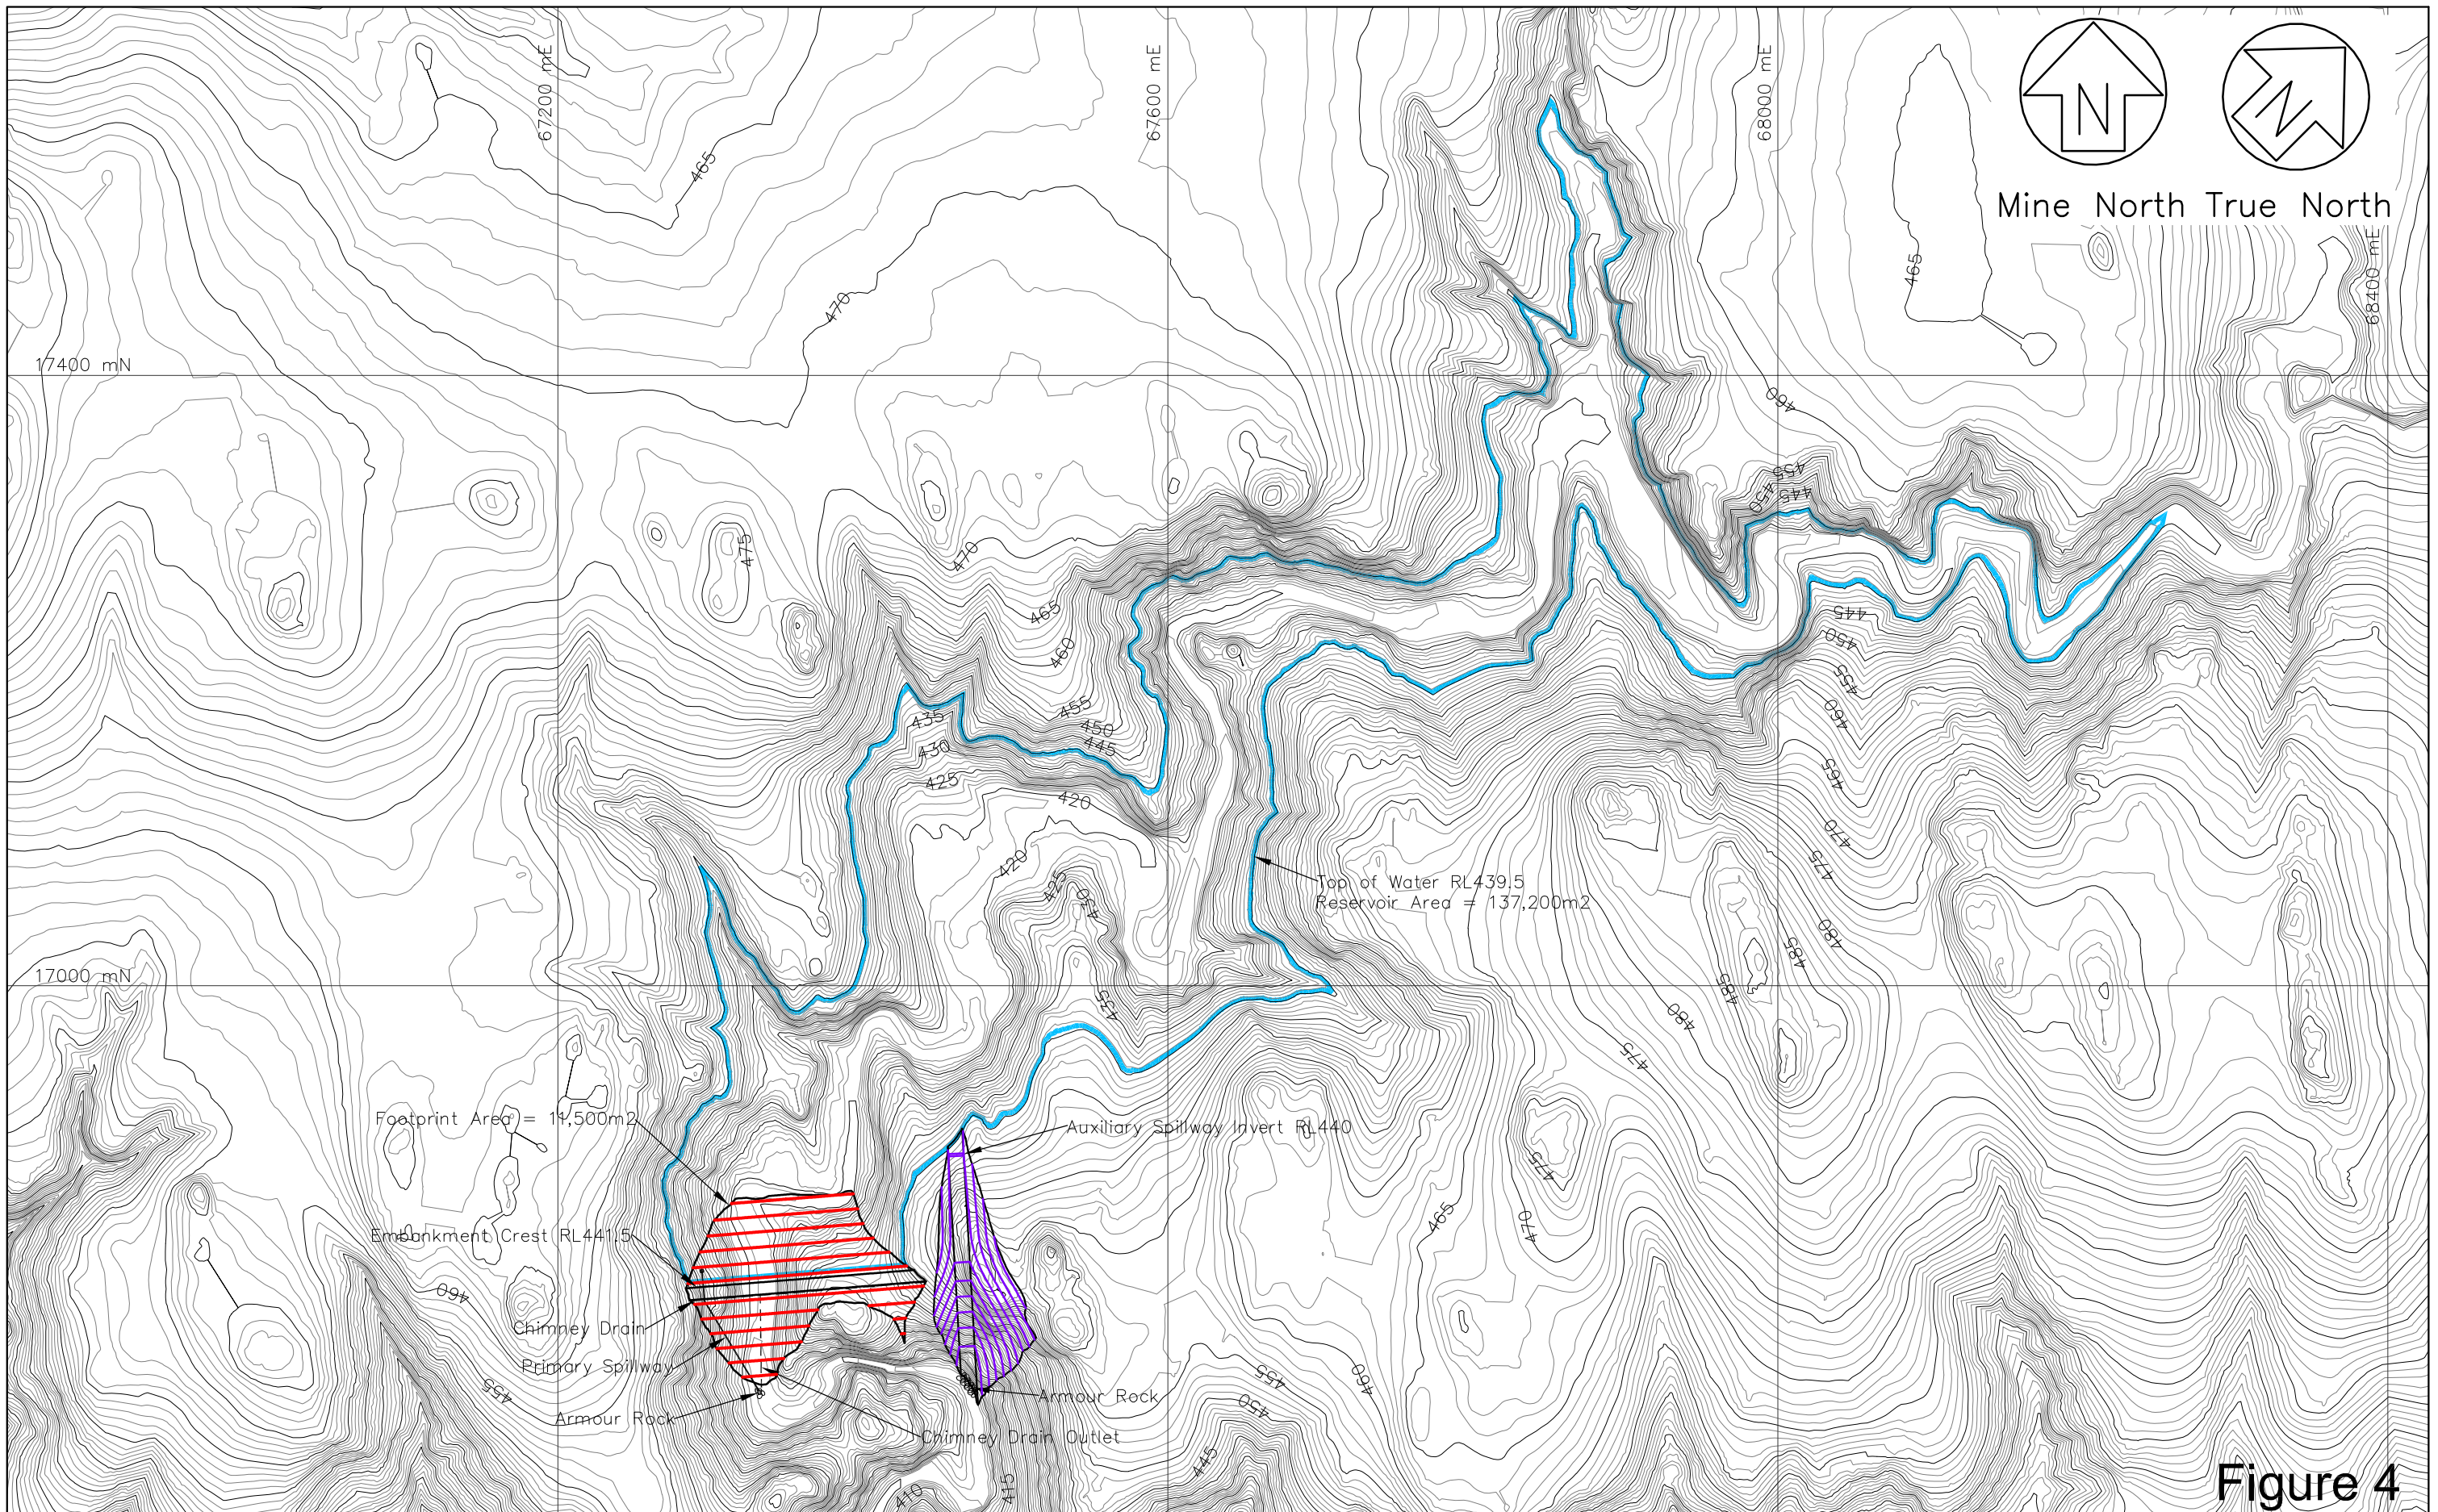
**Figure 4**

**OCEANA GOLD (NZ) LTD, MACRAES GOLD PROJECT**  
**Camp Creek Water Storage Dam**  
*Layout Plan*

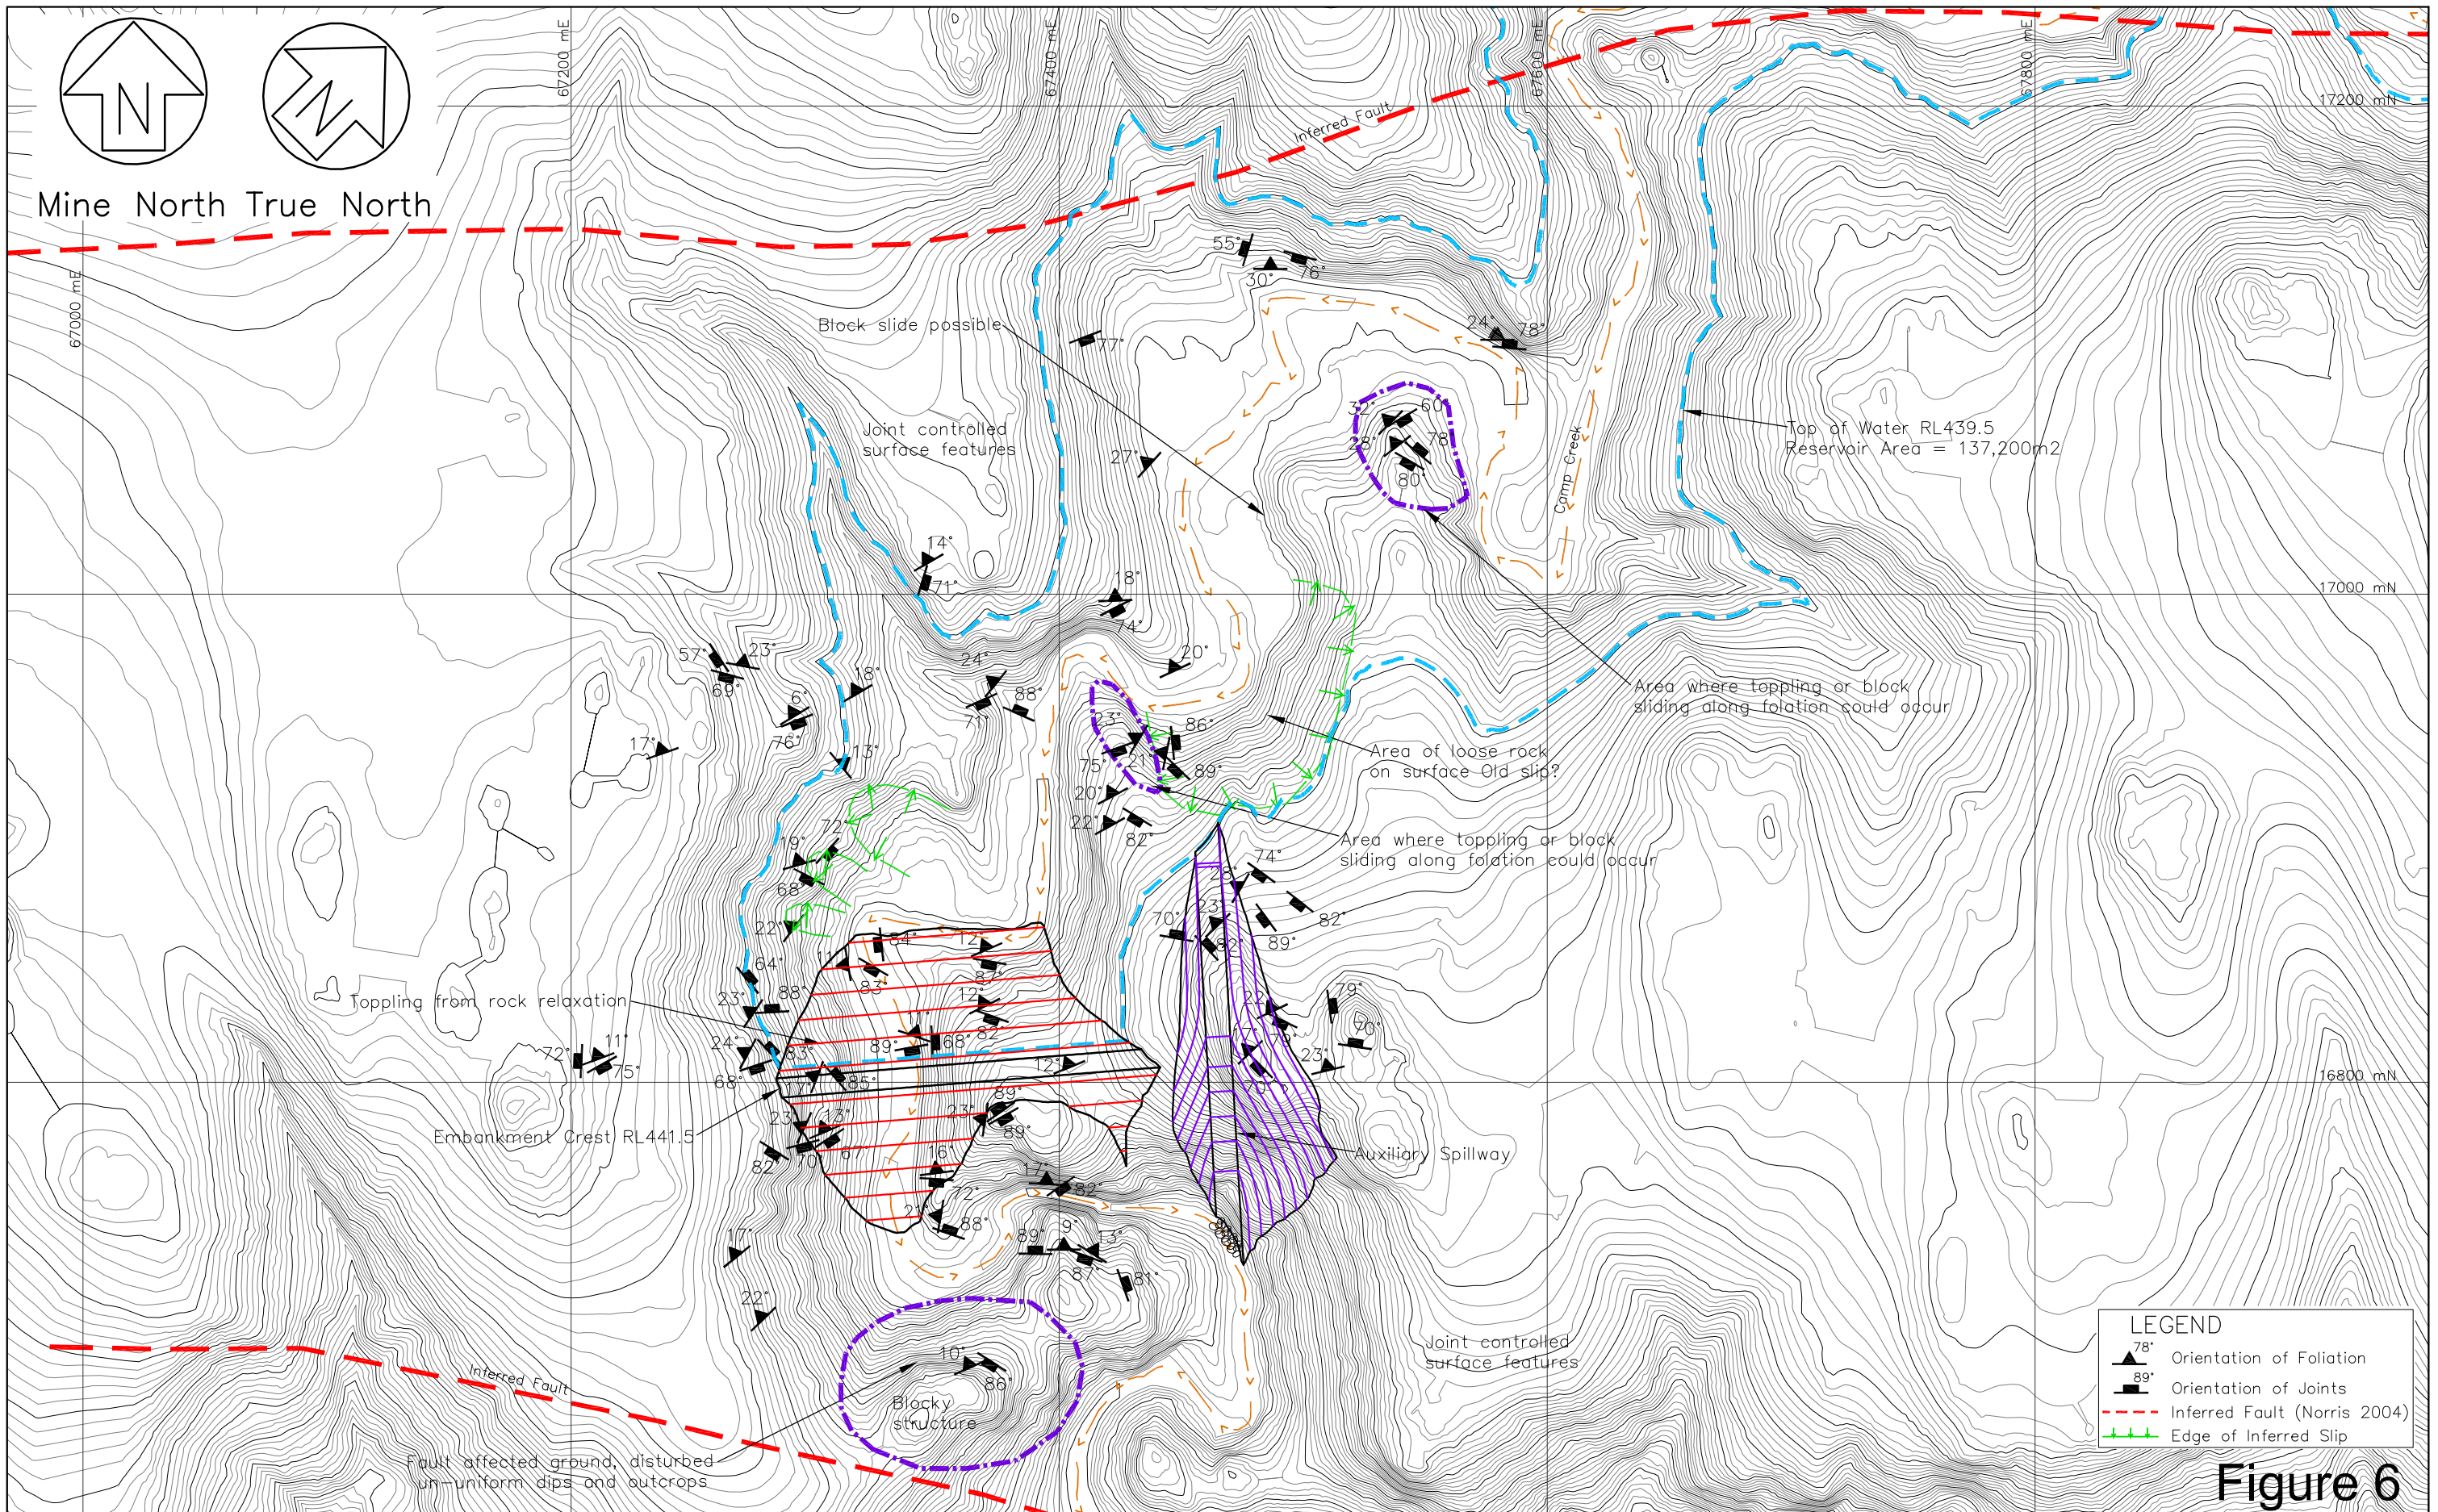
Drawing No. 6914-Fig 6  
Date: 21 Jan 2011  
Drawn: MC/BL  
Scale: 1:2500 (@A3)  
Filename: 6914-Fig 6.dwg

## **OCEANA GOLD (NZ) LTD, MACRAES GOLD PROJECT** **Camp Creek Water Storage Dam** *Geological Mapping*

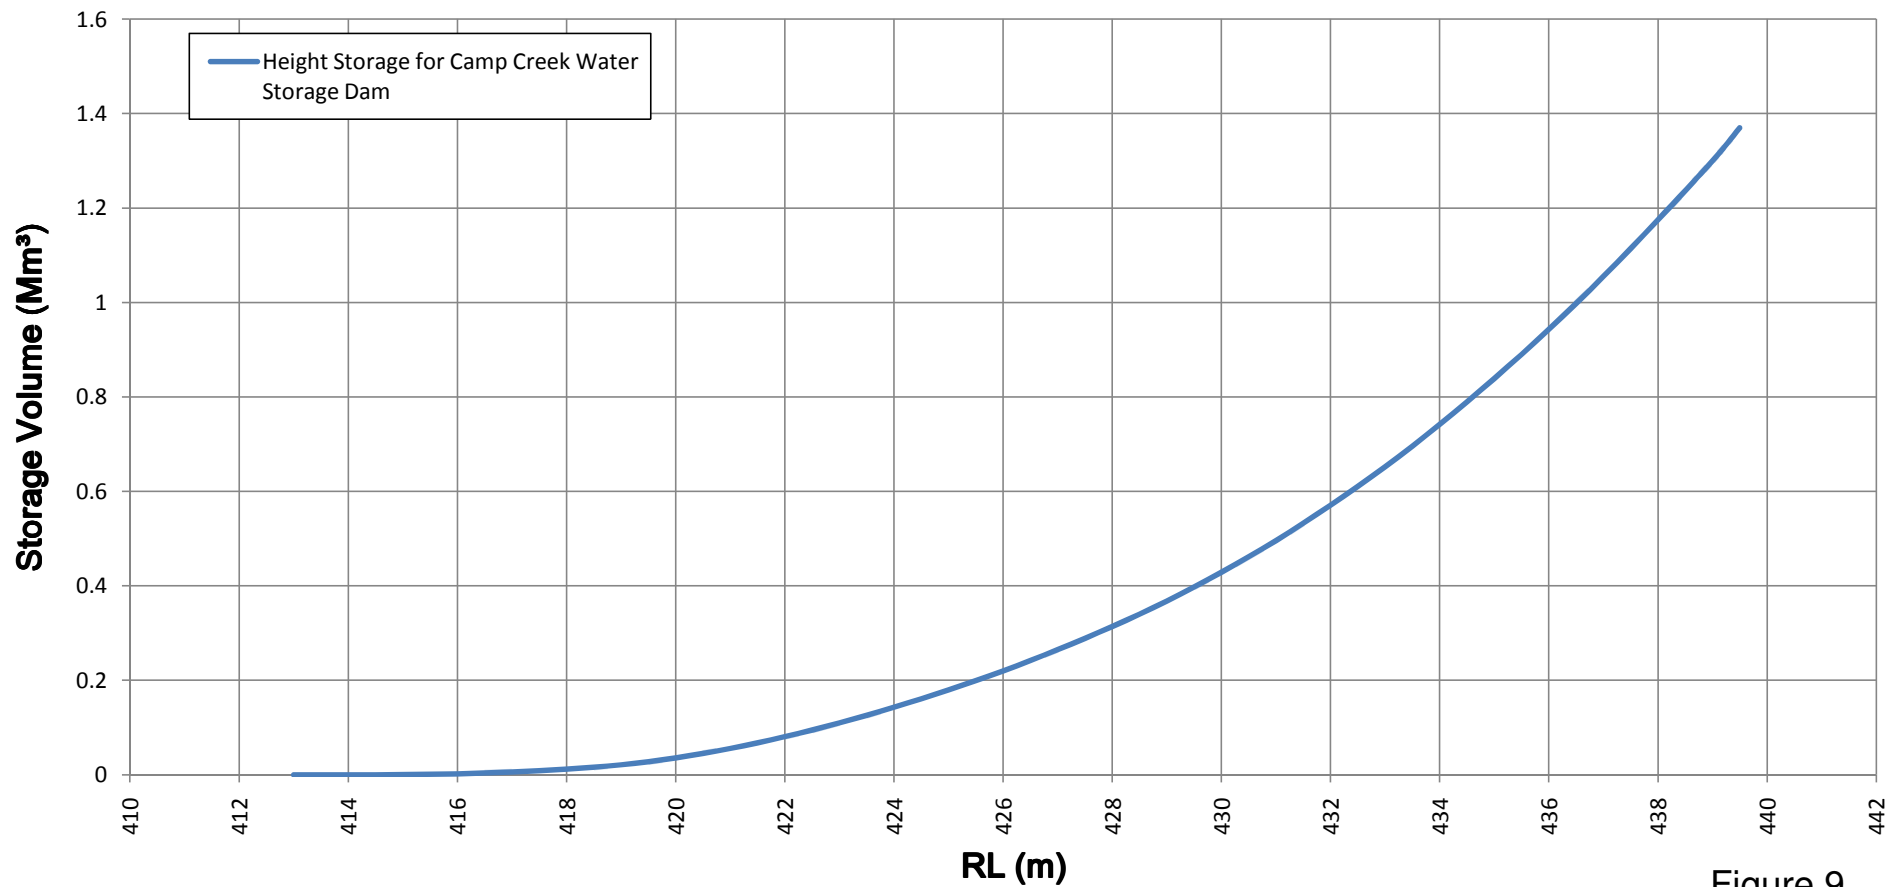
Figure 9

OCEANA GOLD (NZ) LTD  
Camp Creek Water Storage Dam  
*Height Storage Curve*

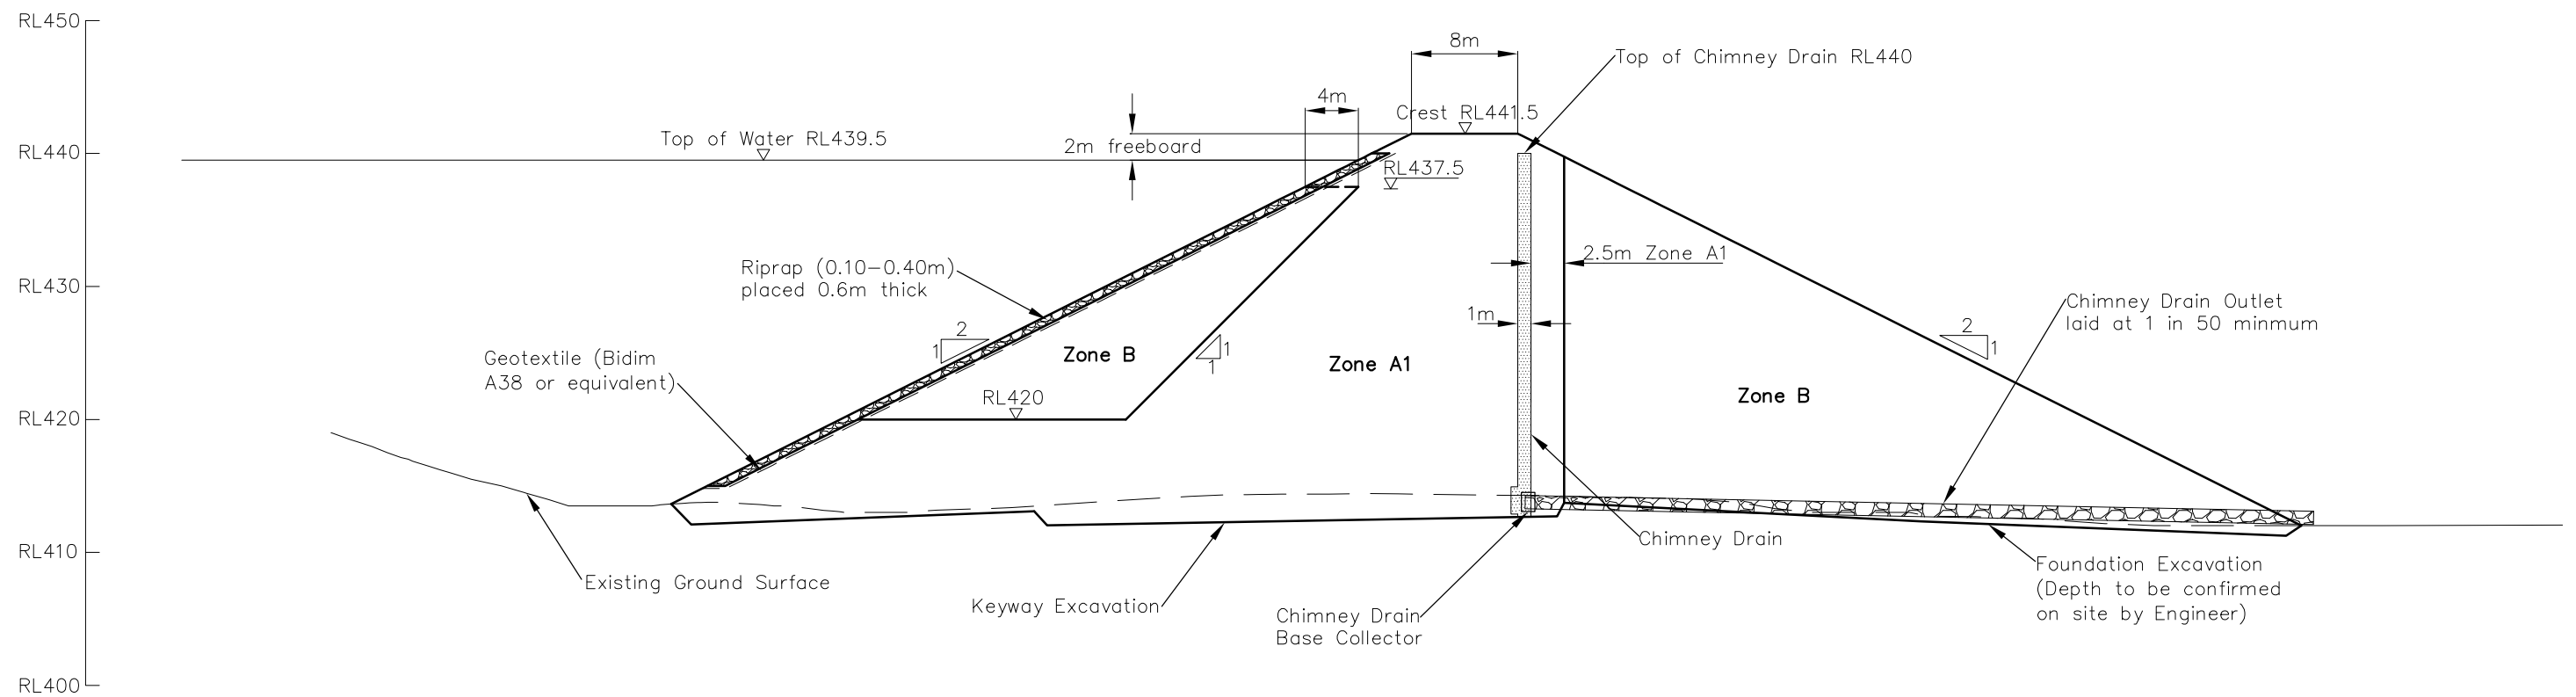
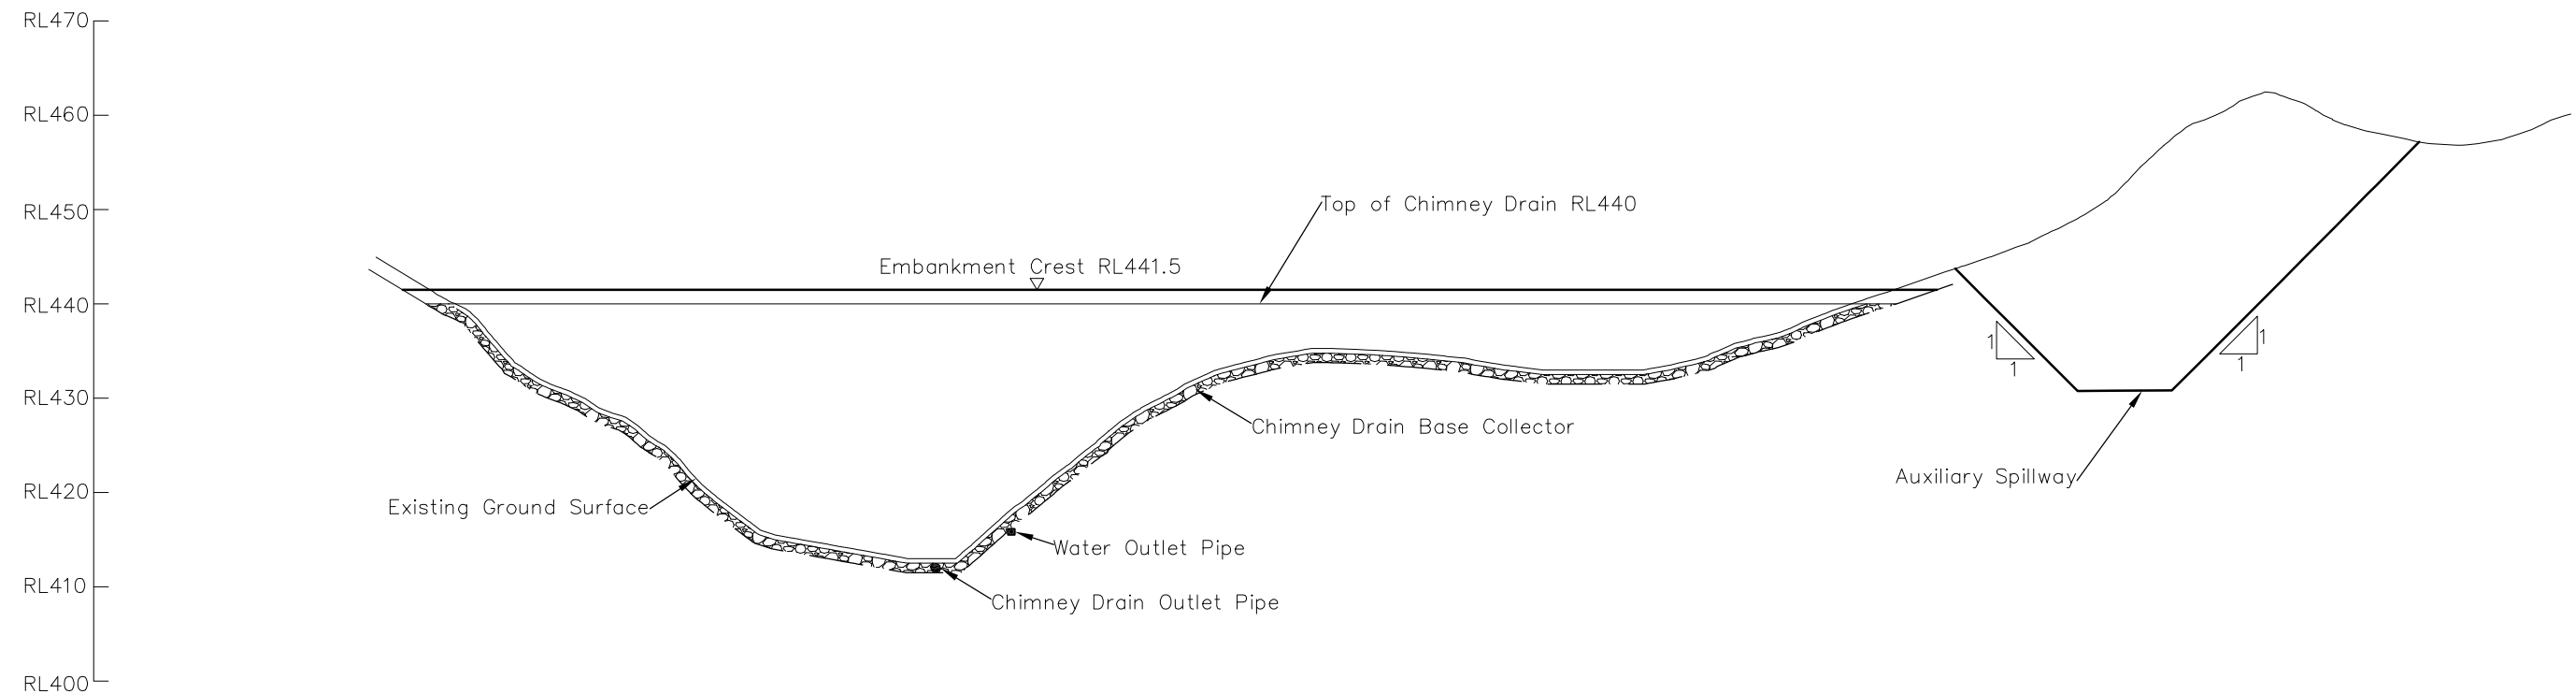
**Figure 10**

**EMBANKMENT CROSS – SECTION A – A'**  
Scale 1:500 (@A3)

**EMBANKMENT LONG – SECTION B – B'**  
Scale 1:750 (@A3)

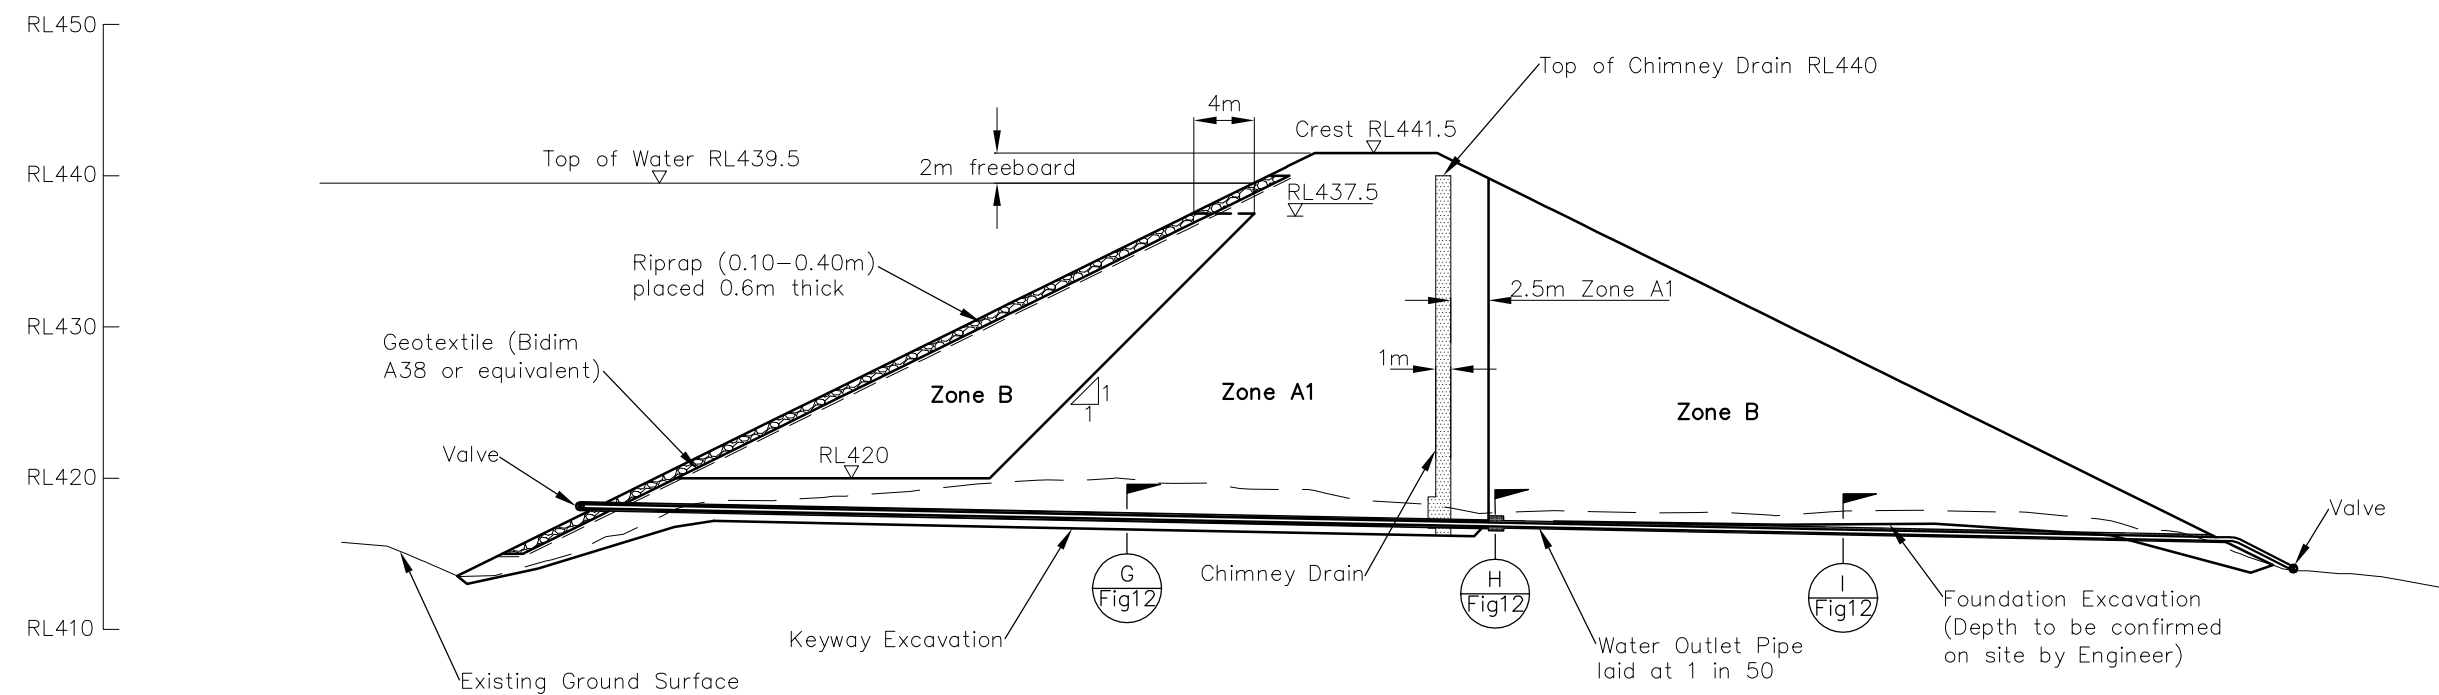
**Figure 11**

EMBANKMENT CROSS – SECTION F – F' AT WATER OUTLET PIPE

**OCEANA GOLD (NZ) LTD, MACRAES GOLD PROJECT**  
**Camp Creek Water Storage Dam**  
***Section at Water Outlet Pipe***

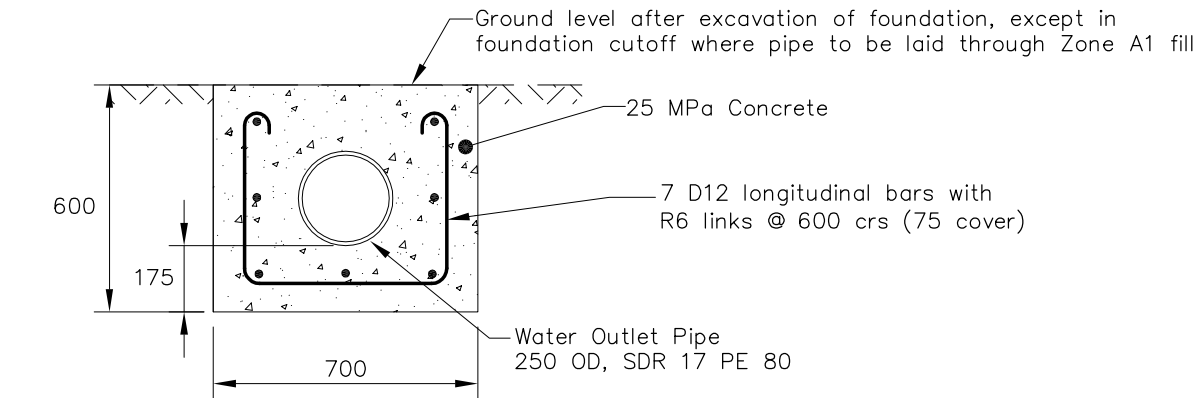
**WATER OUTLET PIPE BENEATH AND THROUGH ZONE A1** (G Fig11)

Note: Concrete shall have an expanding agent added to it (Denka CSA (No. 20) or equivalent). Immediately following placement of concrete the top of the concrete shall be covered with polythene and 1.5m of loose fill placed above. The loose fill shall be removed after 24 hours and the specified compacted fill place above after 5 days.

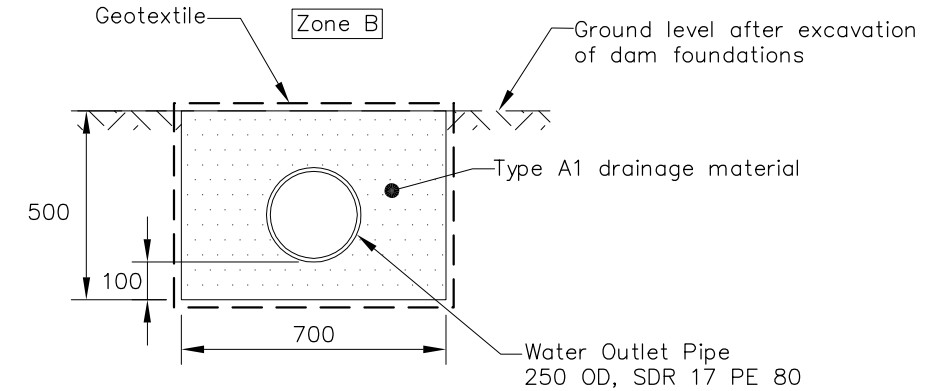
**WATER OUTLET PIPE BENEATH ZONE B** (I Fig11)

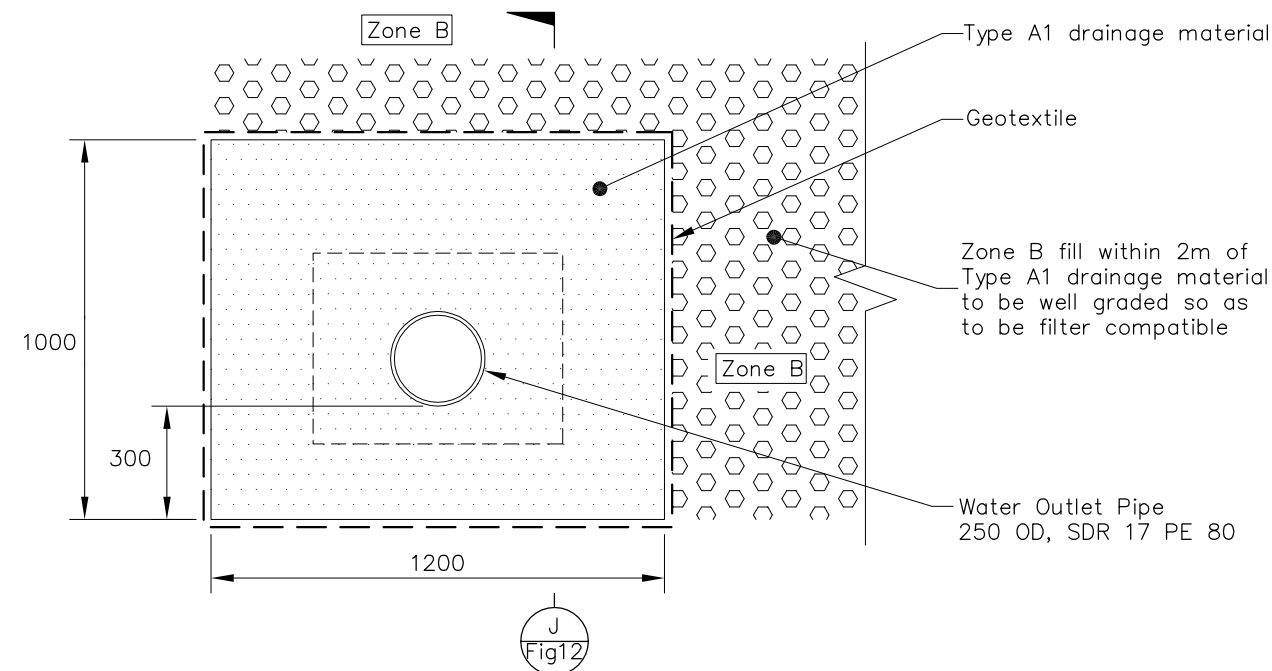
**WATER OUTLET PIPE THROUGH FILTER/SEEPAGE INTERCEPTOR DRAIN** (H Fig11)
