TO: OGNZL MP4 Team  
Oceana Gold New Zealand Limited (OGNZL)

## MP4 COAL CREEK AND CAMP CREEK DAMS - SCHEDULE 9 FISH PASSAGE ASSESSMENT

To enable MP4 to be developed and operate as proposed, water will be stored in two previously consented<sup>1</sup> reservoirs that have yet to be constructed. The two reservoirs will be created by constructing a dam on each of Coal Creek and Camp Creek. The actual and potential effects of the construction and operation of the two dams were described and considered during the consenting process. However, the existing consents have not expressly considered the Freshwater Fisheries Regulations 1983, therefore it has been proposed to include these additional permissions within the wider MP4 Fast-Track application. No components of the initial dam design, construction or discharge regime have been changed since consents were issued, therefore no additional consideration of the effects of the dams, with the exception of how they will impact fish passage, are necessary.

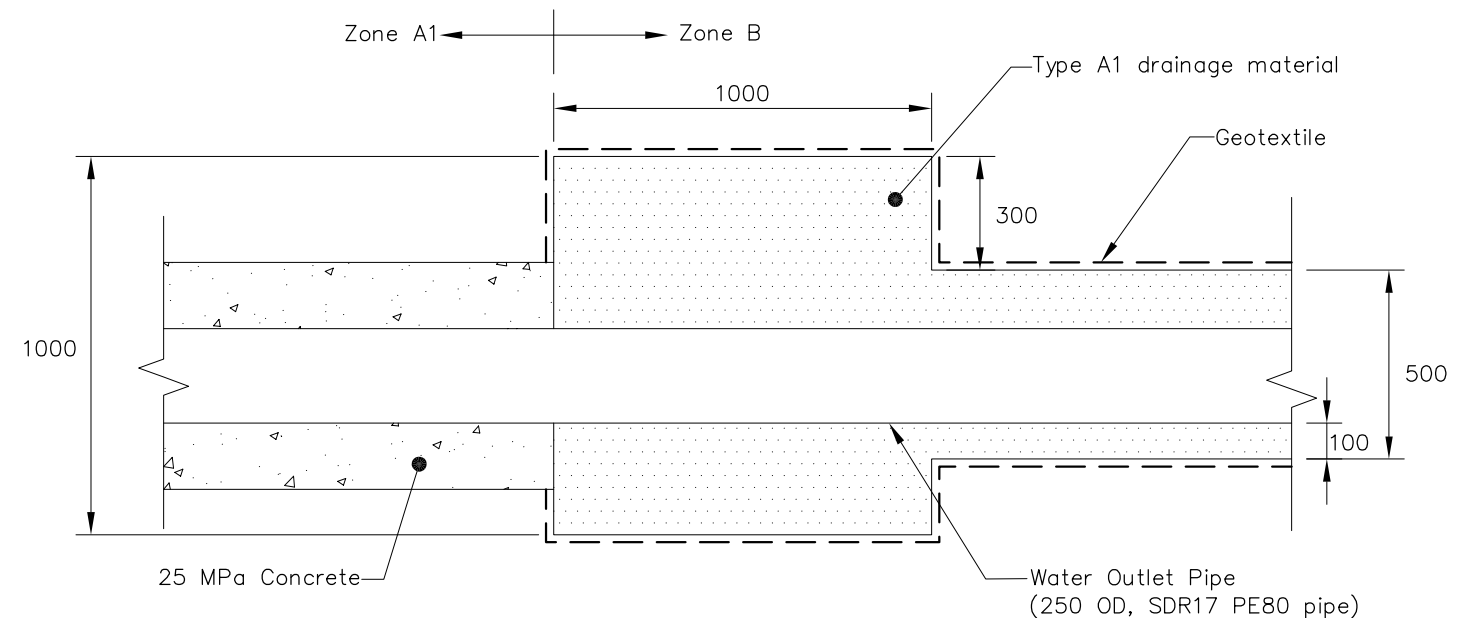
**WATER OUTLET PIPE THROUGH FILTER/SEEPAGE INTERCEPTOR DRAIN** (J Fig12)

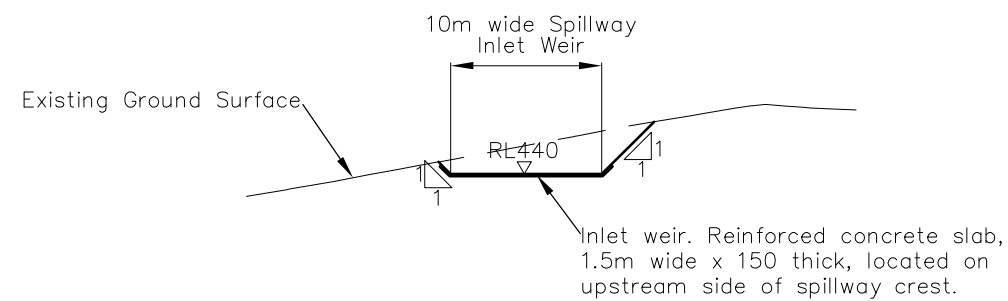
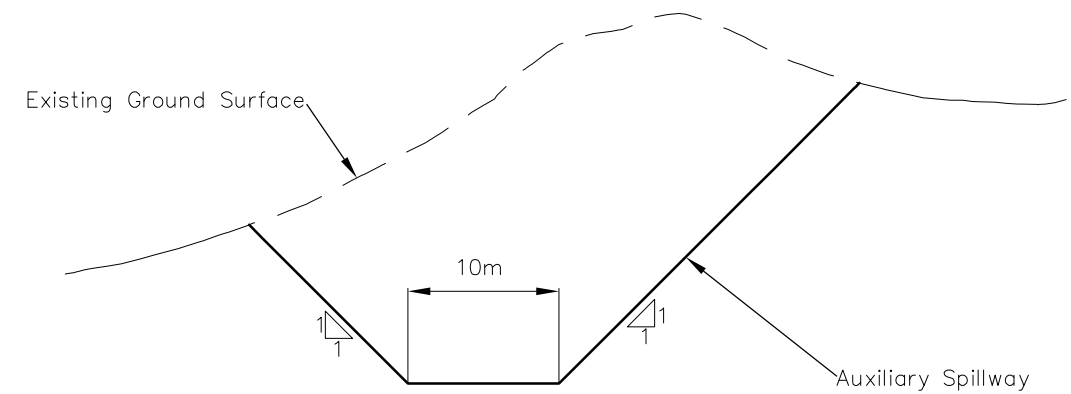
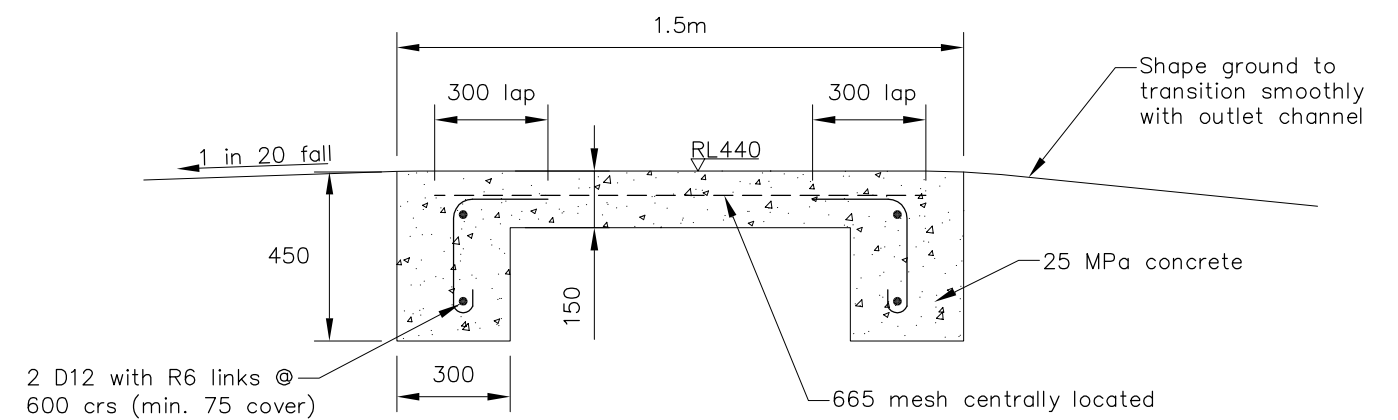
**Figure 14**

**AUXILIARY SPILLWAY CROSS – SECTION  
AT INLET WEIR C – C'**  
Scale 1:500 (@A3)

**AUXILIARY SPILLWAY CROSS – SECTION  
AT CHANNEL D – D'**  
Scale 1:500 (@A3)

**AUXILIARY SPILLWAY – INLET WEIR DETAIL**  
Scale 1:20 (@A3)

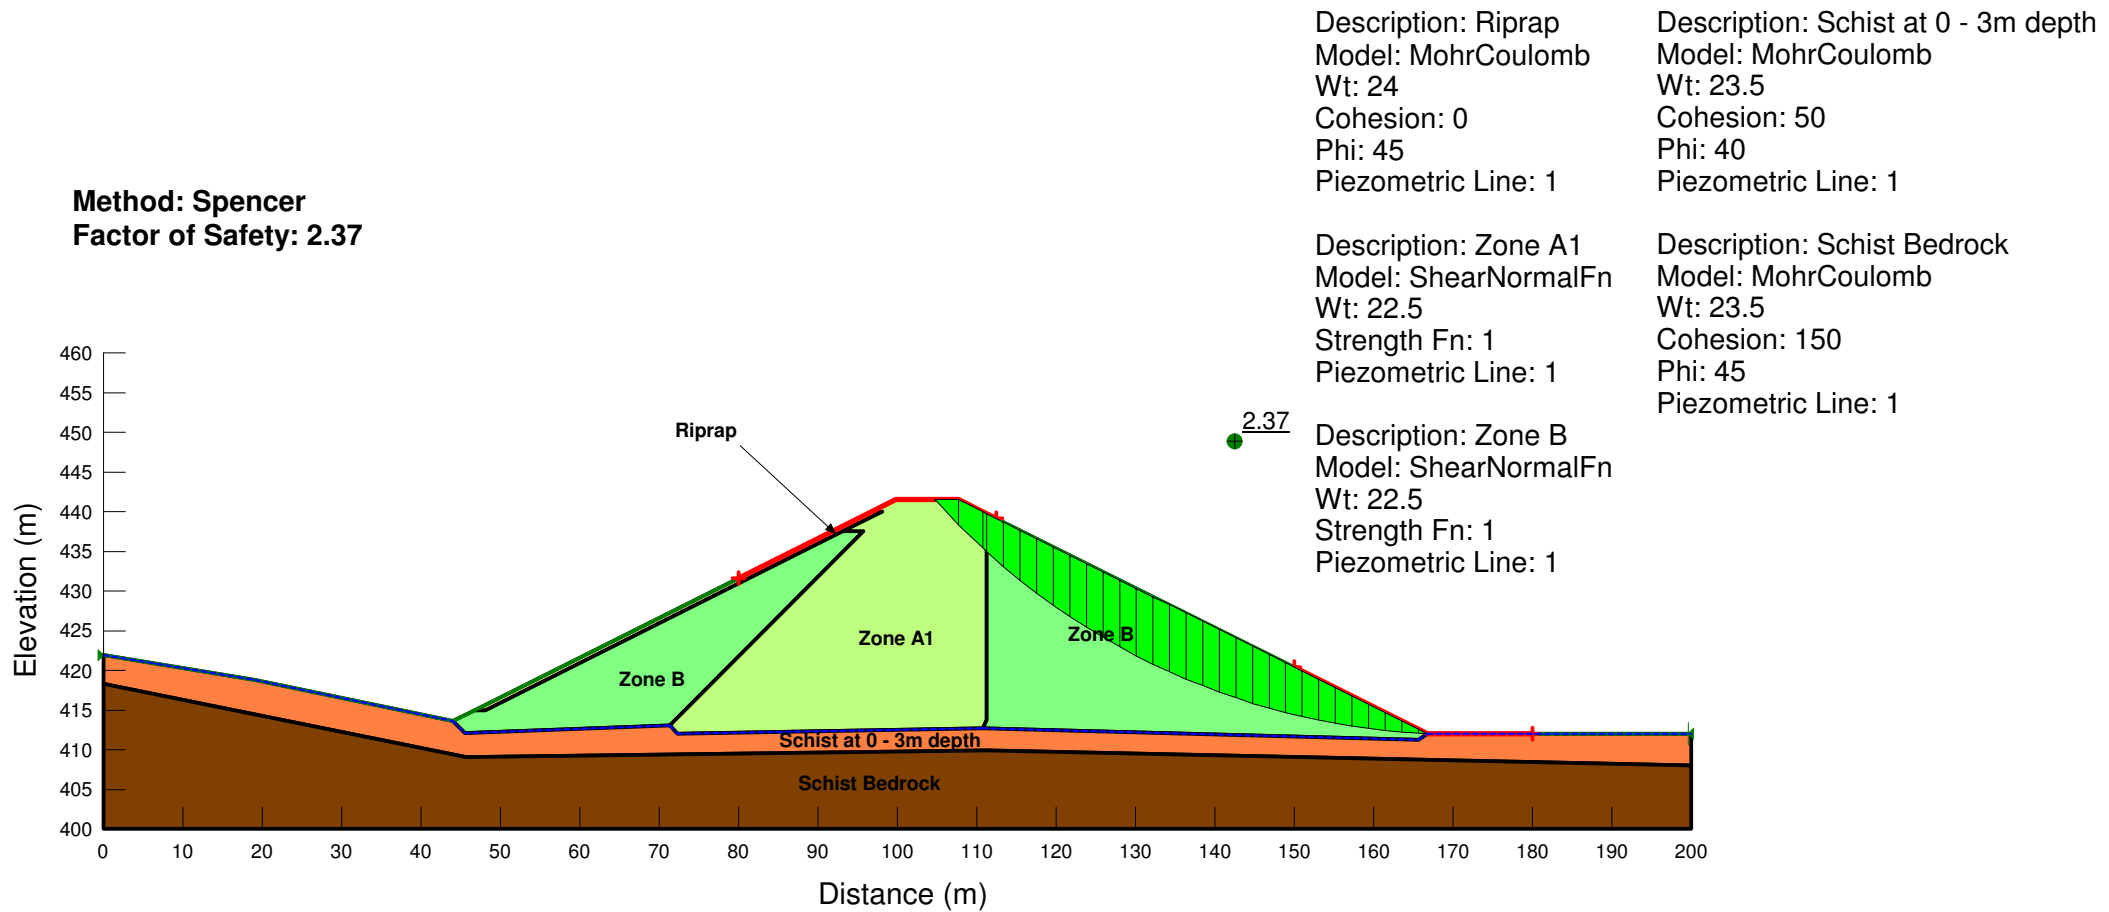
**Figure A2**

**OGL - CAMP CREEK DAM**  
**Static Analysis - Section A - A'**  
**End of Construction - Downstream Shoulder**

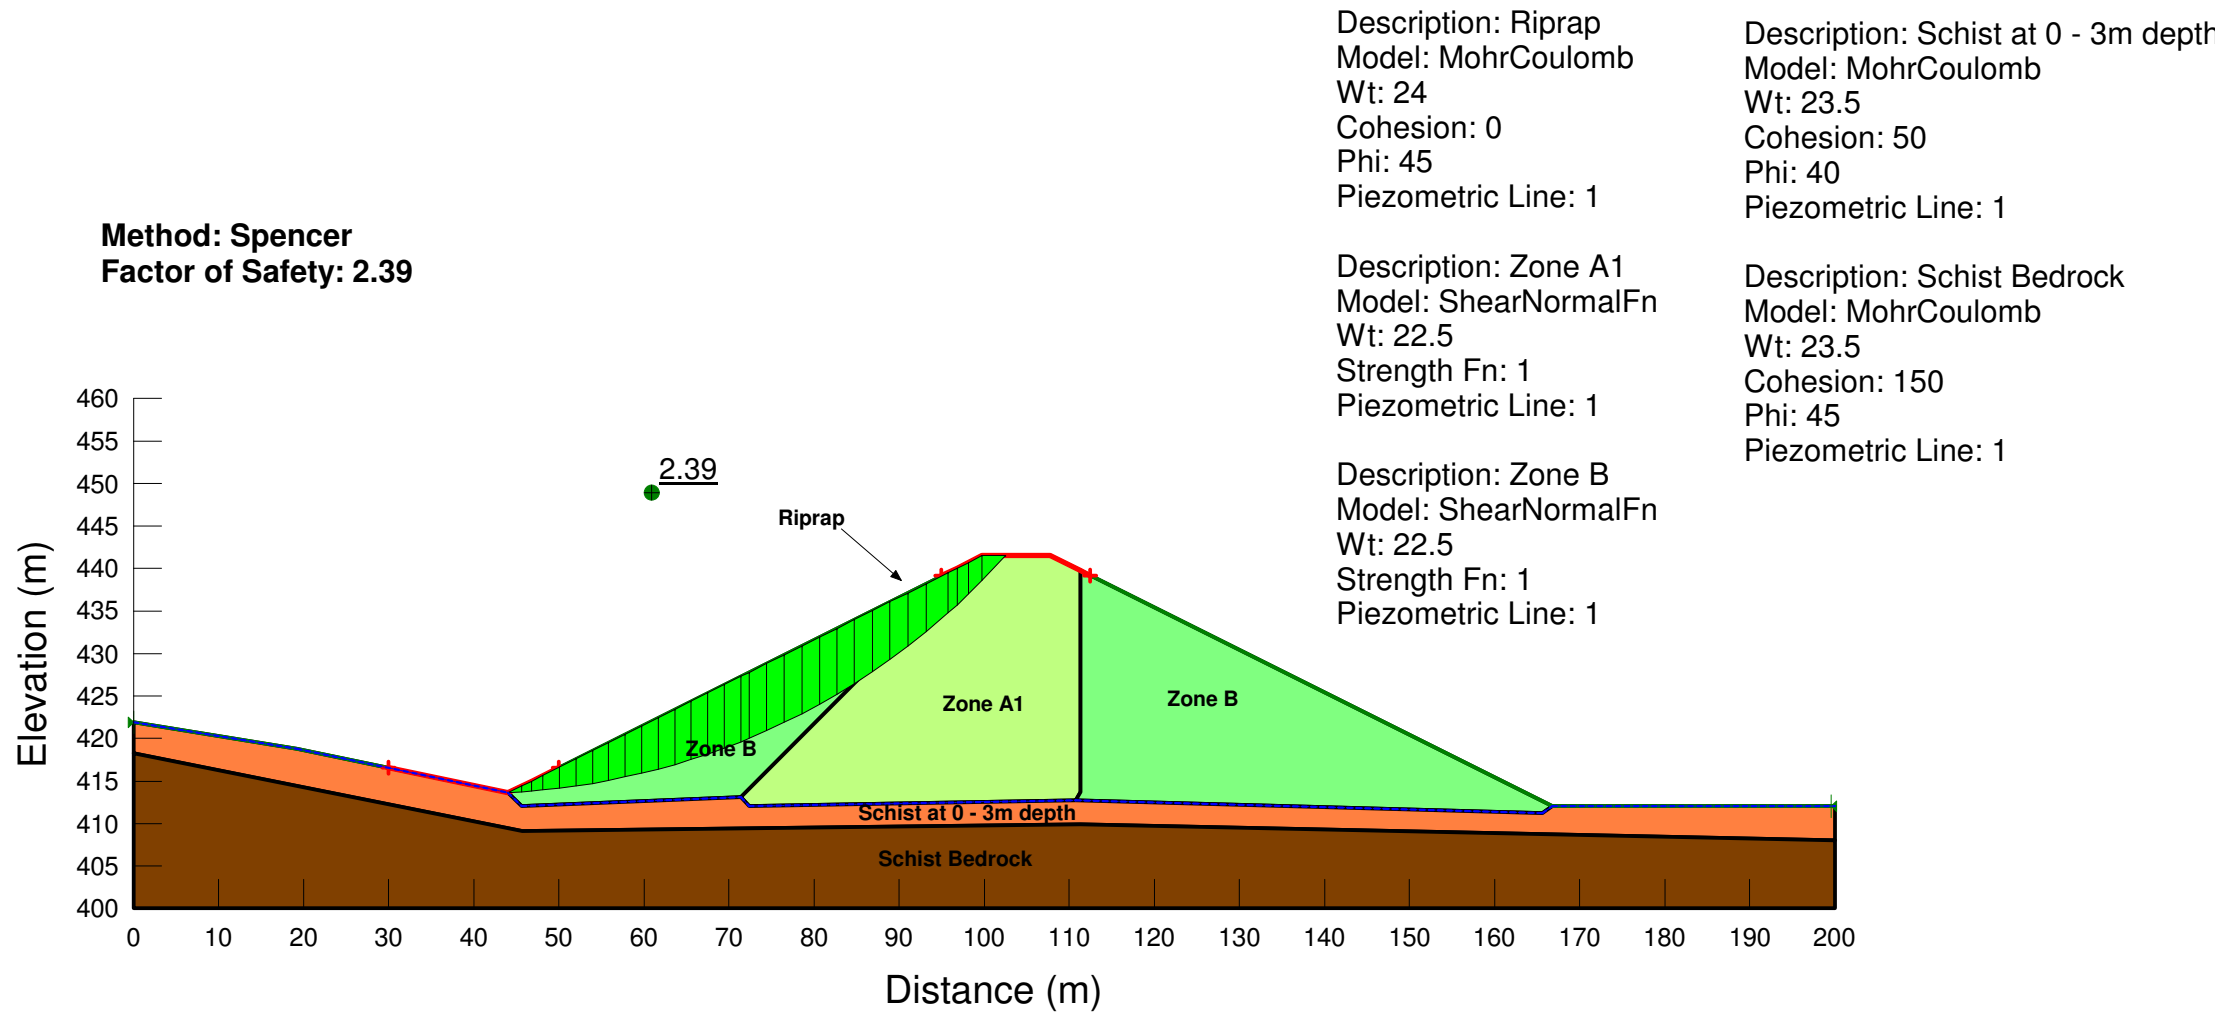
**Figure A3**

**OGL - CAMP CREEK DAM**  
**Static Analysis - Section A - A'**  
**End of Construction - Upstream Shoulder**

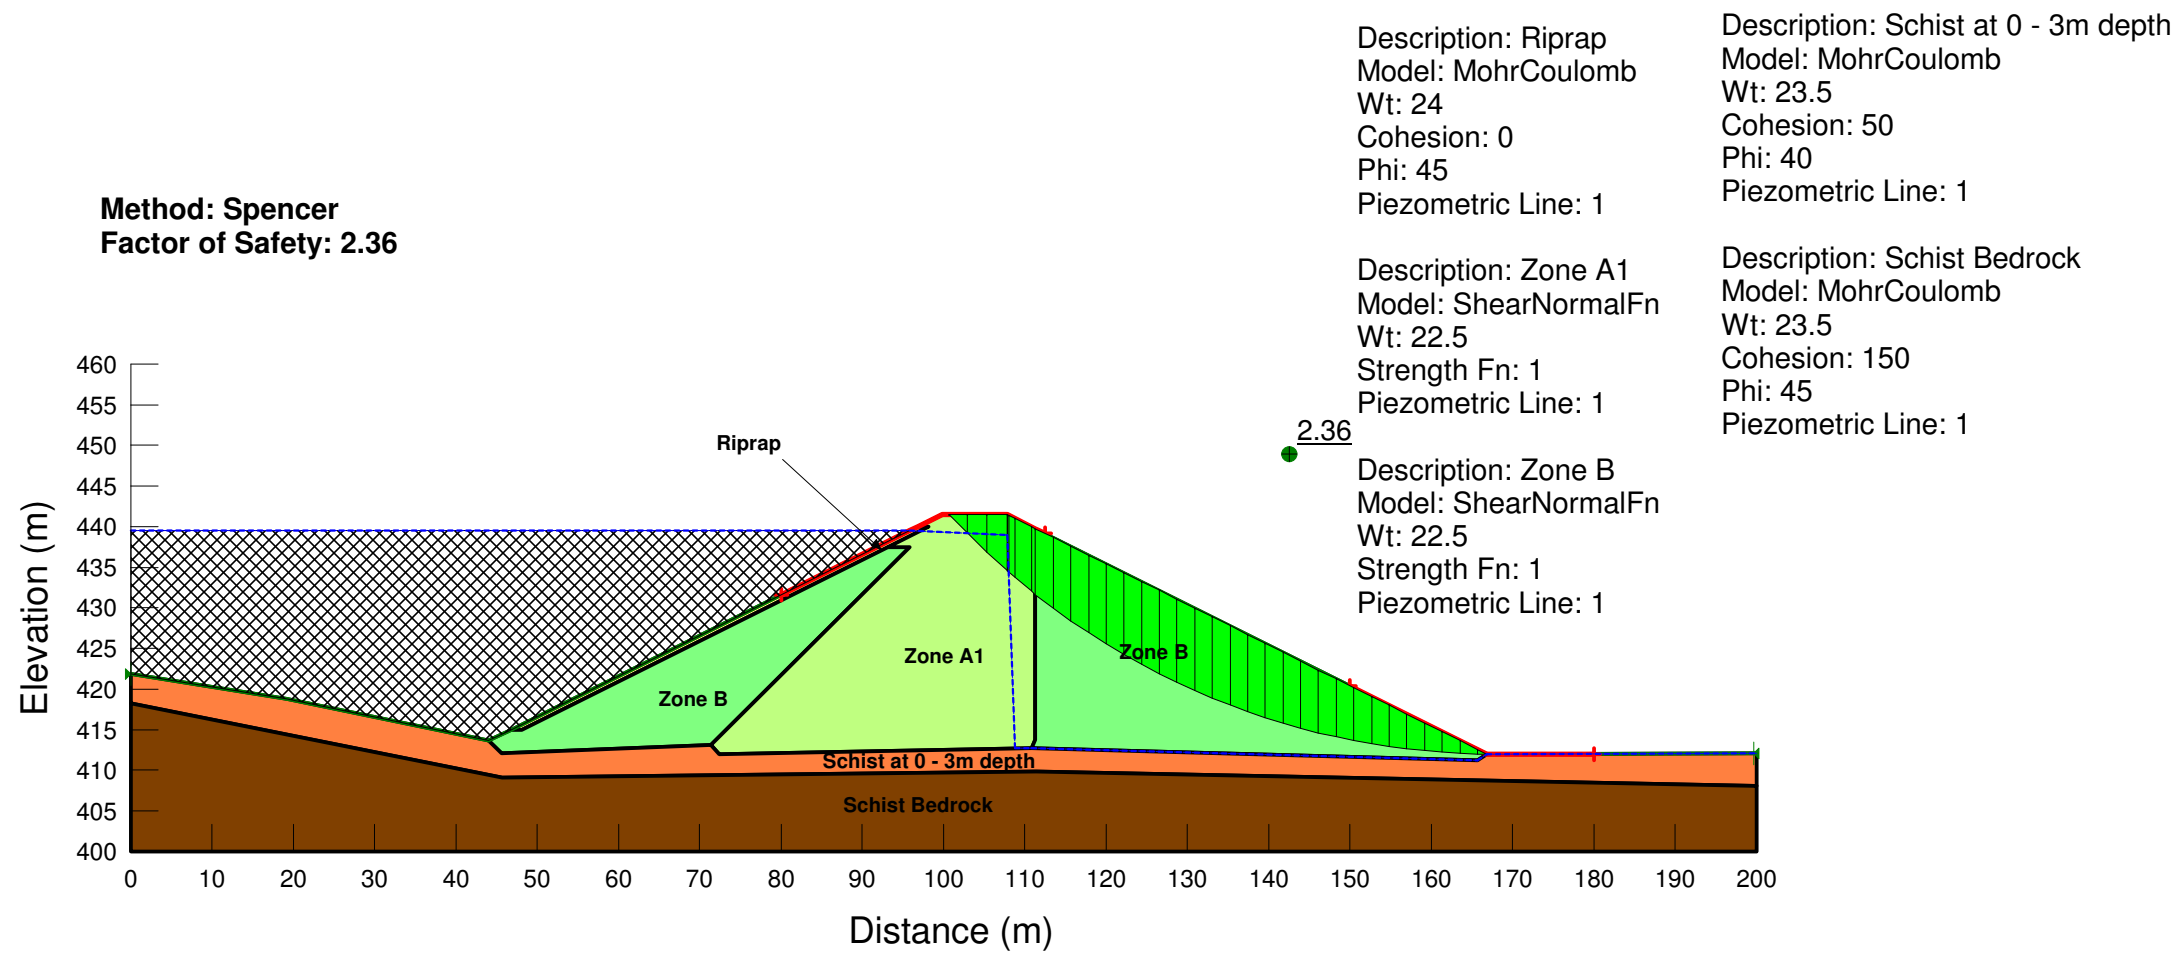
**Figure A4**

**OGL - CAMP CREEK DAM**  
**Static Analysis - Section A - A'**  
**Long Term - Downstream Shoulder**

| Figure No. | Circle Location | Loading | Factor of Safety | Notes |
|---|---|---|---|---|
| A4 | DS | ESA | 2.36 | operating conditions |

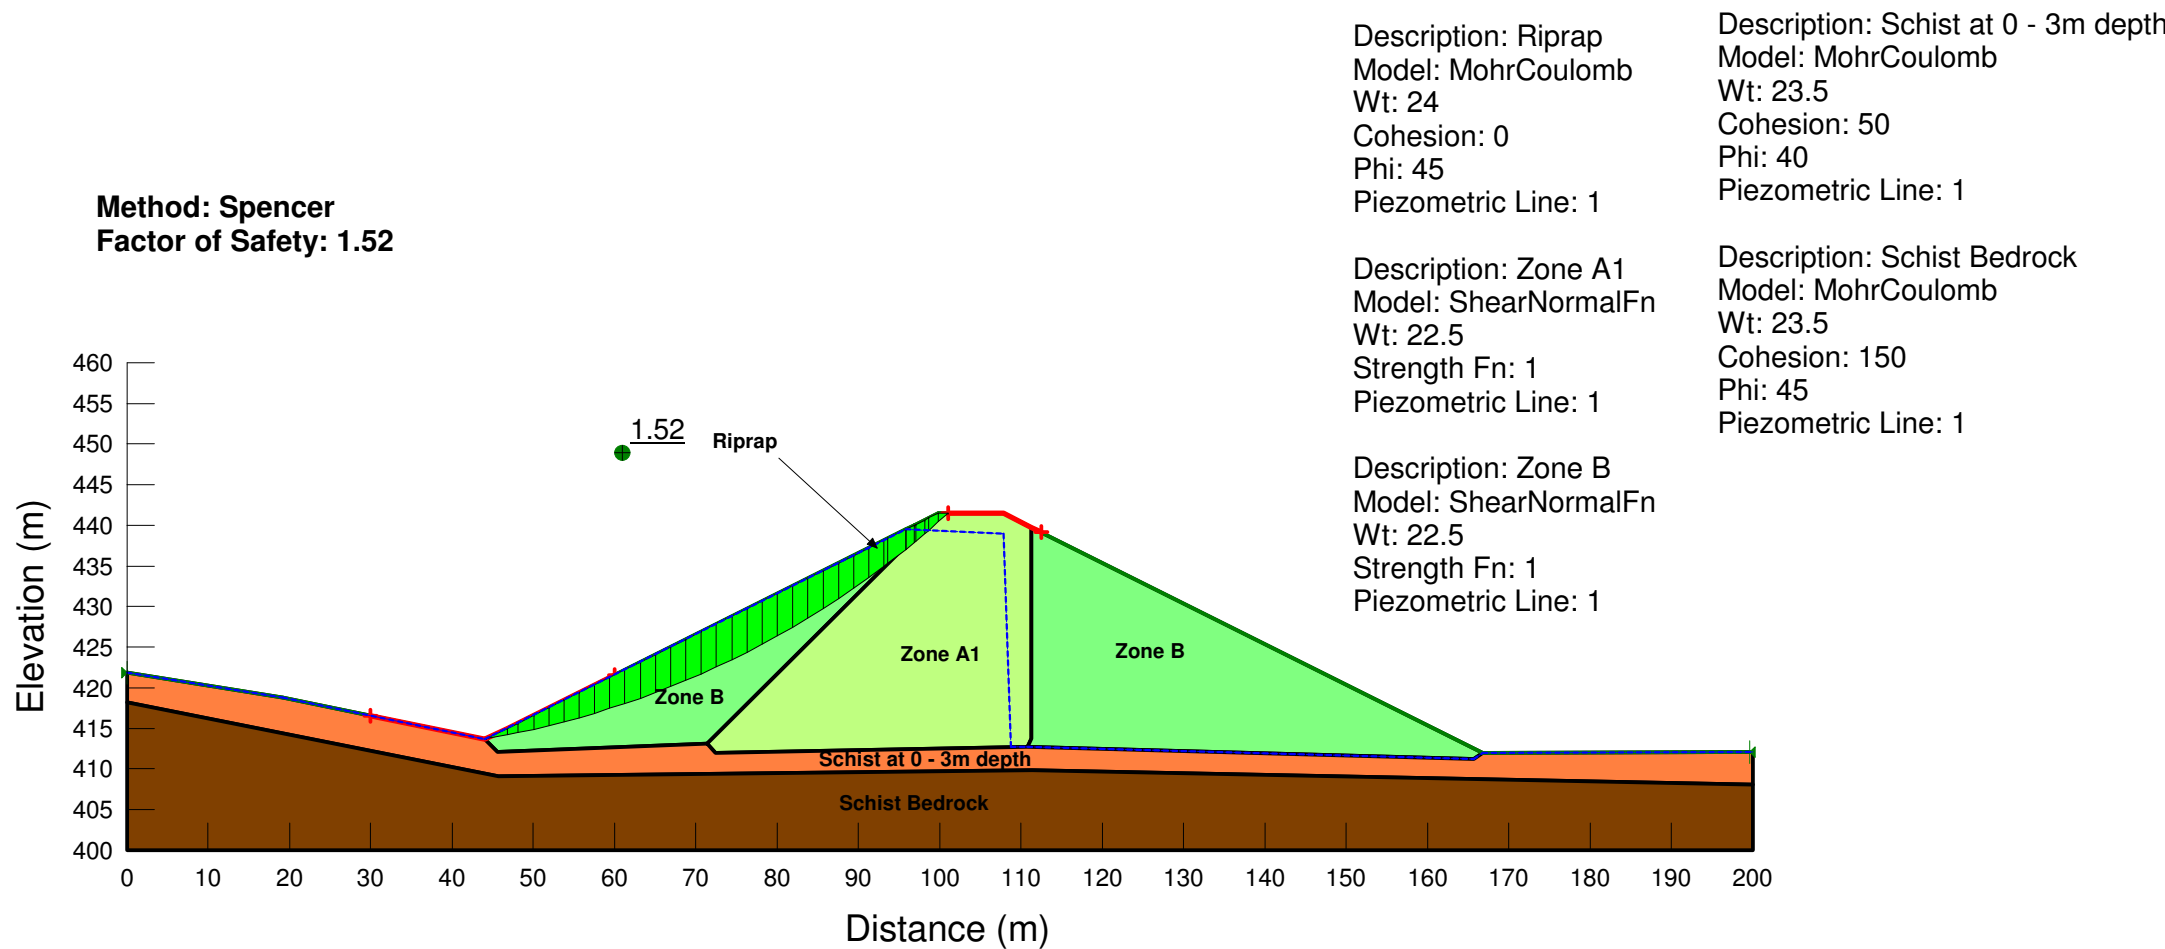
**Figure A5**

**OGL - CAMP CREEK DAM**  
**Static Analysis - Section A - A'**  
**Rapid Drawdown - Upstream Shoulder**

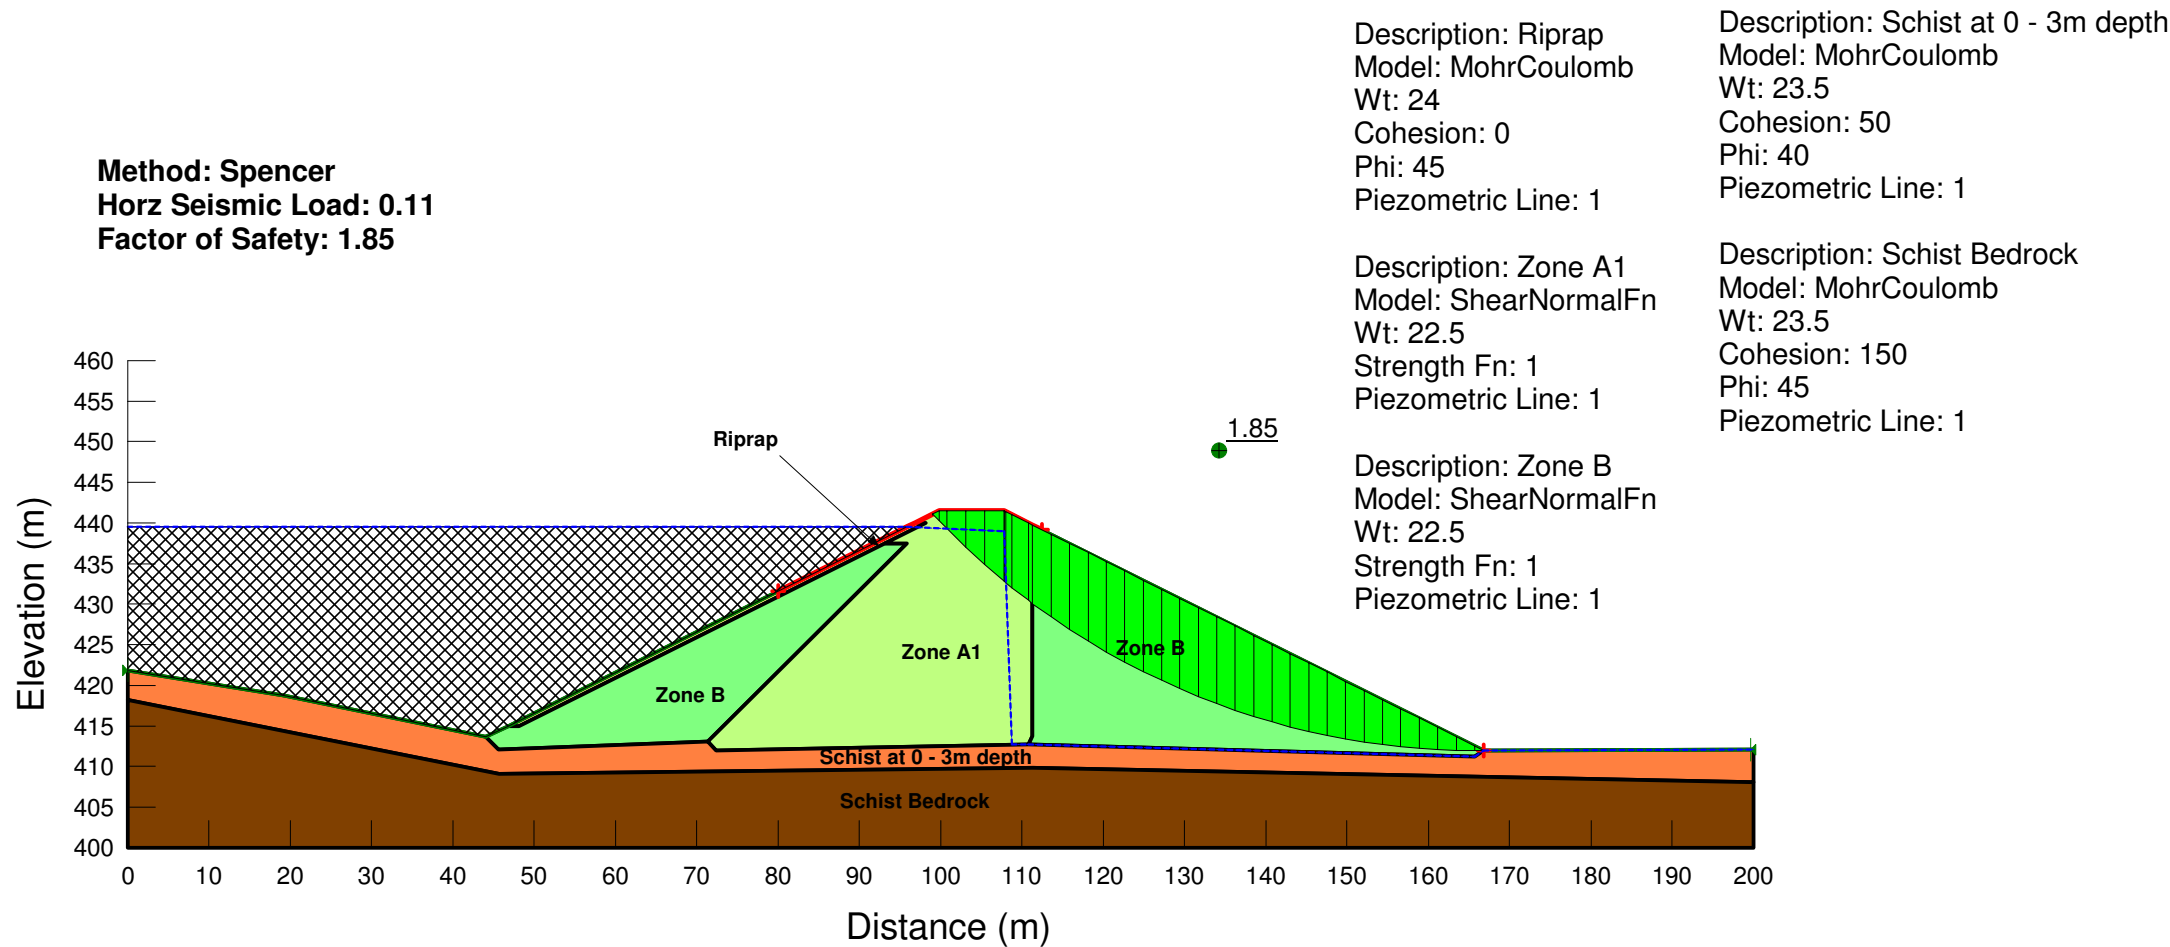
**Figure A6**

**Oceana Gold Mine - Camp Creek Dam**  
**Seismic Analysis - Section A - A'**  
**OBE Downstream Shoulder Full Dam Height**

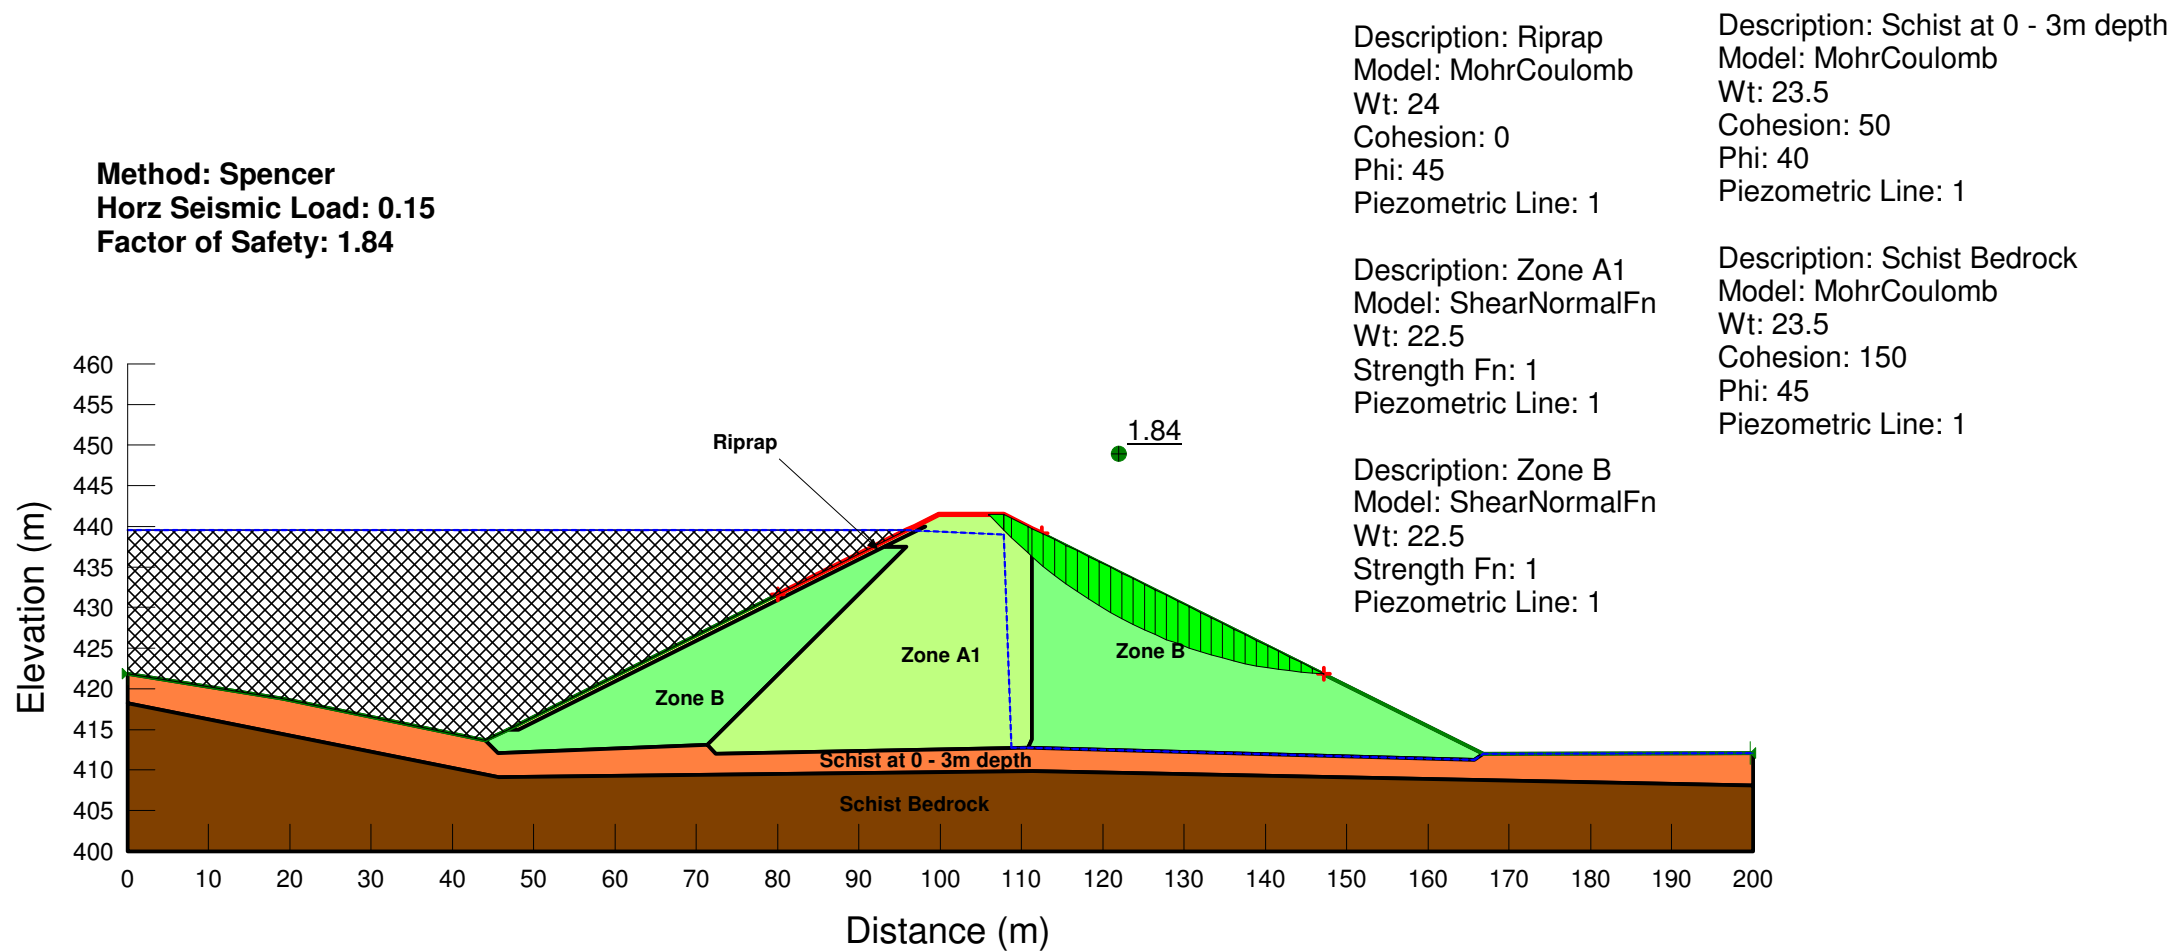
**Figure A7**

**OGI - CAMP CREEK DAM**  
**Seismic Analysis - Section A - A'**  
**OBE - Downstream Shoulder**  
**Two Thirds of Dam Height**

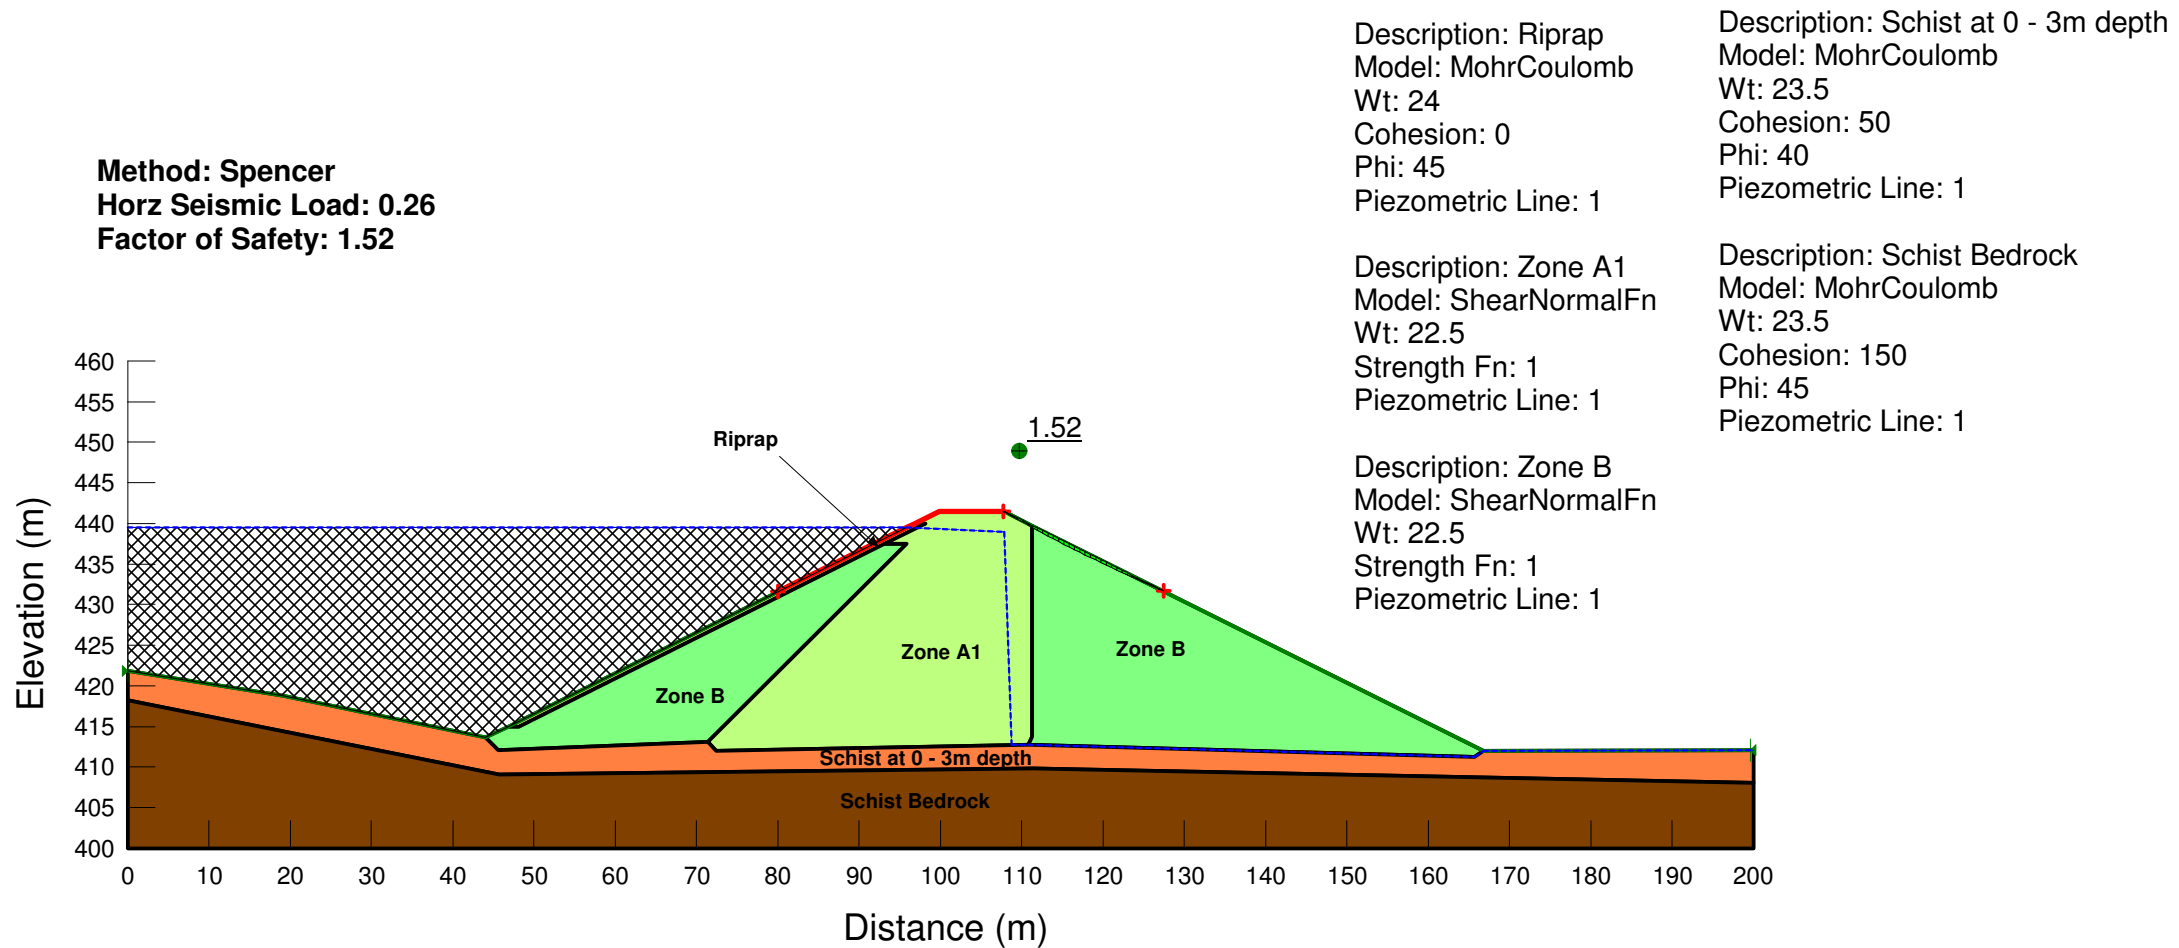
**Figure A8**

**OGL - CAMP CREEK DAM**  
**Seismic Analysis - Section A - A'**  
**OBE - Downstream Shoulder**  
**One Third of Dam Height**

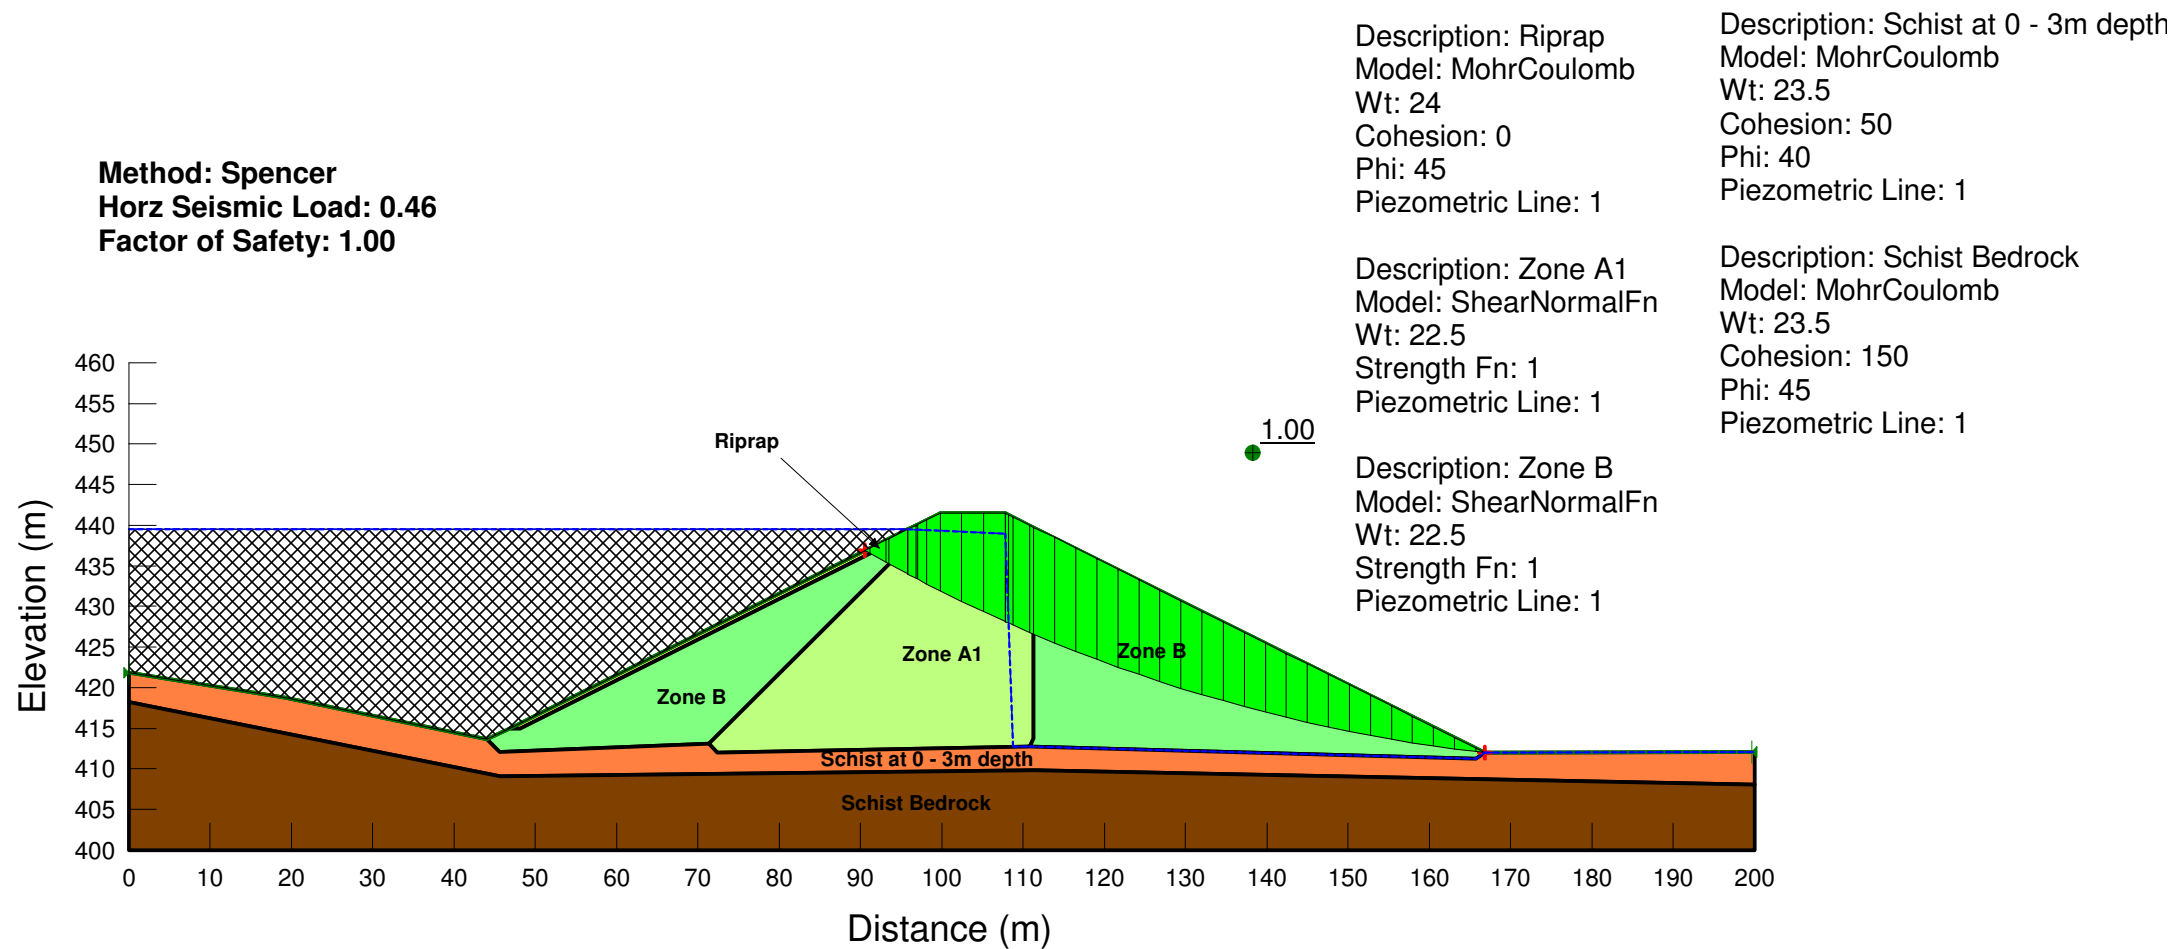
Figure A9

OGL - CAMP CREEK DAM  
Seismic Analysis - Section A - A'  
MDE - Downstream Shoulder  
Full Dam Height - Yield Acceleration

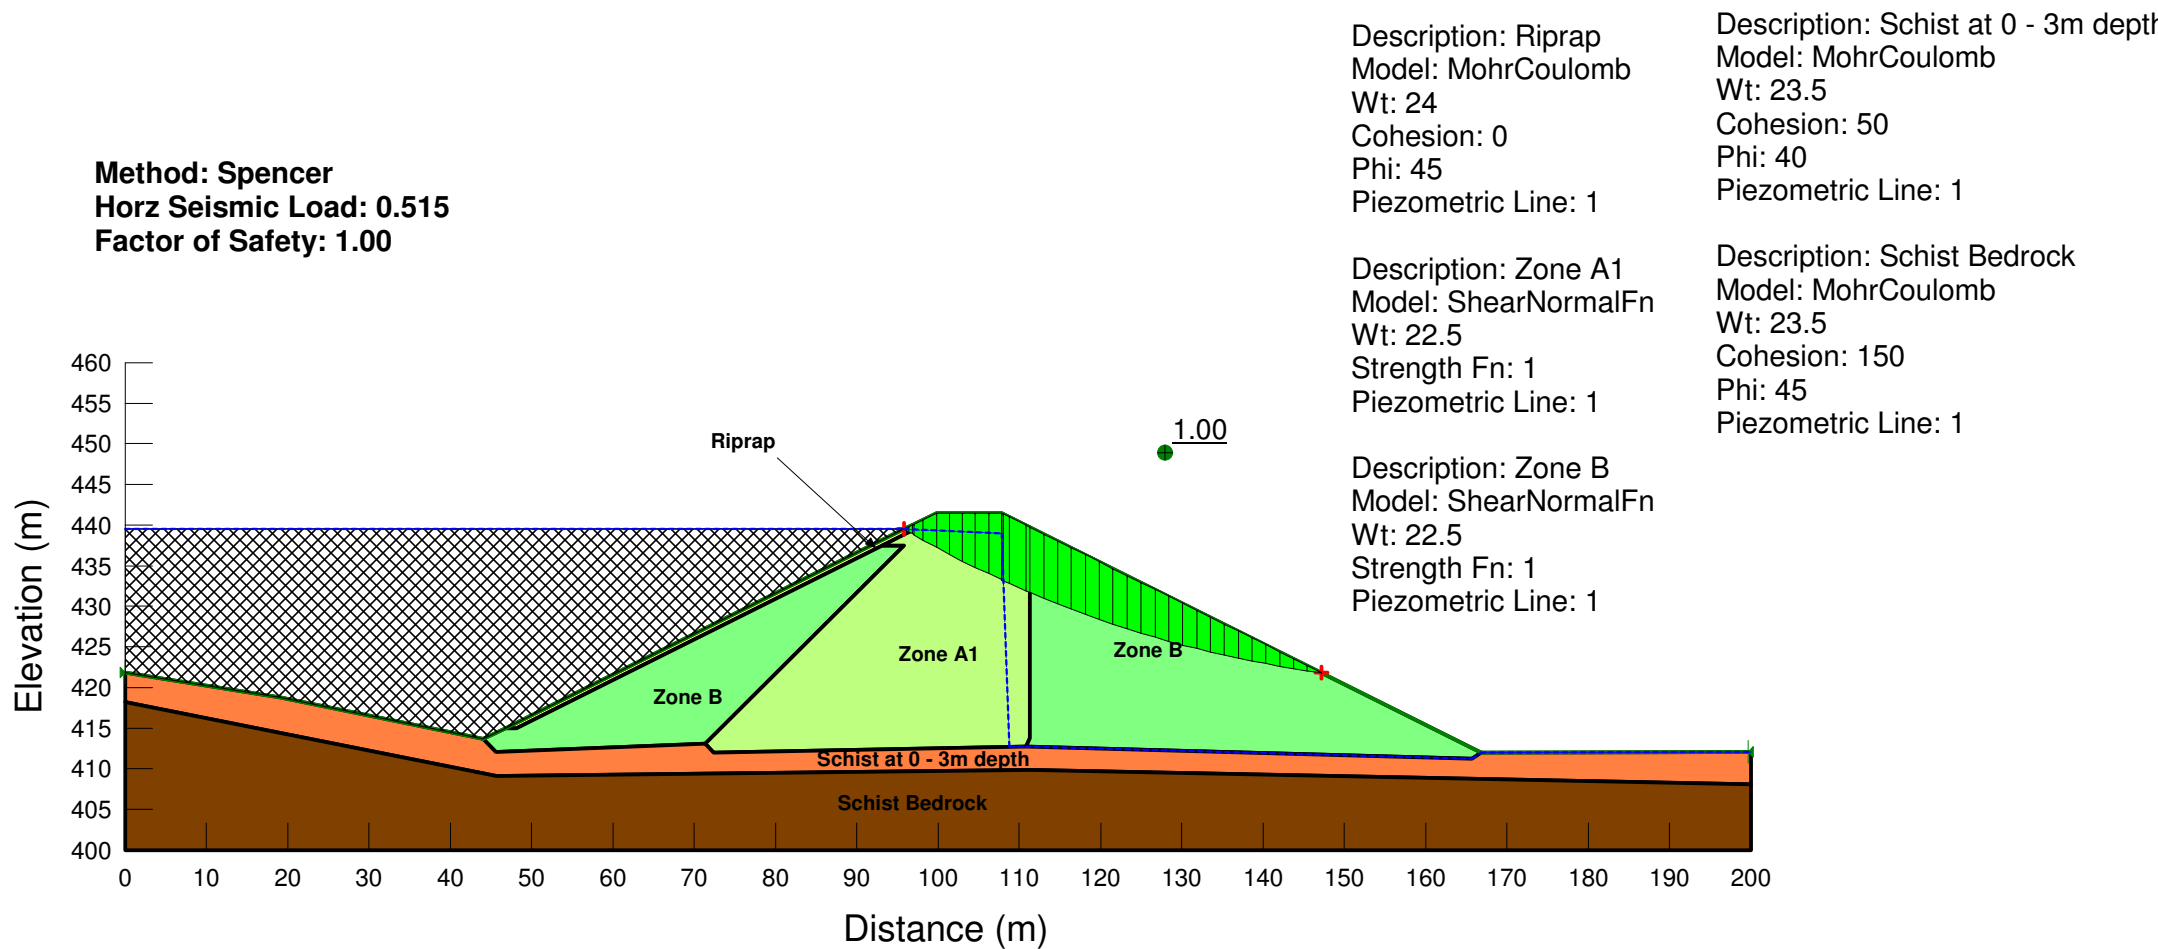
**Figure A10**

**OGL - CAMP CREEK DAM**  
**Seismic Analysis - Section A - A'**  
**MDE - Downstream Shoulder**  
**Two Thirds of Dam Height - Yield Acceleration**
