TO: OGNZL MP4 Team  
Oceana Gold New Zealand Limited (OGNZL)

## MP4 COAL CREEK AND CAMP CREEK DAMS - SCHEDULE 9 FISH PASSAGE ASSESSMENT

To enable MP4 to be developed and operate as proposed, water will be stored in two previously consented<sup>1</sup> reservoirs that have yet to be constructed. The two reservoirs will be created by constructing a dam on each of Coal Creek and Camp Creek. The actual and potential effects of the construction and operation of the two dams were described and considered during the consenting process. However, the existing consents have not expressly considered the Freshwater Fisheries Regulations 1983, therefore it has been proposed to include these additional permissions within the wider MP4 Fast-Track application. No components of the initial dam design, construction or discharge regime have been changed since consents were issued, therefore no additional consideration of the effects of the dams, with the exception of how they will impact fish passage, are necessary.

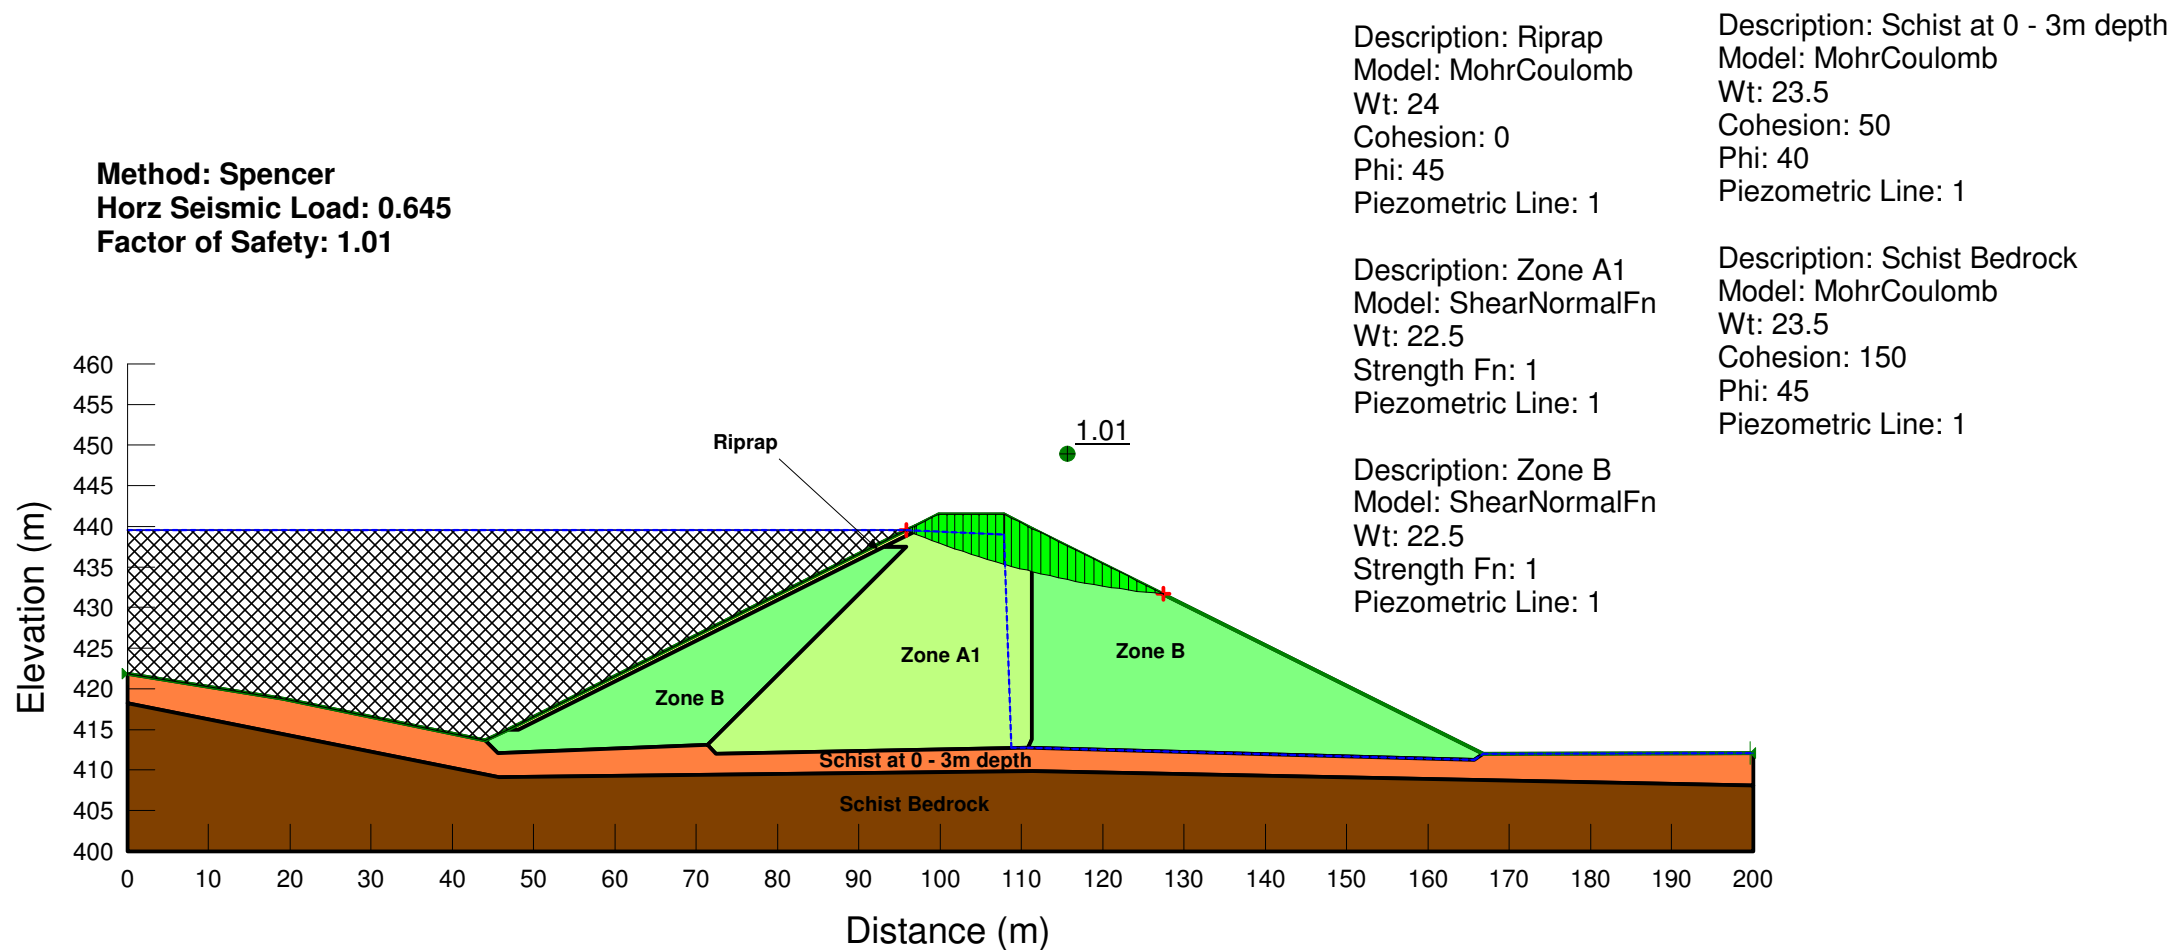
Figure A11

OGL - CAMP CREEK DAM  
 Seismic Analysis - Section A - A'  
 MDE - Downstream Shoulder  
 One Third of Dam Height - Yield Acceleration

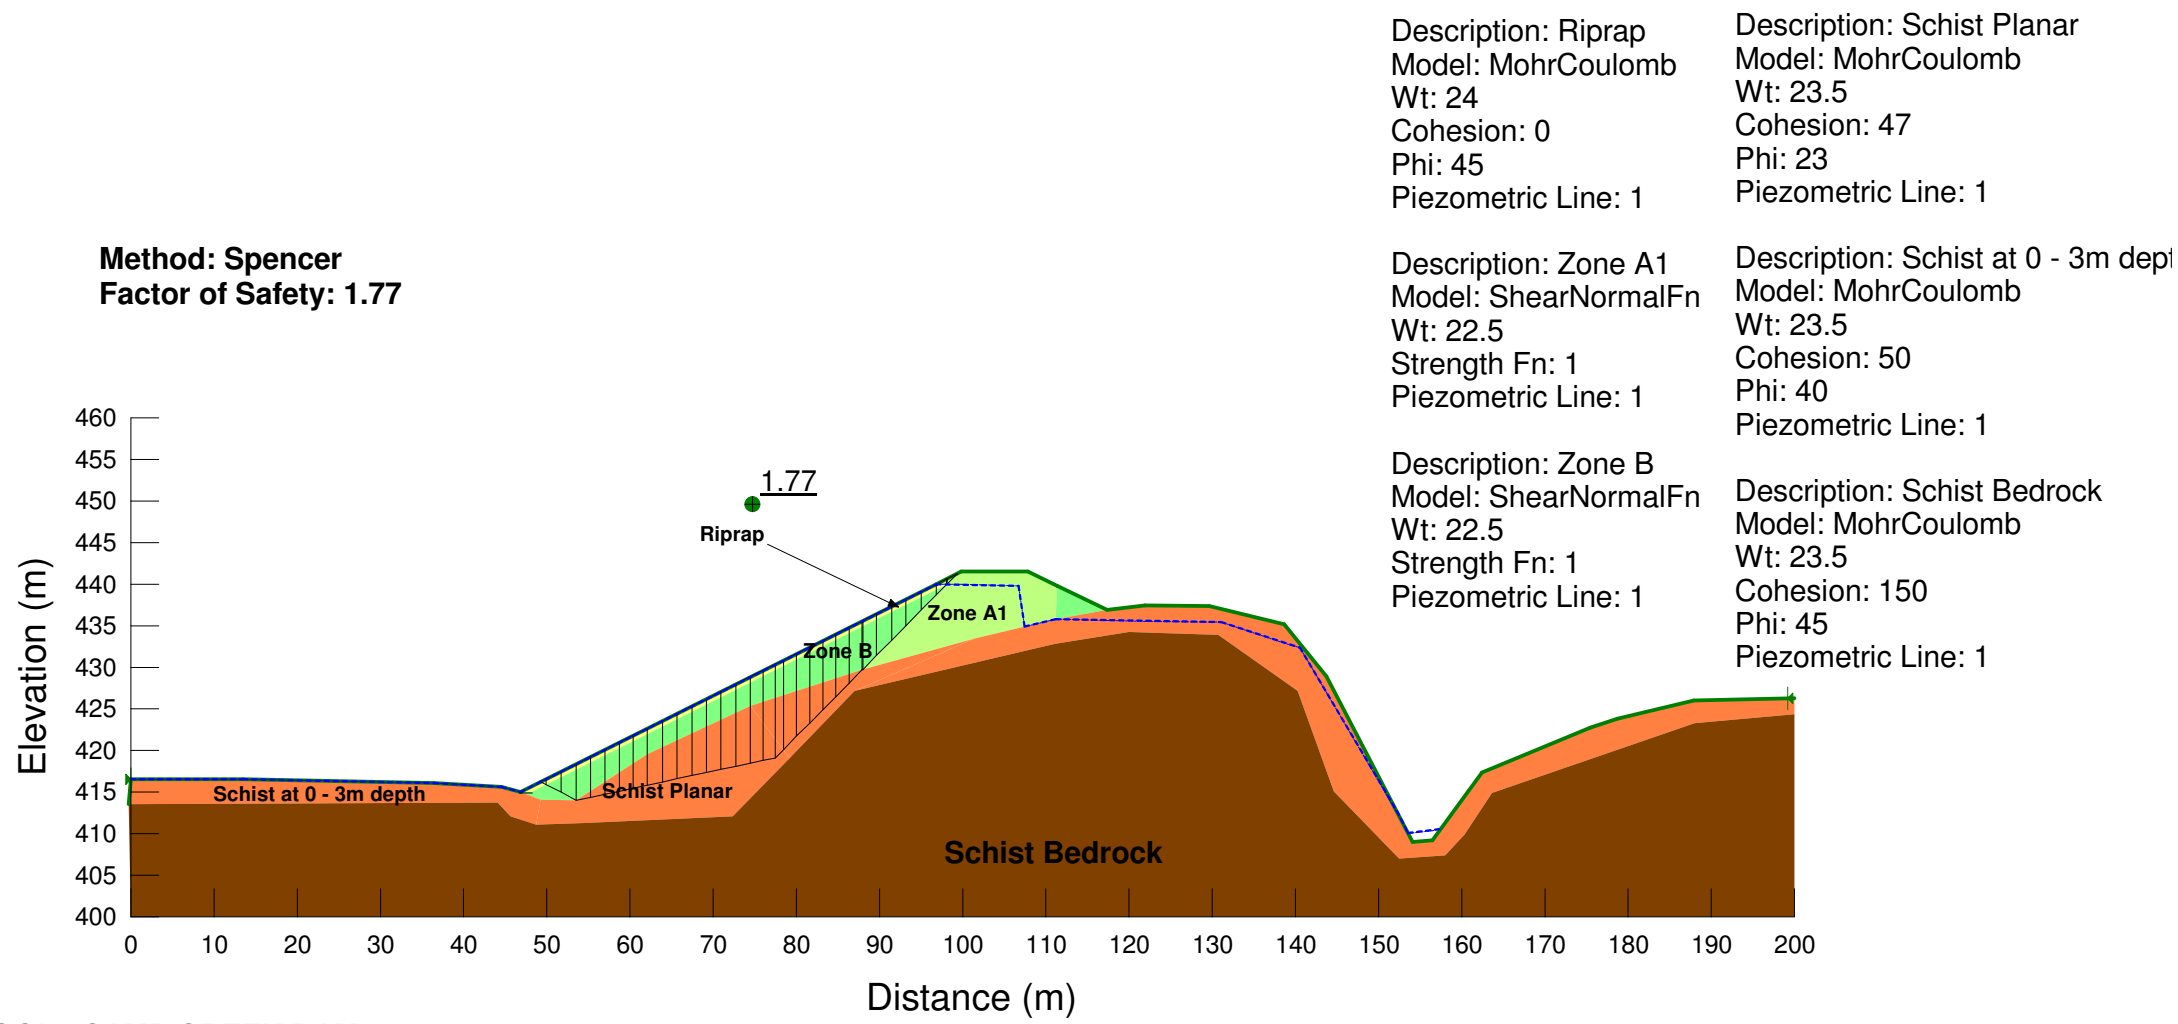
**Figure A12**

**OGL - CAMP CREEK DAM**  
**Static Analysis - Section K - K'**  
**Rapid Drawdown - Upstream Shoulder**  
**(Failure along Foliations)**

| Figure No. | Circle Location | Loading | Factor of Safety | Notes |
|---|---|---|---|---|
| A12 | US | ESA | 1.77 | rapid drawdown, failure along foliation |

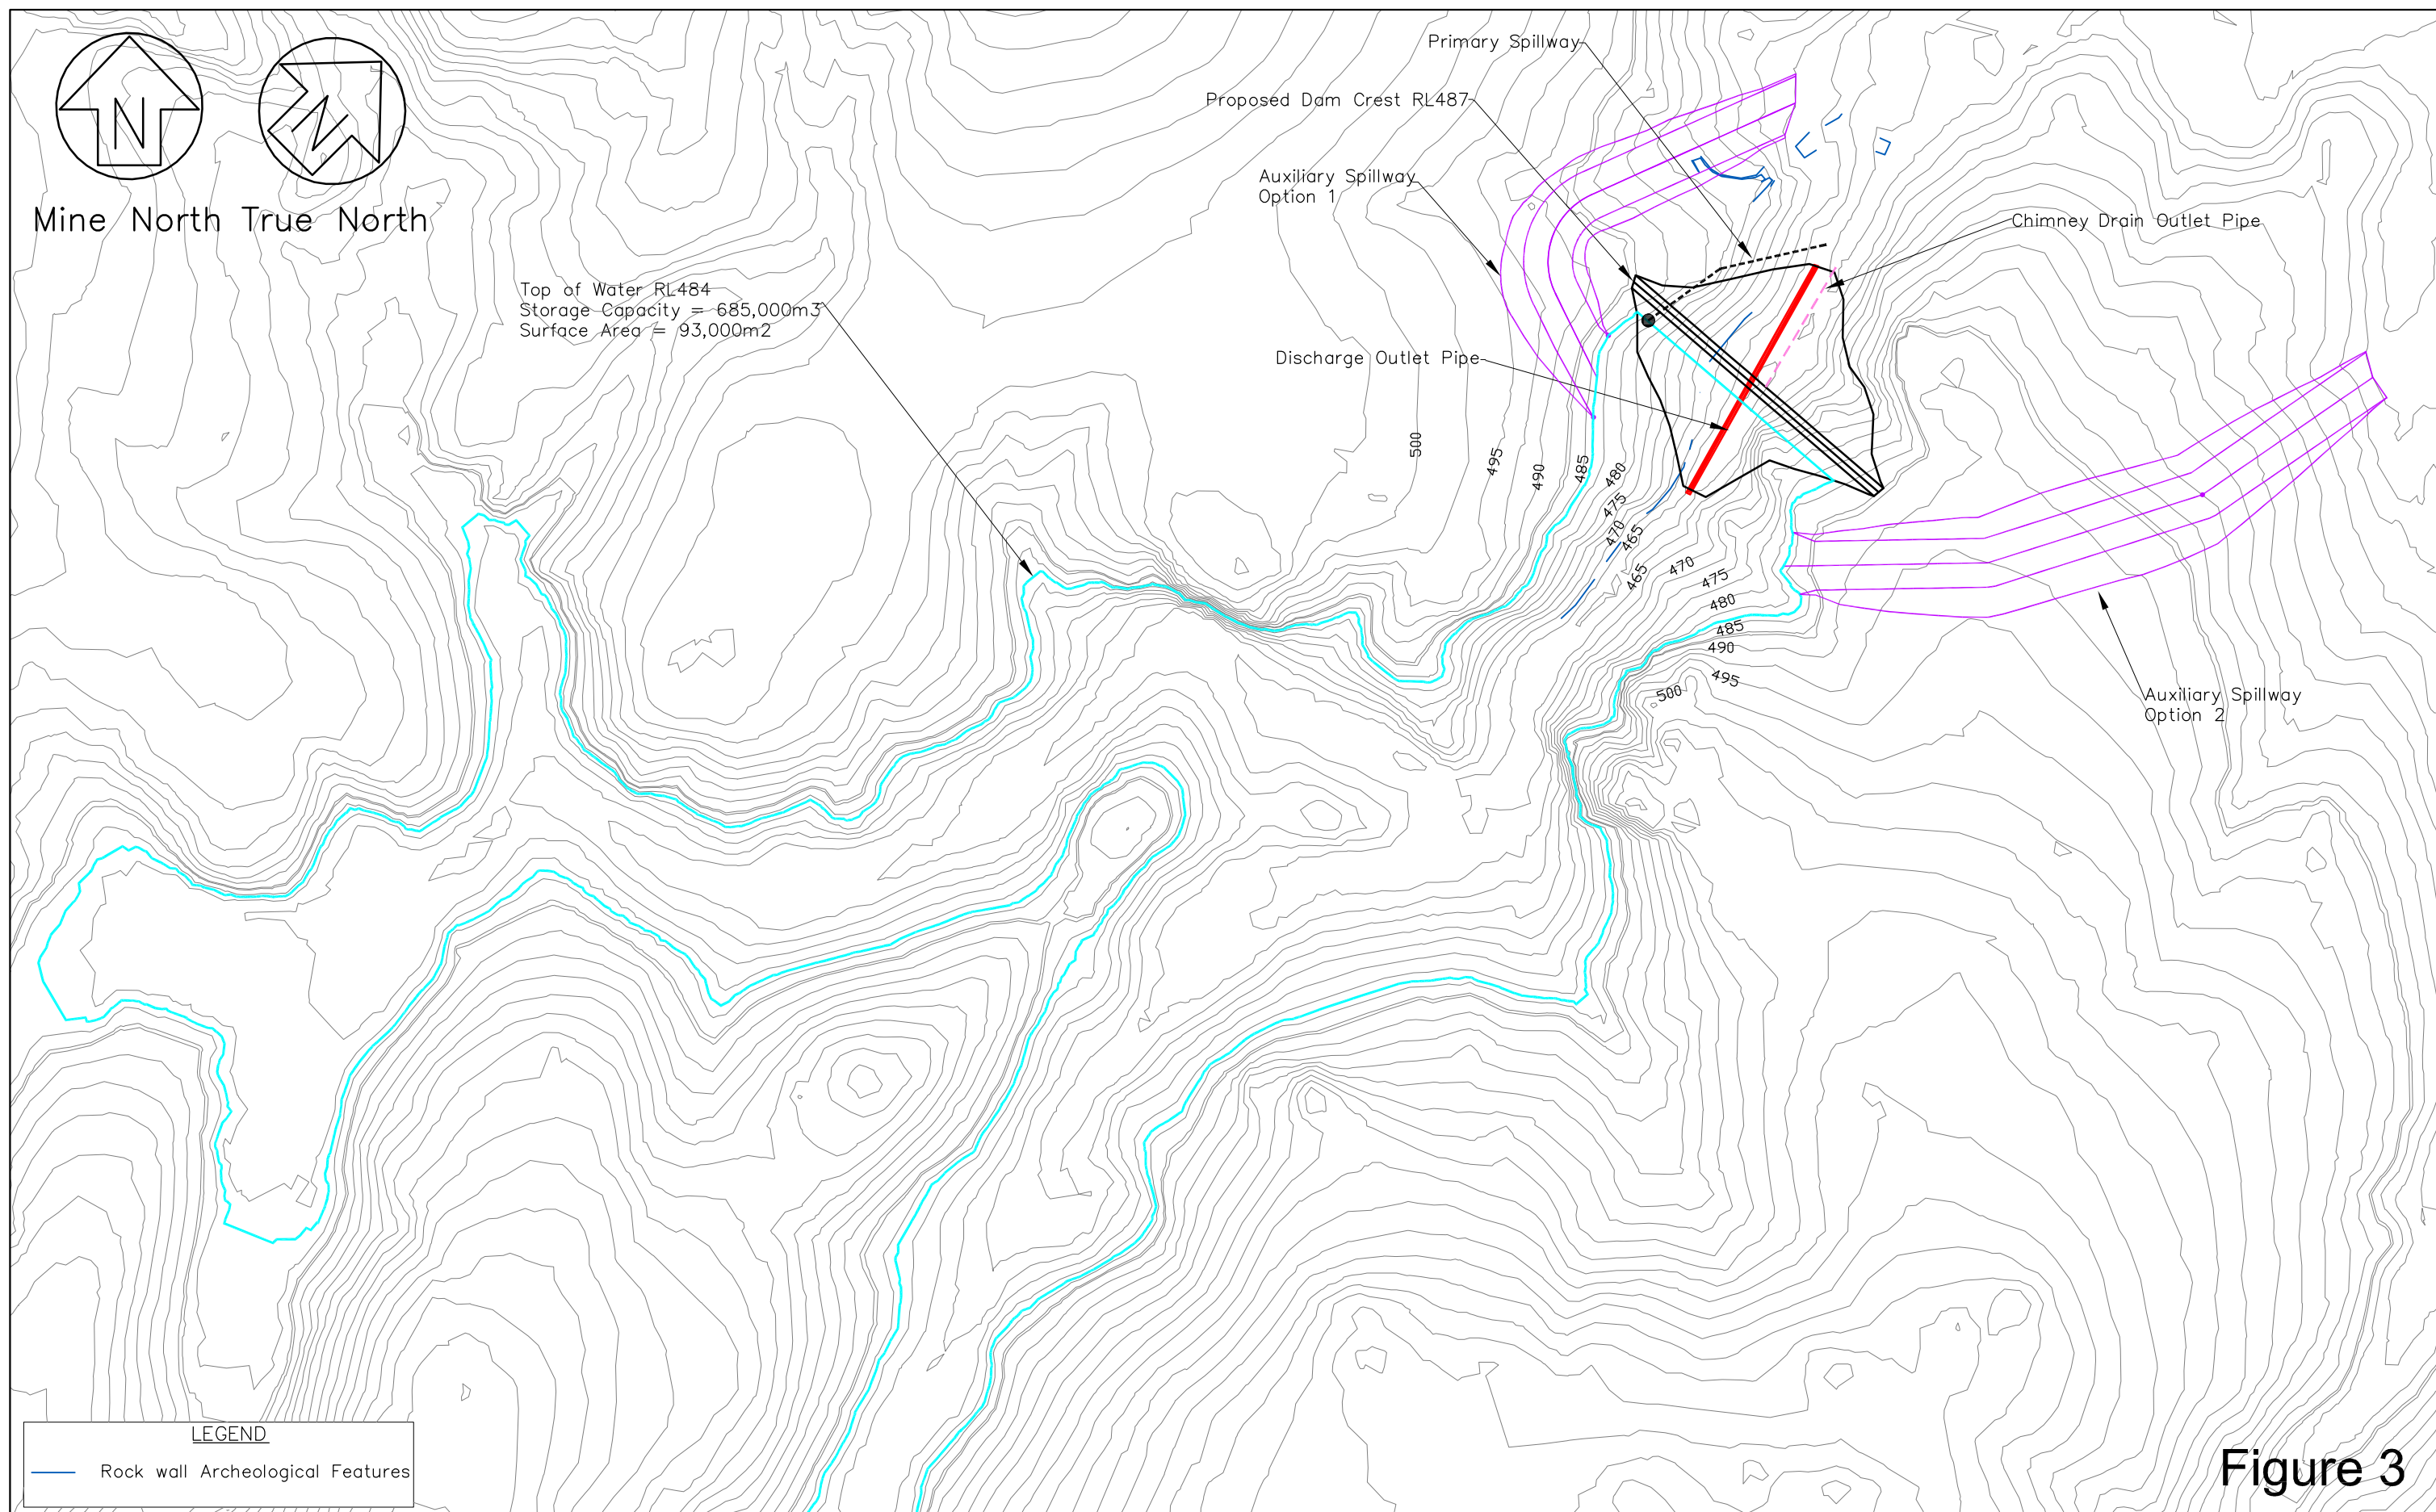
**Figure 3**

**OCEANA GOLD (New Zealand) LTD, MACRAES GOLD PROJECT**  
**Coronation North Project**  
**Proposed Coal Creek Freshwater Dam**  
**Site Plan**

The dam will be designed in accordance with the New Zealand Society Dams (NZSOLD) Dam Safety Guidelines (Ref.2). A layout plan for the proposed dam, including the reservoir is shown in Figure 3. It is formed by an embankment on the north eastern side of the reservoir within a "V" shaped incised gulley. Important features of the proposed dam are summarised below:

Water is to be constantly discharged from the dam at a rate of about 5l/s to augment the downstream flow in Coal Creek. The discharge will be via a pipe laid beneath the embankment as shown on the plan in Figures 3, 4 and 7 and 9. The pipe is 250OD, SDR17, PE100 and located in the northern side of Coal Creek.

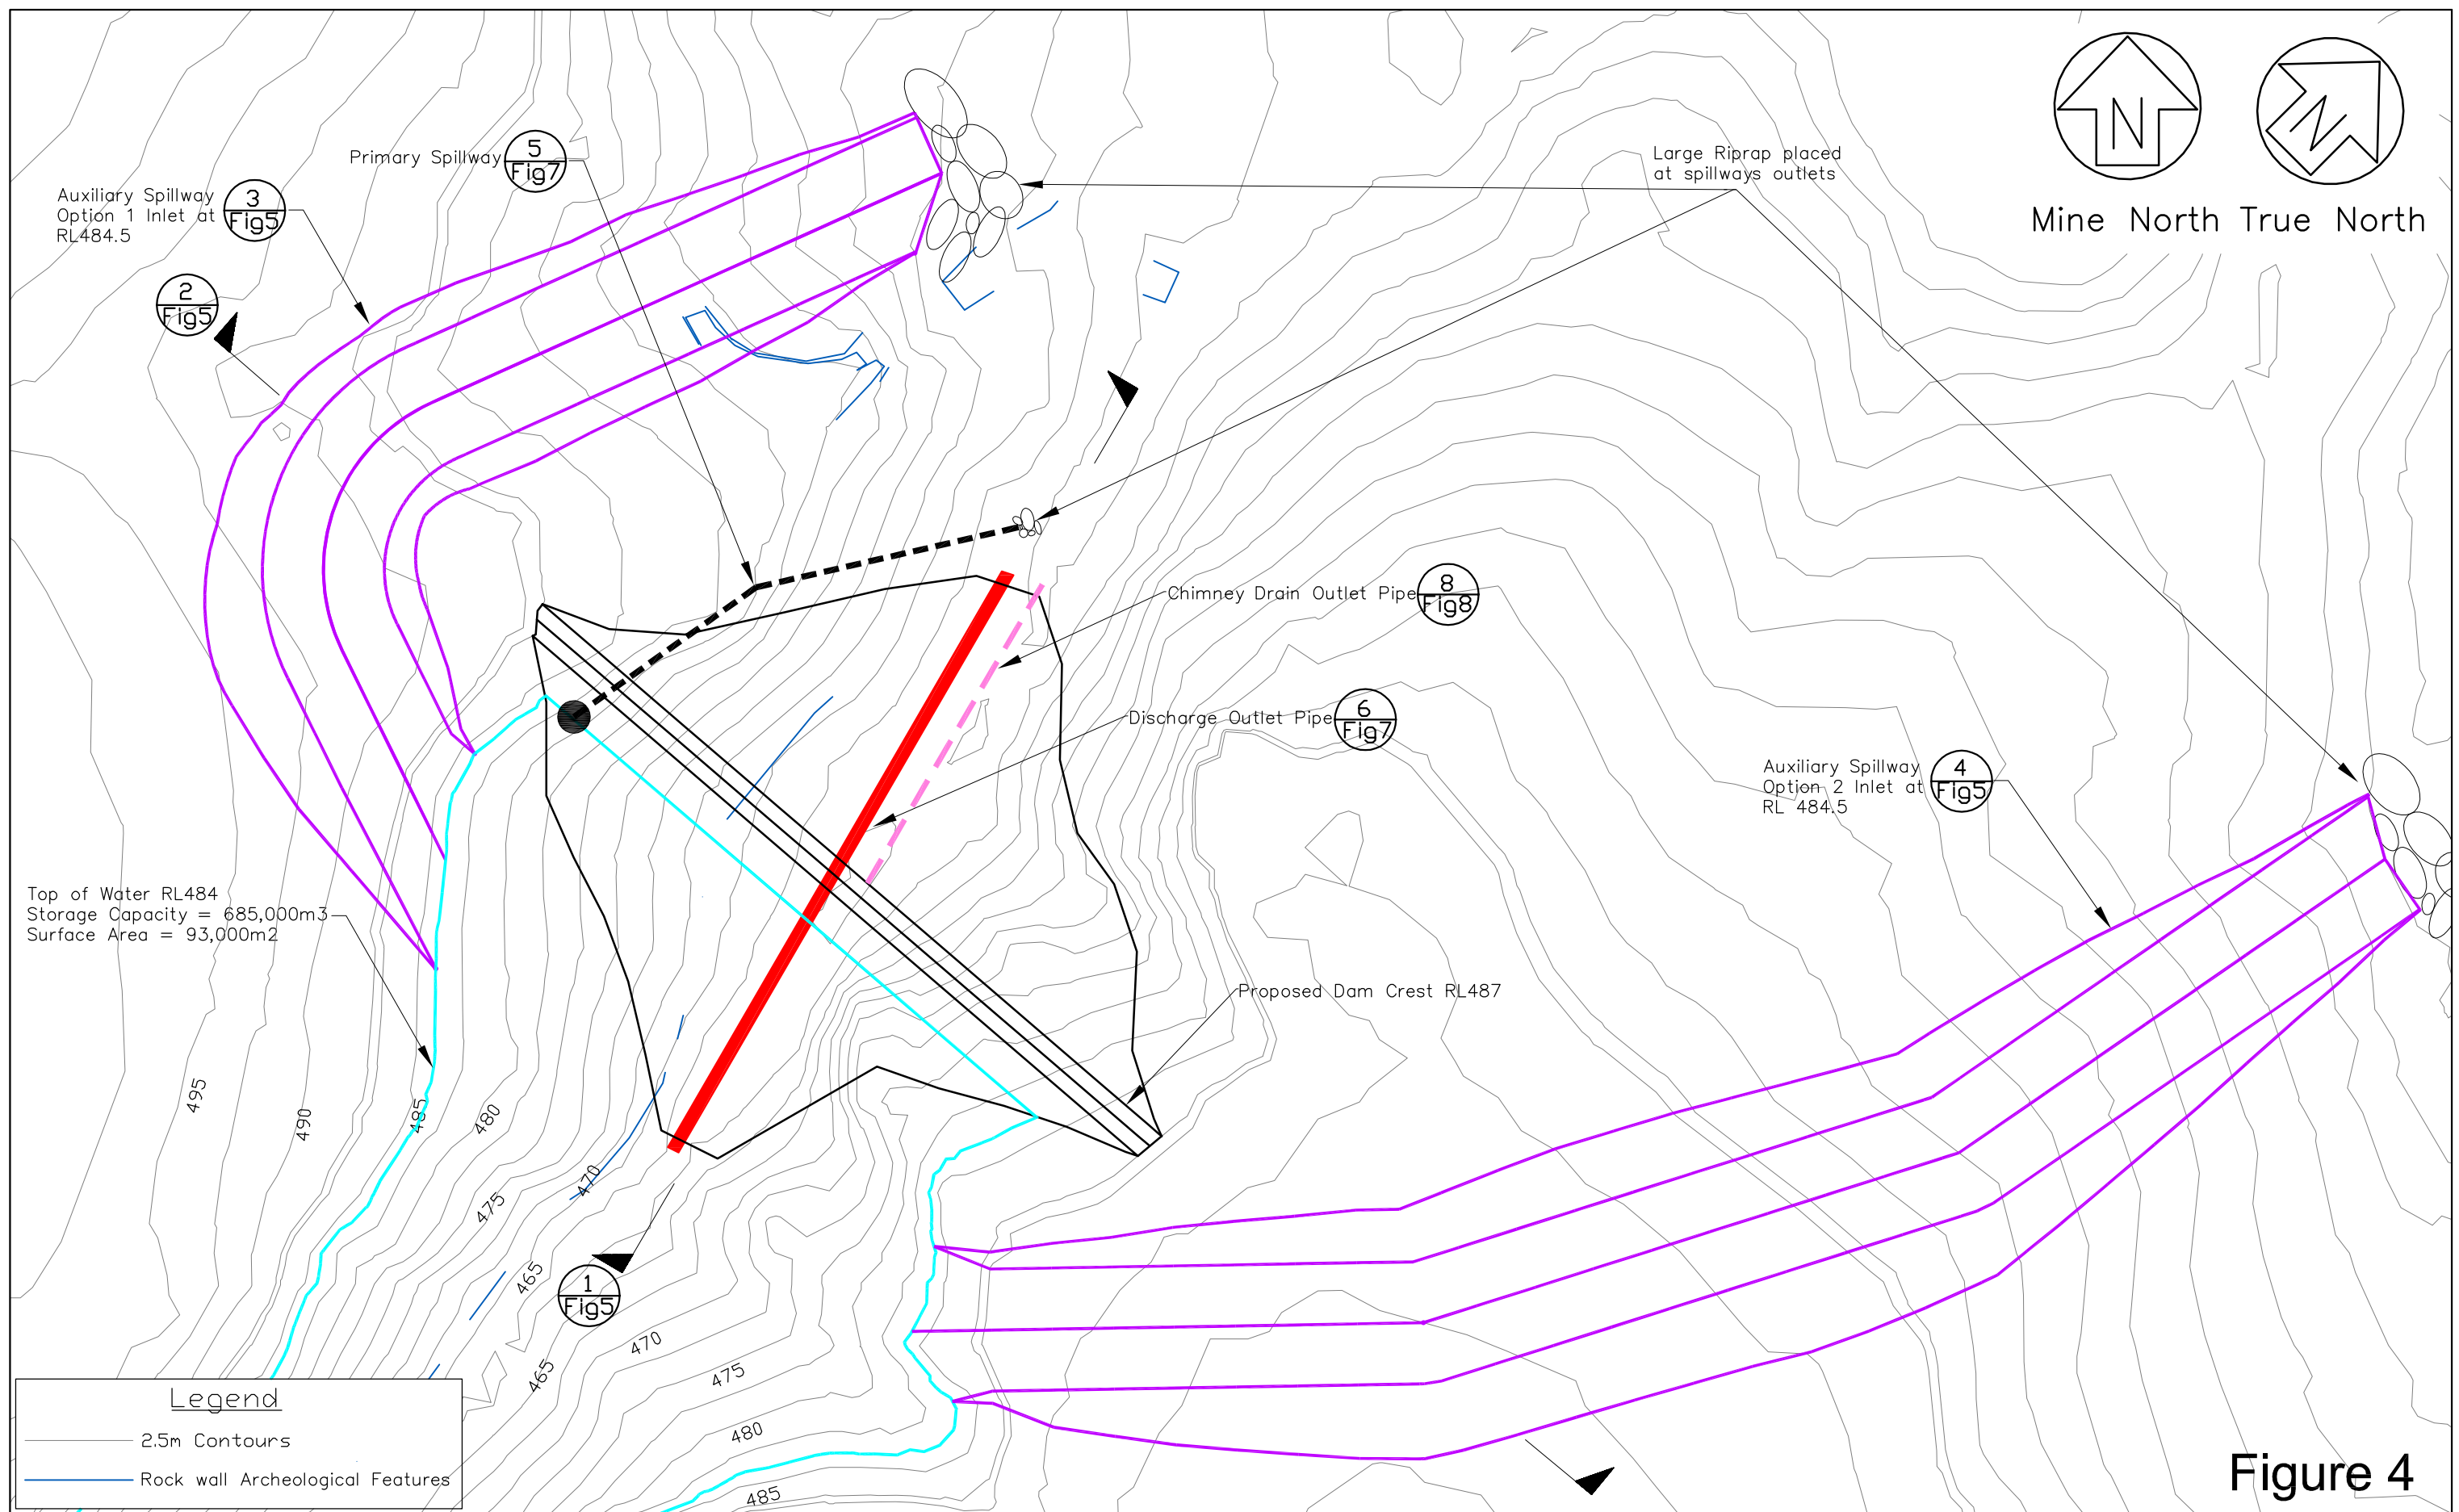
Drawing No. 8122-Fig 4  
 Date: May 2016  
 Drawn: JS  
 Scale: 1:1000 (@A3)  
 Filename: 8122-Fig4.dwg

## **OCEANA GOLD (New Zealand) LTD, MACRAES GOLD PROJECT** **Coronation North Project** **Proposed Coal Creek Freshwater Dam** **Embankment Layout**

The primary spillway is located on the west abutment and consists of a 1500mm diameter manhole entry structure with a 710mm diameter polyethylene outlet pipe (710OD, SDR26, PE100) as shown in Figures 3, 4, 7, 10 and 11.

The auxiliary spillway has been sized to safely discharge a 1 in 5,000 event rainfall with a freeboard of 1m (refer Figures 4 and 5). The spillway consists of an open channel excavated into rock with a 20m base width at the inlet control weir. Two spillway options have been considered, including Option 1 which is located on the northern abutment and Option 2 which is situated on the southern abutment, as shown in Figure 3. The spillway size will be finalised during the detailed design in accordance with the detailed dam breach analyses.

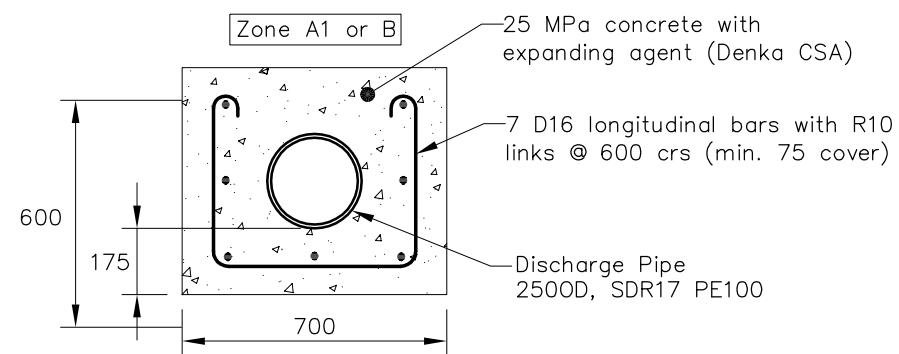
9  
Fig 7

DISCHARGE PIPE THROUGH ZONES A1 & B (UPSTREAM SHOULDER ONLY)

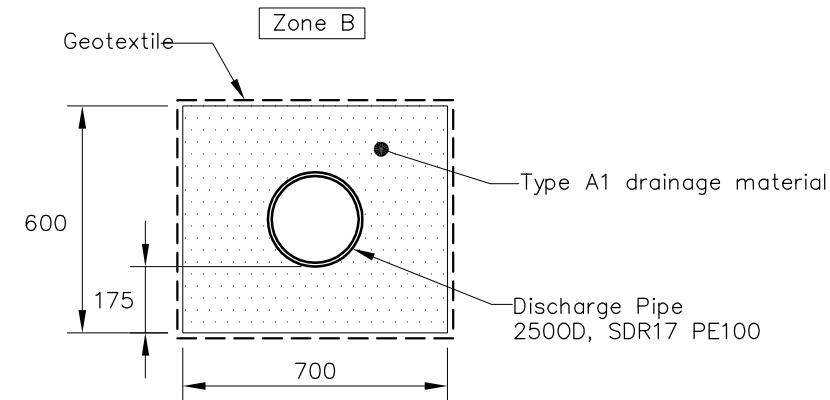
10  
Fig 7

DISCHARGE PIPE THROUGH ZONE B (DOWNSTREAM SHOULDER)

Note: Concrete shall have an expanding agent added to it (Denka CSA (No. 20) or equivalent). Immediately following placement of concrete the top of the concrete shall be covered with polythene and 1.5m of loose fill placed above. The loose fill shall be removed after 24 hours and the specified compacted fill place above after 5 days.

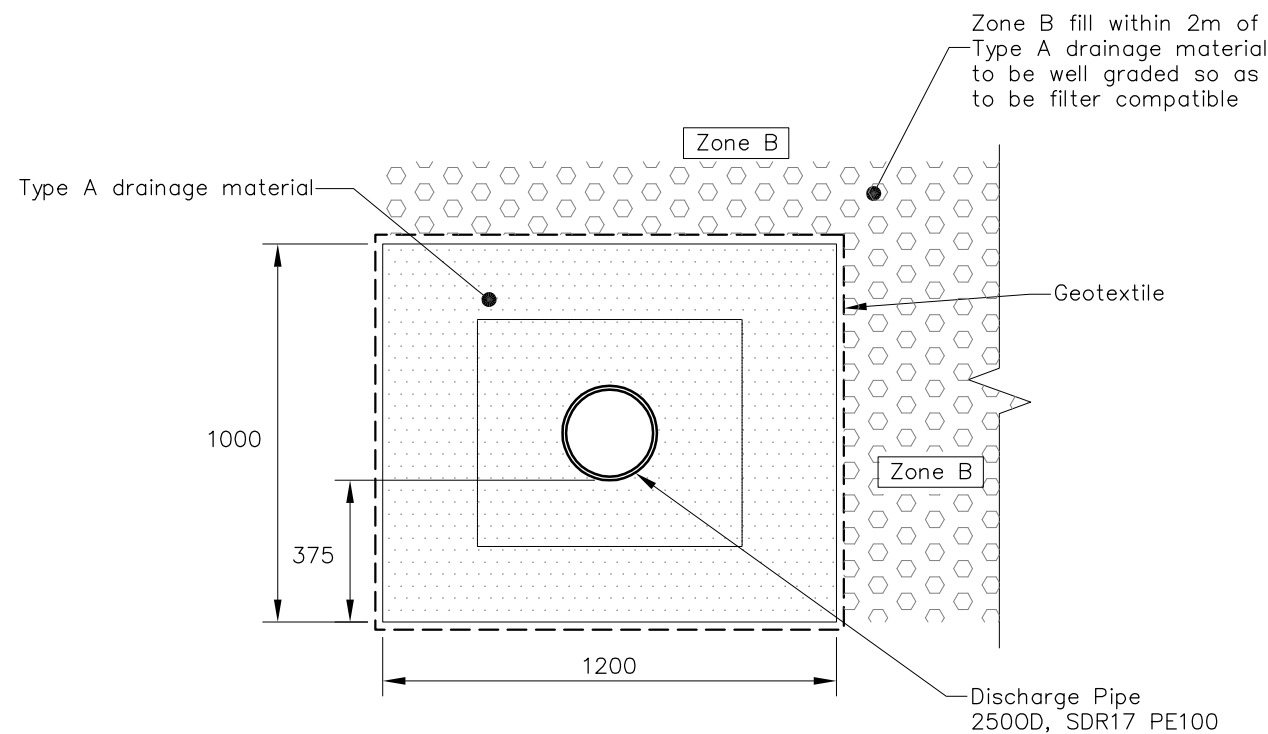
11  
Fig 7

DISCHARGE PIPE THRU FILTER/SEEPAGE INTERCEPTOR DRAIN

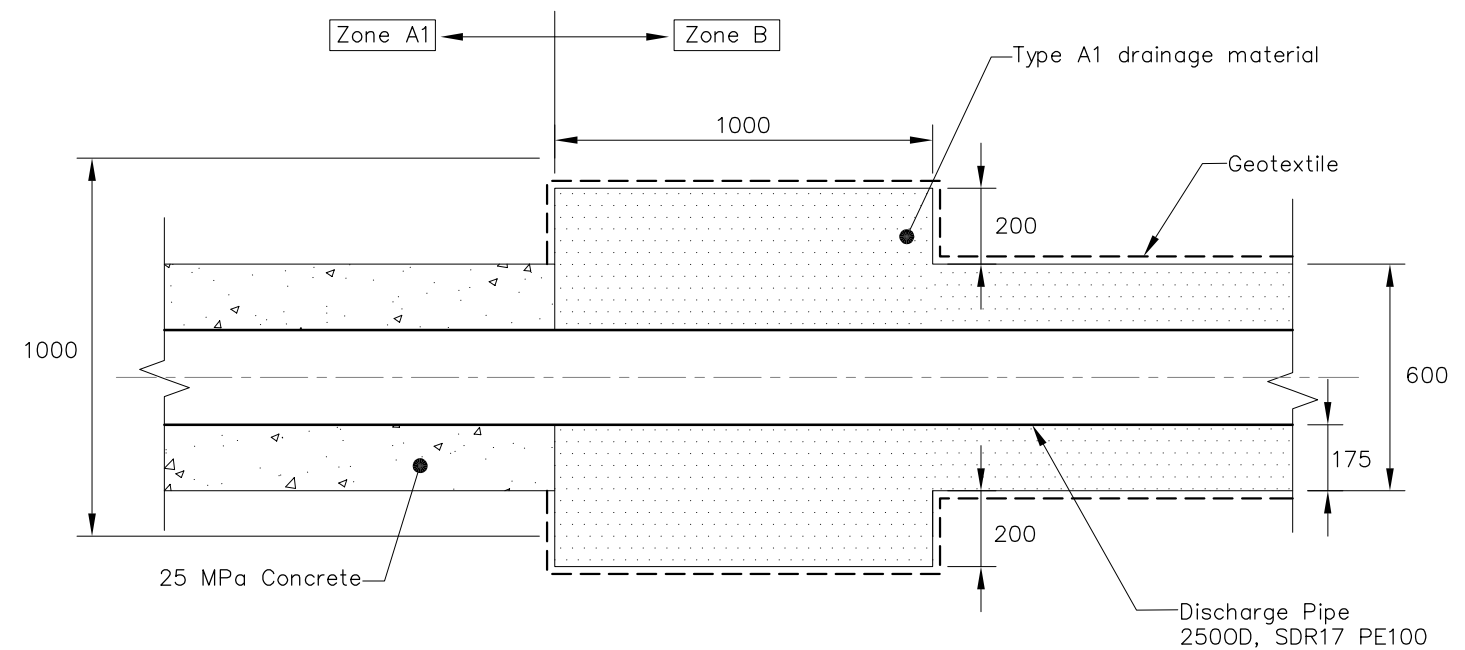
12  
Fig 7

DISCHARGE PIPE THROUGH FILTER/SEEPAGE INTERCEPTOR DRAIN

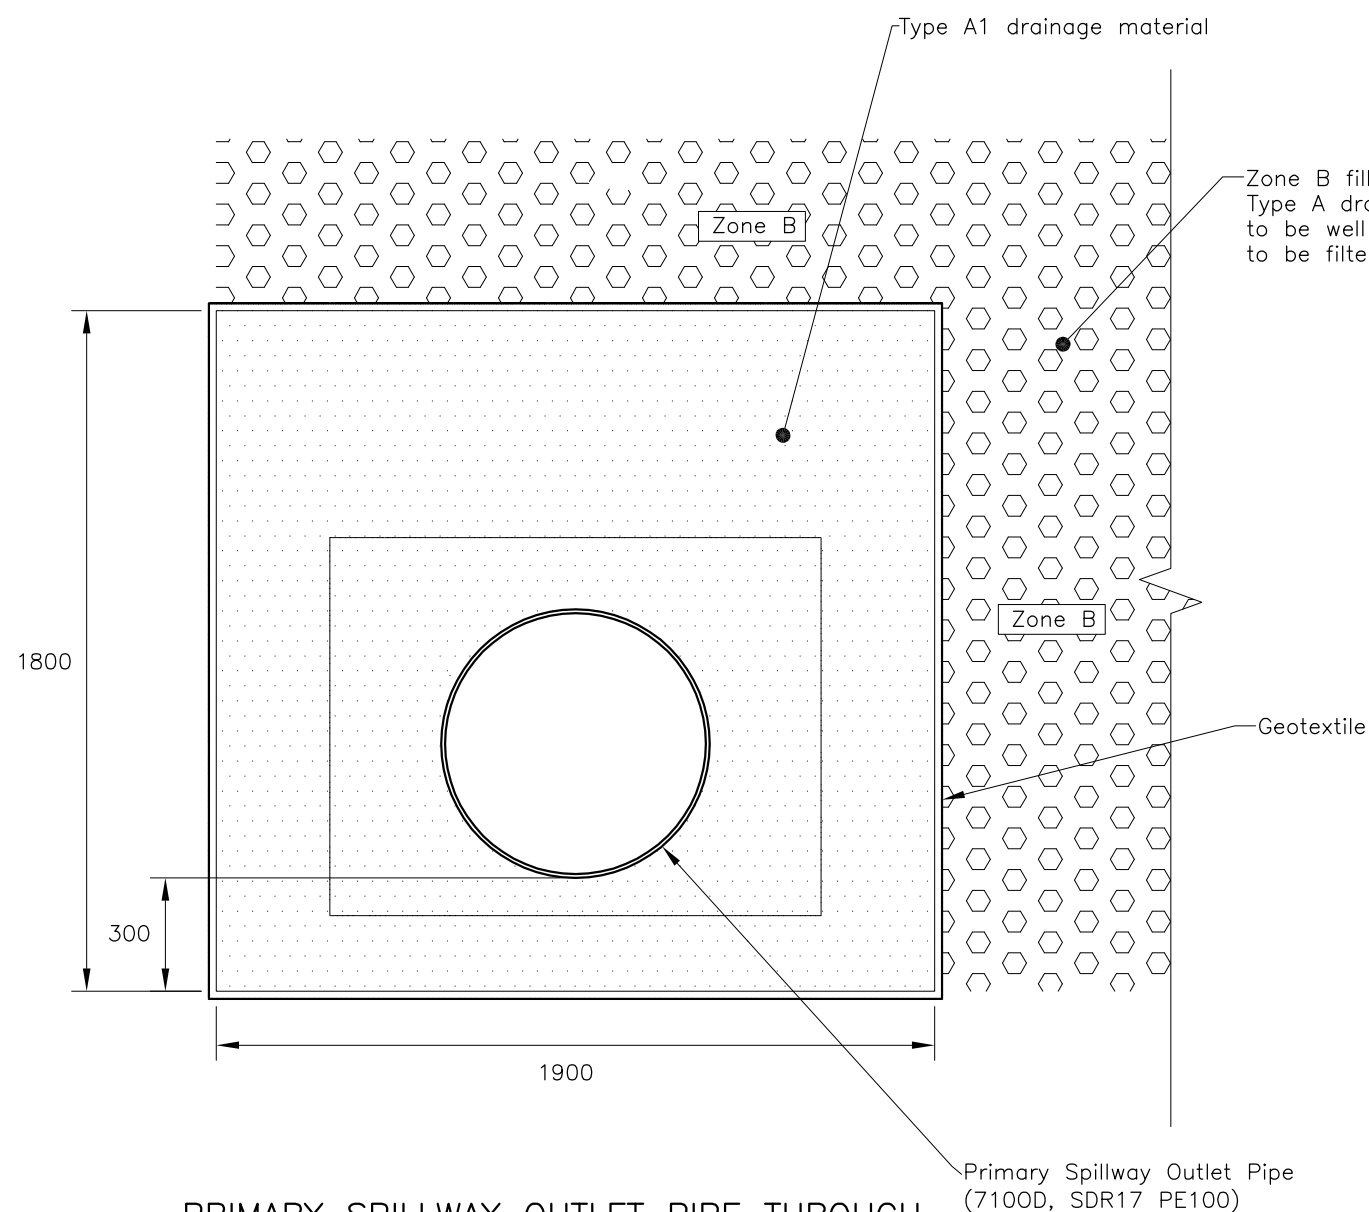
**Note:** Concrete shall have an expanding agent added to it (Denka CSA (No. 20) or equivalent). Immediately following placement of concrete the top of the concrete shall be covered with polythene and 1.5m of loose fill placed above. The loose fill shall be removed after 24 hours and the specified compacted fill placed above after 5 days.

**PRIMARY SPILLWAY OUTLET PIPE THROUGH  
FILTER/SEEPAGE INTERCEPTOR DRAIN** (14 Fig7)

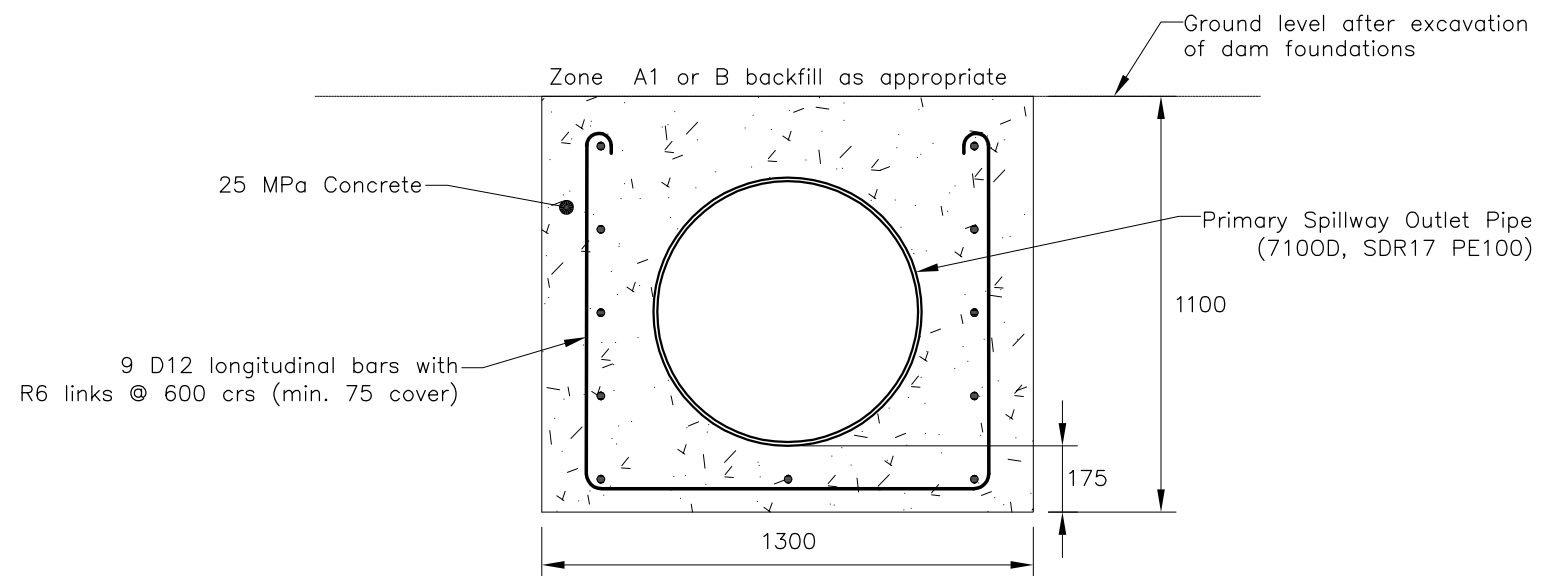
**PRIMARY SPILLWAY OUTLET PIPE BENEATH  
ZONES A1 & B (UPSTREAM SHOULDER ONLY)** (13 Fig7)

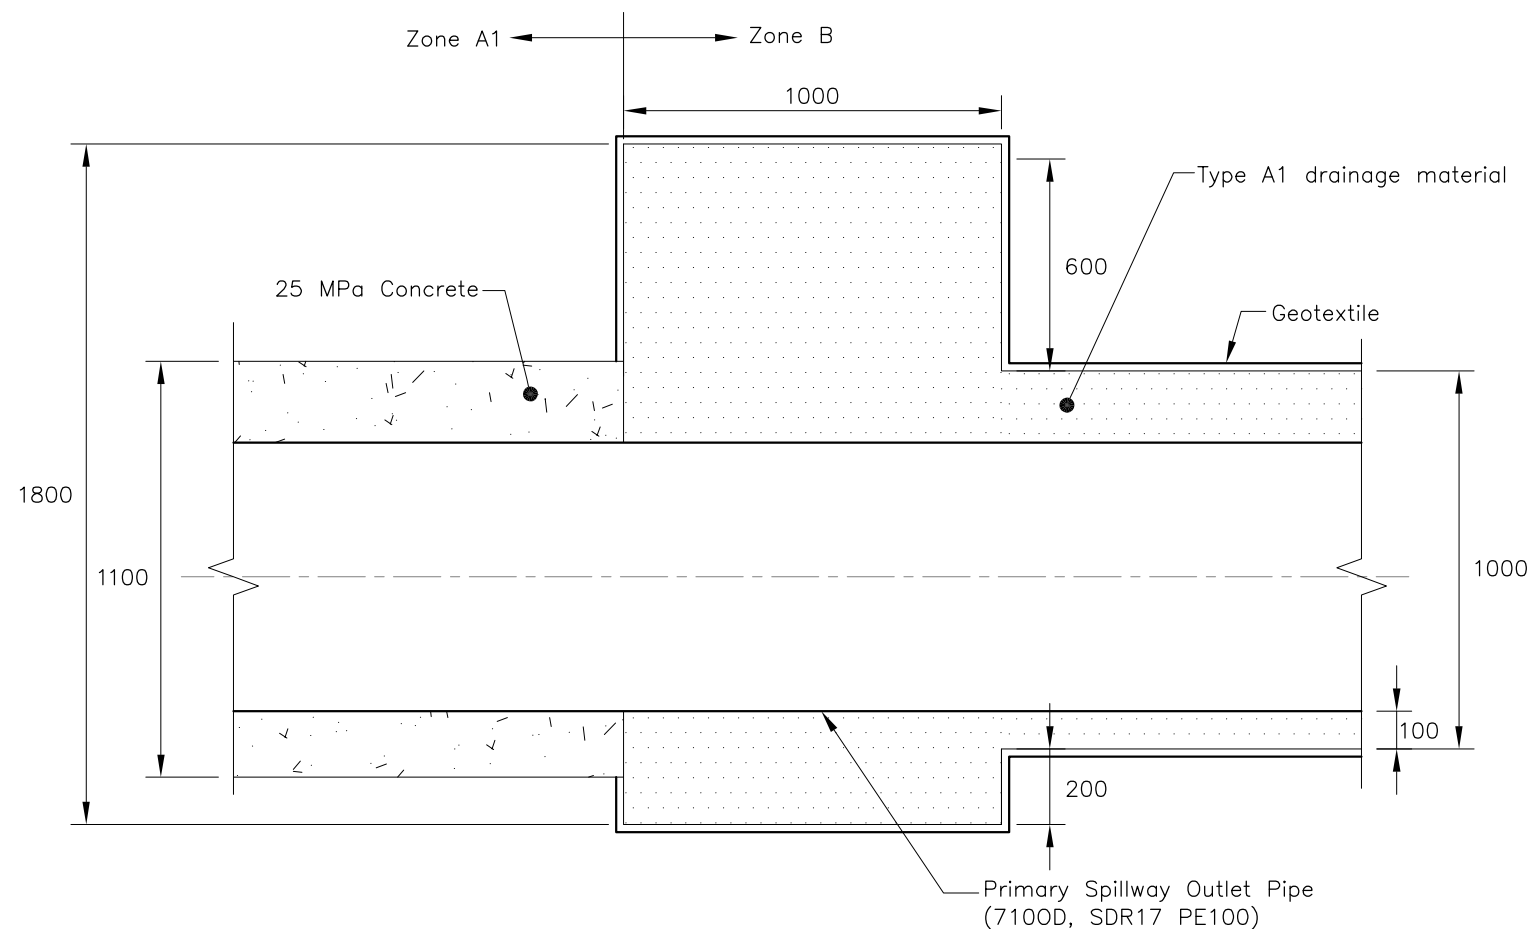
**PRIMARY SPILLWAY OUTLET PIPE THROUGH  
FILTER/SEEPAGE INTERCEPTOR DRAIN** (15 Fig7)

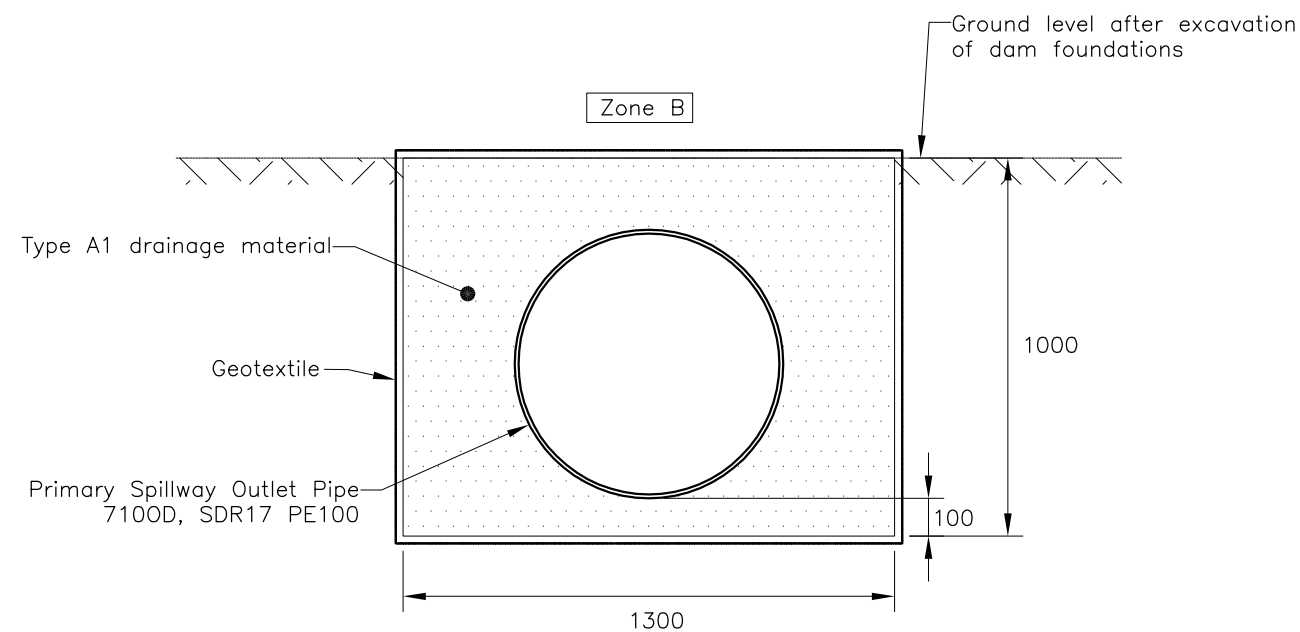
**PRIMARY SPILLWAY OUTLET PIPE BENEATH  
ZONE B (DOWNSTREAM SHOULDER)** 16  
Fig7  
Scale 1:20

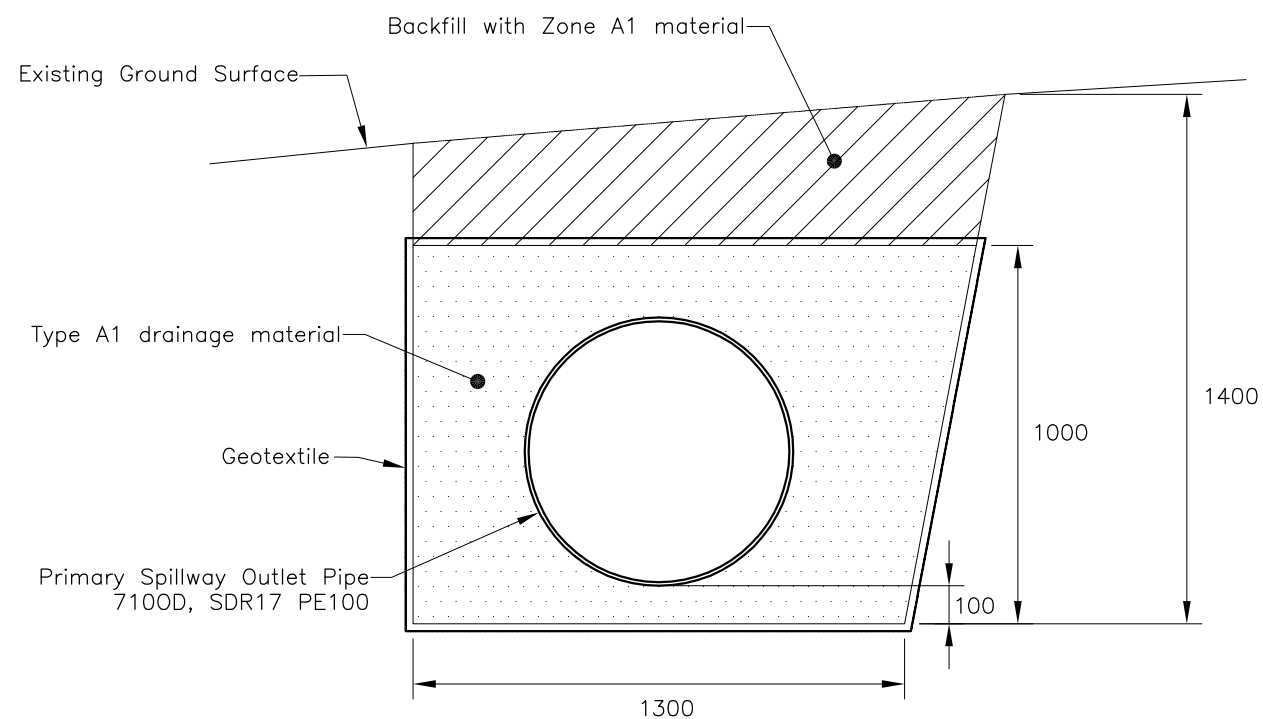
**PRIMARY SPILLWAY OUTLET PIPE  
DOWNSTREAM OF EMBANKMENT** 17  
Fig7  
Scale 1:20

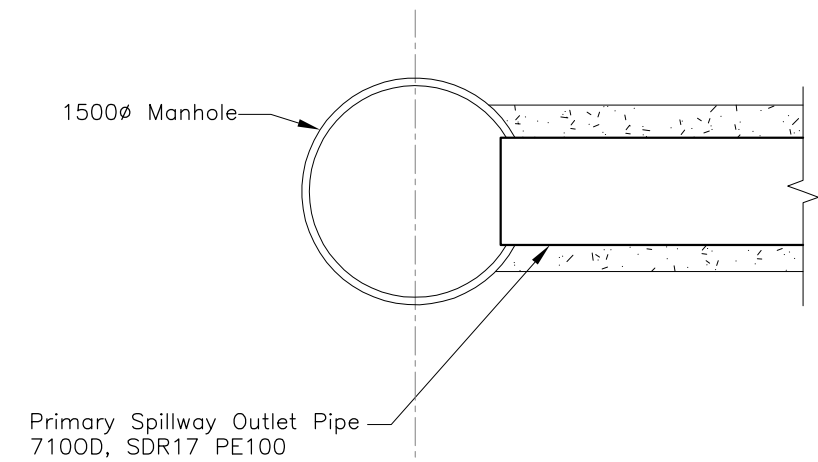
**PRIMARY SPILLWAY INLET SECTION** 19  
Fig11  
Scale 1:50

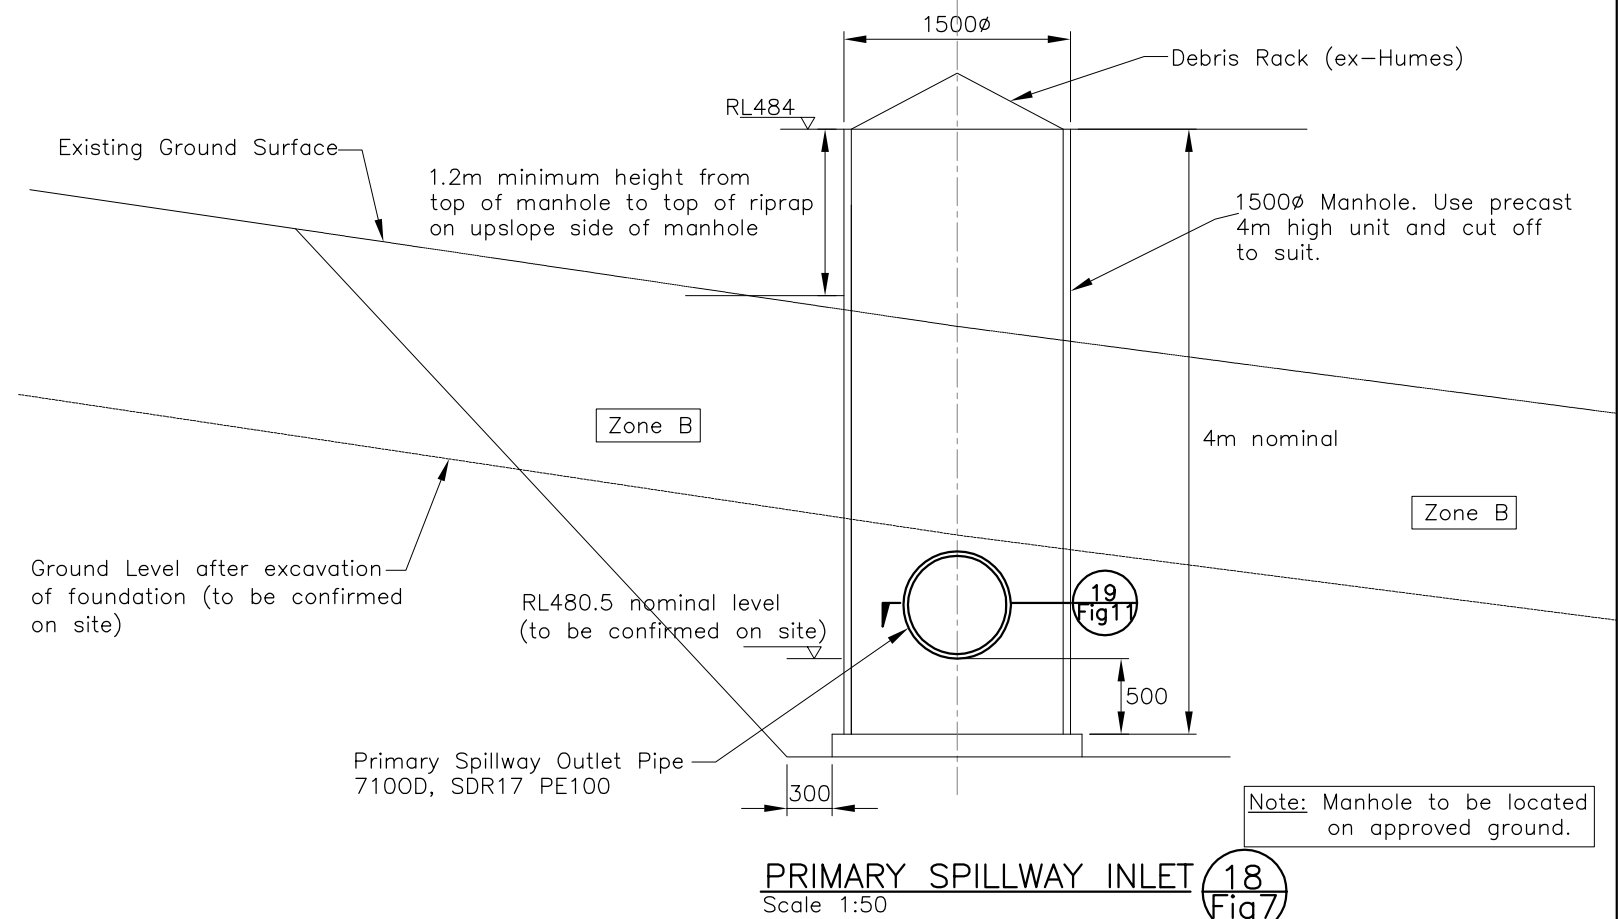
**PRIMARY SPILLWAY INLET** 18  
Fig7  
Scale 1:50
