Geotech Memo

TECHNICAL MEMORANDUM

RE: Geotechnical Memorandum to support a referral Fast Track application at 14 Edmonton Road, Henderson

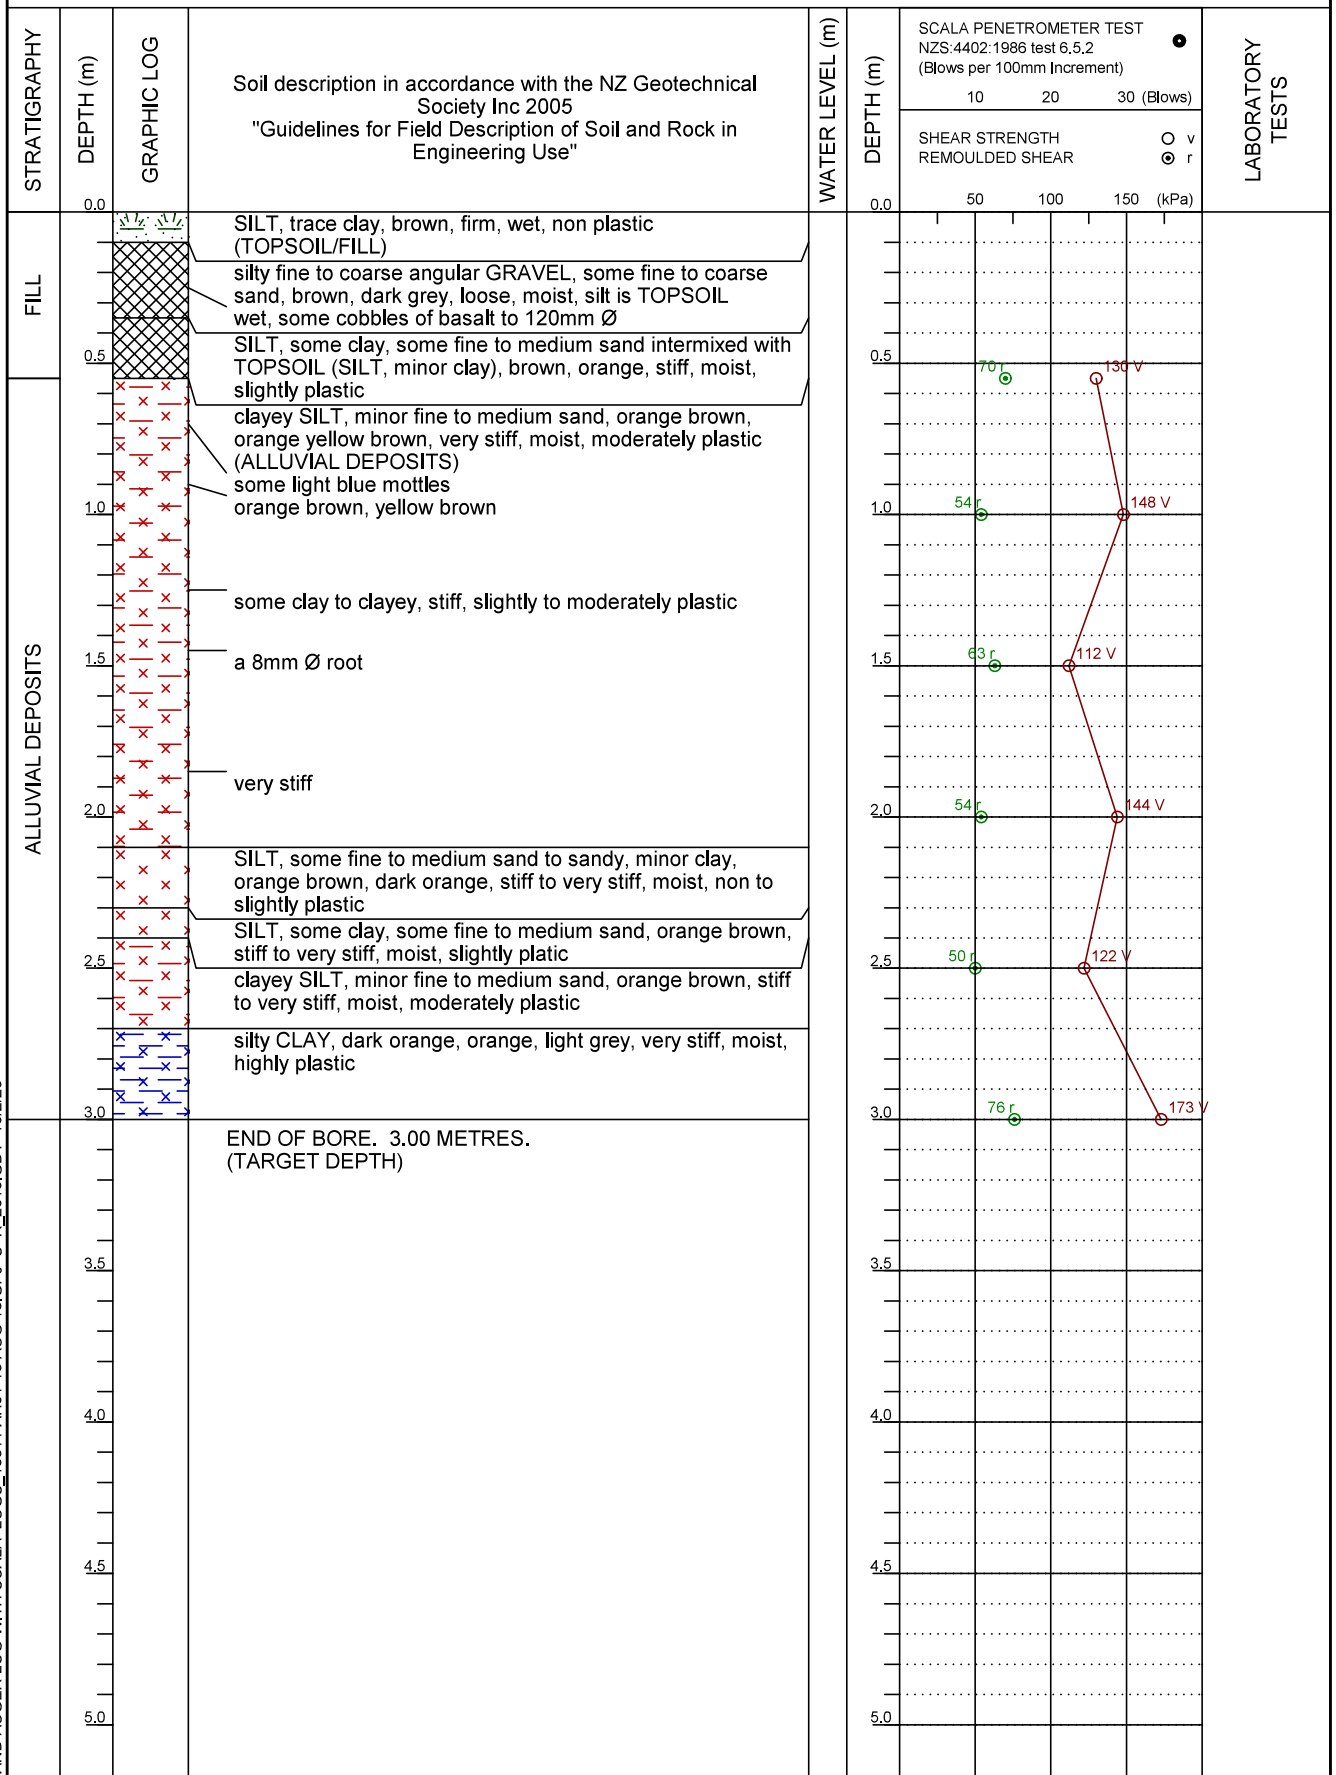
HAND AUGER LOG WITH SCALA LOGS_18511_AH01-13 AUG 18.GPJ S+R_2013.GDT 13/2/23

Drill Type: 50 mm Hand Auger
Drilled By: DG
Date Started: 21/8/18
Date Finished: 21/8/18

Project No: 18511
Coordinates:
Ground Elevation:
Water Level: Ground Water Not Encountered

Logged By: DG
Shear Vane No - Calibration Date: DR1768 - 21/12/2017
Surface Conditions: Slightly Sloping Grass

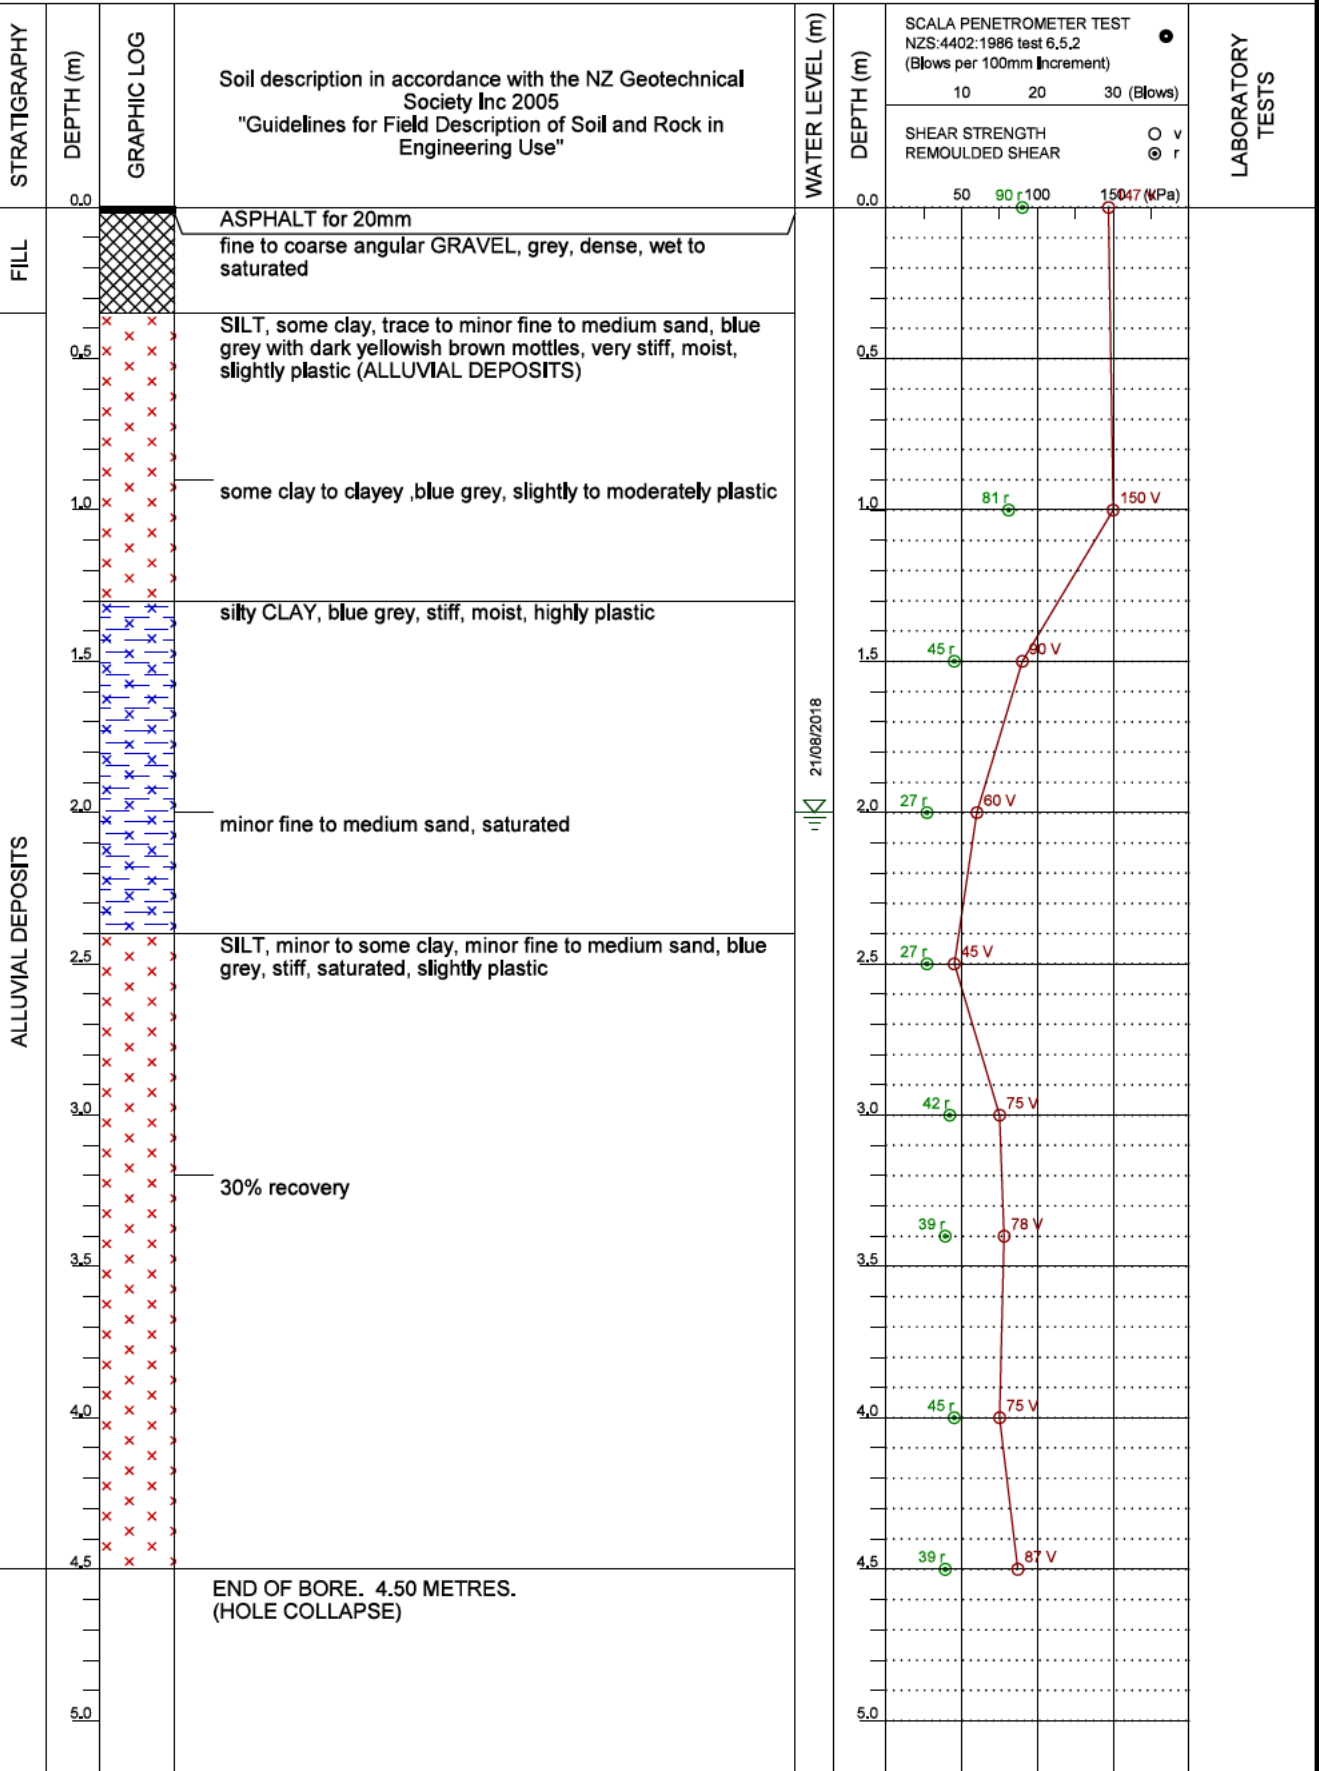
HAND AUGER LOG WITH SCALA LOGS_18511_AH01-13 AUG 18.GPJ S+R_2013.GDT 13/2/23

Project No: 18511
Coordinates:
Ground Elevation:
Water Level: 2.0m 21/08/2018

Logged By: NC
Shear Vane No - Calibration Date: GEO122 - 1/12/2017
Surface Conditions: Near Level Asphalt
