# Geotechnical Report for Resource Consent

Ayrburn Screen Hub  
1 Ayr Avenue, Arrowtown

Waterfall Park Developments Ltd

**GeoSolve Ref: 150098.12**

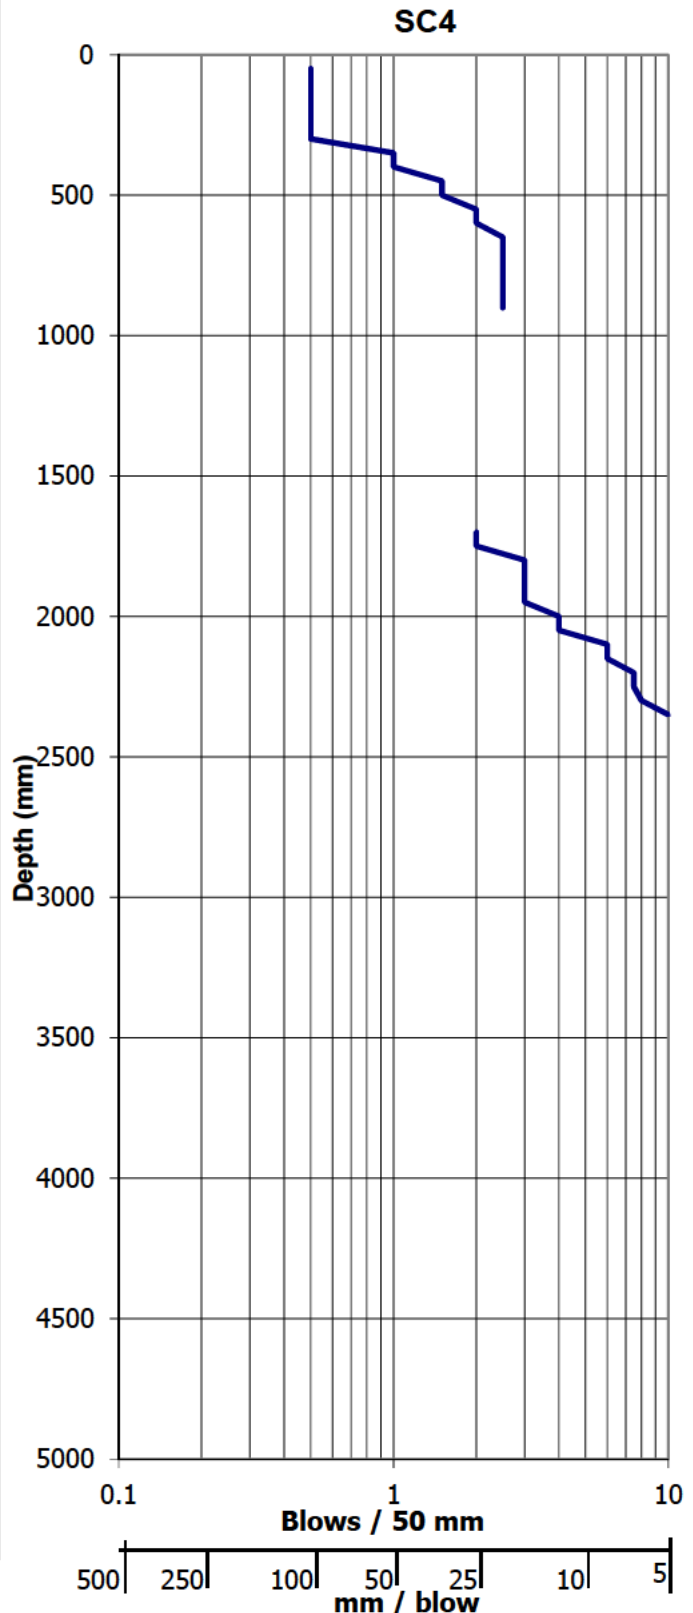
SC4	
mm Driven	No. of Blows
50	0.5
100	0.5
150	0.5
200	0.5
250	0.5
300	0.5
350	1
400	1
450	1.5
500	1.5
550	2
600	2
650	2.5
700	2.5
750	2.5
800	2.5
850	2.5
900	2.5
950	
1000	
1050	
1100	
1150	
1200	
1250	
1300	
1350	
1400	
1450	
1500	
1550	
1600	
1650	
1700	2
1750	2
1800	3
1850	3
1900	3
1950	3
2000	4
2050	4
2100	6
2150	6
2200	7.5
2250	7.5
2300	8
2350	10
2400	
2450	
2500

Test Method Used: NZS 4402:1988 Test 6.5.2 Dynamic Cone Penetrometer

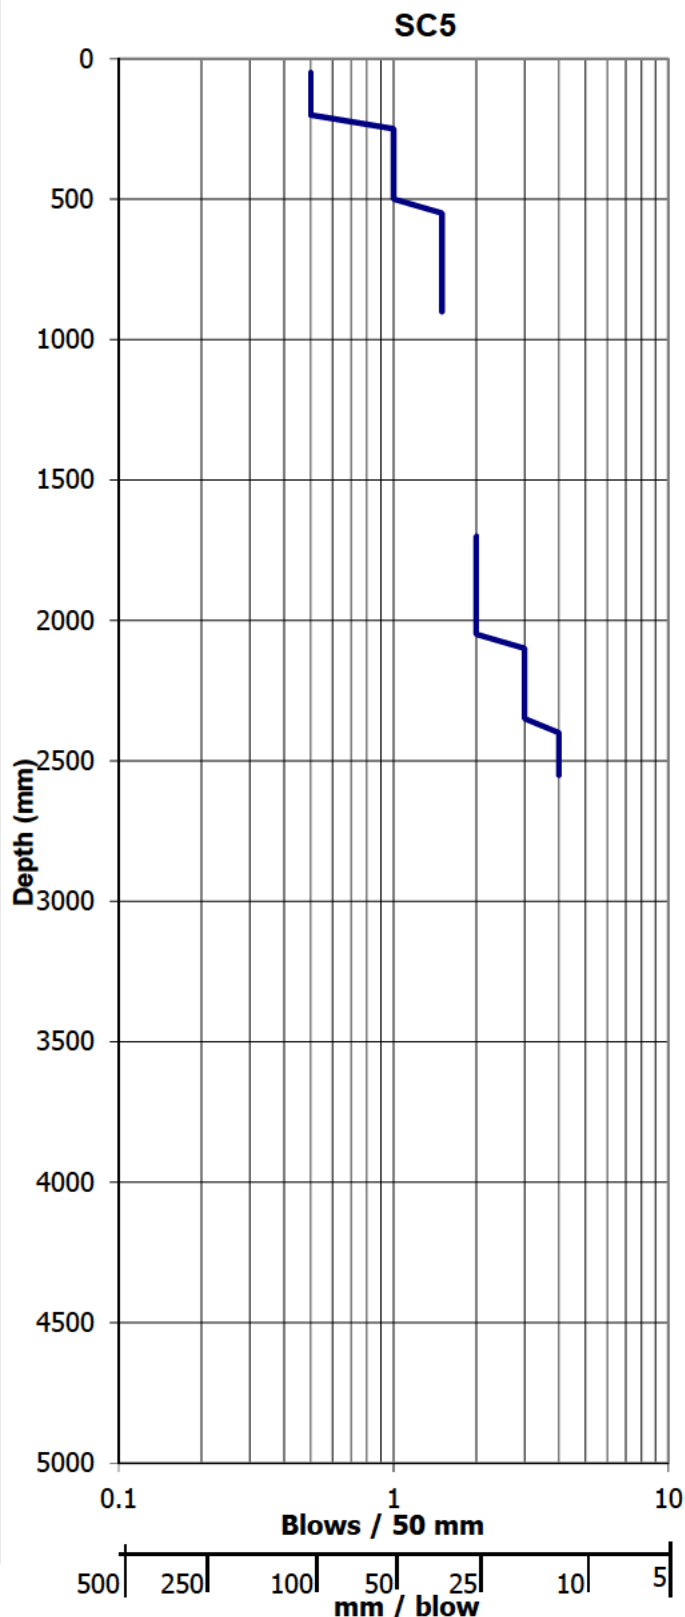
SC5	
mm Driven	No. of Blows
50	0.5
100	0.5
150	0.5
200	0.5
250	1
300	1
350	1
400	1
450	1
500	1
550	1.5
600	1.5
650	1.5
700	1.5
750	1.5
800	1.5
850	1.5
900	1.5
950	
1000	
1050	
1100	
1150	
1200	
1250	
1300	
1350	
1400	
1450	
1500	
1550	
1600	
1650	
1700	2
1750	2
1800	2
1850	2
1900	2
1950	2
2000	2
2050	2
2100	3
2150	3
2200	3
2250	3
2300	3
2350	3
2400	4
2450	4
2500	4

Test Method Used: NZS 4402:1988 Test 6.5.2 Dynamic Cone Penetrometer

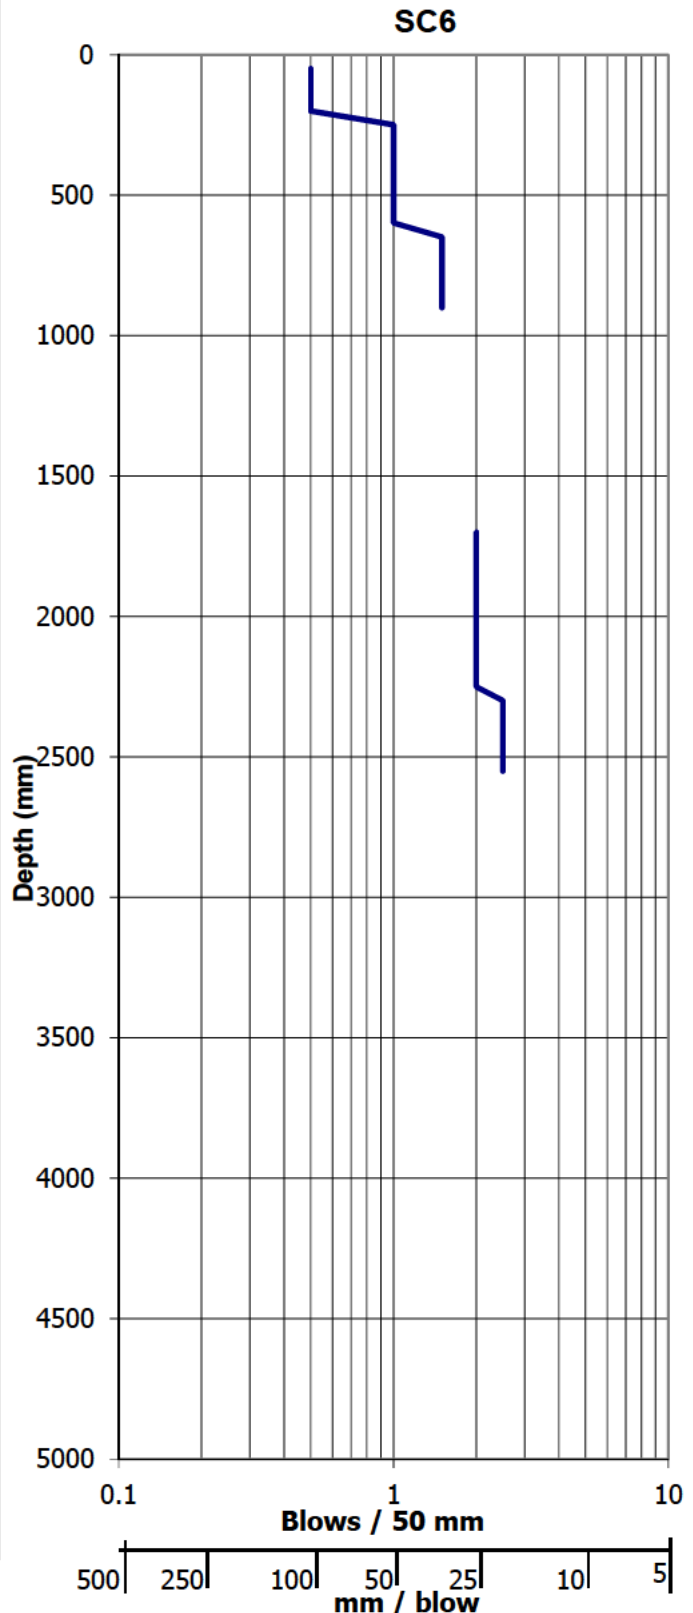
SC6	
mm Driven	No. of Blows
50	0.5
100	0.5
150	0.5
200	0.5
250	1
300	1
350	1
400	1
450	1
500	1
550	1
600	1
650	1.5
700	1.5
750	1.5
800	1.5
850	1.5
900	1.5
950	
1000	
1050	
1100	
1150	
1200	
1250	
1300	
1350	
1400	
1450	
1500	
1550	
1600	
1650	
1700	2
1750	2
1800	2
1850	2
1900	2
1950	2
2000	2
2050	2
2100	2
2150	2
2200	2
2250	2
2300	2.5
2350	2.5
2400	2.5
2450	2.5
2500	2.5

Test Method Used: NZS 4402:1988 Test 6.5.2 Dynamic Cone Penetrometer

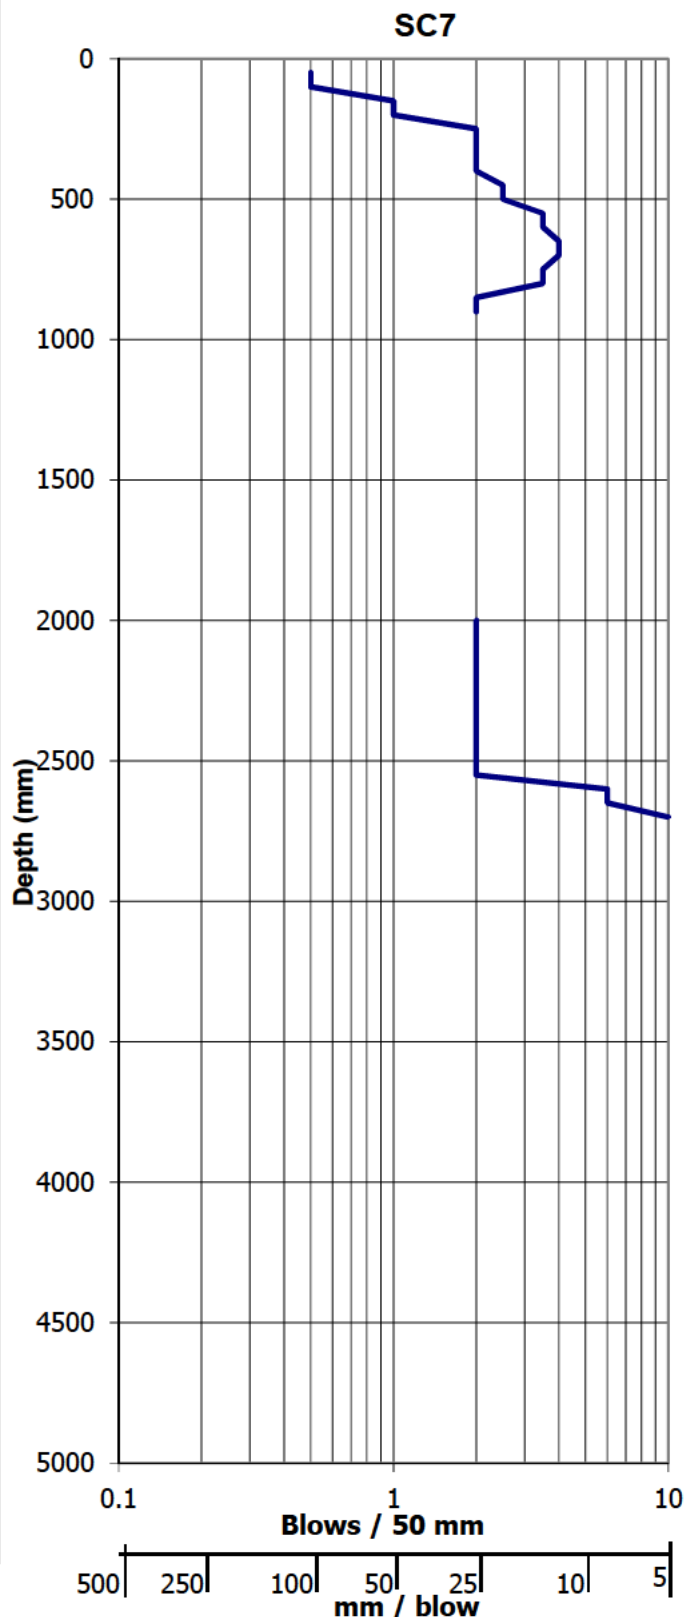
SC7	
mm Driven	No. of Blows
50	0.5
100	0.5
150	1
200	1
250	2
300	2
350	2
400	2
450	2.5
500	2.5
550	3.5
600	3.5
650	4
700	4
750	3.5
800	3.5
850	2
900	2
950	
1000	
1050	
1100	
1150	
1200	
1250	
1300	
1350	
1400	
1450	
1500	
1550	
1600	
1650	
1700	
1750	
1800	
1850	
1900	
1950	
2000	2
2050	2
2100	2
2150	2
2200	2
2250	2
2300	2
2350	2
2400	2
2450	2
2500	2

Test Method Used: NZS 4402:1988 Test 6.5.2 Dynamic Cone Penetrometer

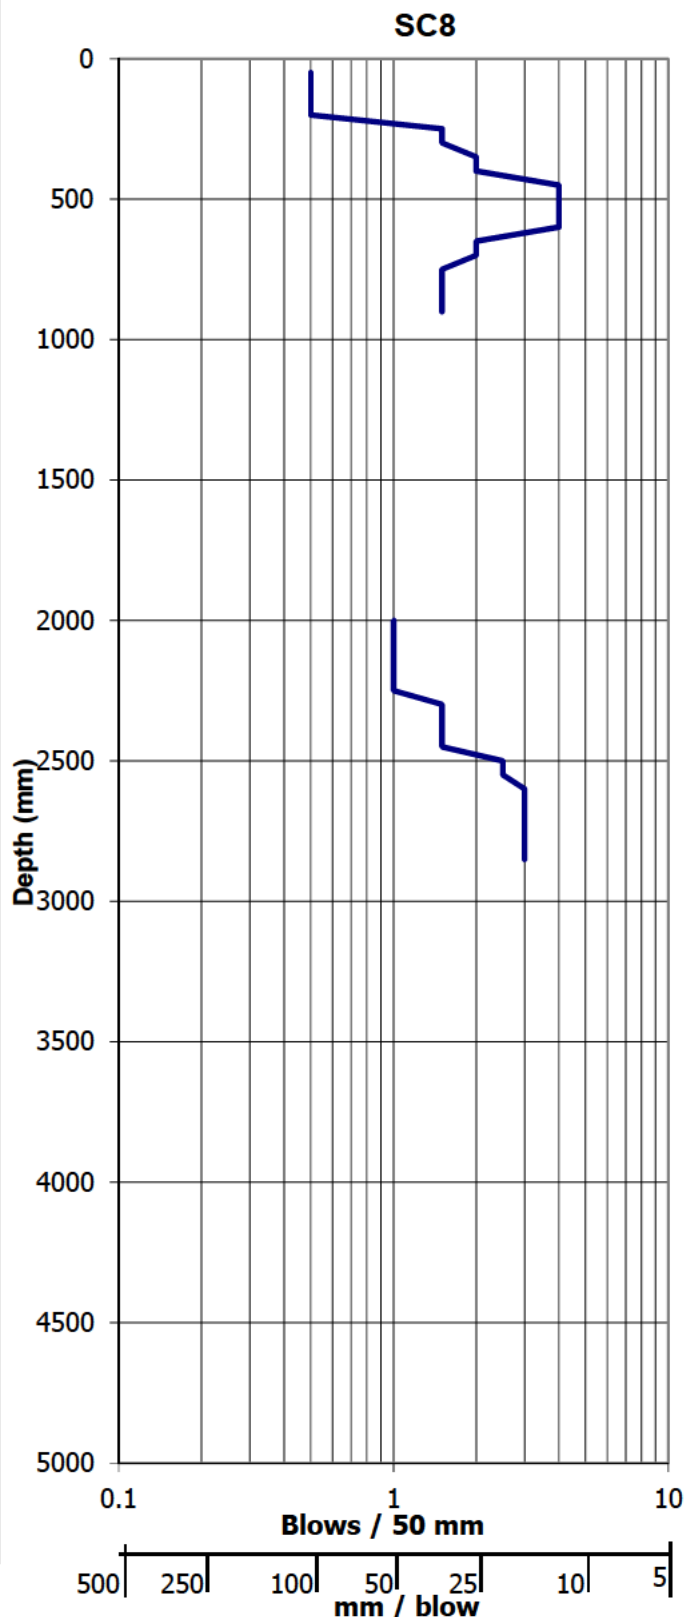
SC8	
mm Driven	No. of Blows
50	0.5
100	0.5
150	0.5
200	0.5
250	1.5
300	1.5
350	2
400	2
450	4
500	4
550	4
600	4
650	2
700	2
750	1.5
800	1.5
850	1.5
900	1.5
950	
1000	
1050	
1100	
1150	
1200	
1250	
1300	
1350	
1400	
1450	
1500	
1550	
1600	
1650	
1700	
1750	
1800	
1850	
1900	
1950	
2000	1
2050	1
2100	1
2150	1
2200	1
2250	1
2300	1.5
2350	1.5
2400	1.5
2450	1.5
2500	2.5

Test Method Used: NZS 4402:1988 Test 6.5.2 Dynamic Cone Penetrometer

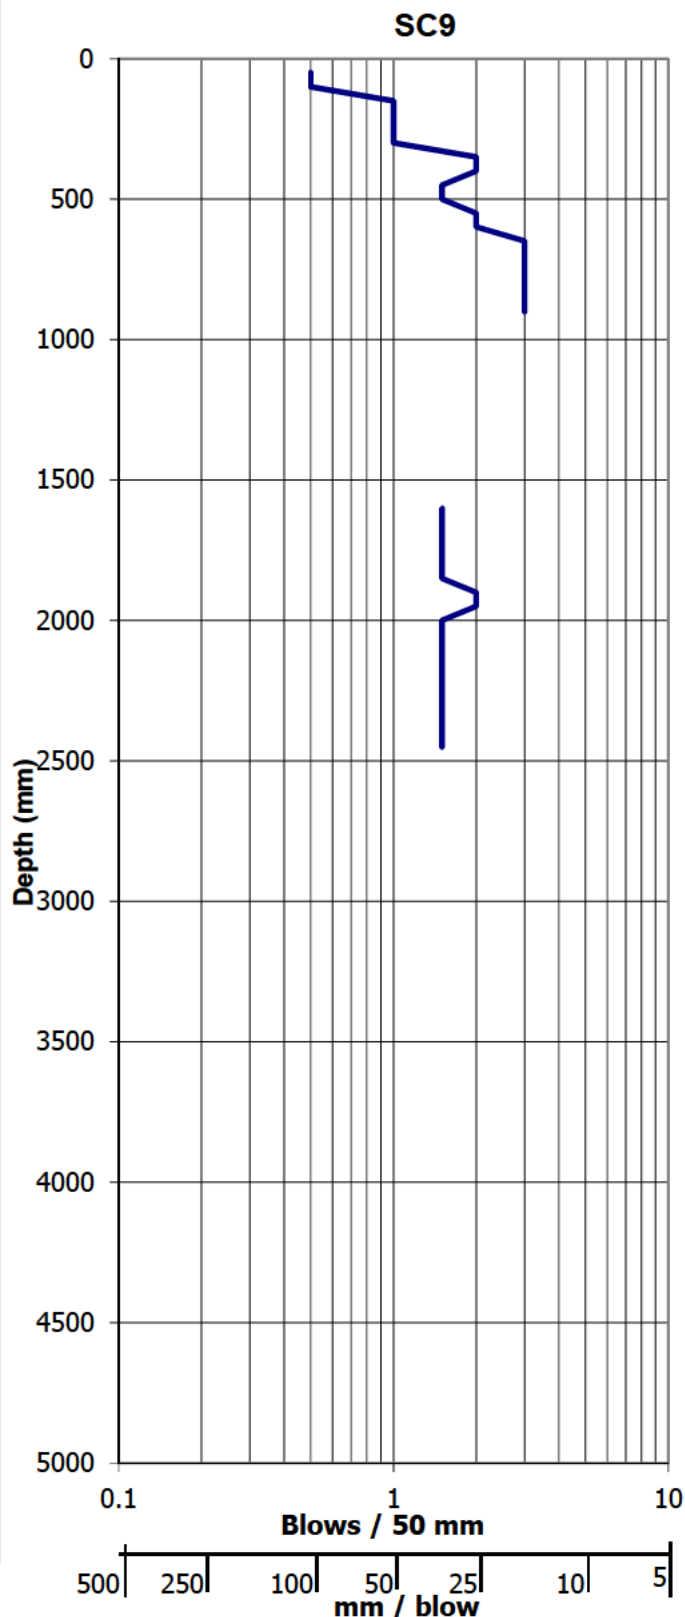
SC9	
mm Driven	No. of Blows
50	0.5
100	0.5
150	1
200	1
250	1
300	1
350	2
400	2
450	1.5
500	1.5
550	2
600	2
650	3
700	3
750	3
800	3
850	3
900	3
950	
1000	
1050	
1100	
1150	
1200	
1250	
1300	
1350	
1400	
1450	
1500	
1550	
1600	1.5
1650	1.5
1700	1.5
1750	1.5
1800	1.5
1850	1.5
1900	2
1950	2
2000	1.5
2050	1.5
2100	1.5
2150	1.5
2200	1.5
2250	1.5
2300	1.5
2350	1.5
2400	1.5
2450	1.5
2500

Test Method Used: NZS 4402:1988 Test 6.5.2 Dynamic Cone Penetrometer

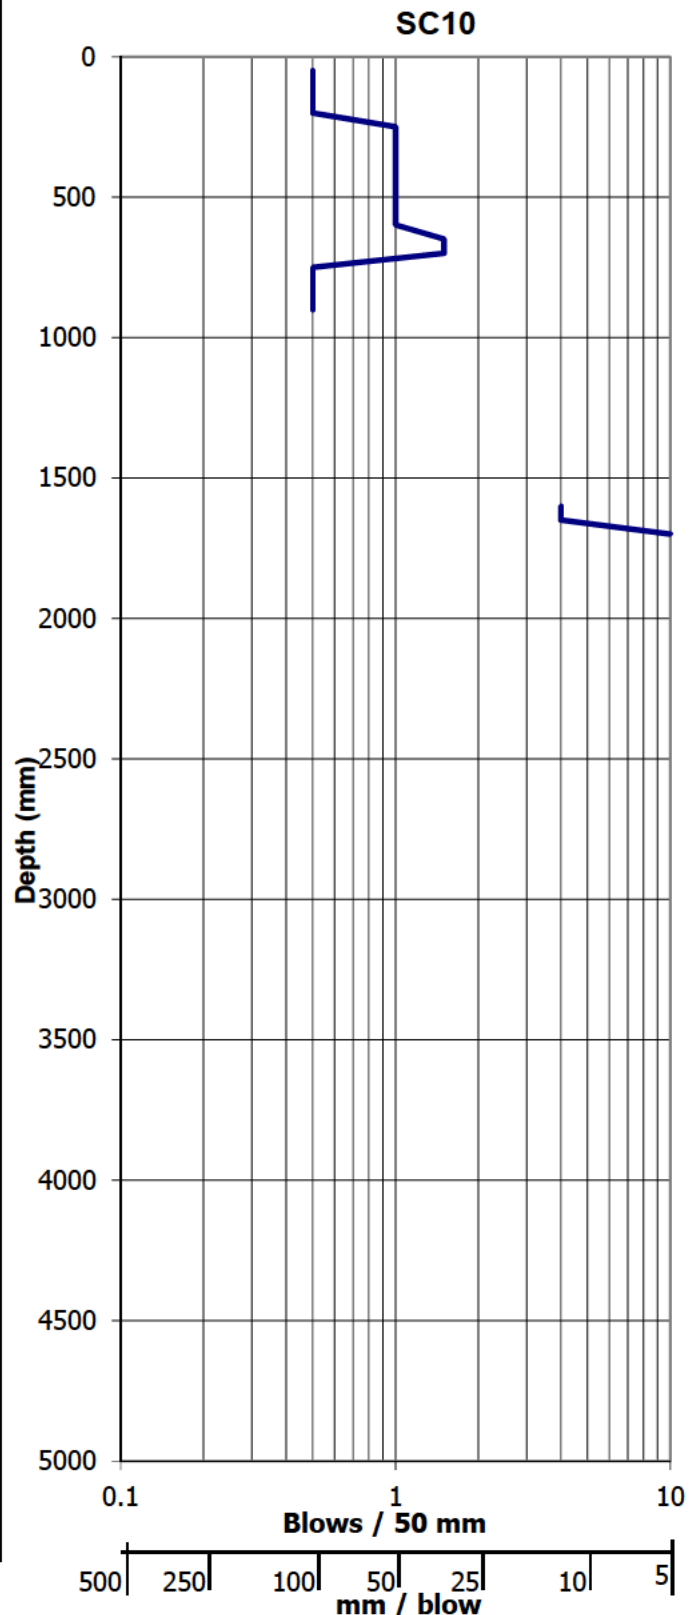
SC10	
mm Driven	No. of Blows
50	0.5
100	0.5
150	0.5
200	0.5
250	1
300	1
350	1
400	1
450	1
500	1
550	1
600	1
650	1.5
700	1.5
750	0.5
800	0.5
850	0.5
900	0.5
950	
1000	
1050	
1100	
1150	
1200	
1250	
1300	
1350	
1400	
1450	
1500	
1550	
1600	4
1650	4
1700	10
1750	
1800	
1850	
1900	
1950	
2000	
2050	
2100	
2150	
2200	
2250	
2300	
2350	
2400	
2450	
2500

Test Method Used: NZS 4402:1988 Test 6.5.2 Dynamic Cone Penetrometer

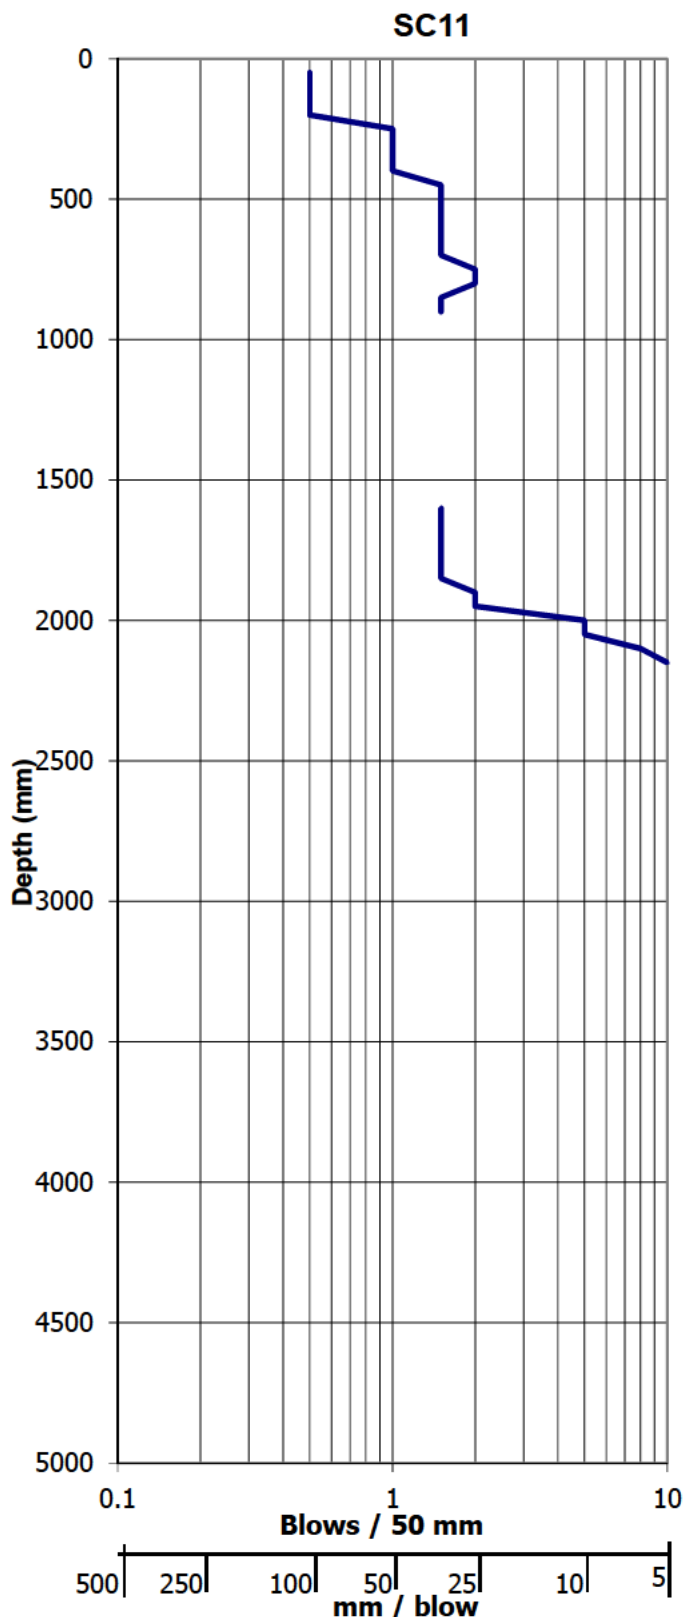
SC11	
mm Driven	No. of Blows
50	0.5
100	0.5
150	0.5
200	0.5
250	1
300	1
350	1
400	1
450	1.5
500	1.5
550	1.5
600	1.5
650	1.5
700	1.5
750	2
800	2
850	1.5
900	1.5
950	
1000	
1050	
1100	
1150	
1200	
1250	
1300	
1350	
1400	
1450	
1500	
1550	
1600	1.5
1650	1.5
1700	1.5
1750	1.5
1800	1.5
1850	1.5
1900	2
1950	2
2000	5
2050	5
2100	8
2150	10
2200	
2250	
2300	
2350	
2400	
2450	
2500

Test Method Used: NZS 4402:1988 Test 6.5.2 Dynamic Cone Penetrometer

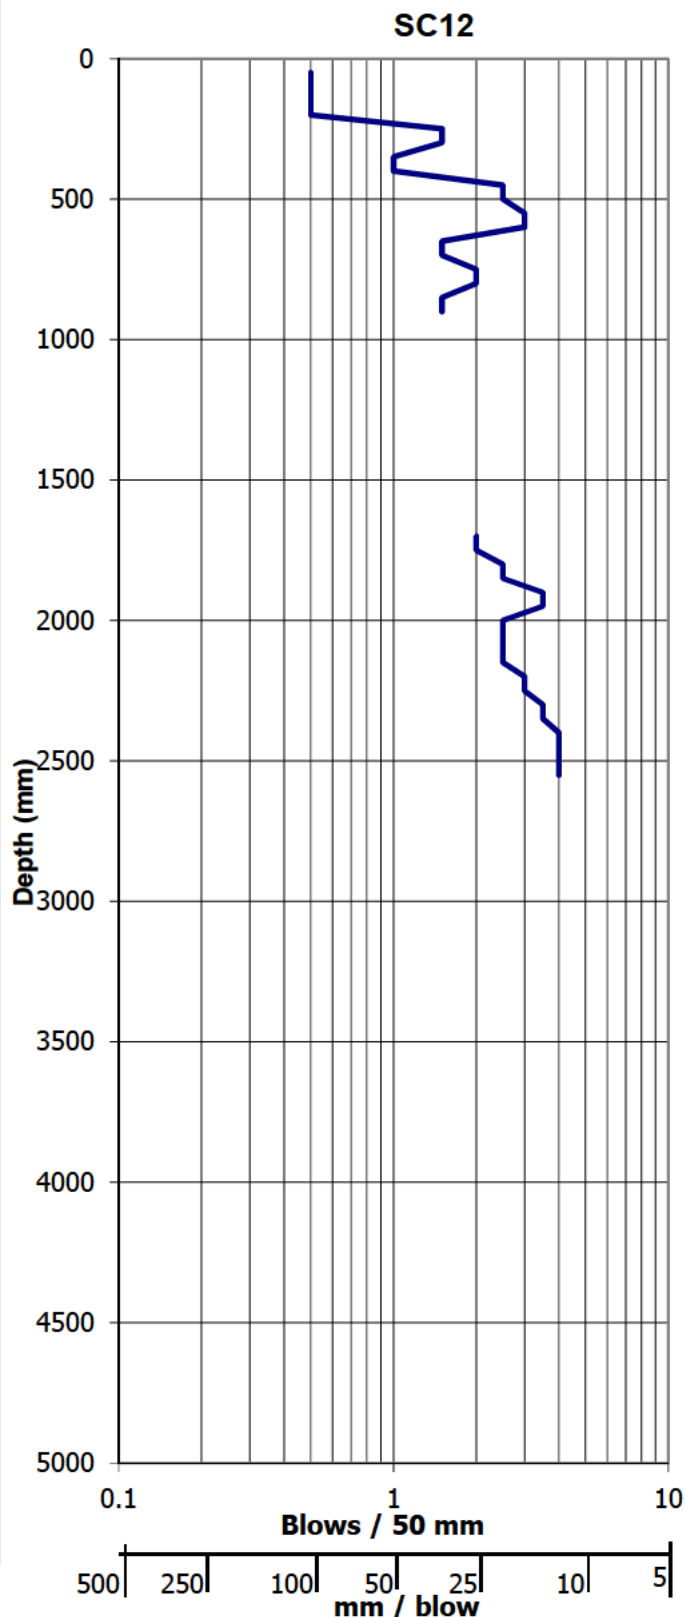
SC12	
mm Driven	No. of Blows
50	0.5
100	0.5
150	0.5
200	0.5
250	1.5
300	1.5
350	1
400	1
450	2.5
500	2.5
550	3
600	3
650	1.5
700	1.5
750	2
800	2
850	1.5
900	1.5
950	
1000	
1050	
1100	
1150	
1200	
1250	
1300	
1350	
1400	
1450	
1500	
1550	
1600	
1650	
1700	2
1750	2
1800	2.5
1850	2.5
1900	3.5
1950	3.5
2000	2.5
2050	2.5
2100	2.5
2150	2.5
2200	3
2250	3
2300	3.5
2350	3.5
2400	4
2450	4
2500	4

Test Method Used: NZS 4402:1988 Test 6.5.2 Dynamic Cone Penetrometer

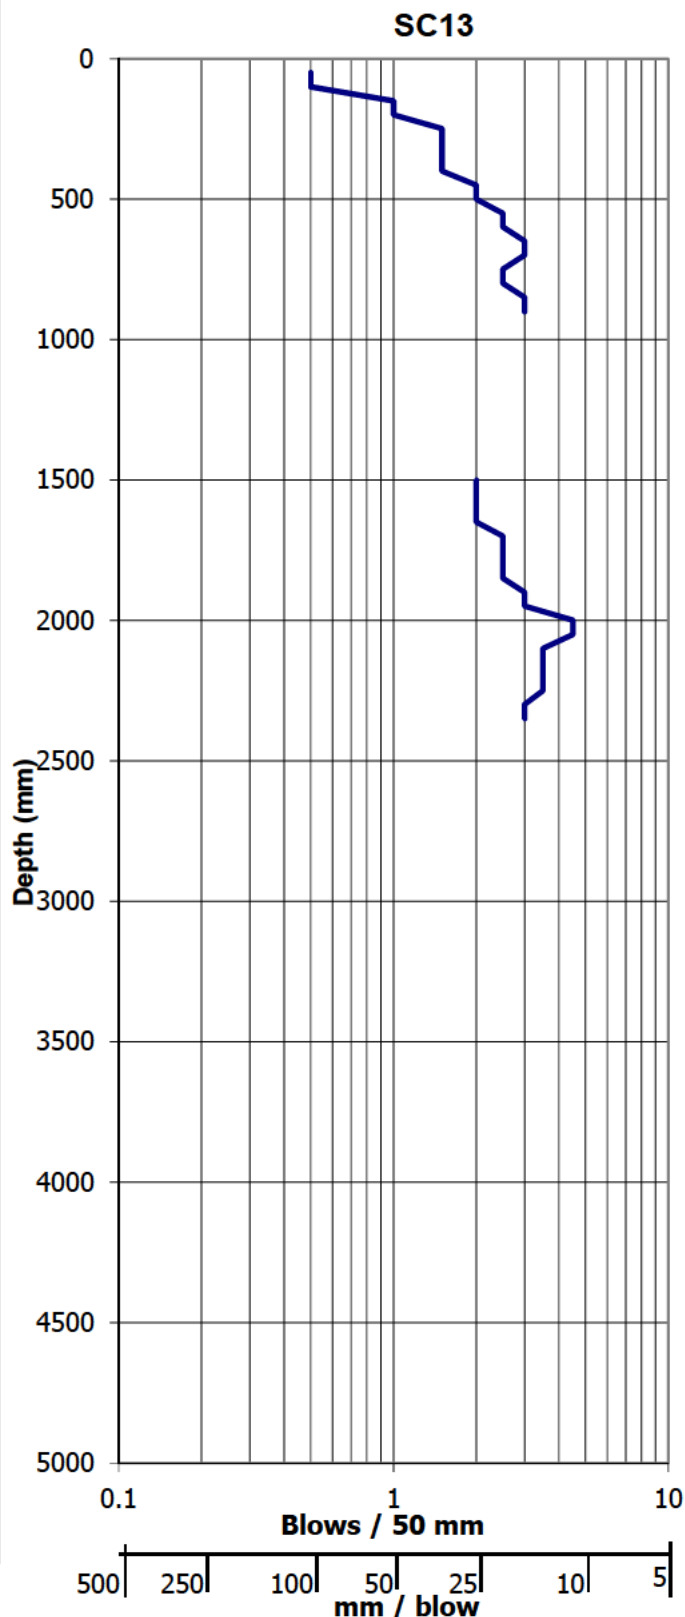
SC13	
mm Driven	No. of Blows
50	0.5
100	0.5
150	1
200	1
250	1.5
300	1.5
350	1.5
400	1.5
450	2
500	2
550	2.5
600	2.5
650	3
700	3
750	2.5
800	2.5
850	3
900	3
950	
1000	
1050	
1100	
1150	
1200	
1250	
1300	
1350	
1400	
1450	
1500	2
1550	2
1600	2
1650	2
1700	2.5
1750	2.5
1800	2.5
1850	2.5
1900	3
1950	3
2000	4.5
2050	4.5
2100	3.5
2150	3.5
2200	3.5
2250	3.5
2300	3
2350	3
2400	
2450	
2500

Test Method Used: NZS 4402:1988 Test 6.5.2 Dynamic Cone Penetrometer

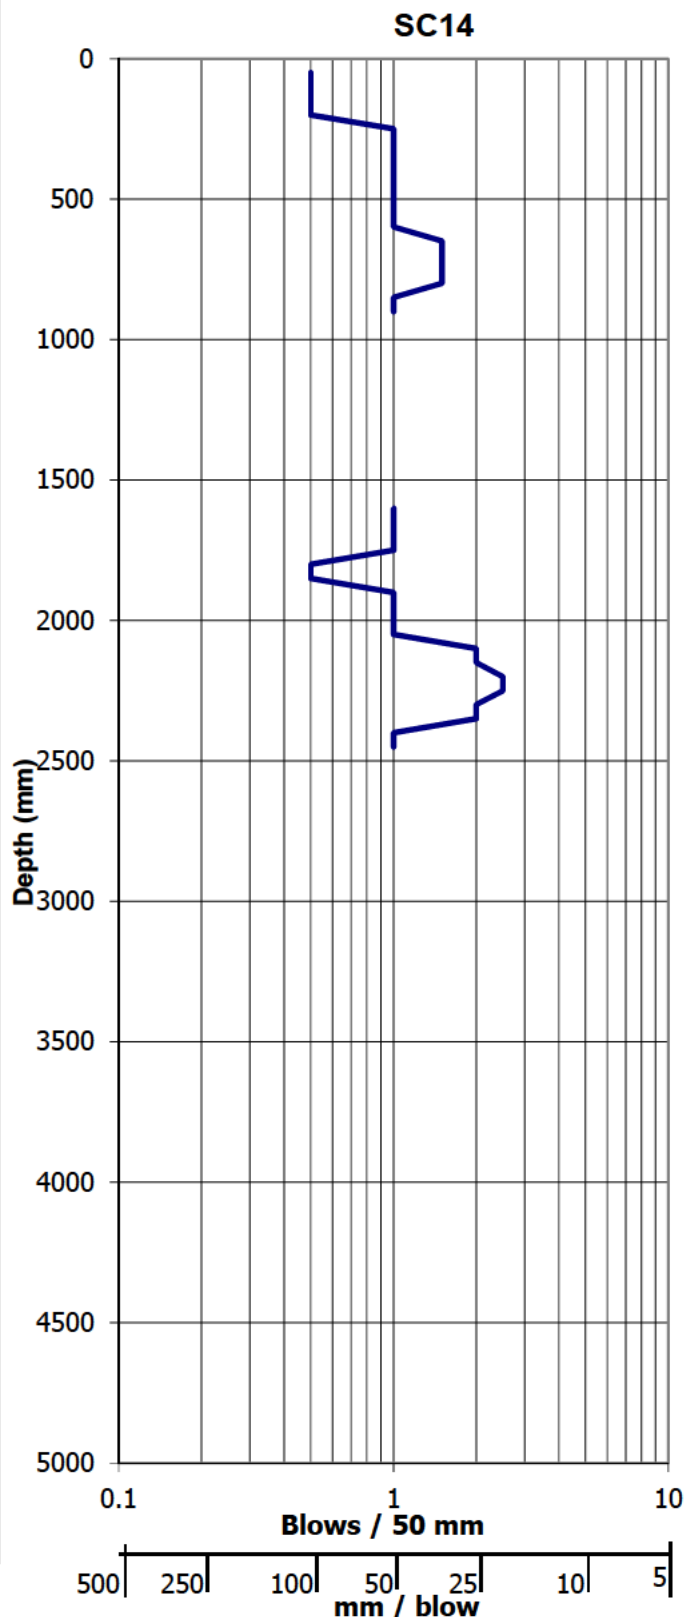
SC14	
mm Driven	No. of Blows
50	0.5
100	0.5
150	0.5
200	0.5
250	1
300	1
350	1
400	1
450	1
500	1
550	1
600	1
650	1.5
700	1.5
750	1.5
800	1.5
850	1
900	1
950	
1000	
1050	
1100	
1150	
1200	
1250	
1300	
1350	
1400	
1450	
1500	
1550	
1600	1
1650	1
1700	1
1750	1
1800	0.5
1850	0.5
1900	1
1950	1
2000	1
2050	1
2100	2
2150	2
2200	2.5
2250	2.5
2300	2
2350	2
2400	1
2450	1
2500

Test Method Used: NZS 4402:1988 Test 6.5.2 Dynamic Cone Penetrometer

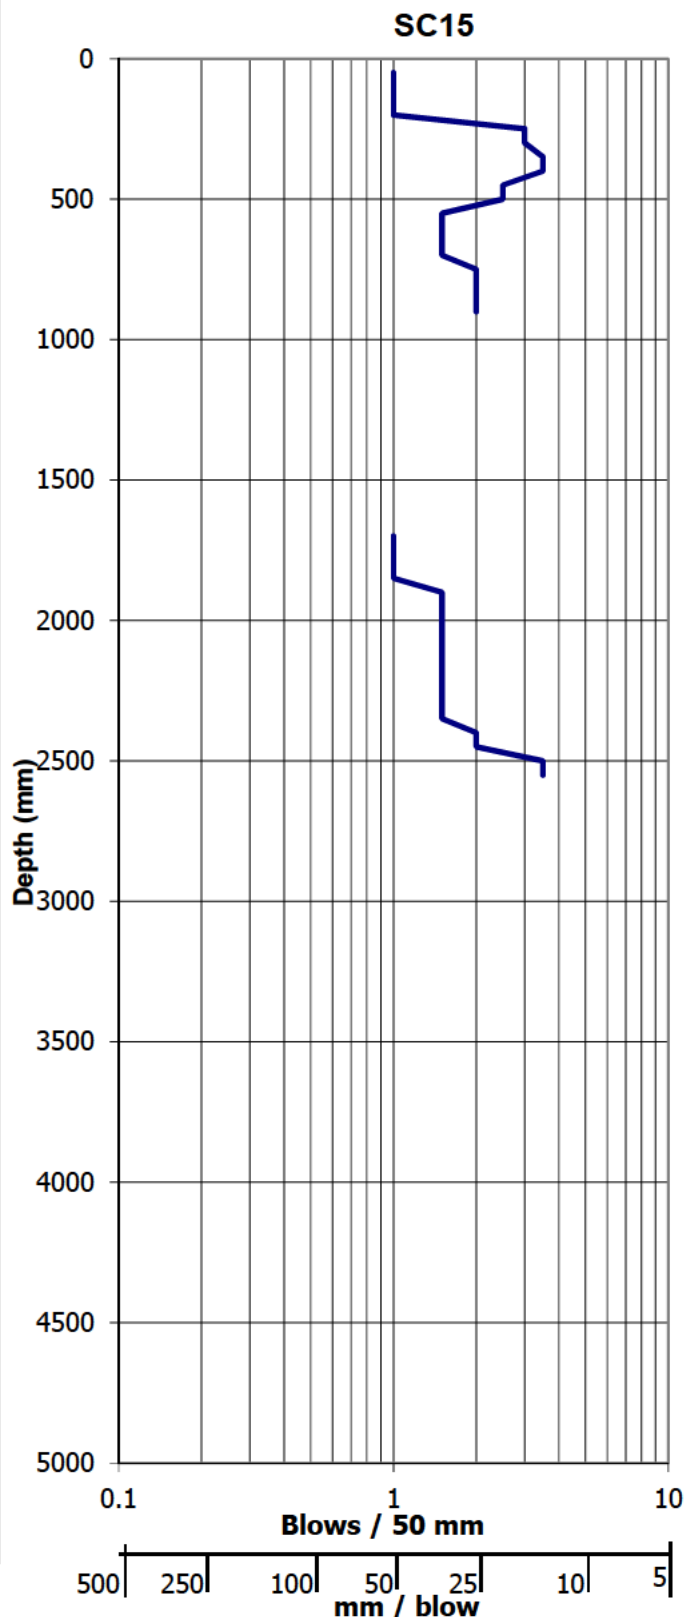
SC15	
mm Driven	No. of Blows
50	1
100	1
150	1
200	1
250	3
300	3
350	3.5
400	3.5
450	2.5
500	2.5
550	1.5
600	1.5
650	1.5
700	1.5
750	2
800	2
850	2
900	2
950	
1000	
1050	
1100	
1150	
1200	
1250	
1300	
1350	
1400	
1450	
1500	
1550	
1600	
1650	
1700	1
1750	1
1800	1
1850	1
1900	1.5
1950	1.5
2000	1.5
2050	1.5
2100	1.5
2150	1.5
2200	1.5
2250	1.5
2300	1.5
2350	1.5
2400	2
2450	2
2500	3.5

Test Method Used: NZS 4402:1988 Test 6.5.2 Dynamic Cone Penetrometer
