Te Tapuae/Southern Corridor

Liquefaction Hazard Assessment

Prepared for Queenstown Lakes District Council

Prepared by Beca Limited

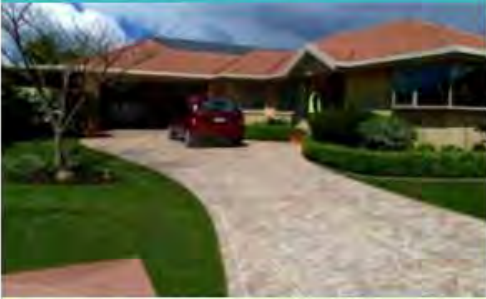
<ul style="list-style-type: none">– None to Minor no signs of ejected liquefied material at the ground surface¹.– No more than minor differential settlement of the ground surface (eg undulations less than 25 mm in height).– No apparent lateral spreading ground movement (eg only hairline ground cracks).– Liquefaction causes no or only cosmetic damage to buildings and infrastructure (but damage may still occur due to other earthquake effects).
<div>Minor to Moderate</div>

Figure 4-3: Degrees of liquefaction-induced ground damage from MBIE (2017).

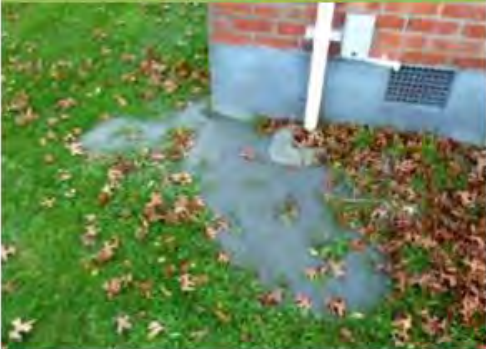
<ul style="list-style-type: none">– Minor to Moderate quantities of ejected liquefied material at the ground surface (eg less than 25 percent of a typical residential site covered²); and/or– Moderate differential settlement of the ground surface (eg undulations 25–100 mm in height).– No significant lateral spreading ground movement (eg ground cracks less than 50 mm wide may be present, but pattern of cracking suggests the cause is primarily ground oscillation or settlement rather than lateral spreading).– Liquefaction causes moderate but typically repairable damage to buildings and infrastructure. Damage may be substantially less where liquefaction was addressed during design (eg enhanced foundations).

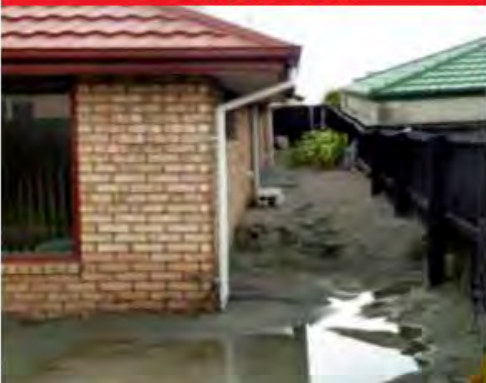
<ul style="list-style-type: none">– Large quantities of ejected liquefied material at the ground surface (eg more than 25 percent of a typical residential site covered²); and/or– Moderate to Severe differential settlement of the ground surface (eg undulations more than 100 mm in height); and/or– Significant lateral spreading ground movement (eg ground cracks greater than 50 mm wide, with pattern of cracking suggesting direction of movement downslope or towards a free-face).– Liquefaction causes substantial damage and disruption to buildings and infrastructure, and repair may be difficult or uneconomic in some cases. Damage may be substantially less, and more likely to be repairable, where liquefaction was addressed during design (eg enhanced foundations and robust infrastructure detailing).

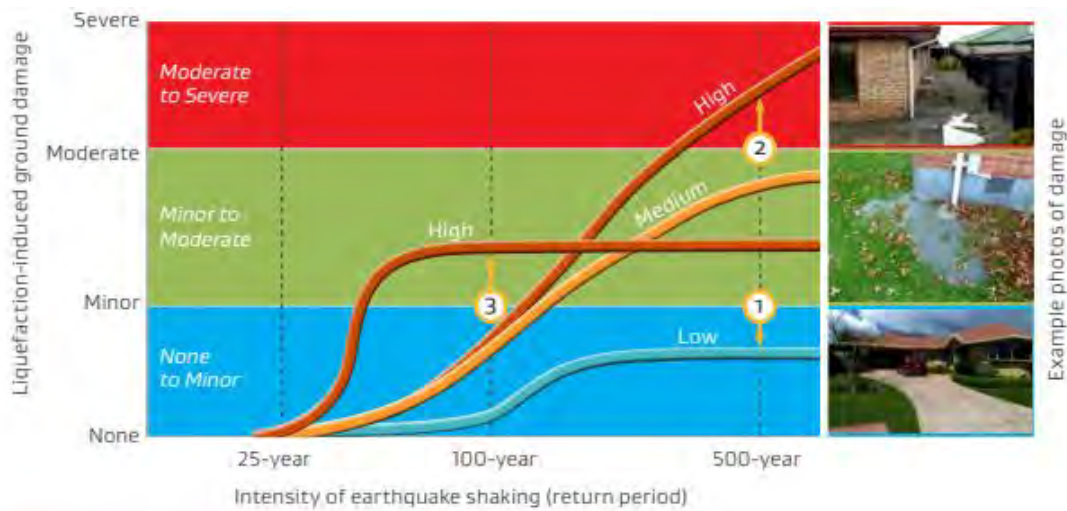
Performance criteria for liquefaction categorisation

Select the highest category from these three criteria. If none apply then the liquefaction vulnerability category is **Medium**

Representative liquefaction vulnerability categories were assigned to each geotechnical investigation using the predicted liquefaction-induced ground damage for the 500-year and 100-year earthquake return period assessments and performance criteria outlined in Table 4-4, Figure 4-7, and Figure 4-8. The adopted liquefaction vulnerability category assigned to each geotechnical investigation is listed in Table 4-5 along with the corresponding predicted land damage. The predicted liquefaction-induced ground damage is coloured according to the criteria set out in Table 4-4, and the assigned liquefaction vulnerability is coloured in accordance with Figure 4-2. Engineering judgement was applied where only part of the criteria set out in Table 4-4 was met. Emphasis was placed on the predicted ground surface settlements followed by LSN. Less emphasis was placed on LPI as these values were found to misalign with observed liquefaction following the Canterbury earthquakes. The assessed range of liquefaction vulnerabilities was used to inform the assessment of the Southern Corridor study area which is outlined in Section 5.

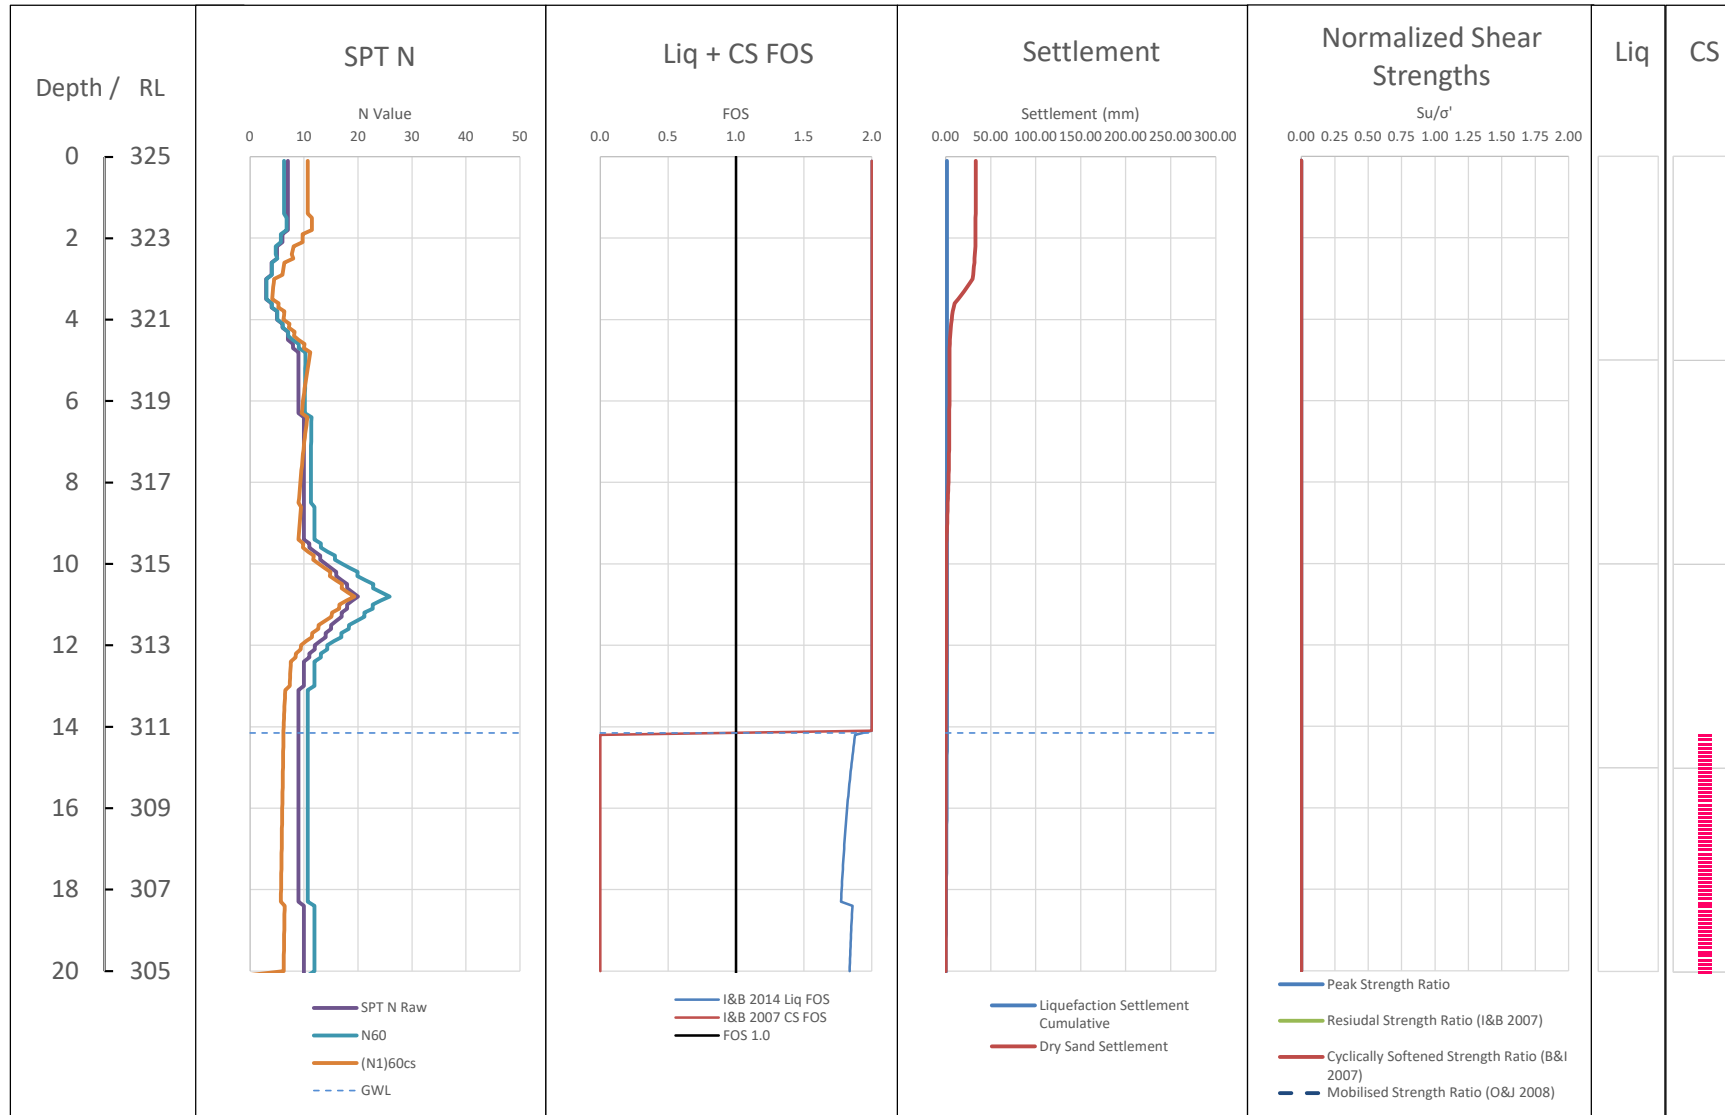
Project Summary	
Project Name	Tapuae/Southern Cor
Project Number	3161129
Unscaled PGA (g)	0.1
Magnitude	6.5
Liquefaction Settlement (mm)	1

Borehole Information	
BH ID:	22BH01
BH Depth (m):	20.0
Ground Level:	325
Water Level:	14.15
Fill:	0

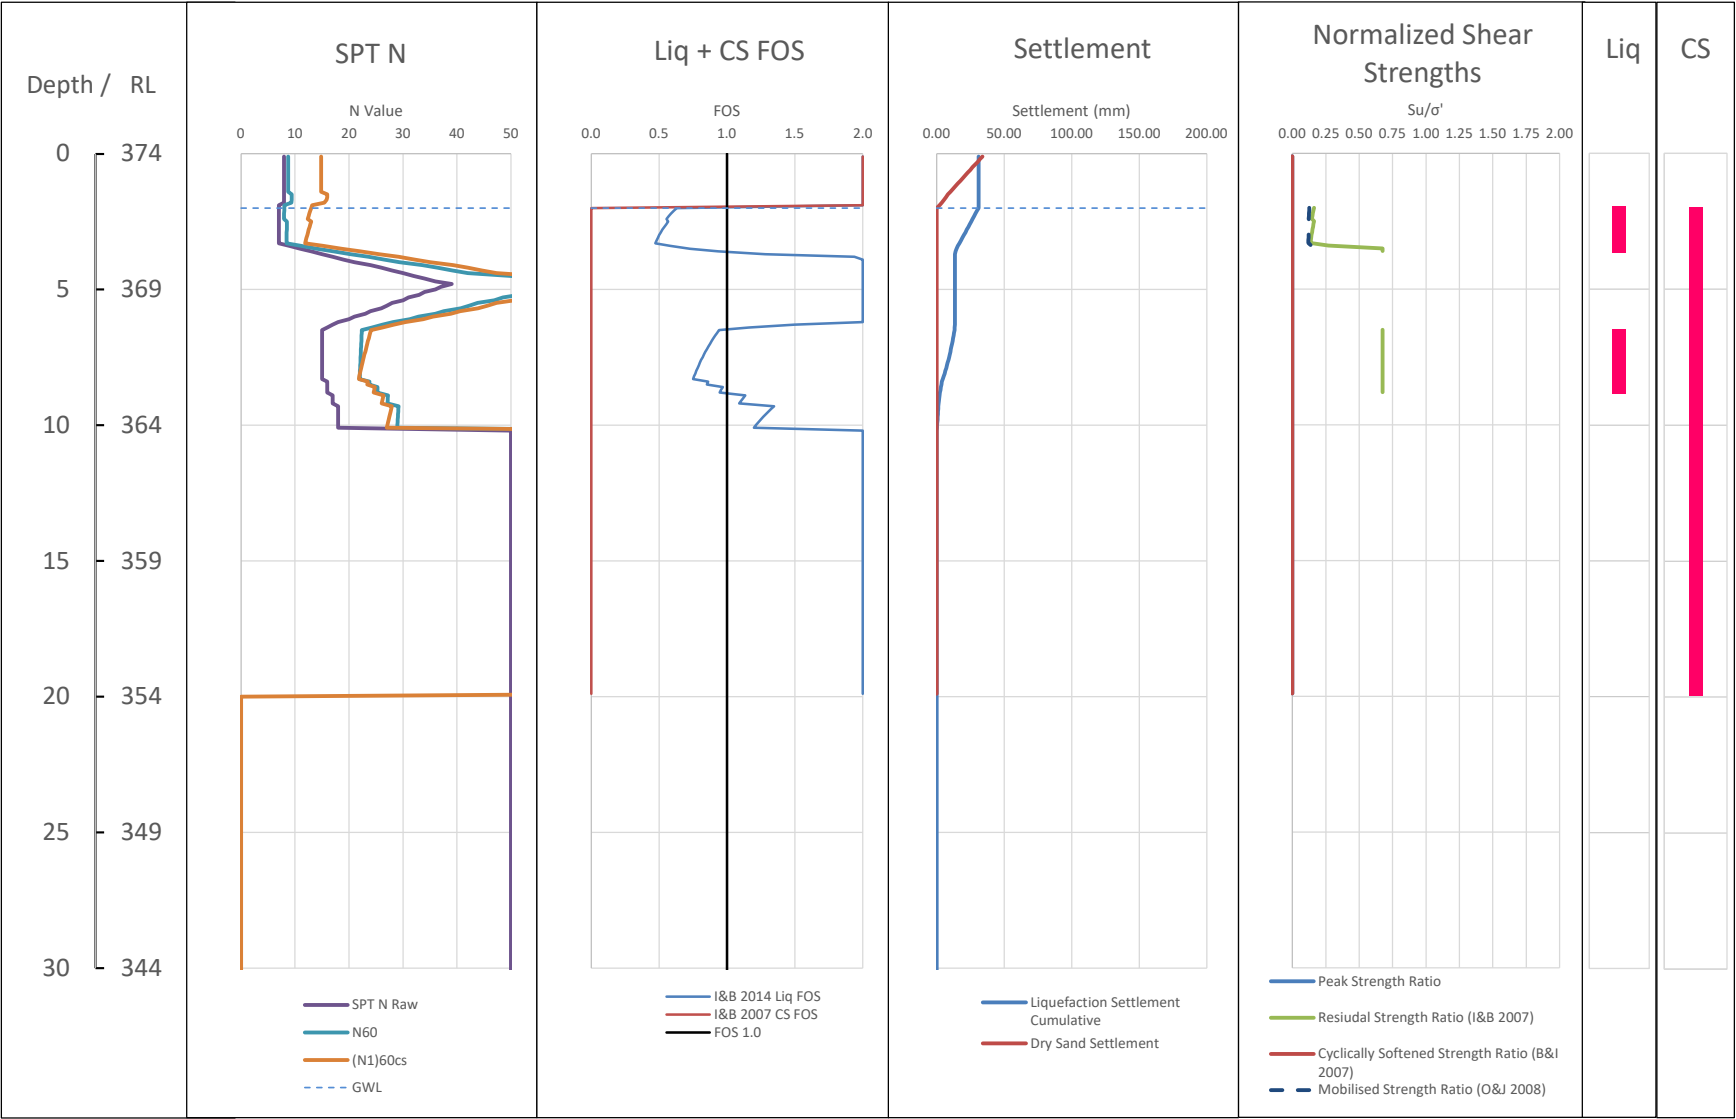
Project Summary	
Project Name	Tapuae/Southern Cor
Project Number	3161129
Unscaled PGA (g)	0.41
Magnitude	6.5
Liquefaction Settlement (mm)	31

Borehole Information	
BH ID:	solve 2024
BH Depth (m):	20.0
Ground Level:	374
Water Level:	2
Fill:	0
