## Powerhouse Fast-track Application

Zealandia Predator-free Fence Design

# Zealandia Te Māra a Tāne: Predator Exclusion Fence Design and Maintenance

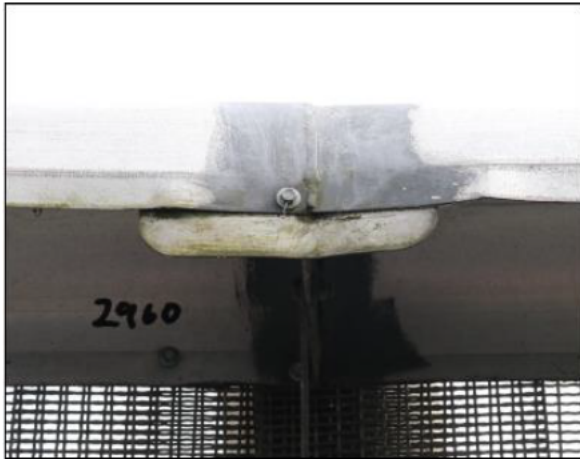
Image 1: Zinc blasted welded joint on the fence hood.

Where hood angles were welded, corrosion has occurred and if this becomes advanced it could provide purchase for animals or lead to other deterioration challenges. The solution to this issue has been to replace them with angles that had been zinc blast sprayed (shown on image to right).

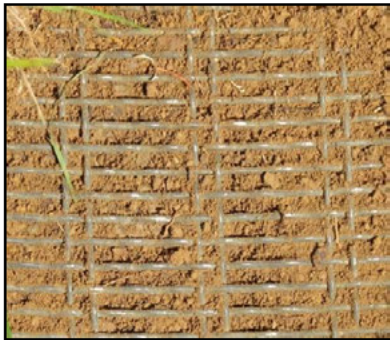
Section of the skirt uncovered for a fence audit.

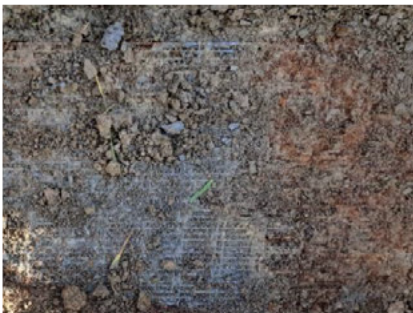
Image showing rust forming on skirt.

Due to surface erosion caused by runoff from the 4WD perimeter track outside the fence there are areas of exposed skirting—this poses a risk of cavities appearing, and can cause more rapid deterioration and rusting of the skirt itself.
