## Memorandum

To:  
Company: Auckland Council  
From: Pierre Verhaeghe  
Date: 14 April 2026 Project No: 145828.16  
Subject: Downtown Carpark Site Development | Environmental Winds | S67 RFI

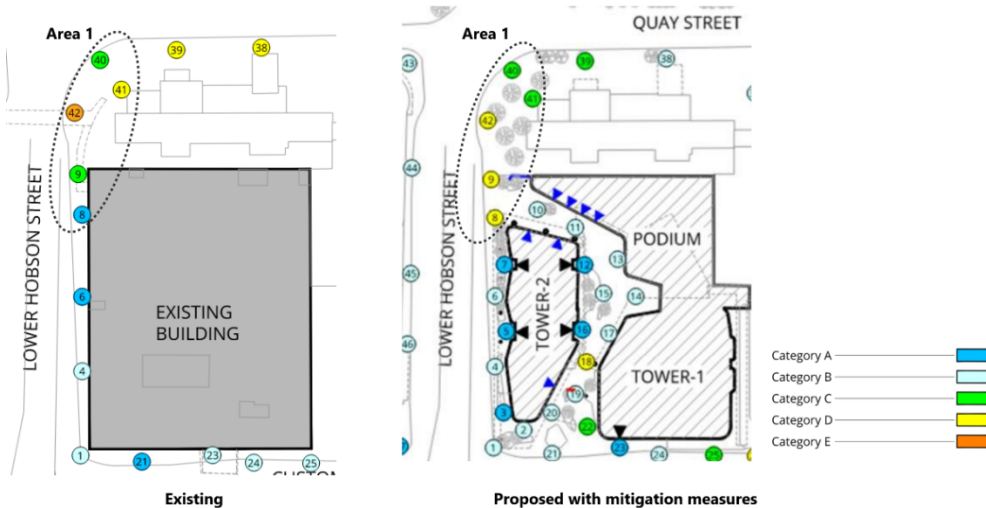
Figure 1: Wind Conditions in Area 1

- *AREA 1 (Sensor 8-9): Lower Hobson Street – North-west corner of P2.* Category D conditions are similar (or even calmer) to the existing conditions currently occurring slightly further north (Sensor 42). The effect of the proposed Development is therefore to shift the existing area of peak windiness occurring near M-Social slightly further south, closer to the corner of P2. In other words, the increase in windiness around Podium P2 is balanced by a reduction of windiness around M-Social (Sensor 42 and 41).

Alternative mitigation measures have been assessed in several wind tunnel tests and in collaboration with the design team, as reported in Appendix A of the Holmes report. It was clearly established from that testing that larger canopies or other potentially feasible measures on site were not found to be effective in improving conditions in Area 1 further. Wind mitigation measures need to be positioned at the north end of Lower Hobson.

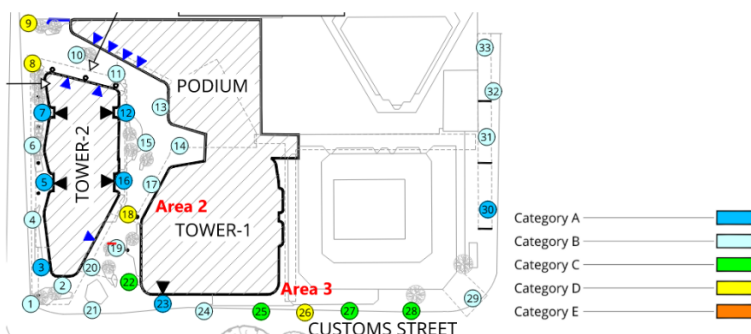
Figure 2: Wind Conditions in Area 2&3

- AREA 2 - Throat between P1 and P2 (Sensor 18).** The conditions are categorised as Category D but the exceedance of the threshold is marginal only, i.e. conditions are almost in Category C. These conditions are local only, i.e. conditions either side of the throat improve significantly. We also confirm this area is for pedestrian transit and is not considered sensitive for comfort. Again, various additional screens were investigated with no effect (Appendix A of Holmes report). Our conclusion was that only further screens specifically located at the throat would improve conditions more, which would not allow pedestrians' movement, and therefore were not feasible.

- AREA 3 – P1 south-east corner Custom Street (Sensor 26).** The Category D area is very local and conditions immediately either side (Sensor 25 and 27) are in Category C. This is not considered a significant effect, given that the use of this footpath space is for walking only.

As above, we confirm that the narrowest section of Urban Room is primarily for pedestrian transit. It is considered acceptable as conditions improve significantly either side of the throat. As above, alternative mitigation measures were considered but were not found to be effective. The conclusion was that additional mitigation on the north or south side of the throat would not improve the local conditions unless positioned exactly under the bridge and impeding pedestrian movement, which was not considered feasible.
