# Beachlands South Fast-Track Application

## Geotechnical Report

Tonkin & Taylor Ltd

1014358.3200 v1.2

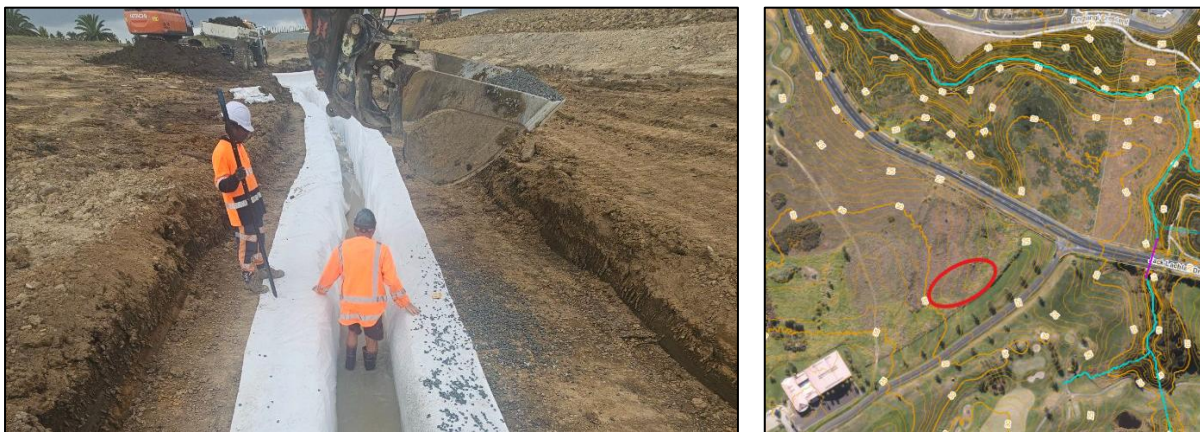
Figure 3.3:

*LEFT: Outflow of groundwater from an intercepted perched lens of groundwater in the Stage 1 area, February 2026. Flow was initially strong (as shown), but reduced to a trickle the next morning.*

As an example, perched groundwater that was encountered during Stage 1 earthworks in February 2026 near the golf course entrance encountered an initially strong flow of groundwater (Figure 3.3) when it was encountered mid-afternoon, but it reduced to a trickle by the following morning, i.e. confirming that the groundwater was perched and of limited volume. At this particular location, the ground level of approximately 27mRL is well above the elevation of the gully to the immediate north at 16mRL, dropping to the permanent stream at 8mRL.

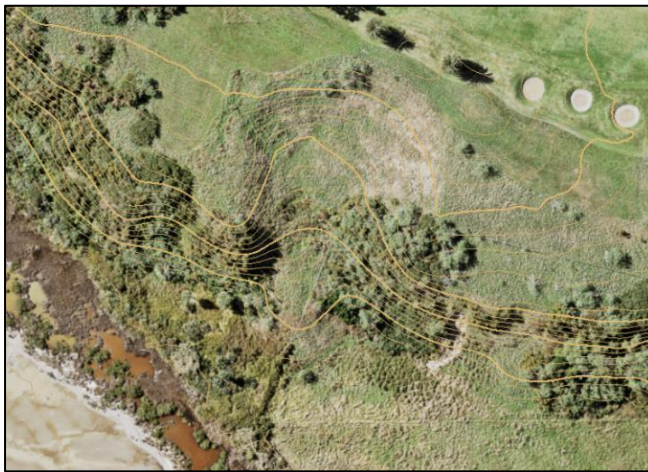
Figure 4.2: Historical landslide at the south-western edge of the proposed Coastal sub-precinct

A slip feature is located at the south-western edge of the proposed Coastal sub-precinct (Figure 4.2), where a semi-circular evacuated feature is evident. The geomorphology suggests this may be a drainage pathway, which on regression has instigated mass movement. Stability of the slopes along the coastline are discussed in Section 4.3.7 of this report. This slope has been modelled as Section 6.

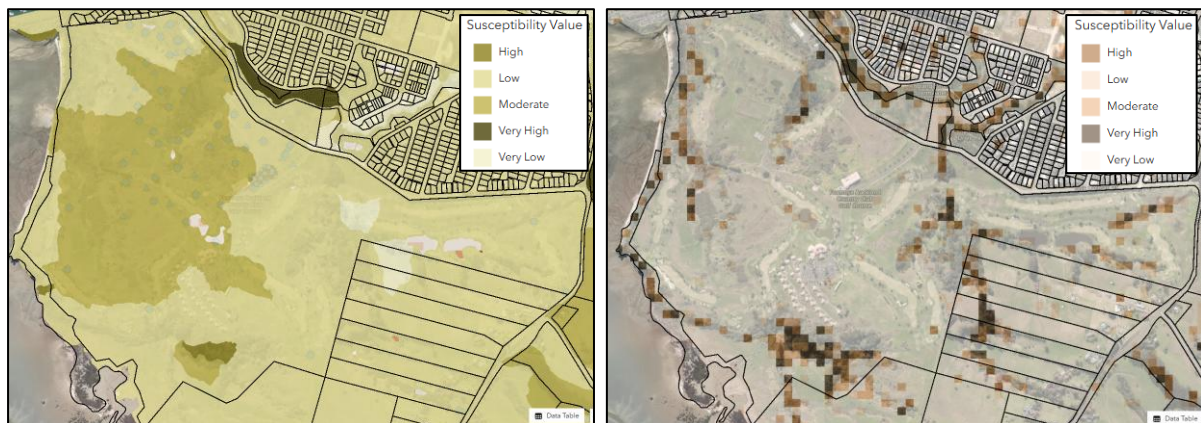
Figure 4.5: Auckland Council PC120 landslide hazard maps (Left: large-scale; Right: shallow instability)

In terms of PC120, both the large-scale and shallow landslide susceptibility maps (Figure 4.5) indicate that the Site generally presents a low to moderate landslide hazard prior to earthworking (with the exception of the gully area at the south, which will be set aside as an EPAN and will not be developed). The areas where moderate to very high shallow instability are indicated have been specifically analysed in Section 4.3 of this report. The analyses have identified that:

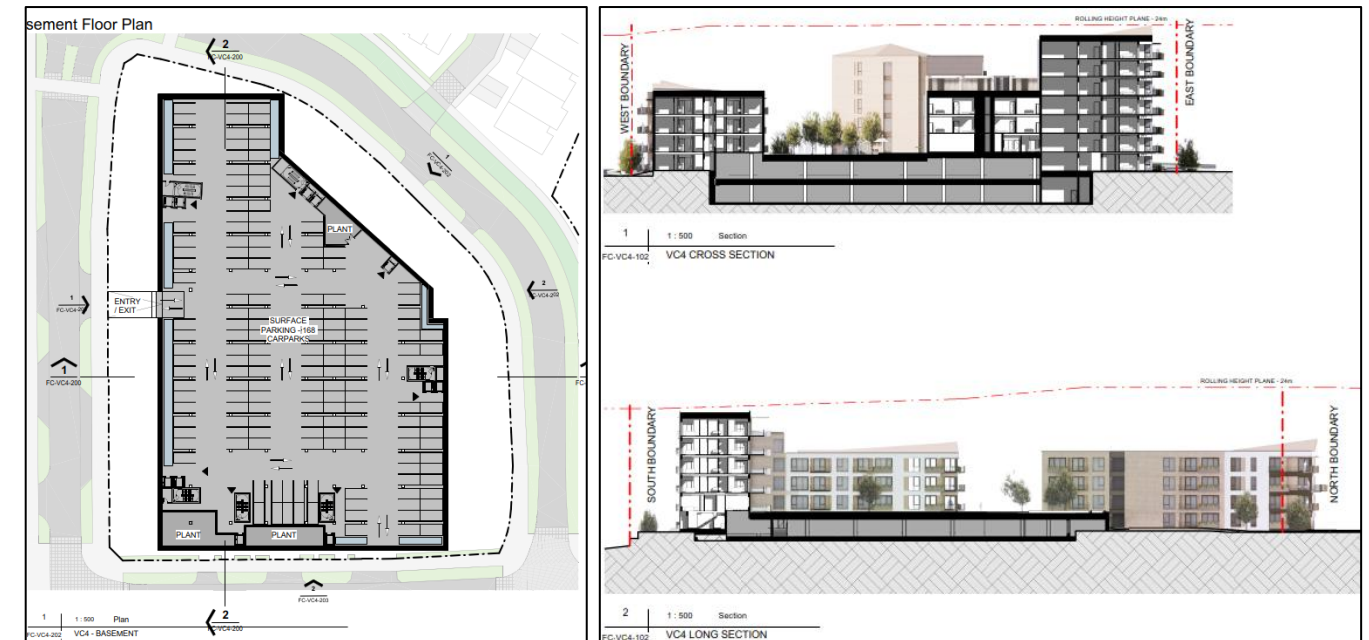
Figure 5.6: Concept plan and sections for the VC4 apartment basement (excerpt from drawings FC-VC4-105 & -200 rev A)

A carparking basement is proposed to service the overlying apartment buildings at VC4<sup>2</sup>, as shown in Figure 5.6.

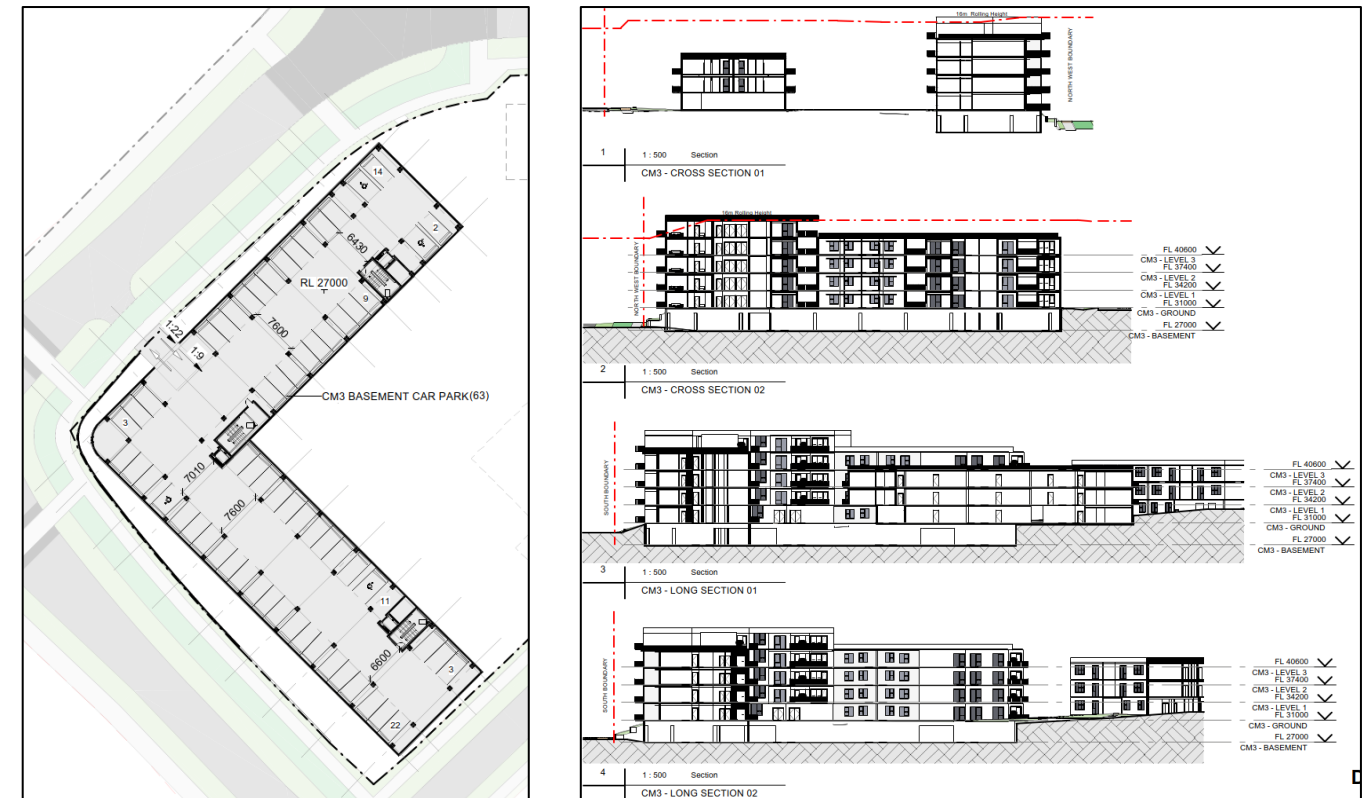
Figure 5.8: Concept plan and sections for the CM3 apartment basement (excerpt from drawings FC-CM3-105 & -200 rev A)

A carparking basement is proposed to service the overlying apartment buildings at CM3<sup>3</sup>, as shown in Figure 5.8.

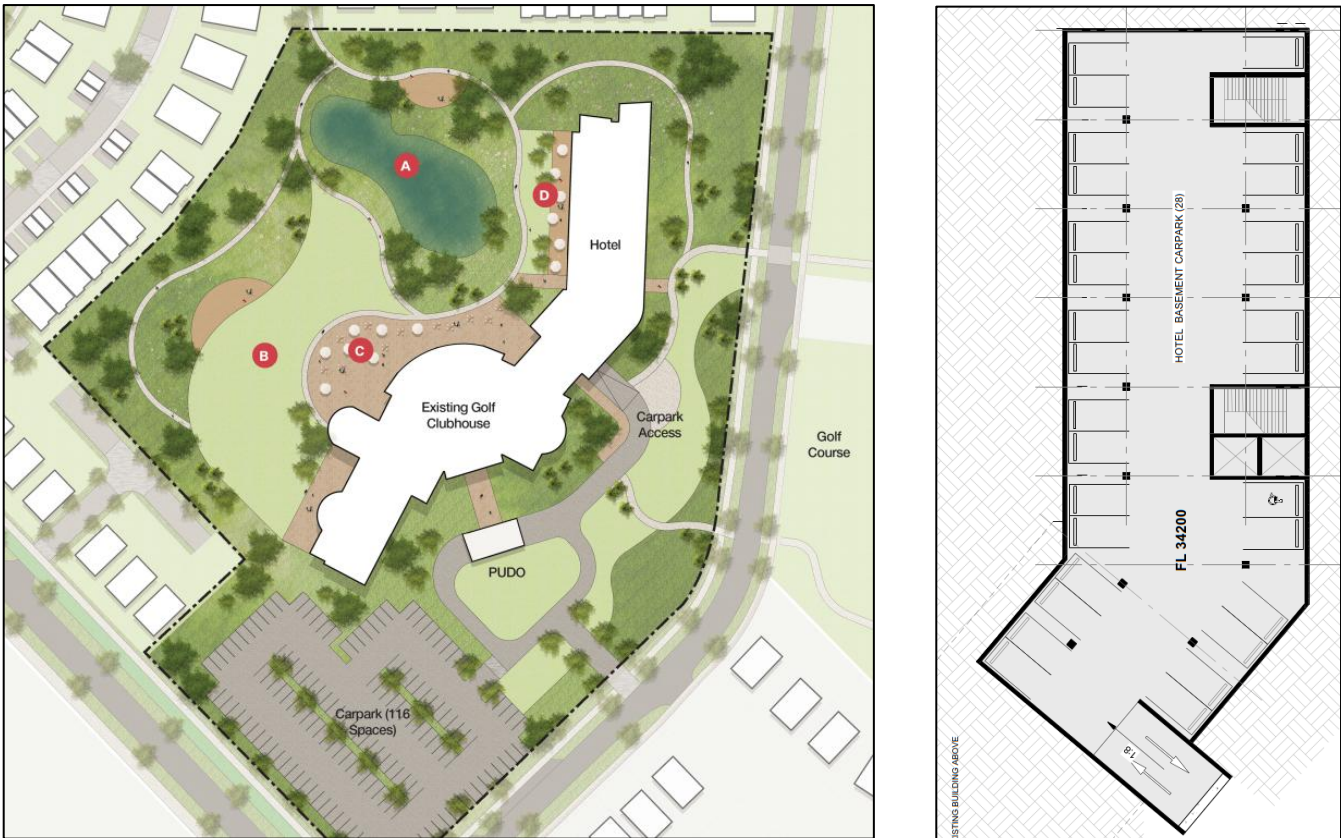
Figure 5.10: Concept plan for the CM5 hotel basement (excerpt from drawings FC-CM5-100 & -105 rev A)

A hotel<sup>3</sup> is proposed to be built as an extension of the existing clubhouse building, with a basement carpark, as shown in Figure 5.10. This area is currently beneath a pond, and bulk earthworks plans for this area propose general fill (Figure 5.11). The proposed basement will be constructed at FL 34.200 m, approximately 2 m below the estimated level of the existing pond bed (Figure 5.12).

Based on the investigations, the basement is likely to be founded in stiff to very stiff alluvial soils, across the centre of the basement, potentially transitioning to ECBF soils at the north and south; reflecting the original gully geology prior to landscaping for the golf course. Bulk earthworks will need to muck out any soft sediments in the base of the pond prior to placement of general fill. As noted in Section 5.2.5 of this report, subsoil drains should be used to intercept groundwater seepages in low areas and/or sandy soil lenses during bulk earthworks, which will help to mitigate against concentrated flows of perched water that could affect basement excavations. Subsoil drainage layout should be considered against the proposal for a permanent pond to the west of the new hotel (labelled “A” in Figure 5.10).

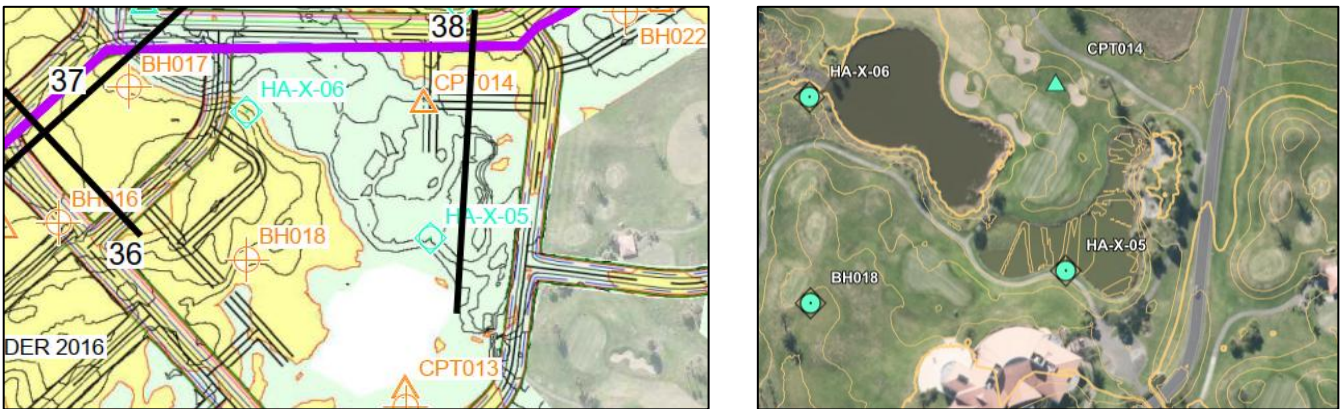
Figure 5.11: Site investigation location plans, and cross-section 38 location. Refer to Appendix J for the full plan

Hand auger borehole HA-X-05 was put down at the south of the existing pond (Figure 5.11), encountering stiff fill (silty fine to medium sand) over very stiff alluvial deposits (silty clay). CPT-014 to the north of the pond and the proposed hotel encountered stiff sandy silts and clays down to approximately 6 m depth, becoming very stiff below approximately 8 m depth, and hard below approximately 10 m depth. Groundwater is currently governed by the pond, which is inferred to create a general perched water table surrounding the pond, overlying a deeper regional groundwater table at the level of the surrounding gullies and sea level.

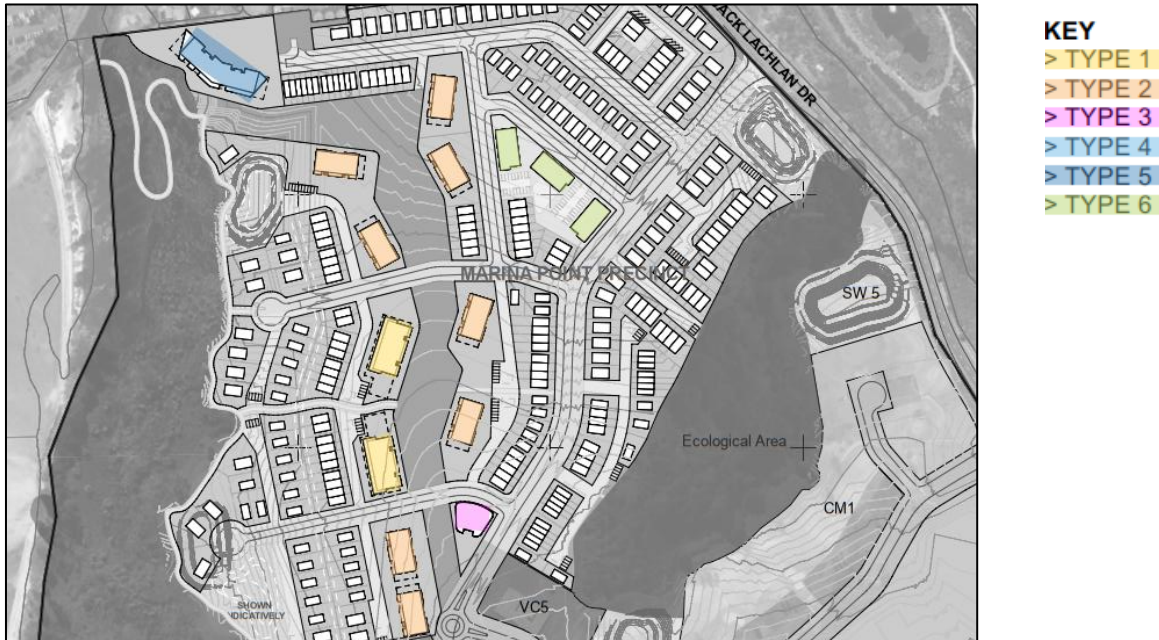
Figure 5.13: Conceptual locations of apartment buildings in the Marina Point Precinct. Excerpt from drawing 4655-WD.103<sup>4</sup>

Several apartment buildings are proposed for the Marina Point and Coastal Precincts, as shown in Figure 5.13 and Figure 5.14. Apartment Types 1 to 5 propose single-level or partial basements, whereas the smaller Type 6 apartments appear unlikely to require basement excavations (Figure 5.15).

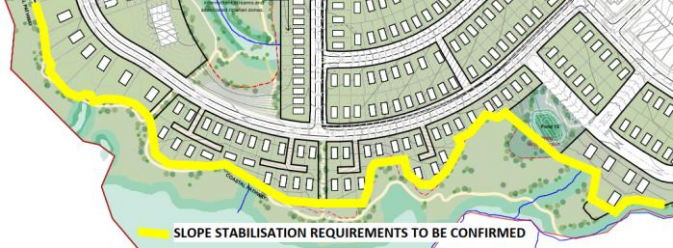
| Recommended resource consent conditions | Background |
|---|---|
| <p>Geotechnical stabilisation near the southern cliffs (shown below) should be confirmed at detailed design stage, to meet the Auckland Code of Practice for Land Development and Subdivision (Ref. [5]) requirements for slope stability.</p> | <p>Preliminary assessment indicates that slope stabilisation may be required in parts of this area (as detailed in Section 4.3.7 of this report). Stabilisation measures could comprise in-ground palisade piled walls or similar, potentially combined with earthworks and/or building setback lines. Supplementary site investigations including cored machine boreholes and measurement of perched groundwater would be required for design refinement.</p> |

For some parts of the southern cliff area (as identified on Geological Cross-Sections 7, 8 and 9), a reinforced concrete palisade pile wall will be required to provide long-term stabilisation of the slope and achieve the target FoS. The indicative location and extent of the wall, including a typical detail, are shown in Figure 1014358.3200–Figure 12 in Appendix E.
