# OLD GROWTH TREE MANAGEMENT PLAN

NZ Transport Agency Waka Kotahi  
Mill Road Stage 1

AUGUST 2026

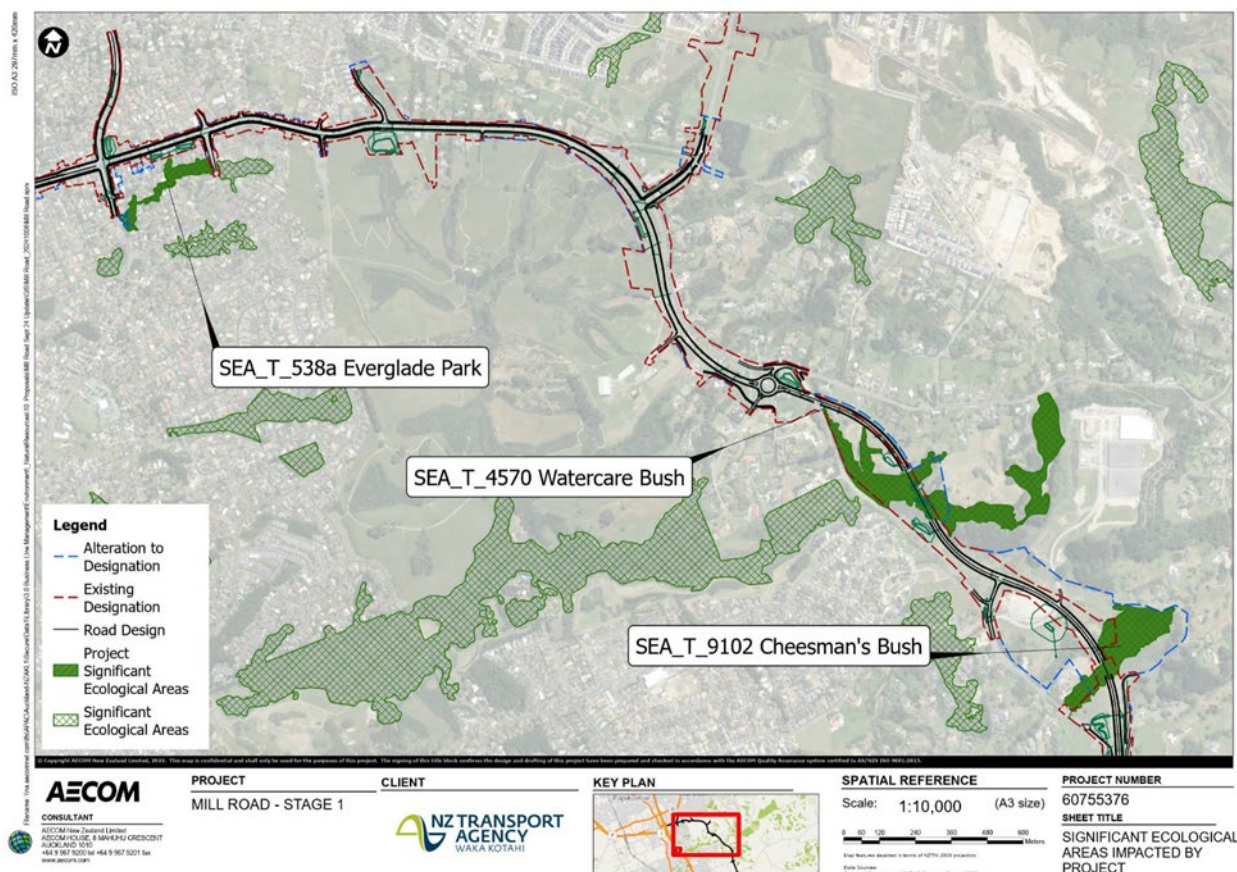
Figure 1 This OGTMP applies to the SEAs at Puhinui Gully/Watercare Bush and Cheesman's Bush. Although there is an area at Everglade Park which is an SEA, the location affected by the Project does not contain any Significant Trees and is not covered by this plan.

This Old Growth Tree Management Plan (**OGTMP**) has been prepared for the Mill Road Stage 1 Project (**the Project**). The OGTMP applies to works within the Significant Ecological Areas (**SEAs**) at Cheesman's Bush and Puhinui Gully (also known as the Watercare Bush) as shown in **Figure 1**.

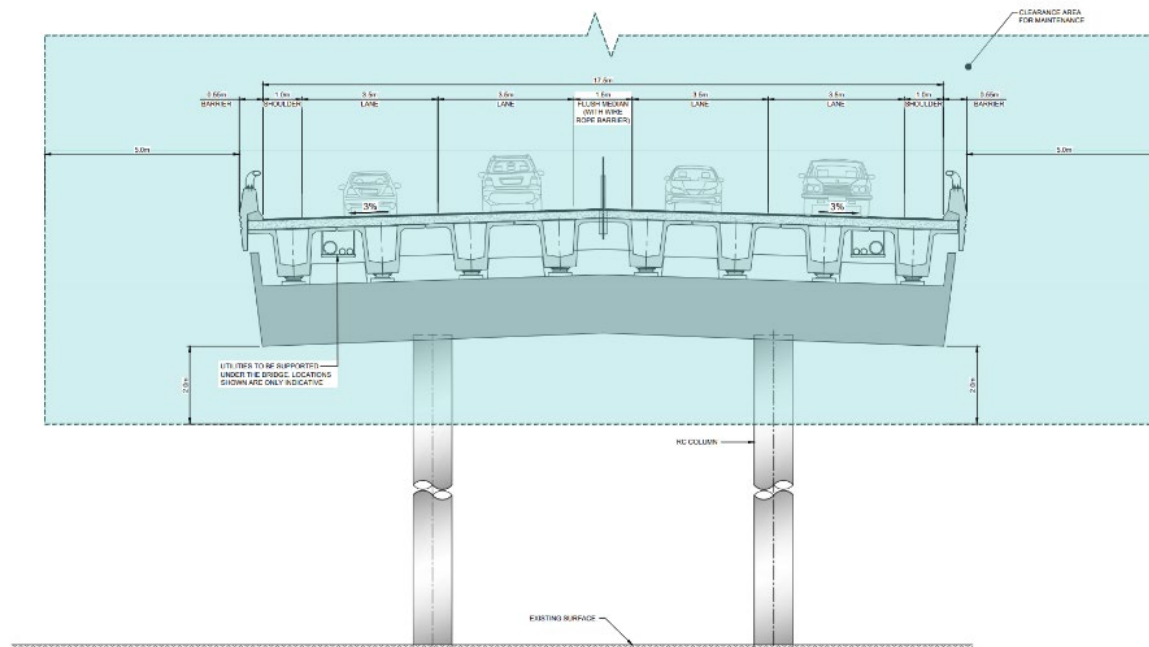
Figure 2 Image showing Bridge Maintenance Area for Puhinui Gully Bridge

A clearance space of 2m beneath the bridge deck is required to allow for a platform to be attached to the underside of each bridge for under-structure inspection and maintenance (anticipated to include graffiti removal, bridge beam bearing inspections and replacements, and tree canopy management).

This space is referred to as the Bridge Maintenance Area and is illustrated on Figures 2, 3, 4 and 5 and extends 5m either side of the bridge abutments. Ongoing pruning and trimming of the canopy for maintenance will be limited to ensuring that the tree canopy does not extend into this zone.

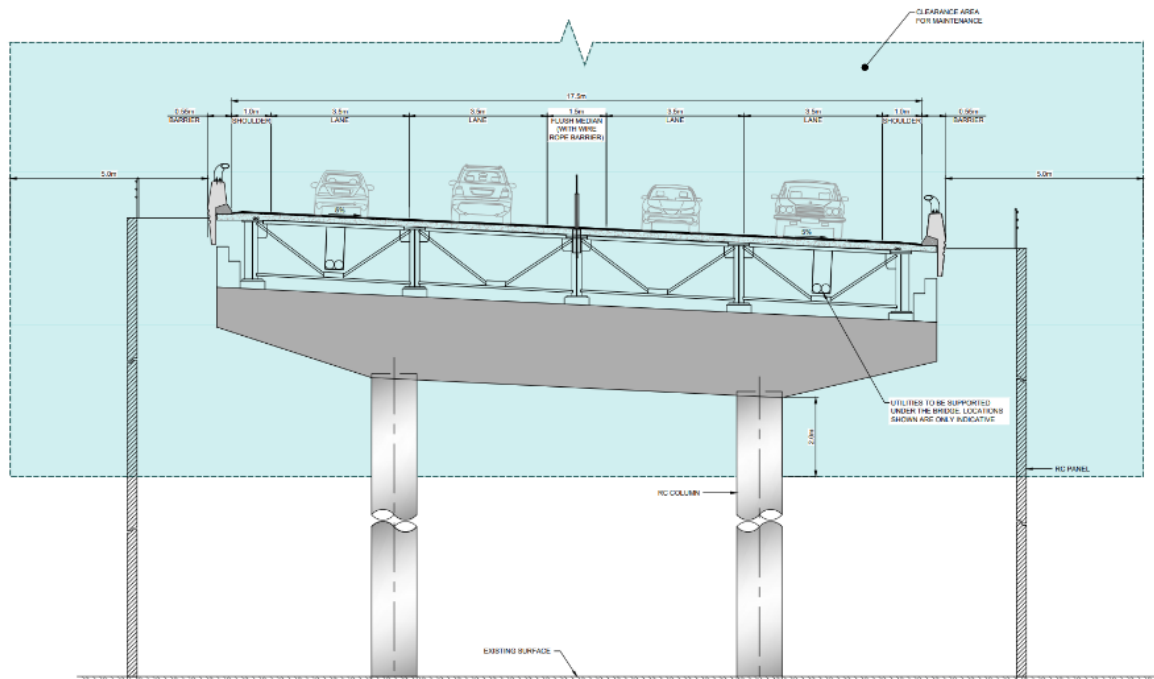
Figure 3 Image showing Bridge Maintenance Area for Cheesman's Bush Bridge
