# Remediation Action Plan: 92, 108, 148 Middle Road and 139 Te Aute Road

Prepared for  
CDL Land New Zealand Ltd

Carl O'Brien  
21 September 2026

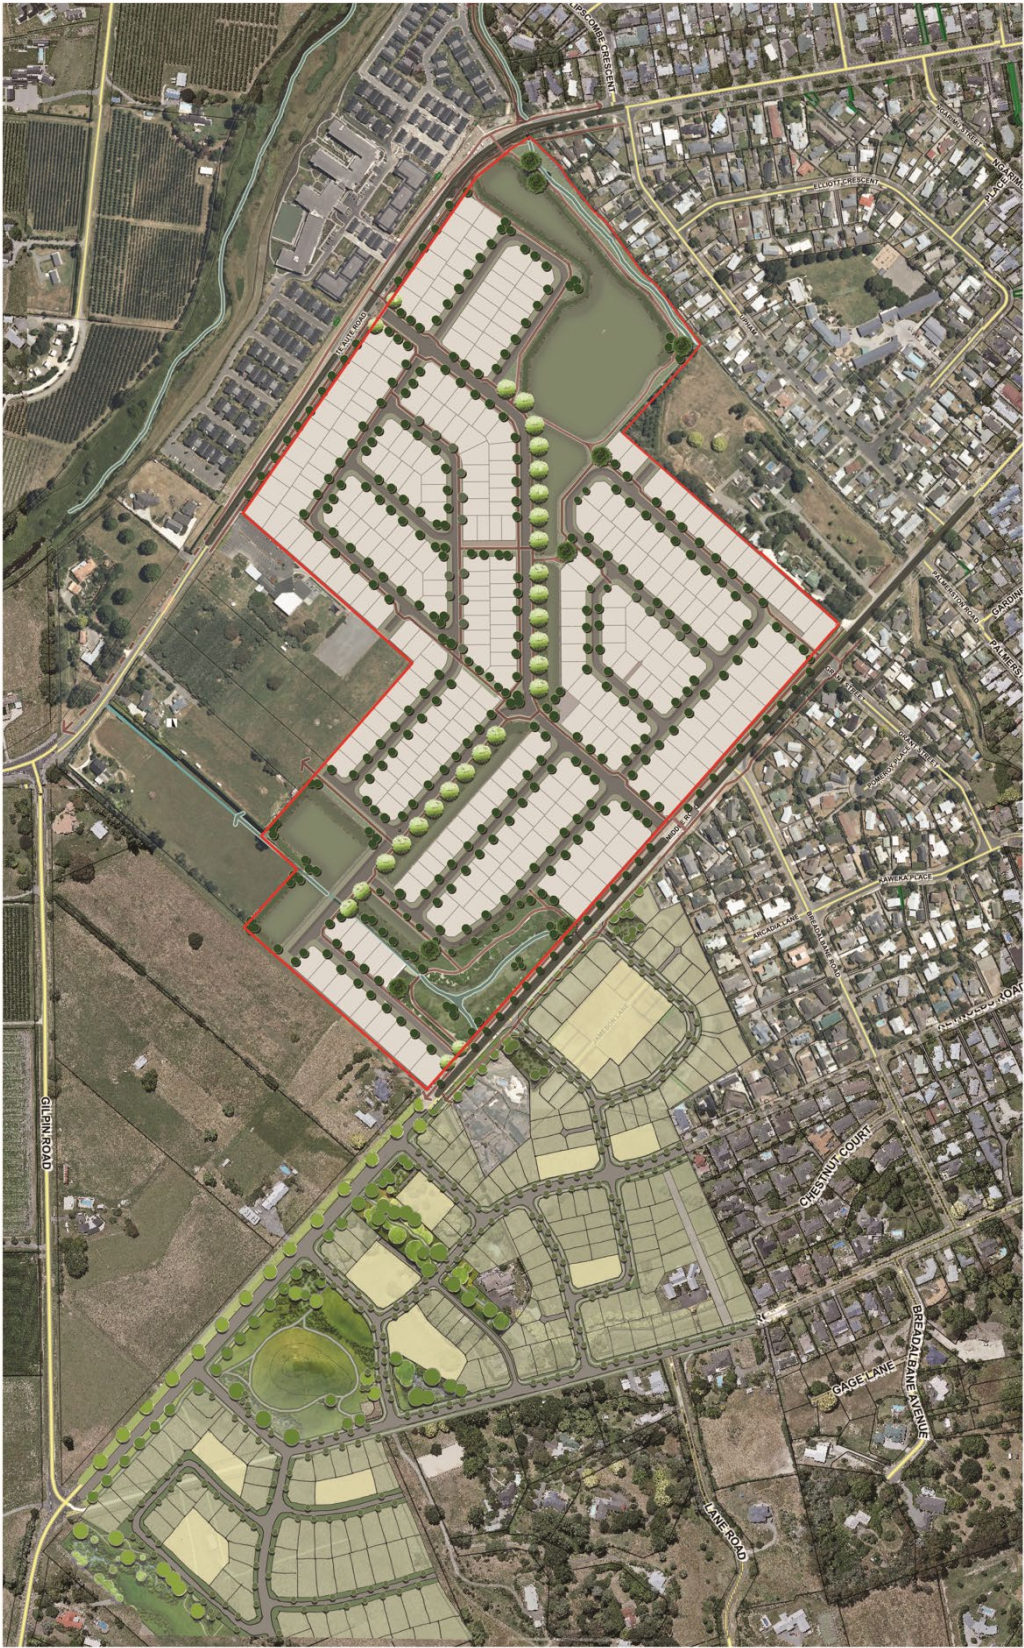
Figure 2: Master Plan.

The Middle Road project will provide for the residential subdivision of the site to enable the development of 317 lots. The intended subdivision layout will provide for a range of lot sizes to enable conventional residential development along with medium density development opportunities. A masterplan has been prepared to inform the substantive application and is provided as **Figure 2**. The development is supported by a suite of technical assessments addressing key environmental matters, including infrastructure, stormwater, geotechnical, groundwater, landscape, transport, ecology, contamination, productive land, noise, archaeology and urban design.

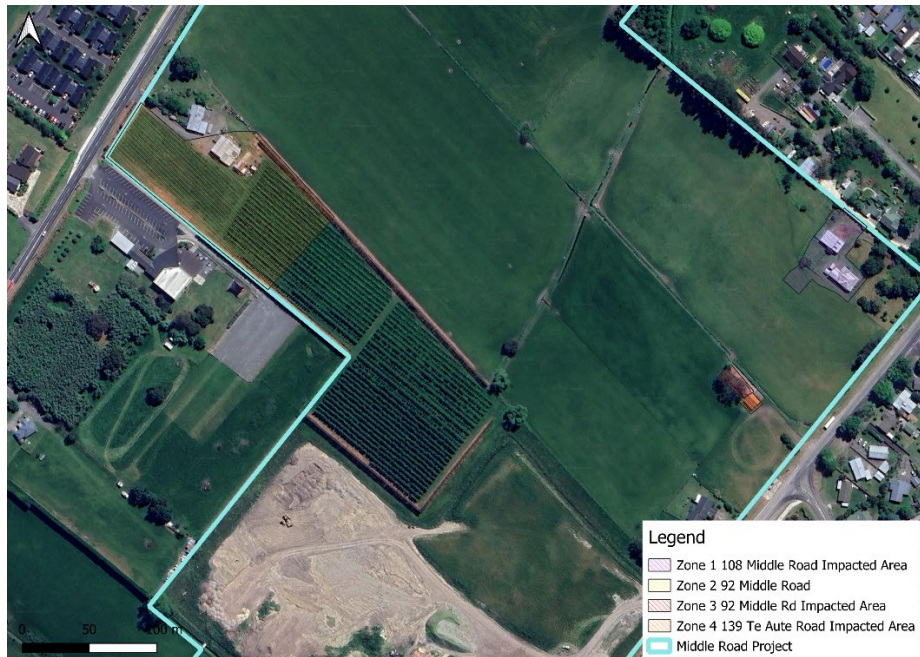
Figure 4: Remedial Extents.

Risks are confined to discrete areas of the site and concentrated in the surficial soil layers of soil. Testing has identified four discrete areas of impact encompassing 12,556 m<sup>2</sup> (3.7%) of the development footprint with an estimated 5,865 m<sup>3</sup> of impacted soil that requires remediation and / or management as set out in Table 1 and Figure 4:

Approximately 2,460m<sup>2</sup> surrounding the villa (Figure 4), containing an estimated 738 m<sup>3</sup> of material exceeds the NES-CS for residential landuse, but is compliant with NES-CS for recreational landuse.
