Lodestone Haldon Geotechnical Desktop Study

Mackenzie Country

Prepared for Lodestone Energy Ltd
Prepared by Beca Limited

12 September 2024

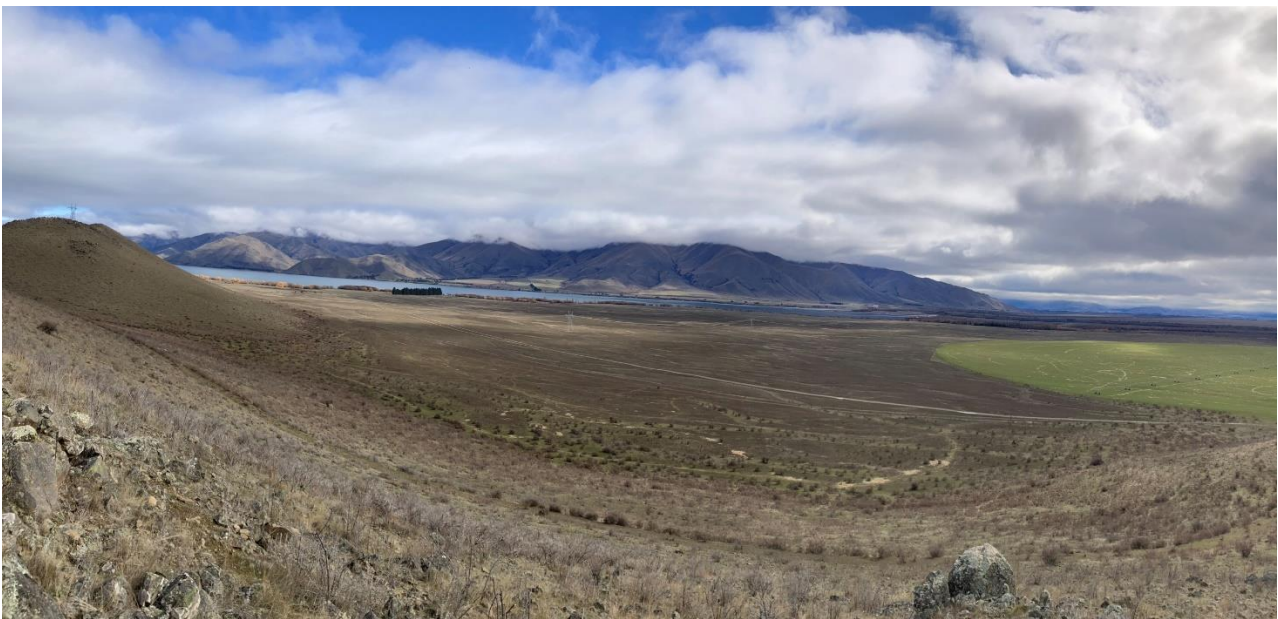
Figure 2: Site overview from Mount Maggie, photograph looking west-southwest.

A walkover by a Beca Engineering Geologist was completed on 26 August 2024 within the site boundary and surrounding area, to gain a greater understanding of the site condition and hazards relevant to the proposed development. A site plan is attached in Appendix C, site photographs taken during the walkover are presented in Figure 2 to Figure 5. A summary of the generalised findings from the site walkover is presented below:

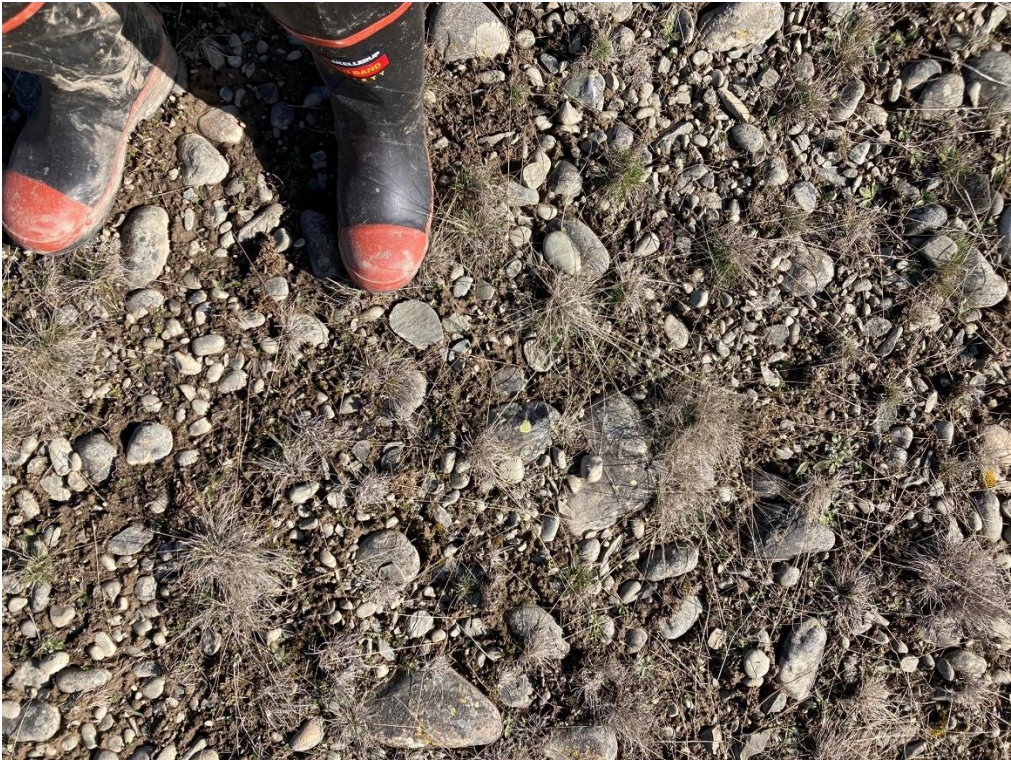
Figure 3: General ground cover of dry short grasses, with gravel and cobbles at surface.

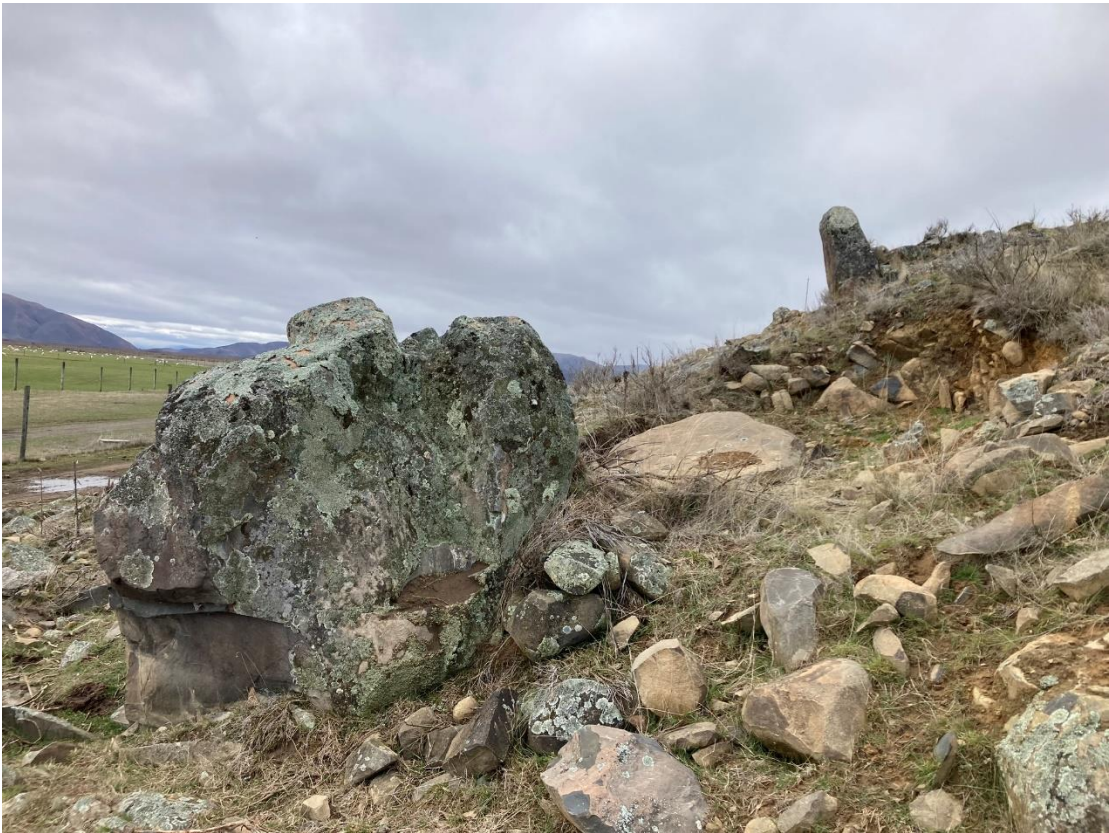
Figure 4: In situ sandstone and boulders on the lower slopes of Mount Maggie.

- The high ground connected with Mount Maggie includes slightly metamorphosed sandstone at the surface. Boulders greater than 1 m in diameter are also scattered across the hillsides of Mount Maggie and at the base of the hillside indicating that they could be buried beneath the site as well as the possibility for an extension of the sandstone beneath the eastern side of the site below the alluvial material.

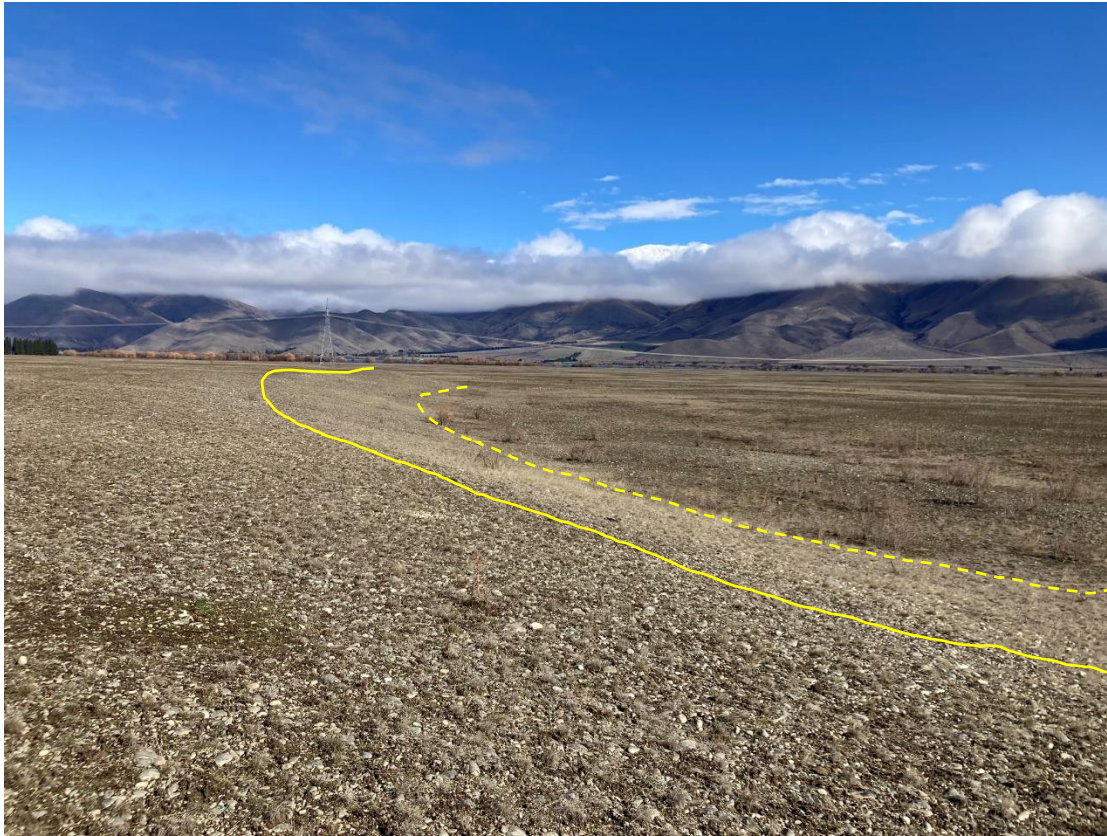
Figure 5: Terrace feature that is present across the site (shown in yellow), photograph looking southwest from the northern extent of the site.

Slope instability hazards are not expected at this site, other than potentially local instability risks near any existing farm drains or areas of higher elevation (such as the terrace slope).

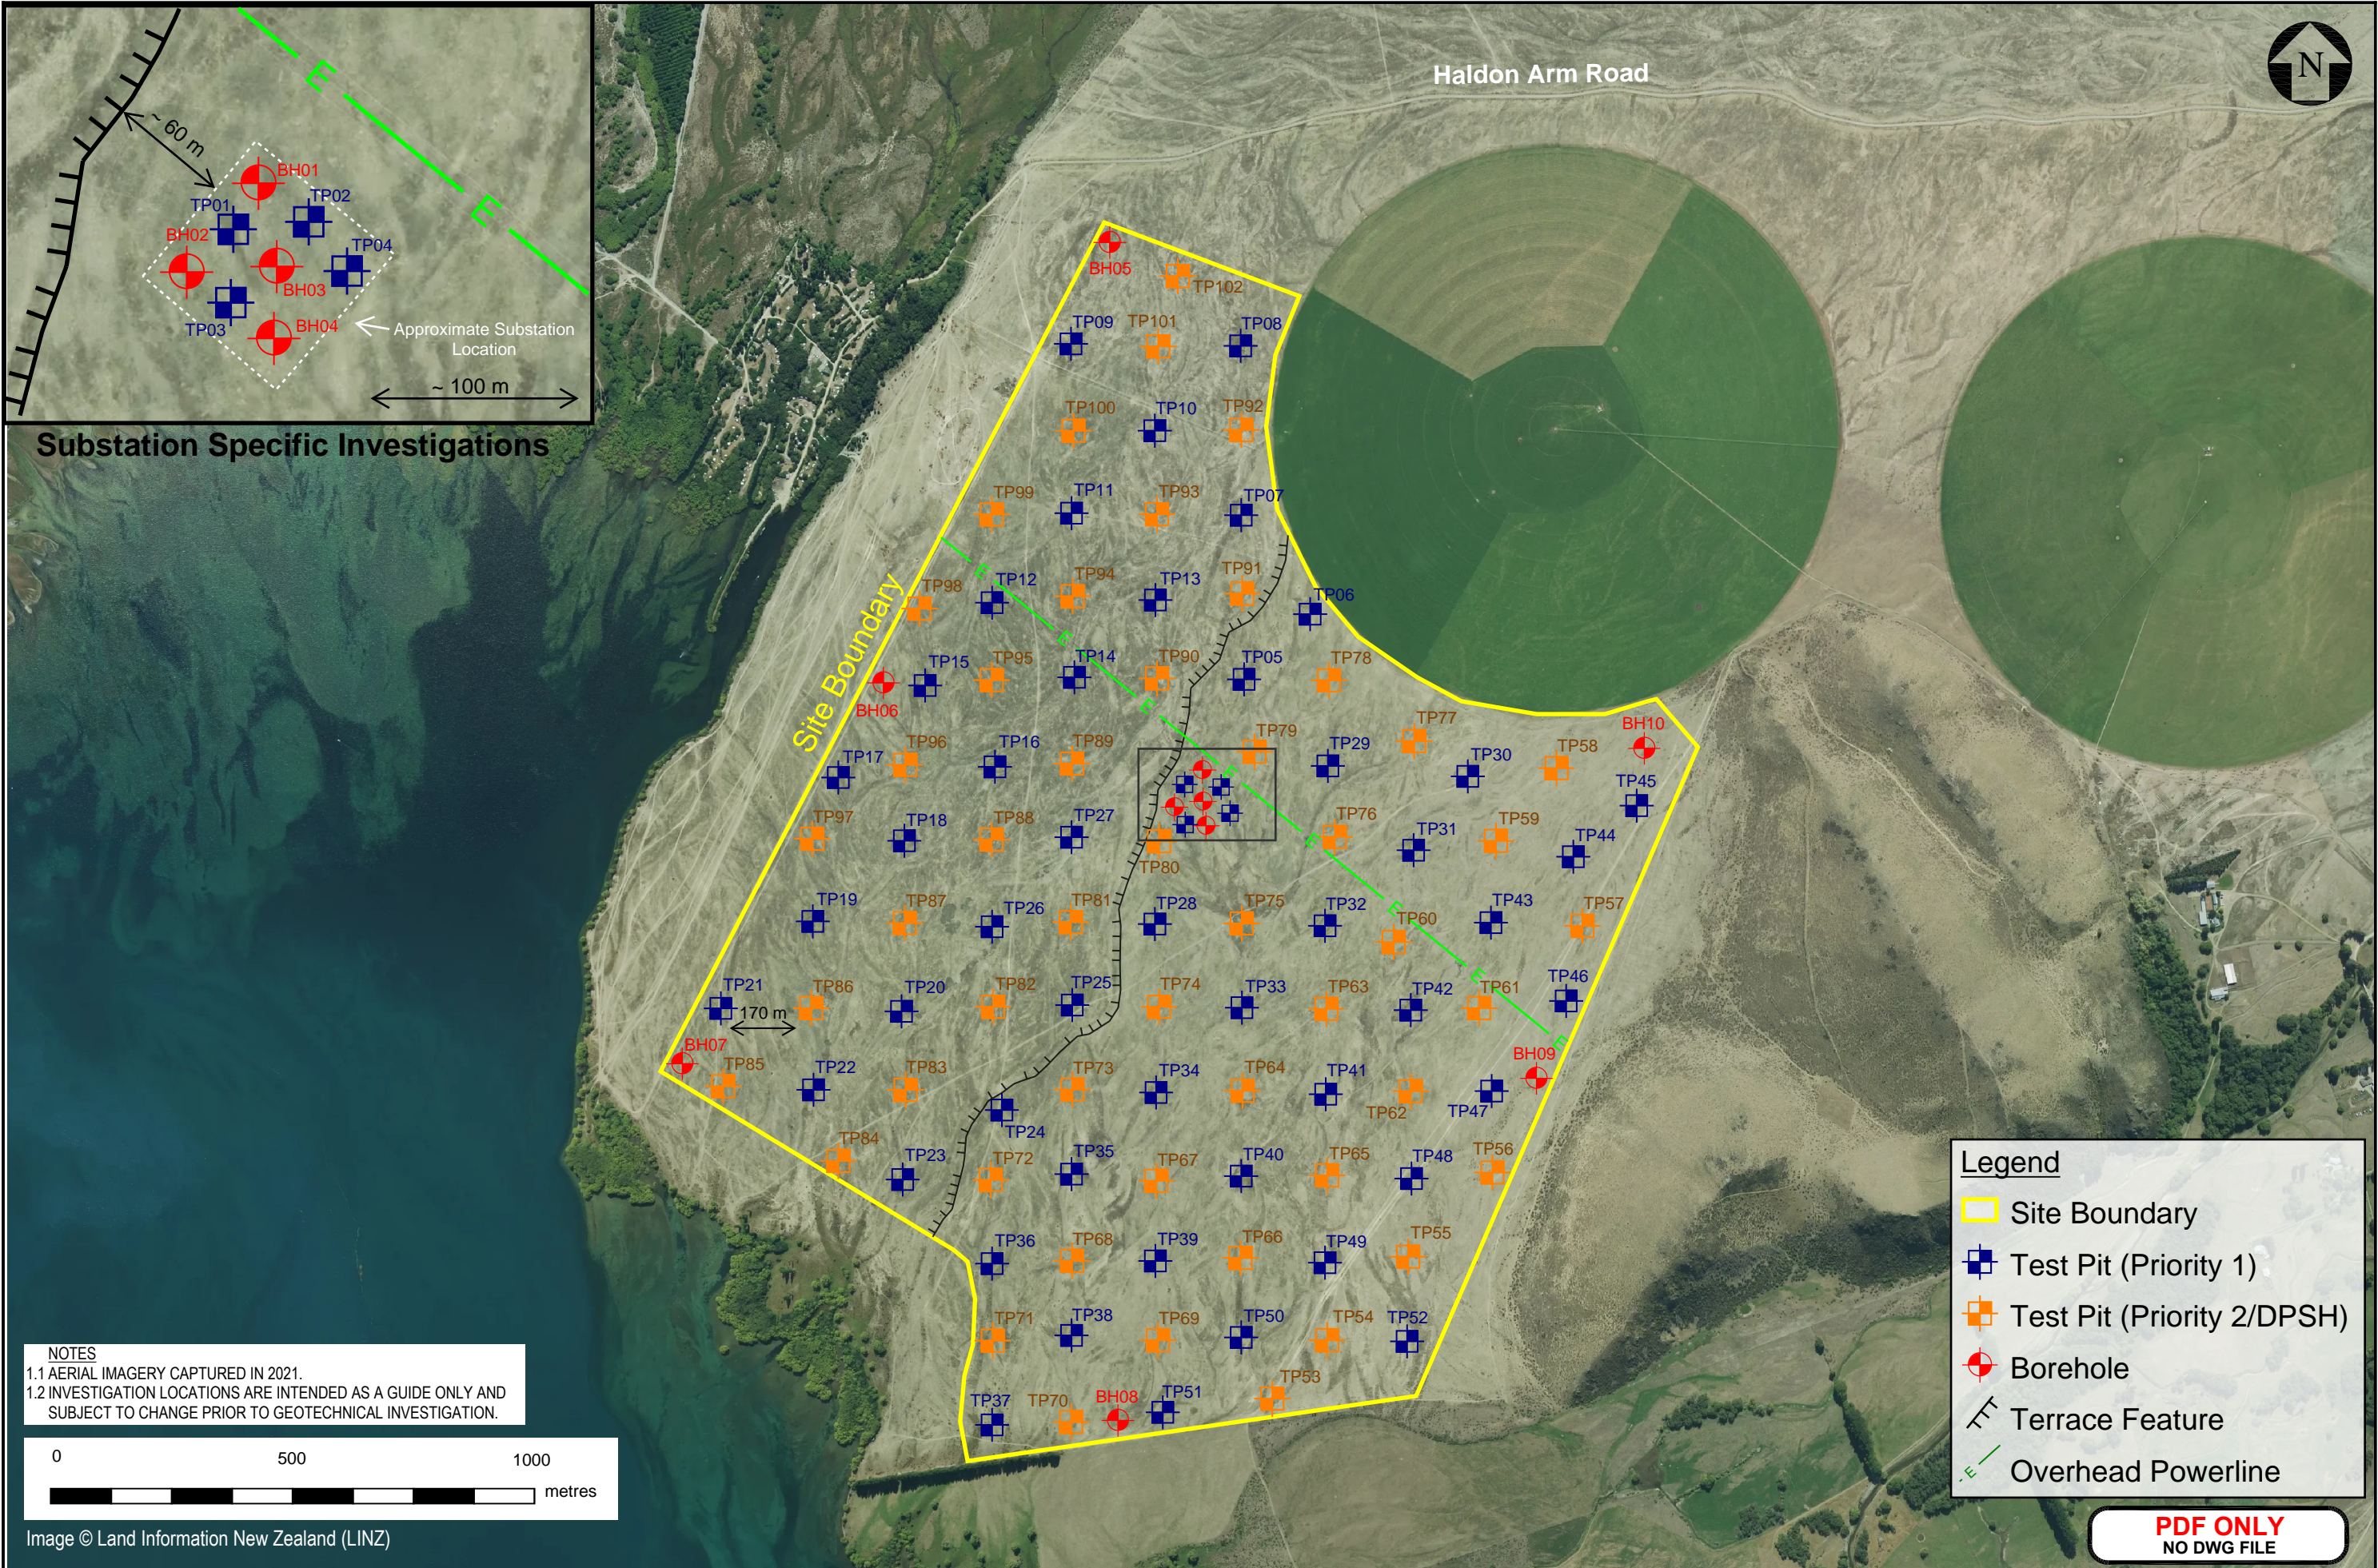
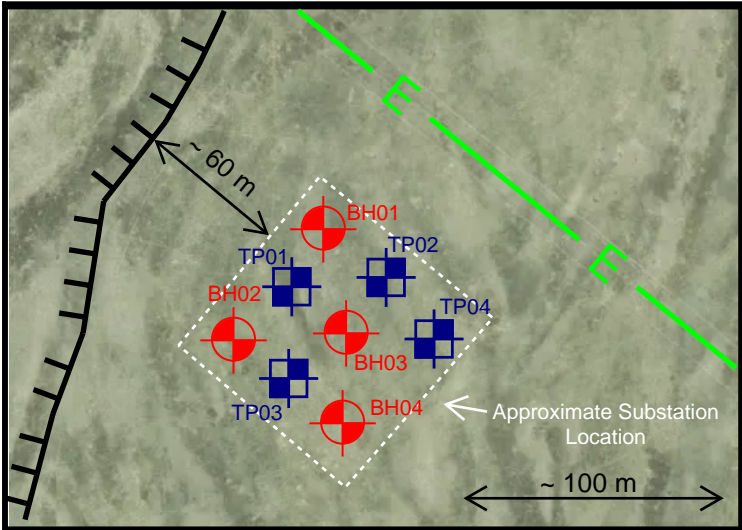
Title:	PROPOSED GEOTECHNICAL INVESTIGATION SITE PLAN
--------	---

Substation Specific Investigations

NOTES
1.1 AERIAL IMAGERY CAPTURED IN 2021.
1.2 INVESTIGATION LOCATIONS ARE INTENDED AS A GUIDE ONLY AND
SUBJECT TO CHANGE PRIOR TO GEOTECHNICAL INVESTIGATION.
