Proposed Residential and Agricultural Development

1073, 1171 and 1185 Tauwhare Road, Tauwhare

# PRELIMINARY GEOTECHNICAL DESKTOP STUDY

Job No. HAM2025-0122AB | Version 0

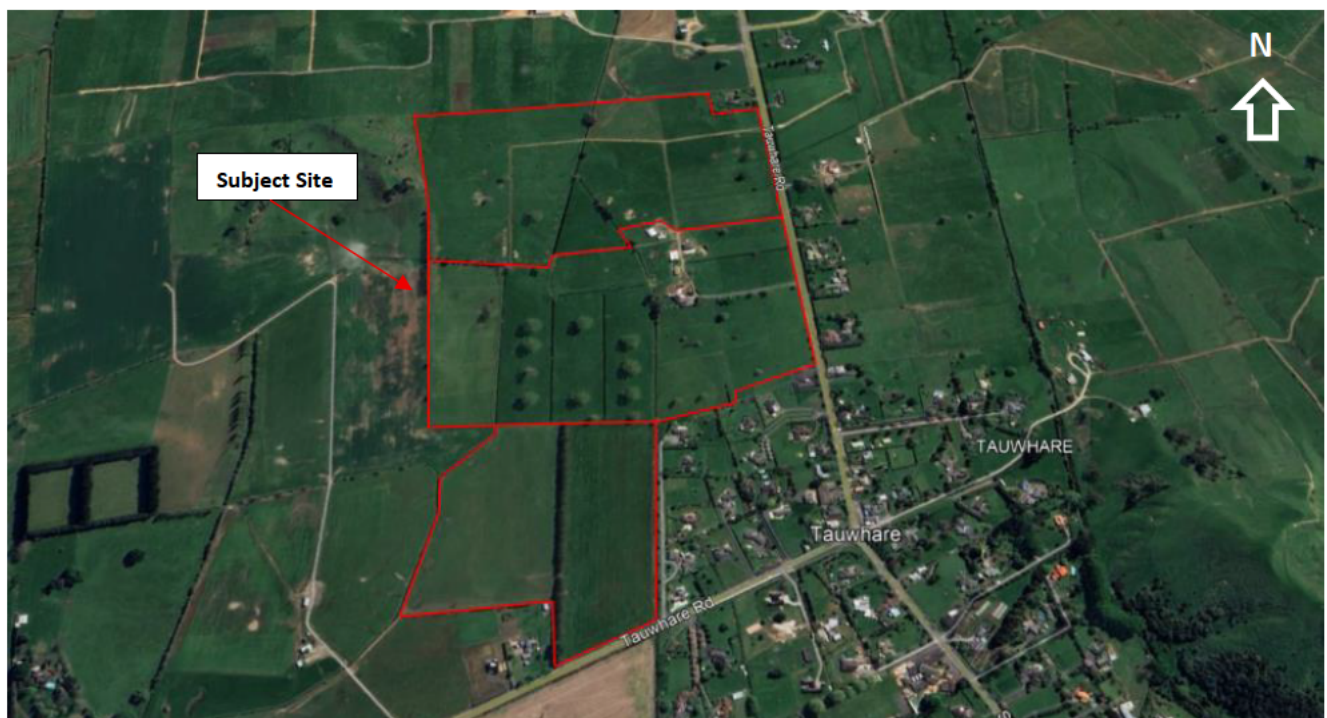
Figure 1: Site Location Plan (Source: Google Earth Pro).

The proposed development is located on Tauwhare Road, Tauwhare, as shown in Figure 1. The site is currently used for pastoral purposes and comprises a total area of approximately 69ha, with three individual Lot titles:

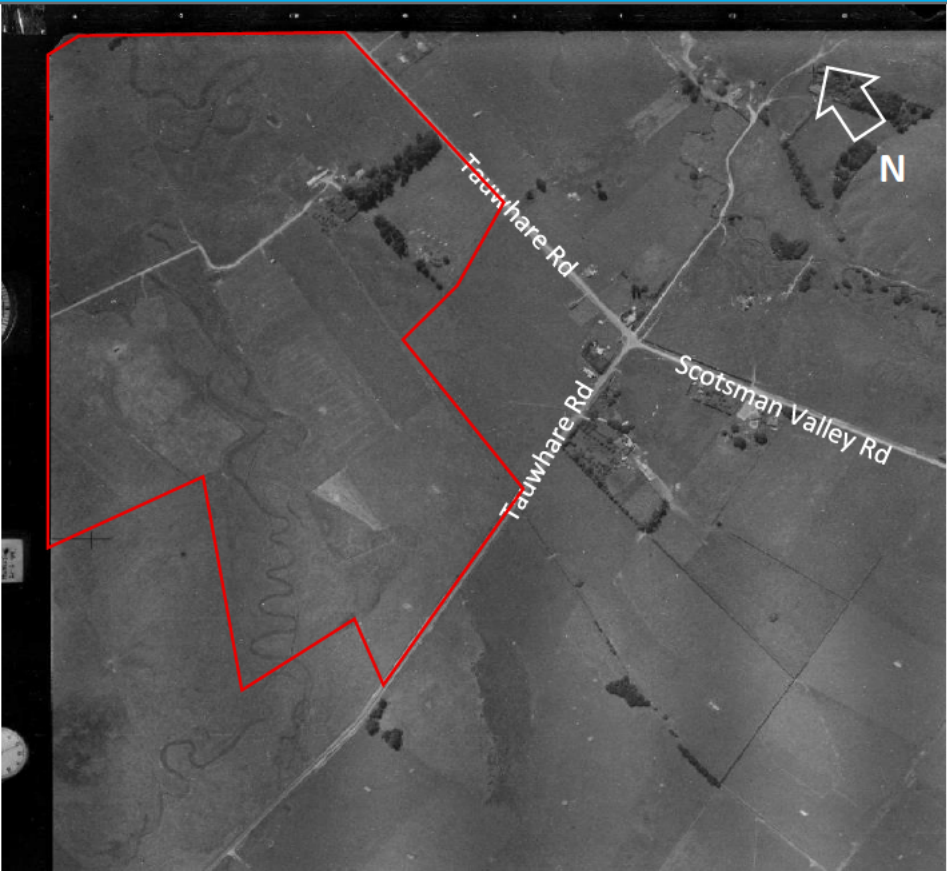
| Date and source | Key Features |
|---|---|
| 1939<br>Retrolens | <ul style="list-style-type: none"> <li>Stream observed running through the site (site boundary outlined in red).</li> </ul> |

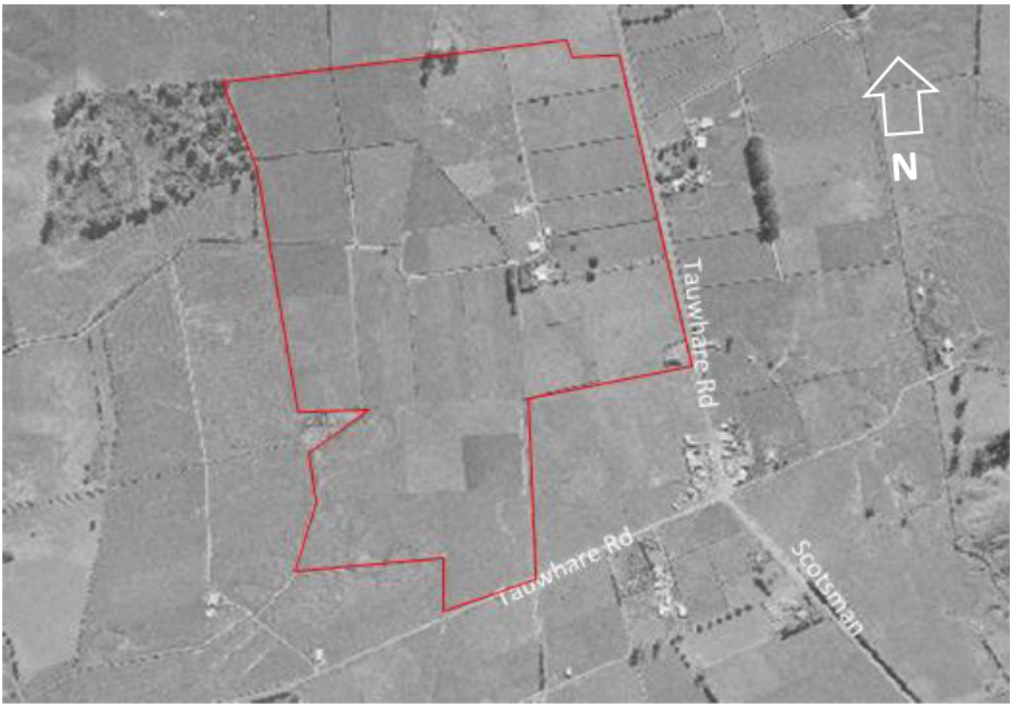
| Date and source | Key Features |
|---|---|
| 1971<br>Retrolens | <ul style="list-style-type: none"> <li>Stream no longer visible and additional paddocks have been created.</li> </ul> |

and by 1971 water had been rediverted to the council drains as part of the Waikato drainage scheme. In 2008, houses were being developed in the area southeast of the site. The old stream could also still be seen in the north of the site. In 2017, ponding is observed in the southern paddock of the site.

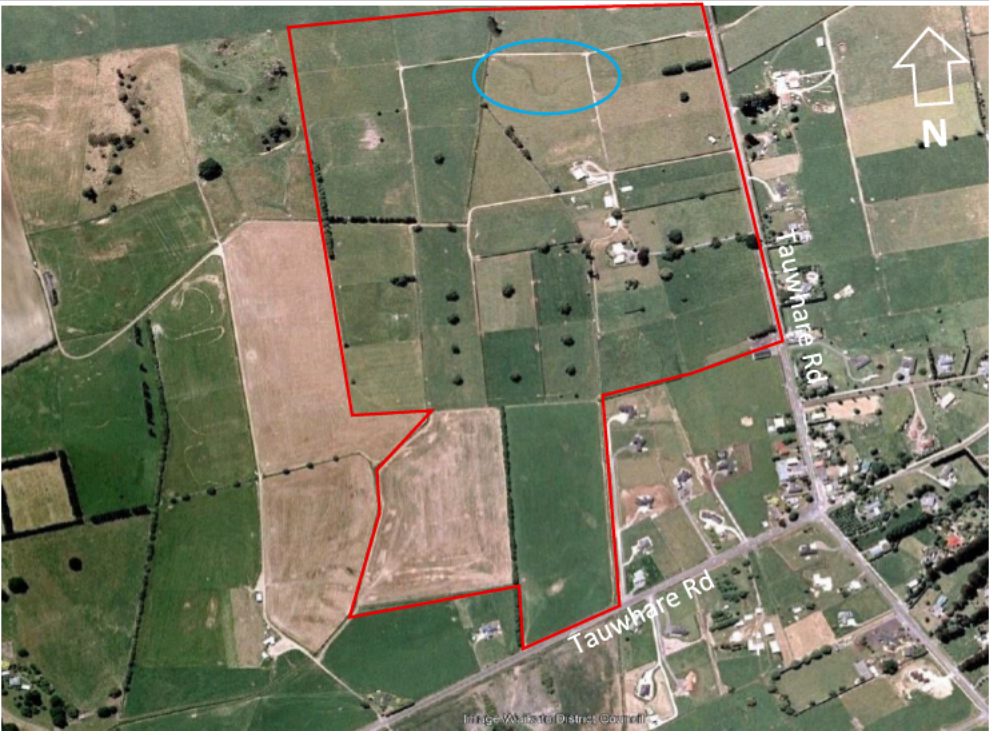
| Date and source | Key Features |
|---|---|
| 2008<br>Google<br>Earth | <ul style="list-style-type: none"> <li>• Housing being built in the south-eastern corner below the site.</li> <li>• Features from the old stream can be seen in the northern part of site (circled in blue).</li> </ul> |

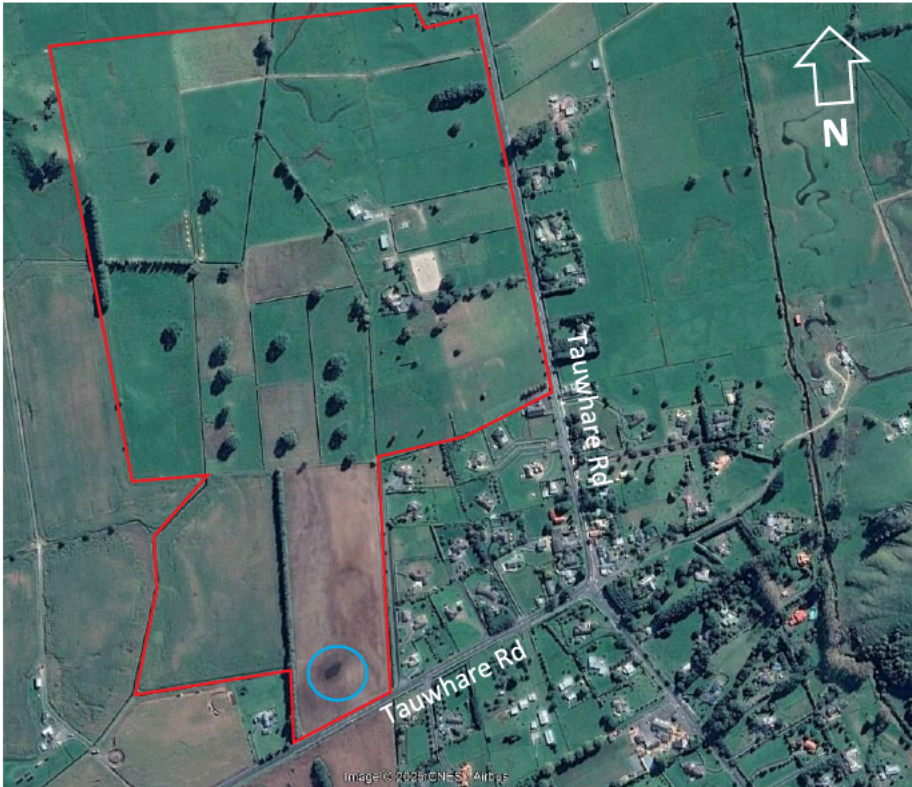
| Date and source | Key Features |
|---|---|
| 2017<br>Google<br>Earth | <ul style="list-style-type: none"> <li>• Ponding identified in southern paddock (circled in blue).</li> </ul> |
